# DOT Auto Safety Hotline Vehicle Owner's Questionnaire

Re: 1999 Mercury Villager Gas Tank Puncture

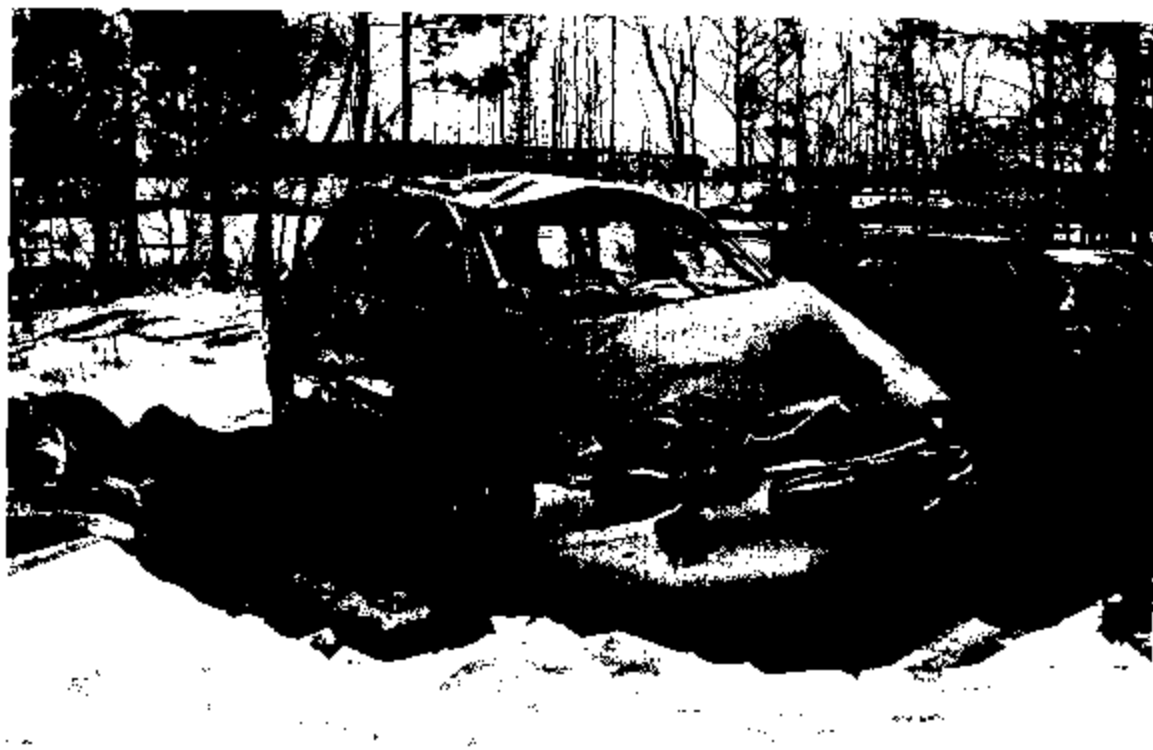
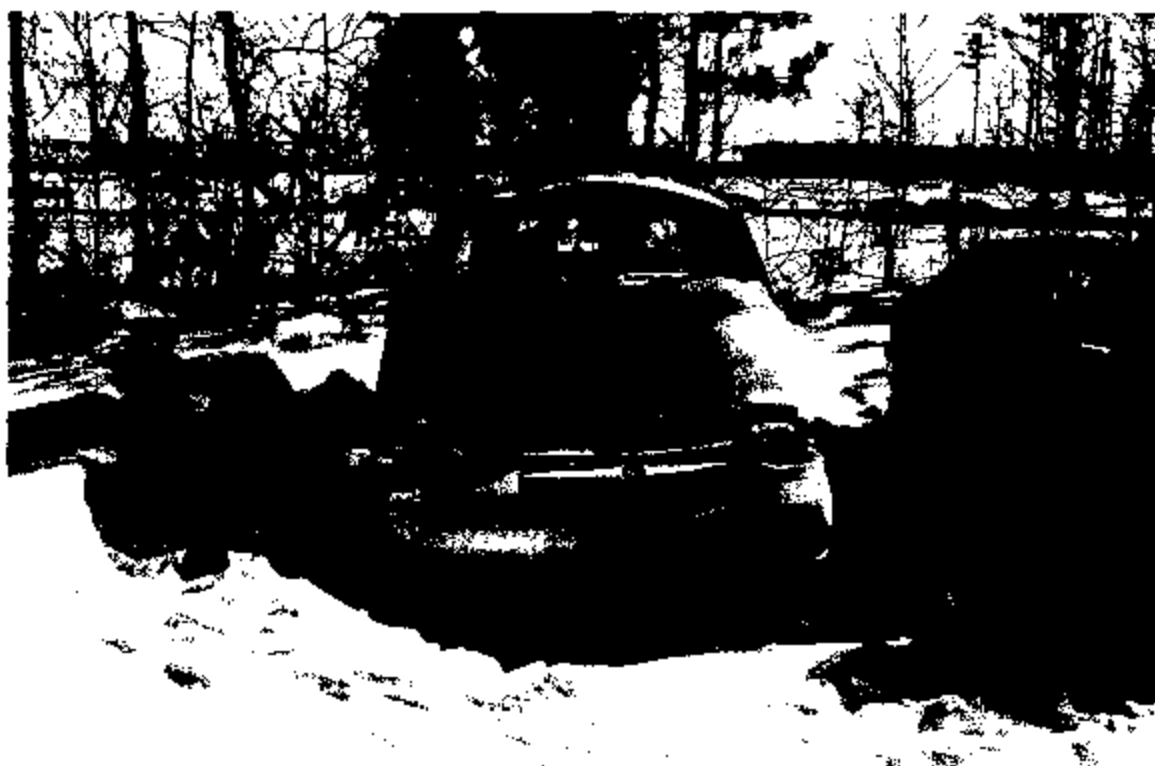
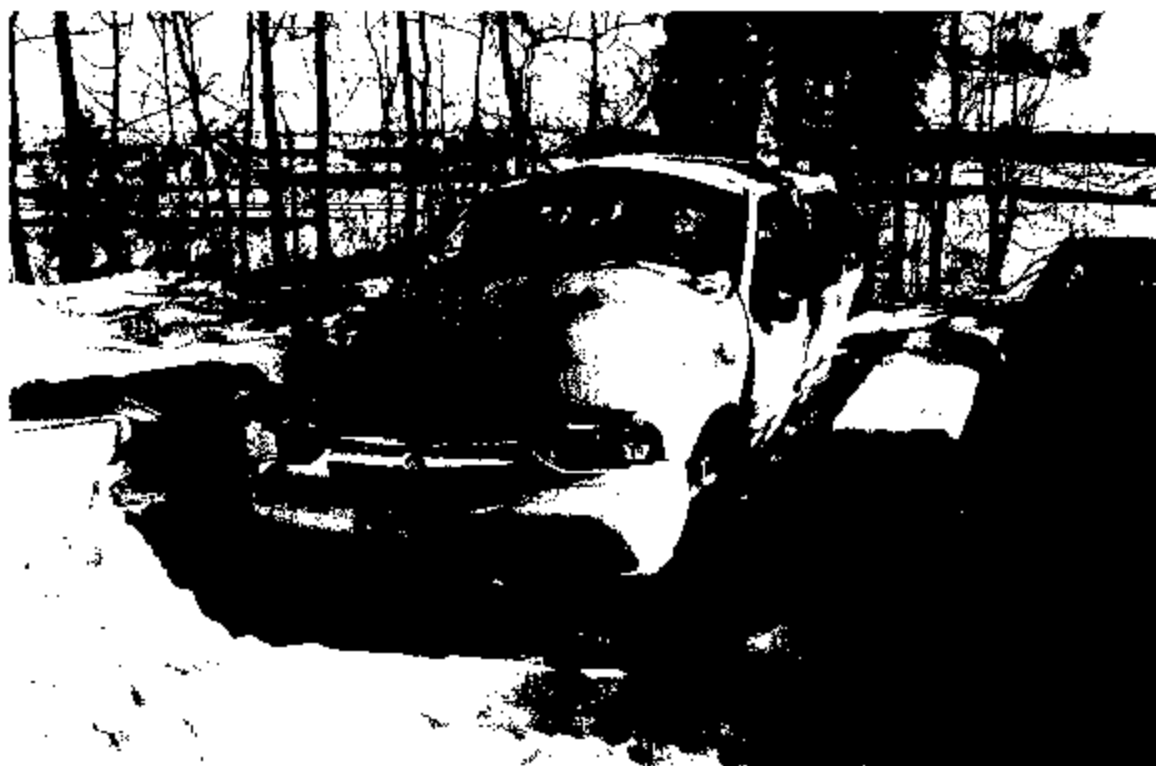
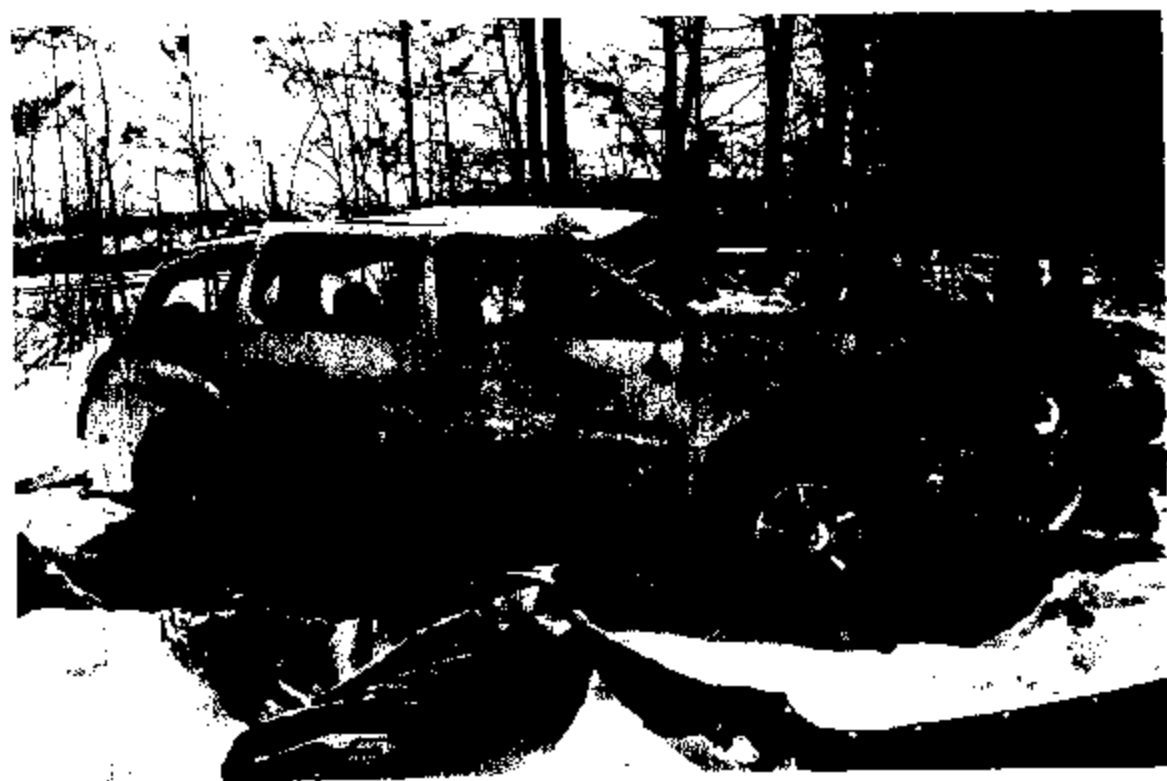
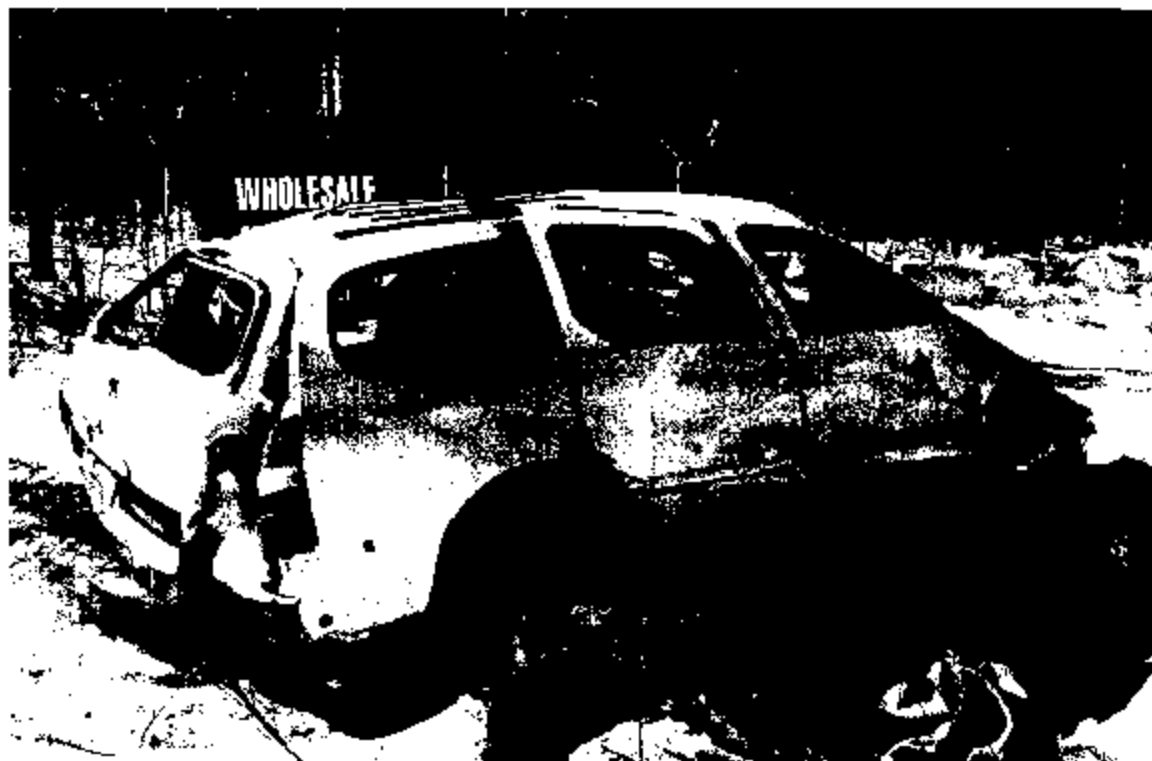
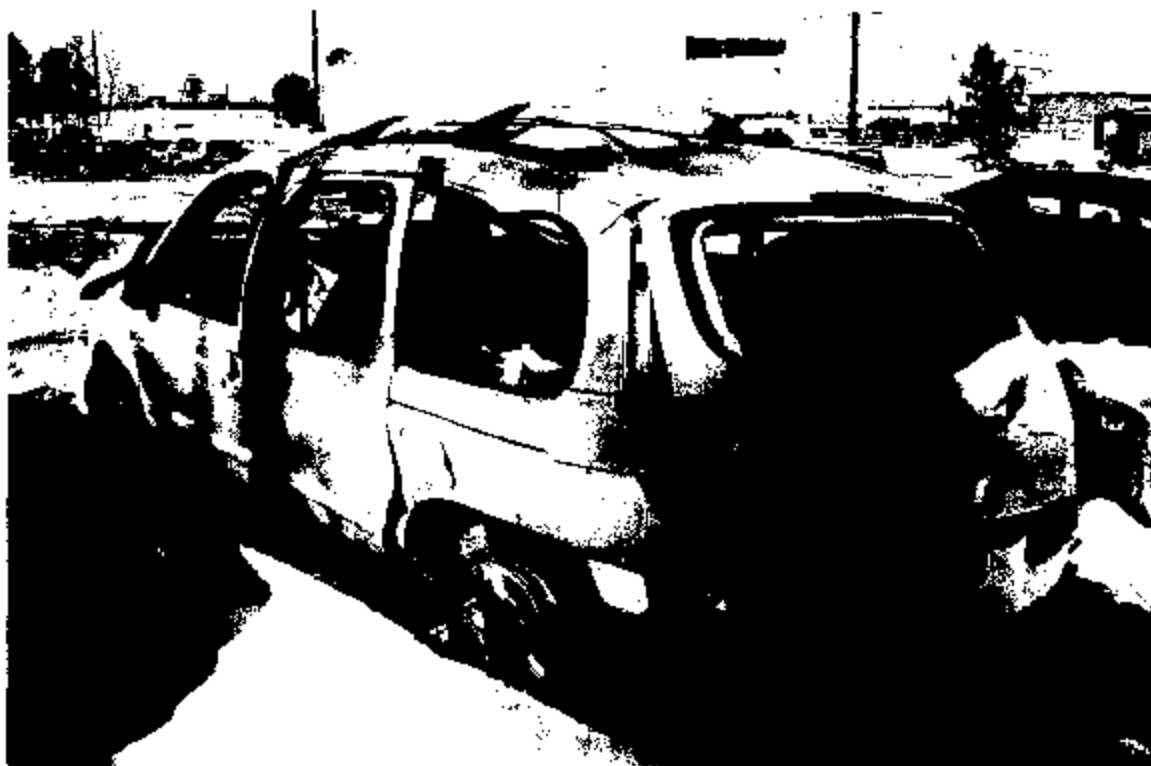
I have enclosed copies of the photographs I took of this minivan. Photographs 21 and 22 show the puncture and photograph 23 shows the data label with the VIN. I believe that the puncture was caused by a vertical brake line support bracket welded to the rear axle. I apologize for the small number of photographs, but the puncture wasn't related to my job that day and I took them more for curiosity than anything else. I never received a police report, but I do know that the accident took place on Interstate 95 in Virginia on May 27, 1999. If you need more information I could put you touch with the attorney I got the assignment from.
