## EXPLORING THE LIMITS OF OCCUPANT SAFETY IN FRONTAL CAR-HGV IMPACTS

### ABSTRACT

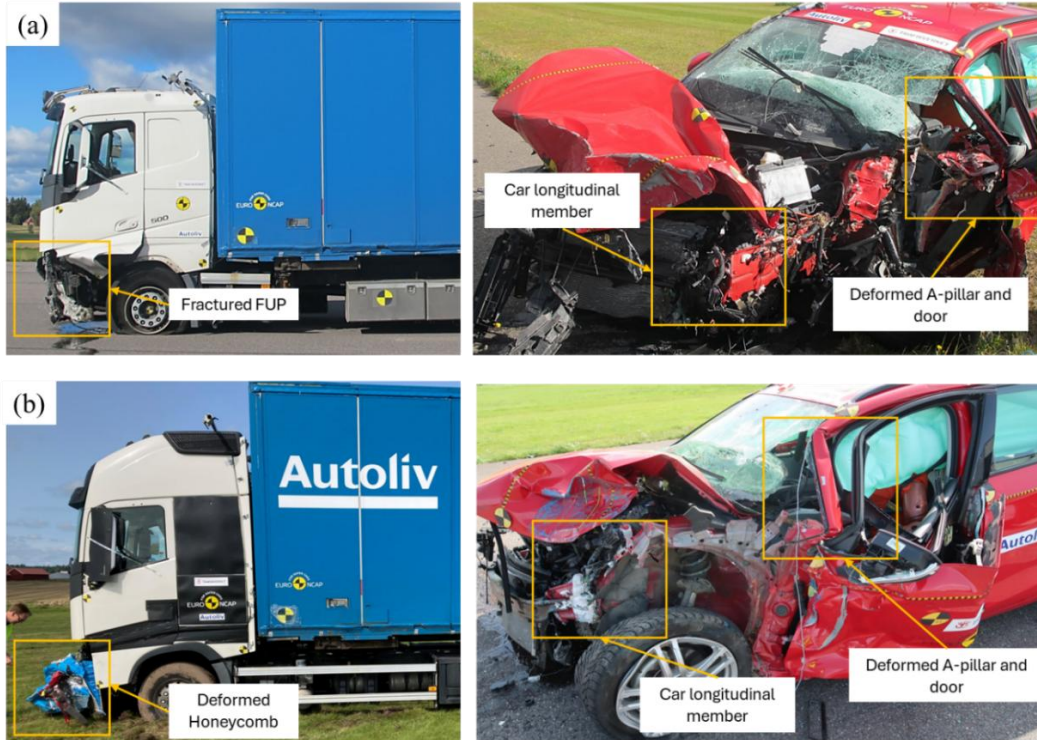
**Figure 9: Deformed HGV and car structure in (a) Test-1 and (b) Test-2 after the frontal collision 50% offset impact between passenger car and HGV.**

In both Test 1 and Test 2, the crash involved 3,000 kJ of energy, which tested the frontal crash protection limits of the vehicles. For the HGV, the damage was primarily to the front structures, affecting the truck's steering ability after the crash. The passenger car's occupant compartment was compromised, as shown in Figure 9. Structural intrusions were observed at points where occupants could contact with the interior (Figure 10).

In Test-1, the HGV FUP fractured (Figure 9 (a)) and exposed the cab's bottom to the car's structural members, causing damage to the HGV's steering system and puncturing its left front tire. This led to the HGV moving laterally after the impact. The car rotated after contacting the HGV in Test-1 and came to rest 30m from the impact point. The car's crush zone and longitudinal members remained relatively undamaged in the first test (Figure 9 (a)). In Test-2, with the experimental truck front, deformation of the door and A-pillar of the car showed significant improvements compared to Test-1 (Figure 9 (b)). Specifically, the change in door opening decreased by 64%, the deformation at the bottom of the A-pillar was reduced by 66%, and the top deformation of the A-pillar decreased by 35% (Figure 11). The intrusion values at the accelerator pedal, footrest, and toe-pan increased in Test-2 compared to Test-1. This difference in intrusion values can be attributed to the distributed horizontal and vertical loading in Test-2 due to the backup structure. The overall deformation of the car in Test-2 is shown in Figure 12.

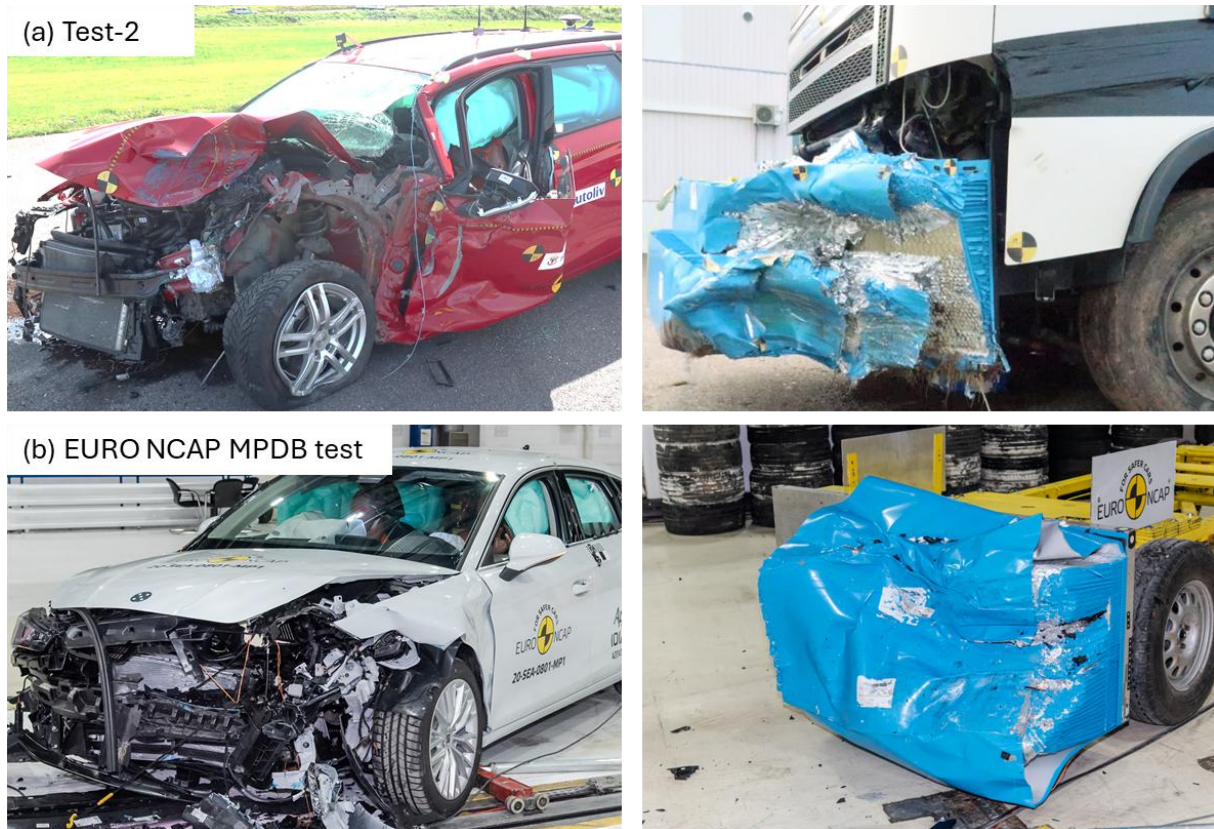
**Figure 14: Deformation comparison for the car in the 50% offset frontal impact between (a) Test-2 (Passenger car and HGV), (b) car to MPDB in EURO NCAP test.**

During first 20 ms of impact, the car in Test-2 did not engage effectively with the experimental truck front compared to the MPDB test. Figure 13 shows how the magnitude of car acceleration increases in the first 10 ms but then drops suddenly to zero for both vehicle-vehicle tests. This is not apparent in the MPDB test where a consistent crush resistance of the barrier is seen in the crash pulse. Peak car accelerations in Test-2, from 30 to 50 ms, are comparable to those observed in the MPDB test and indicate renewed honeycomb crush resistance in the experimental truck front. The peak acceleration for both Test-2 and the MPDB occurred at the same time, 58g and 35g, respectively (Figure 13). This variation in the peak values was primarily due to: (1) the honeycomb structure in the HGV front bottoming-out locally at the contact point with the car's longitudinal member and, (2) the honeycomb HGV front was stiffer compared to MPDB barrier in Test-2 (Figure 14). It is important to note that the impact energy in Test-2 was significantly higher than that of the MPDB test.
