August 9, 2022

Product Change Notice - In-Wall slide-out temporary emergency stop brackets

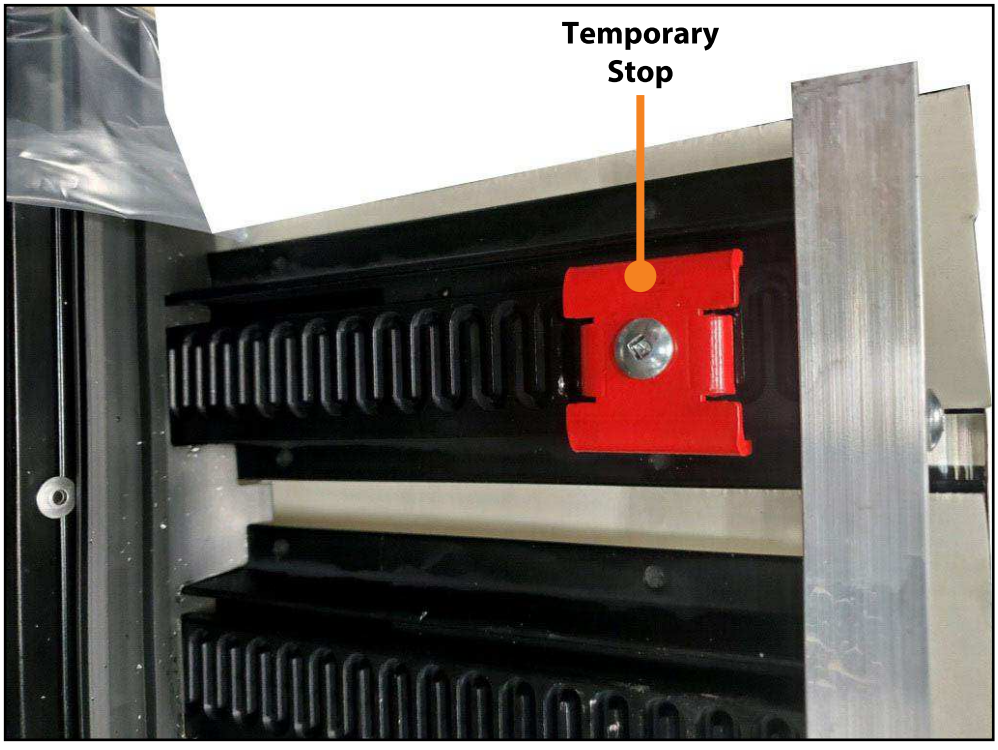
Please be advised Lippert is installing temporary emergency stop brackets on the In-Wall Slide-out racks to provide additional safety measures for installation of the In-wall system.

The stop brackets will be installed on both the left (Fixed) and right (Float) side top racks near the end of the extend travel position by Lippert production prior to shipping the In-Wall systems.

These temporary stop brackets will prevent the room from extending too far and possibly falling out before the OEM's permanent method (fascia and/or their own stop) is installed.

NOTE: Failure to remove these temporary emergency stop brackets before end use could result in the In-Wall Slide-out not extending to its fullest extension or damage to the system itself. This is not designed to be the permanent method of stopping the system on the extend stroke.
