TECHNICAL SERVICE BULLETIN **26-2226**
Harsh/Delayed Engagement And/Or Harsh/Delayed Shift 08 May 2026

Issue: Some of the vehicles listed in the Model statement above may exhibit at least one of the following conditions:

This may be due to PCM software and/or axial movement of the CDF clutch cylinder (7H351) sleeve causing hydraulic circuit leaks.

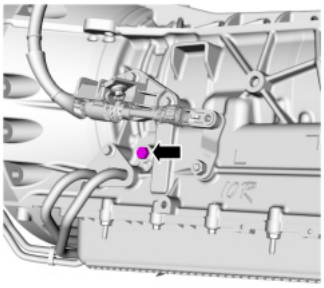
Figure 1

1. Install the VCMM PVT to the transmission line pressure port. (Figure 1)

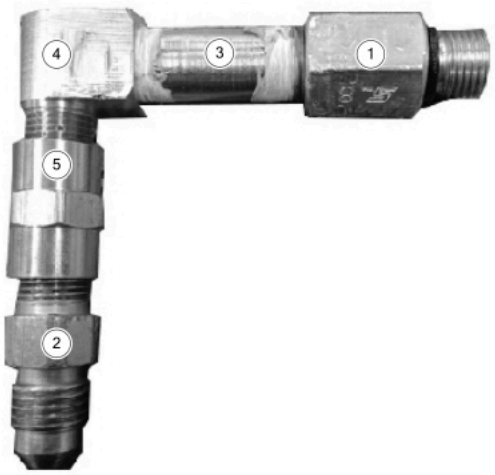
Figure 3 - Transit only

- VCMM Transmission Extension Kit
- Locally obtain the necessary adapter fittings to connect the VCMM PVT to the transmission line pressure port (Figure 3)
