EA02-027

LETTER TO ODI

APPENDIX A

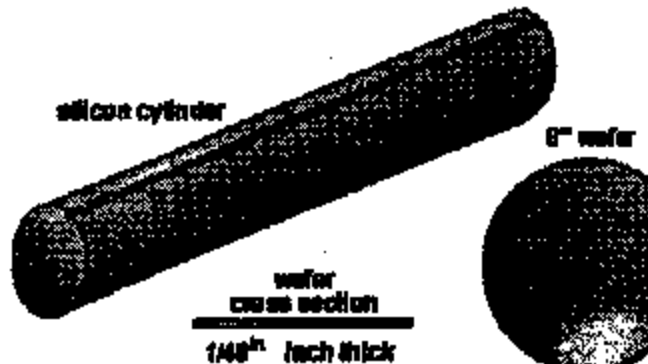
Pure single-crystal cylinders of silicon are sliced into thin, highly polished wafers less than one-fourth of an inch thick. Hundreds of memory chips are etched onto each wafer.

Most chip designs are developed with the help of computer systems or computer-aided design (CAD) systems. Circuits are developed, tested by simulation, and perfected on computer systems before they are actually built. When the design is complete, glass photomasks are made—one mask each layer of the circuit. These glass photomasks are used in a process called photolithography.

Semiconductor memory chips are manufactured in cleanroom environments because circuitry is so small even tiny bits of dust can damage it. Micron has class 1 and class cleanrooms. In a class 1 cleanroom, there is no more than 1 particle of dust in a cubic foot of air. In comparison, a clean, modern hospital has about 10,000 dust particles cubic foot. The air inside a cleanroom is filtered and recirculated continuously, and employees wear special clothing such as dust-free gowns, caps, and masks to help keep the air particle-free.

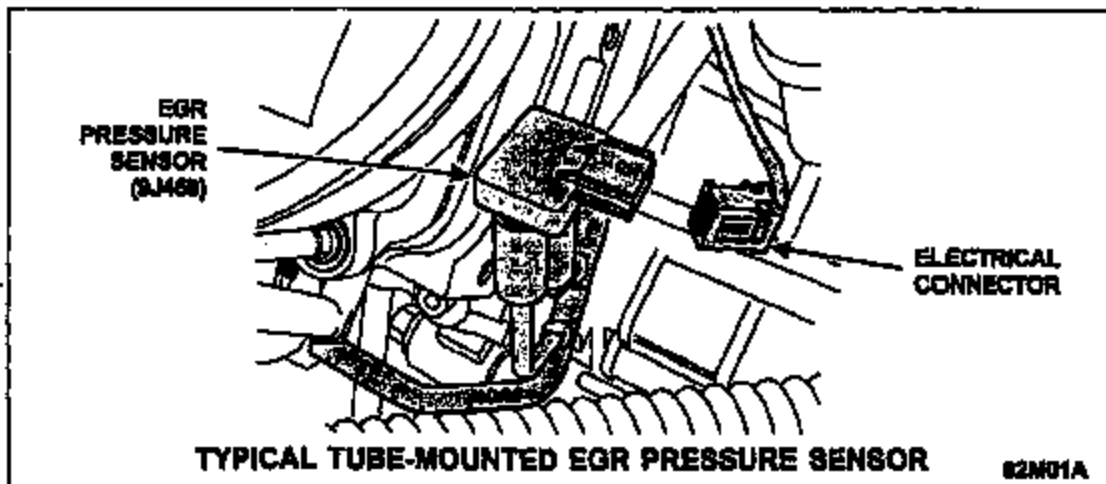
2. If one or more of the DTCs listed above is present, replace the EGR pressure sensor (9J460) as follows:
 - a) Key off.
 - b) Disconnect the electrical connector and remove the EGR pressure sensor from the EGR tube.
 - c) Install the new EGR pressure sensor onto the EGR tube and connect the electrical connector.
Note: Refer to Section 303-08 of the appropriate workshop manual if additional information is required.
3. Clear continuous DTCs.
4. Perform KOEO self test.
