EA02-027

LETTER TO ODI

PolySwitch Surface-mount Resettable Devices

PolySwitch Automotive Resettable Devices

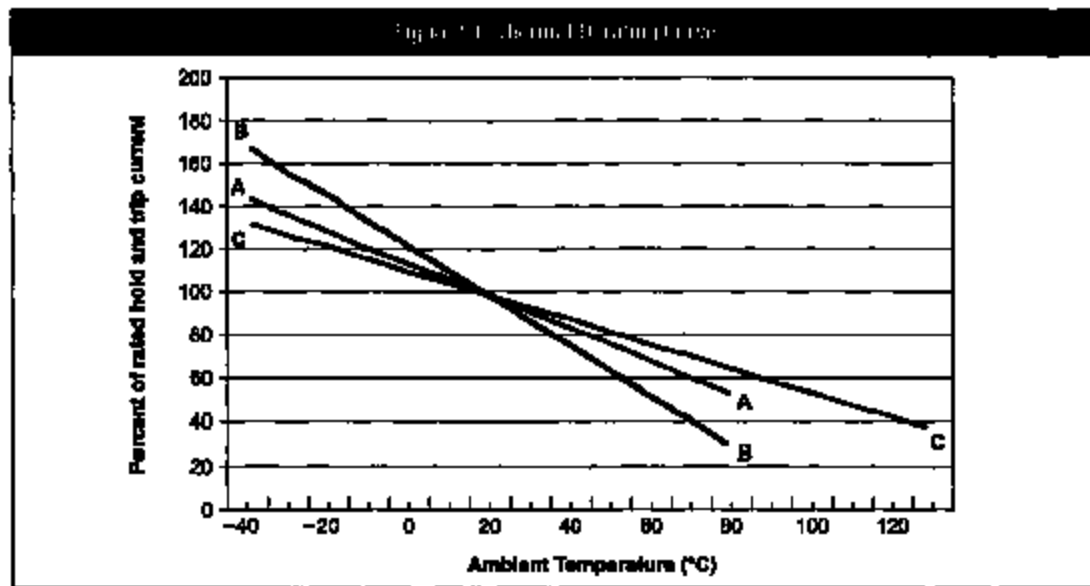
B = miniSMDE190

C = SMDH100

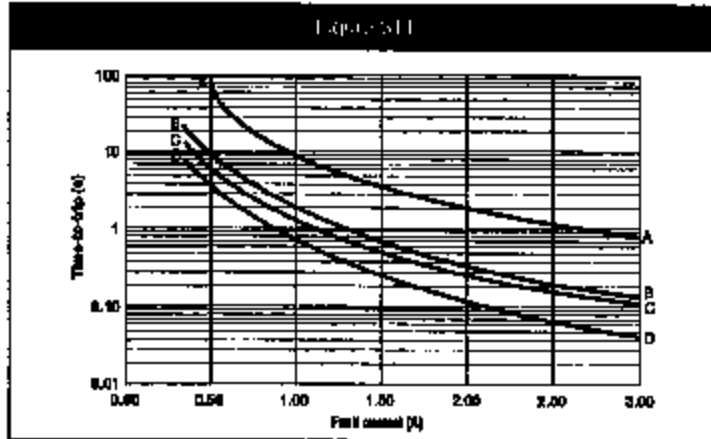
Telecom and Networking Devices

- A = TS600-170/TS600-200
- B = TS250-130
- C = TSV250-130
- D = TSL250-060

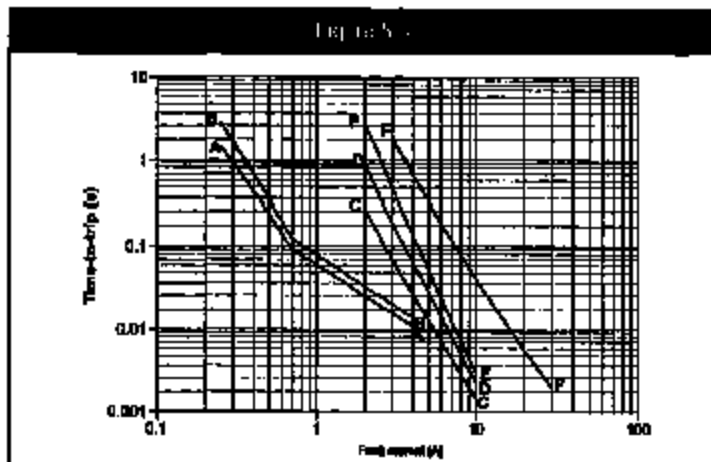
nanoSMD (data at 25°C)

- A = nanoSMDM012
- B = nanoSMDM016
- C = nanoSMDM050, nanoSMDM050F
- D = nanoSMDM075, nanoSMDM075F
- E = nanoSMDM100, nanoSMDM100F
- F = nanoSMDM150

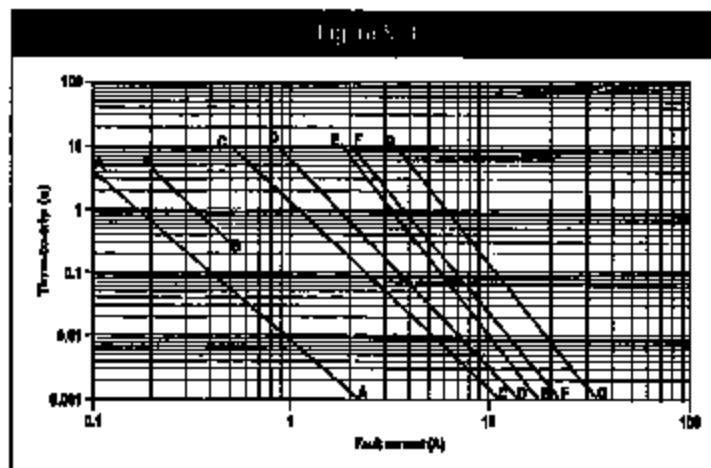
microSMD

- A = microSMD005
- B = microSMD010
- C = microSMD035
- D = microSMD050
- E = microSMD075
- F = microSMD110
- G = microSMD150

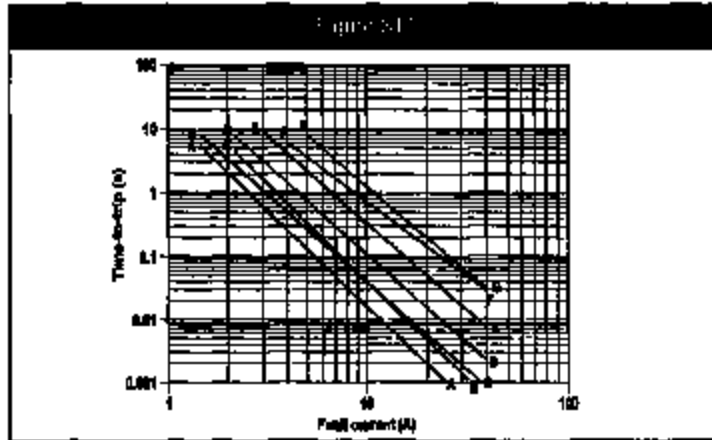
Figures S11-S18. Typical Time-to-trip Curves at 20°C for Surface-mount Devices *continued*miniSMDM (data at 25°C)

- A = miniSMDM075
- B = miniSMDM075/24
- C = miniSMDM110
- D = miniSMDM110/16,
miniSMDM110F/16
- E = miniSMDM160,
miniSMDM160F
- F = miniSMDM200,
miniSMDM200F
- G = miniSMDM280,
miniSMDM280F

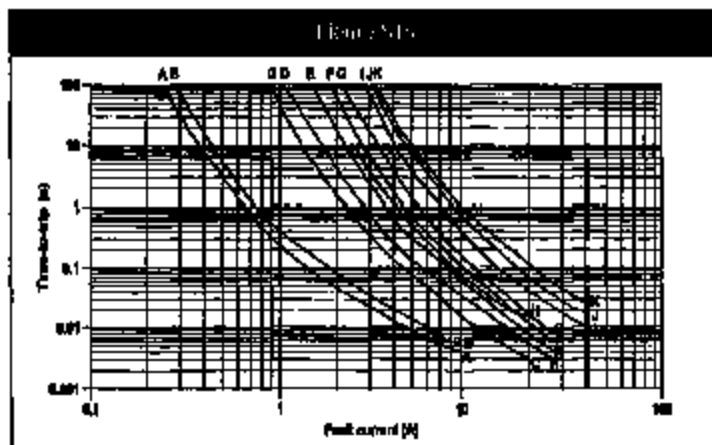
miniSMDC and miniSMDE

- A = miniSMDC014
- B = miniSMDC020
- C = miniSMDC050
- D = miniSMDC075
- E = miniSMDC110
- F = miniSMDC125
- G = miniSMDC160
- H = miniSMDC160F
- I = miniSMDC200
- J = miniSMDE190
- K = miniSMDC280

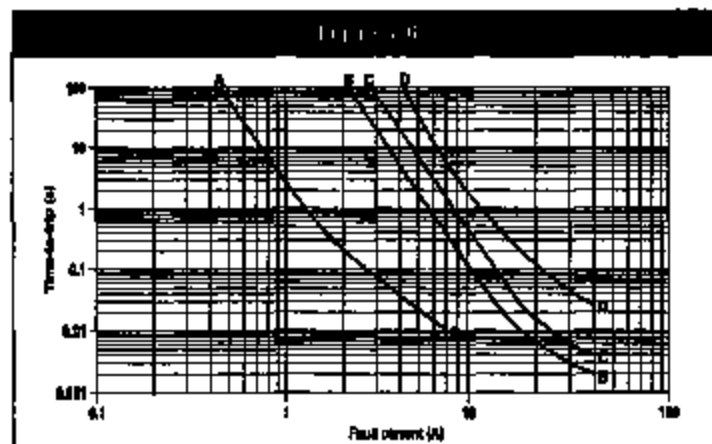
midSMD

- A = SMD030-2018
- B = SMD100-2018
- C = SMD150-2018
- D = SMD200-2018

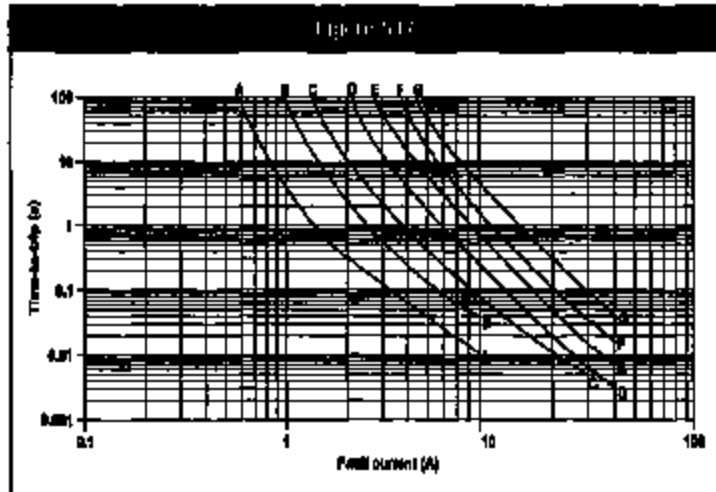
Figures S11–S18. Typical Time-to-Trip Curves at 20°C for Surface-mount Devices

SMD

- A = SMD030
- B = SMD050
- C = SMD075
- D = SMD100 and 100/33
- E = SMD125
- F = SMD260 and SMD260RB
- G = SMD300

Time-to-trip is the amount of time it takes for a device to switch to a high-resistance state once a fault current has been applied across the device. Identifying the PolySwitch device's time-to-trip is important in order to provide the desired protection capabilities. If the device you choose trips too fast, undesired or nuisance tripping will occur. If the device trips too slowly, the components being protected may be damaged before the device switches to a high-resistance state.

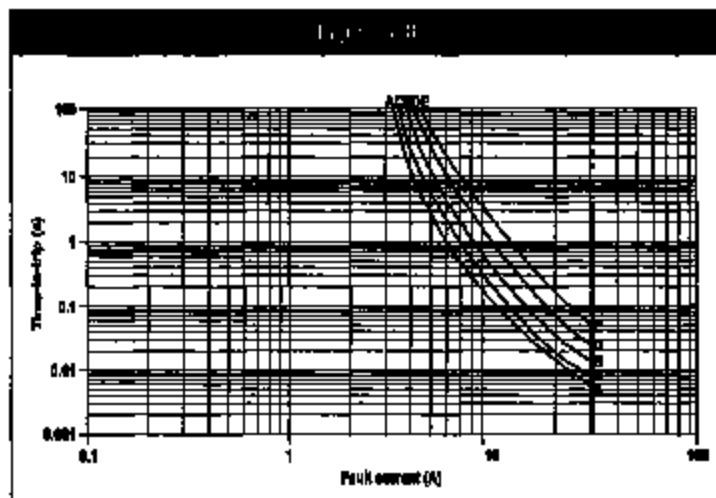
SMD2

- A = SMD150 and 150/33
- B = SMDH180
- C = SMD185
- D = SMD200
- E = SMD260

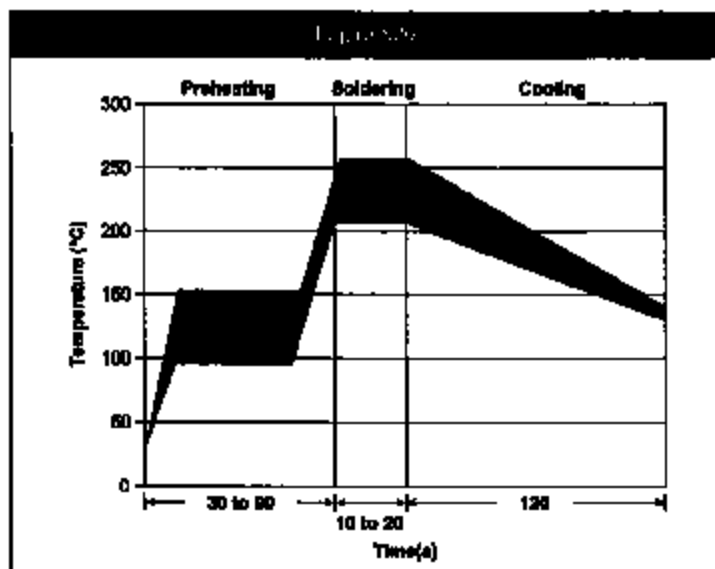
Solder Reflow and Rework Recommendations for Surface-mount Devices

- If reflow temperatures exceed the recommended profile, devices may not meet the performance specifications.

- Recommended reflow methods: IR, Vapor phase, and hot air oven.
- The following product series are not designed to be wave soldered to circuit boards:
 - nanoSMDM
 - miniSMDM
 - midSMD
 - SMD
 - SMD2
 - TS
- The following product series are designed to be wave soldered to circuit boards:
 - nanoSMDC
 - microSMD
 - miniSMDC, miniSMDE
- Recommended maximum paste thickness for the microSMD, miniSMDC, and miniSMDE devices is 0.25 mm (10 mils).
- Devices can be cleaned using standard methods and solvents.

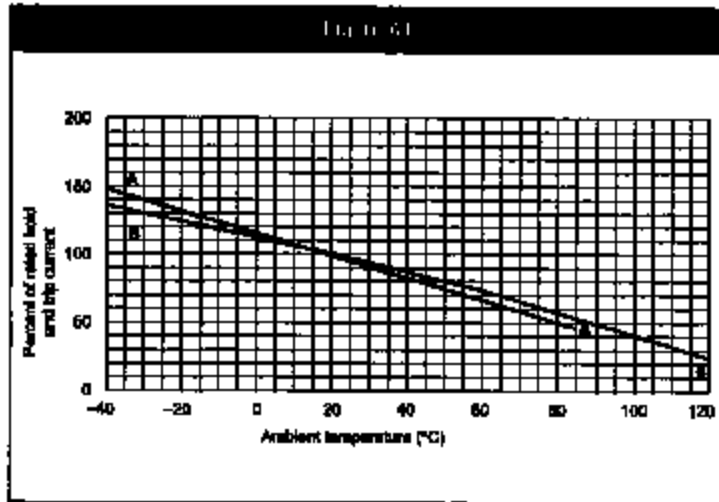
Figures A1-A2. Thermal Derating Curves for Automotive Devices

A = AGR
B = AHR

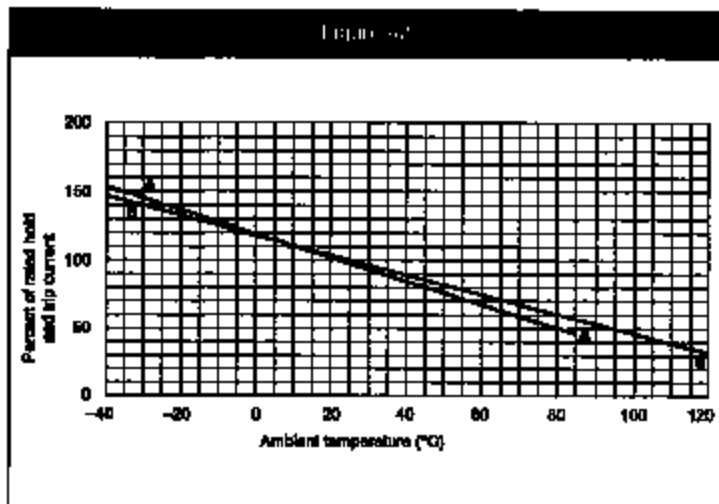
4 A = ASMD
B = AHS

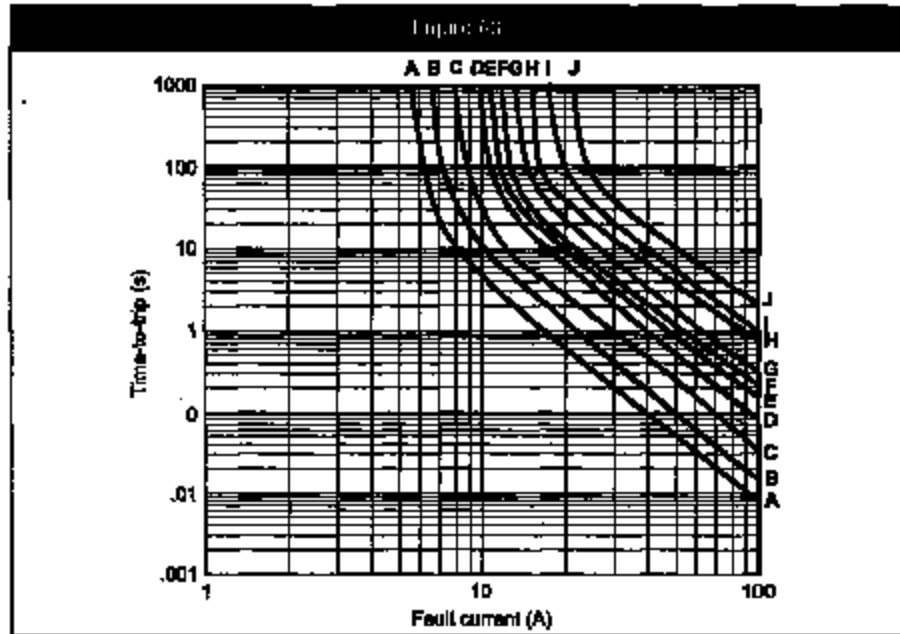
AGR

- A = AGR400
- B = AGR600
- C = AGR800
- D = AGR1000
- E = AGR1200
- F = AGR1400
- G = AGR1600
- H = AGR1800
- I = AGR2000
- J = AGR2400

Refer to the typical time-to-trip curves for each of the PolySwitch devices found in Figures A8-A11.

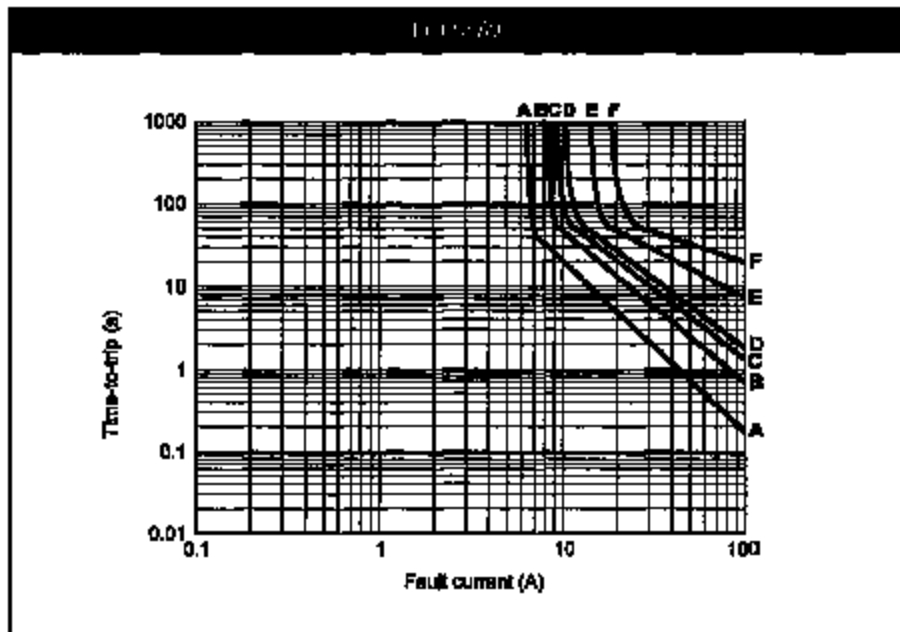
AHR

- A = AHR460
- B = AHR600
- C = AHR850
- D = AHR1000
- E = AHR1300
- F = AHR1600

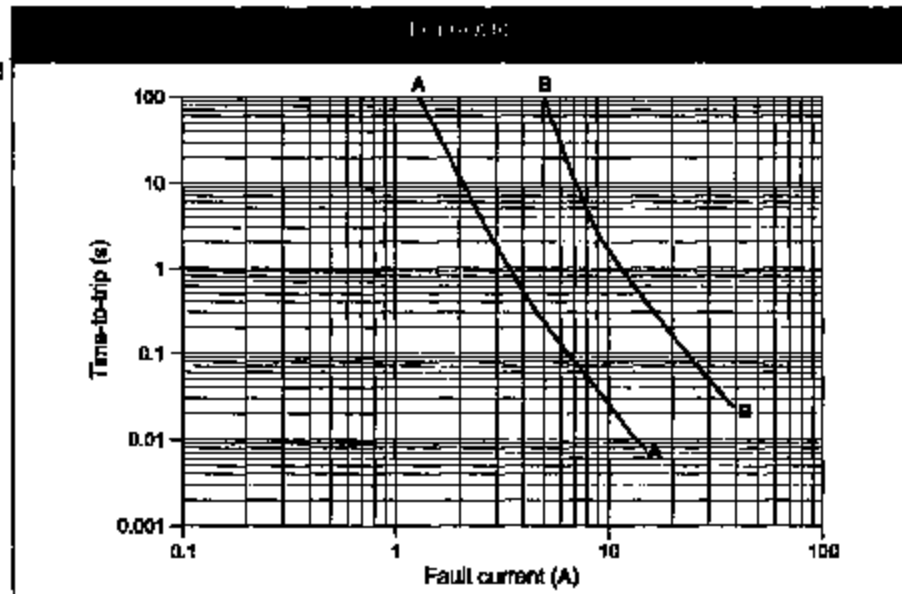
Figures A8–A11. Typical Time-to-trip at 25°C for Automotive Devices *continued*

AHS

A = AHS080-2018

B = AHS160

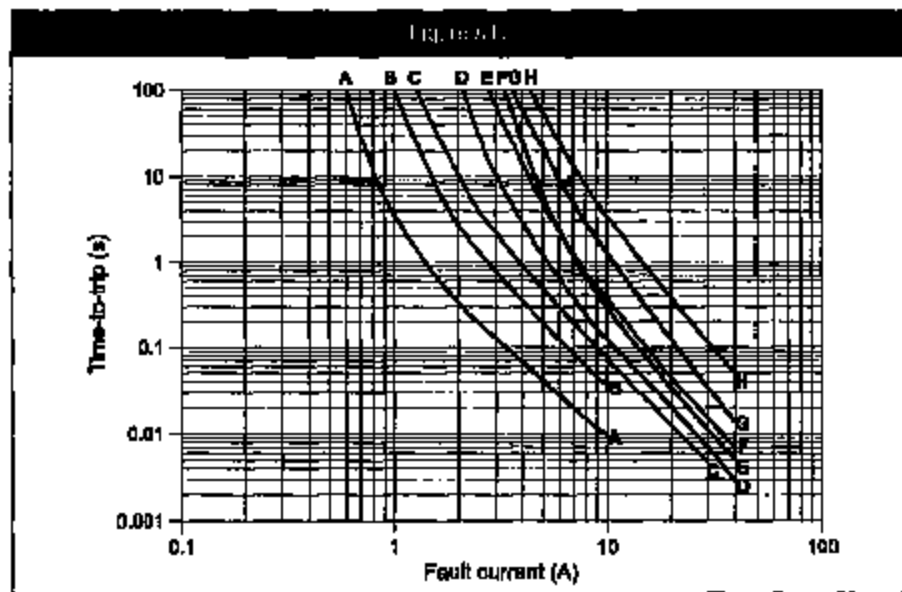
ASMD

G = ASMD200

H = ASMD260

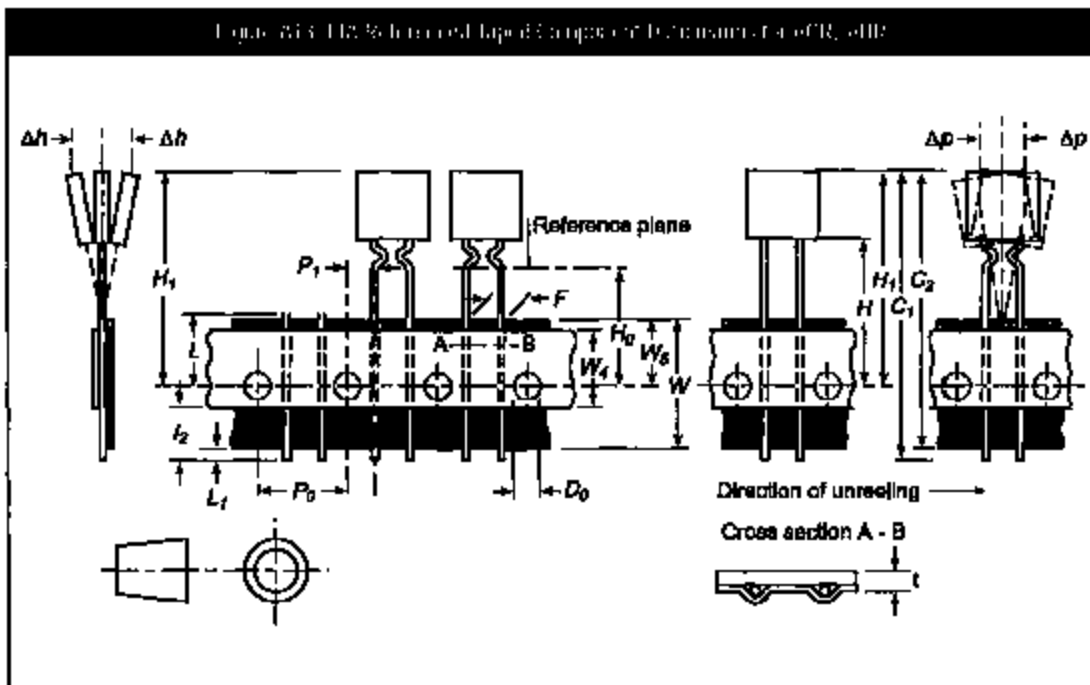
Figure 20-113. Schematic diagram of a component of a CR, 600

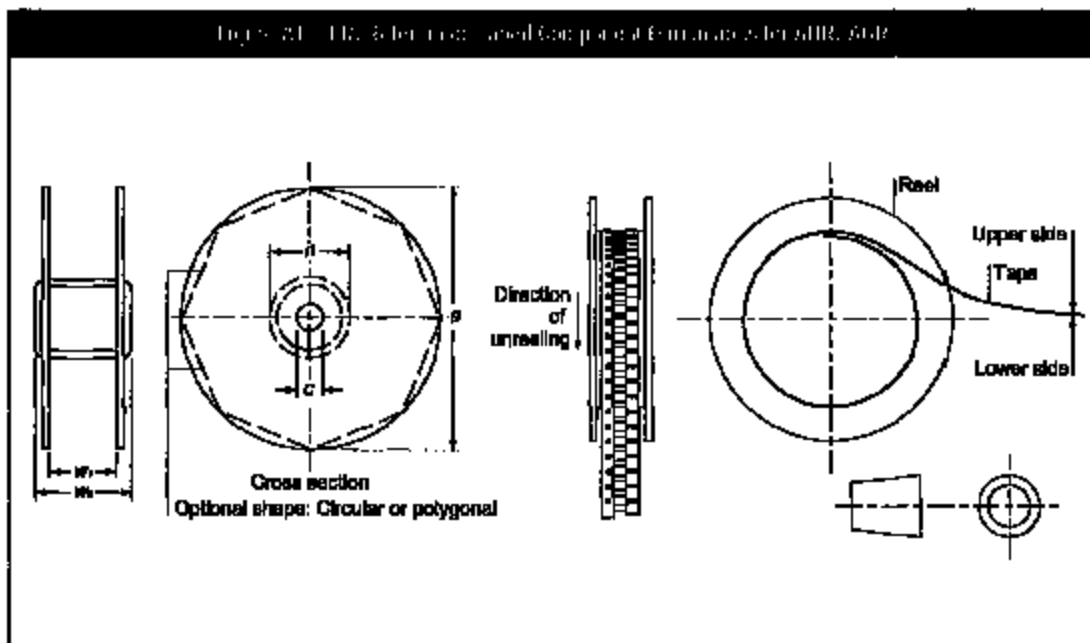
Figure 20-114. Schematic diagram of a component of a CR, 600

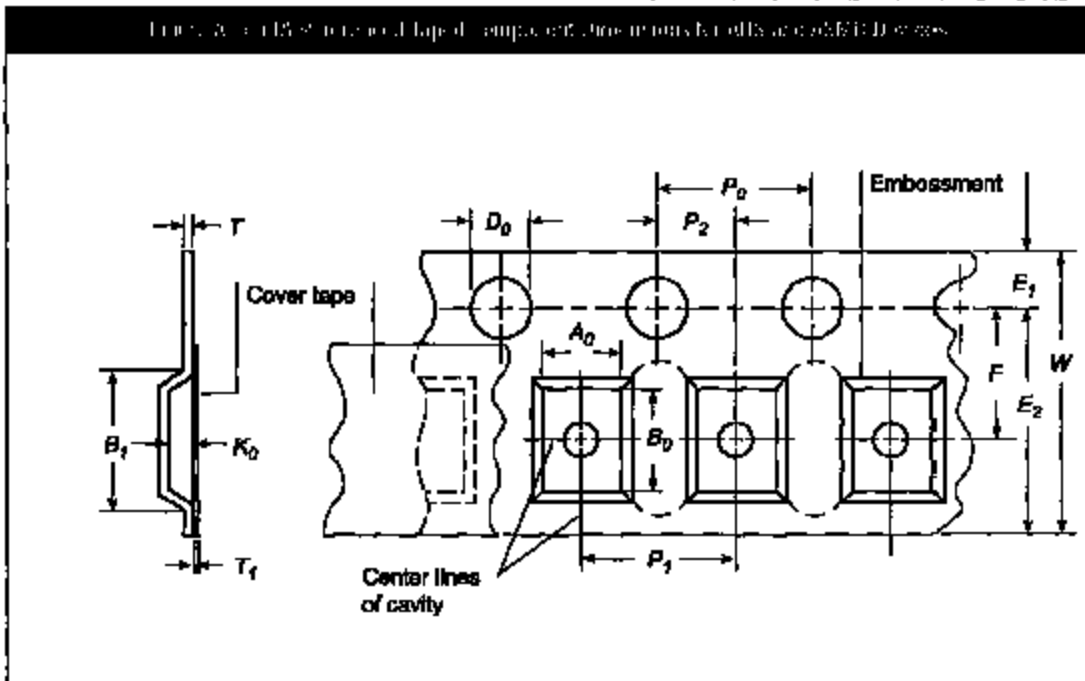
Figure 20. Embossed metal tape component, three inductor coils and 25331 device.

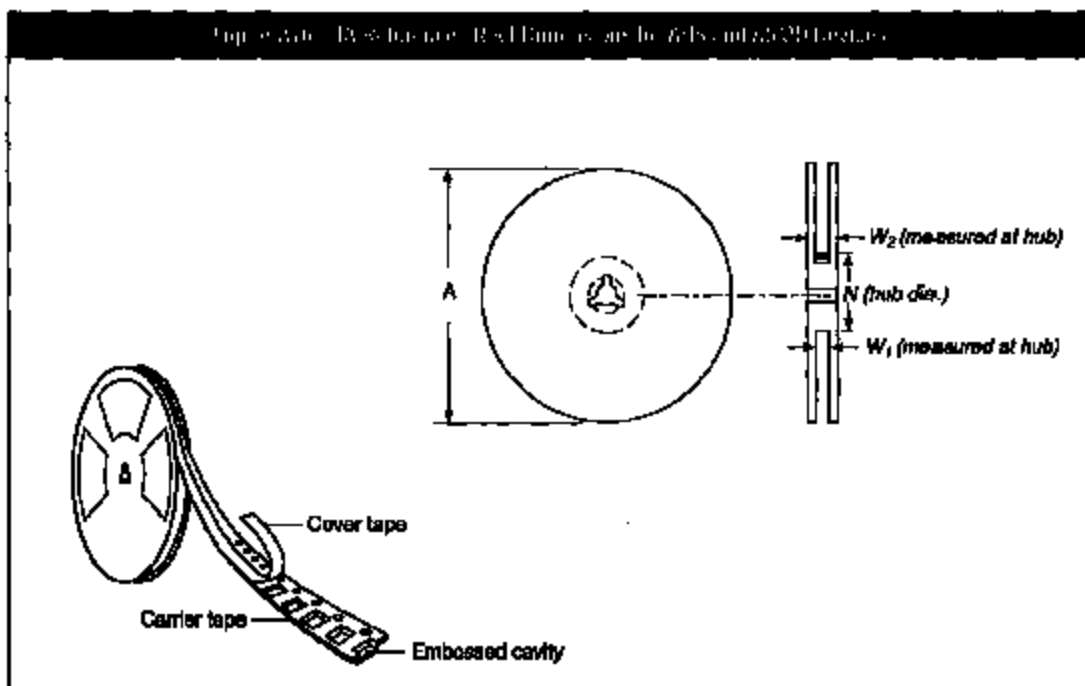
Figure 21. Resistor tape component, as for 25331 device.

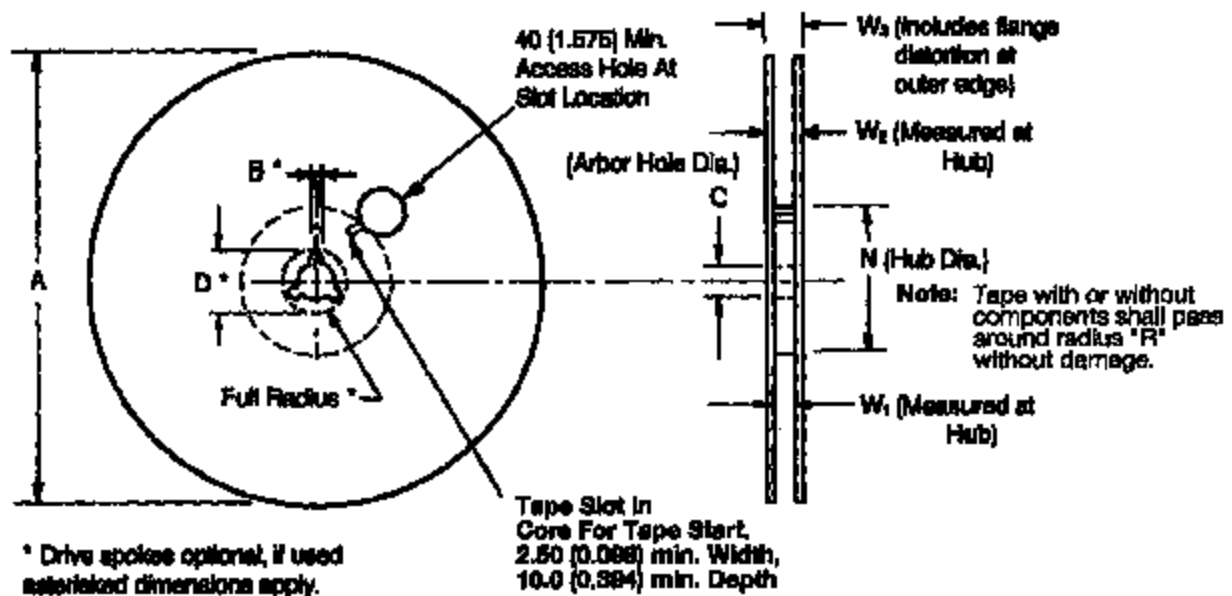
REEL DIMENSIONS

Tape Size ⁽¹⁾	A Max.	B* Min.	C	D* Min.	N Min.	W ₁	W ₂ Max.	W ₃
6mm						8.40 ±0.10 (0.331 ±0.004)	14.4 (0.567)	7.50 Min. (0.311) 10.9 Max. (0.429)
12mm	330 (12.992)	1.5 (0.059)	13.0 ±0.1 (0.512 ±0.004)	21.2 (0.795)	50.0 (1.969)		18.4 (0.724)	11.9 Min. (0.469) 15.4 Max. (0.607)

Metric dimensions will govern.

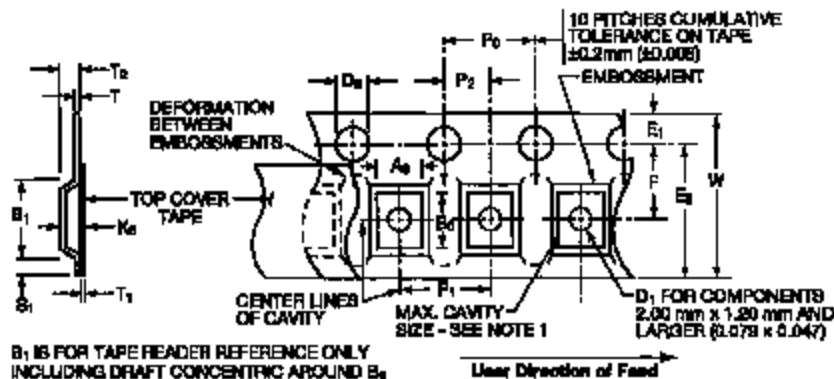
8 & 12mm Tape Only

8 & 12mm Embossed Tape Metric Dimensions Will Govern

2. Tape with or without components shall pass around radius "R" without damage.

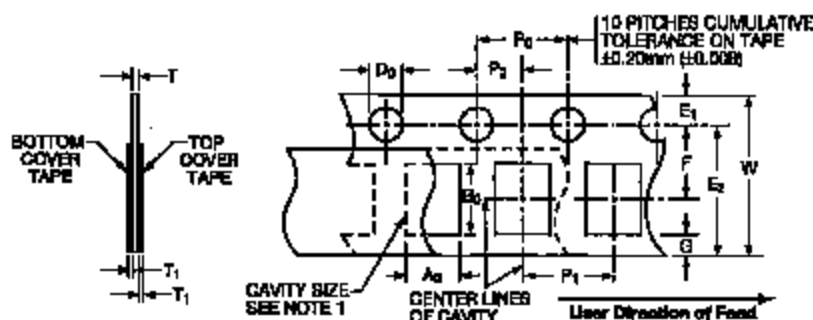
8 & 12mm Tape Only

8 & 12mm Paper Tape Metric Dimensions Will Govern

2. Tape with or without components shall pass around radius "R" without damage.

4. If $P_1 = 2.0mm$, the tape may not properly index in all tape feeders.

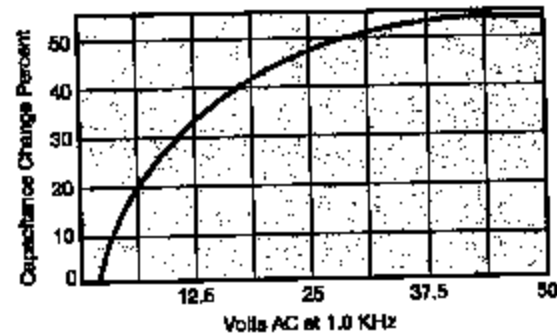
Cap. Change vs. A.C. Volts X7R

Effects of Voltage - Variations in voltage have little effect on Class 1 dielectric but does affect the capacitance and dissipation factor of Class 2 dielectrics. The application of DC voltage reduces both the capacitance and dissipation factor while the application of an AC voltage within a reasonable range tends to increase both capacitance and dissipation factor readings. If a high enough AC voltage is applied, eventually it will reduce capacitance just as a DC voltage will. Figure 2 shows the effects of AC voltage.

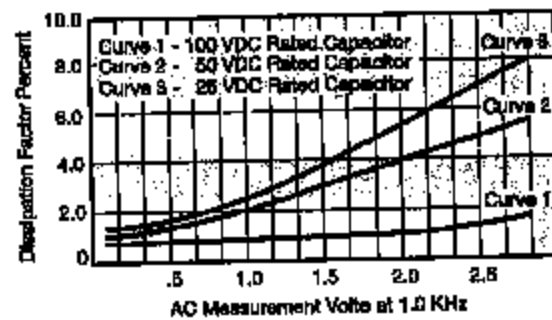
D.F. vs. A.C. Measurement Volts X7R

Capacitor specifications specify the AC voltage at which to measure (normally 0.5 or 1 VAC) and application of the wrong voltage can cause spurious readings. Figure 3 gives the voltage coefficient of dissipation factor for various AC voltages at 1 kilohertz. Applications of different frequencies will affect the percentage changes versus voltages.

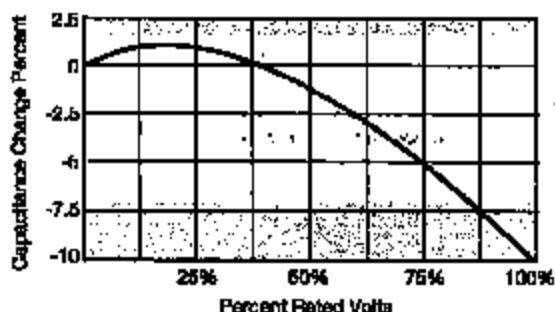
Figure 4

**Typical Cap. Change vs. D.C. Volts
X7R**

Typical effect of the application of DC voltage is shown in Figure 4. The voltage coefficient is more pronounced for higher K dielectrics. These figures are shown for room temperature conditions. The combination characteristic known as voltage temperature limits which shows the effects of rated voltage over the operating temperature range is shown in Figure 5 for the military BX characteristic.

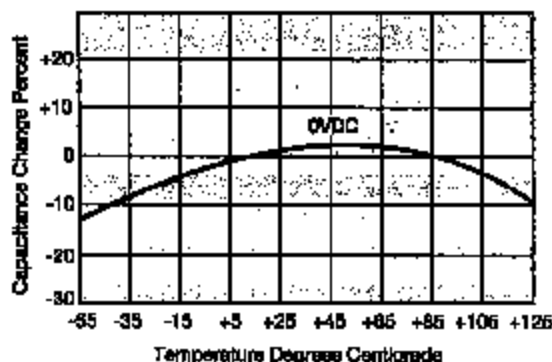
Figure 5

**Typical Cap. Change vs. Temperature
X7R**

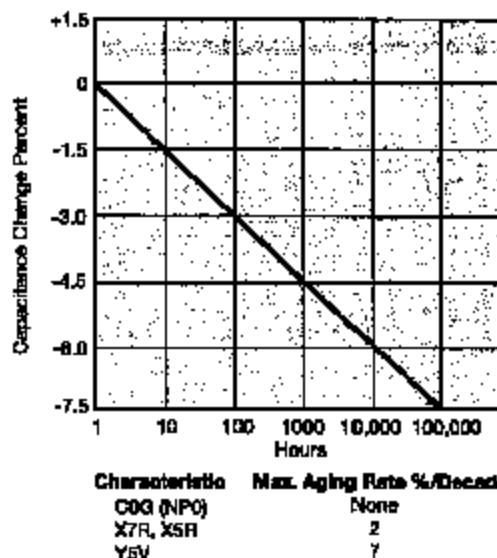
Figure 6

**Typical Curve of Aging Rate
X7R**

Effects of Time – Class 2 ceramic capacitors change capacitance and dissipation factor with time as well as temperature, voltage and frequency. This change with time is known as aging. Aging is caused by a gradual re-alignment of the crystalline structure of the ceramic and produces an exponential loss in capacitance and decrease in dissipation factor versus time. A typical curve of aging rate for semi-stable ceramics is shown in Figure 6.

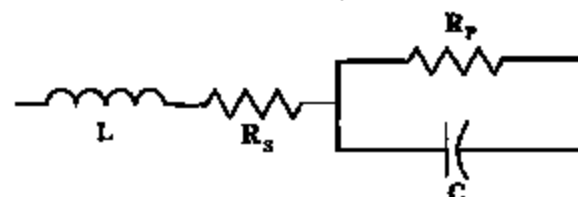
Equivalent Circuit – A capacitor, as a practical device, exhibits not only capacitance but also resistance and inductance. A simplified schematic for the equivalent circuit is:

C = Capacitance L = Inductance
 R_s = Series Resistance R_p = Parallel Resistance

Insulation Resistance - Insulation Resistance is the resistance measured across the terminals of a capacitor and consists principally of the parallel resistance R_p shown in the equivalent circuit. As capacitance values and hence the area of dielectric increases, the I.R. decreases and hence the product ($C \times IR$ or RC) is often specified in ohm farads or more commonly megohm-microfarads. Leakage current is determined by dividing the rated voltage by IR (Ohm's Law).

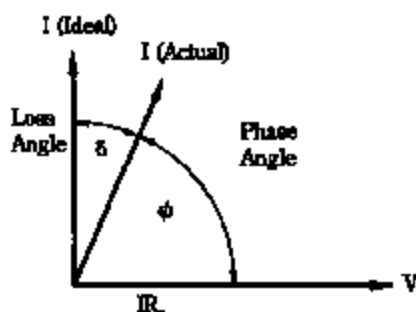
Phase Angle – Power Factor and Dissipation Factor are often confused since they are both measures of the loss in a capacitor under AC application and are often almost identical in value. In a "perfect" capacitor the current in the capacitor will lead the voltage by 90°.

In practice the current leads the voltage by some other phase angle due to the series resistance R_s . The complement of this angle is called the loss angle and:

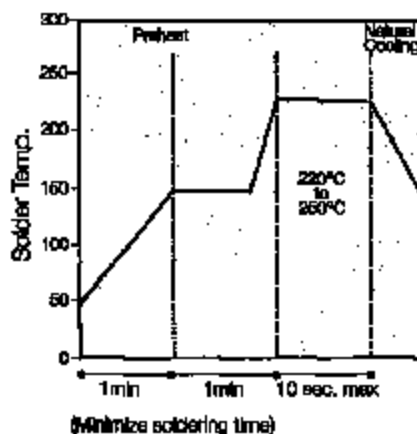
Reflow

Recommended Soldering Profiles

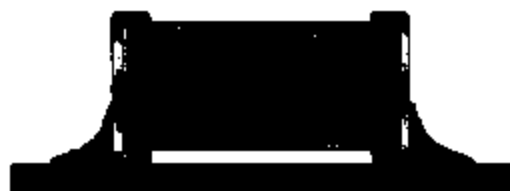
Cracks caused by mechanical flexure are very easily identified and generally take one of the following two general forms:

Type A:
Angled crack between bottom of device to top of solder joint.

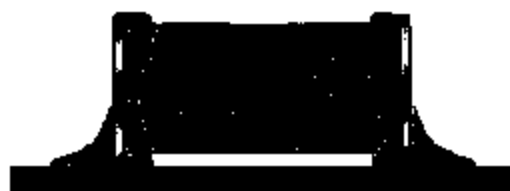
Type B:
Fracture from top of device to bottom of device.

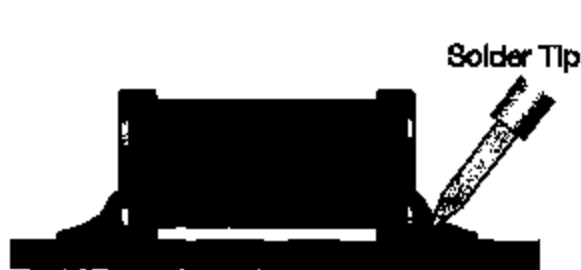
Preferred Method - No Direct Part Contact

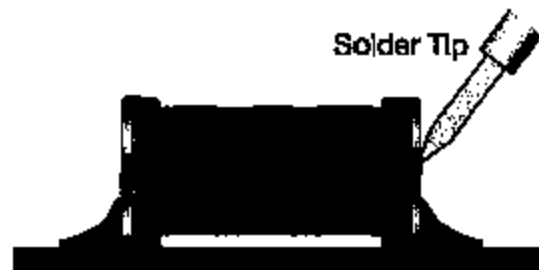
Poor Method - Direct Contact with Part

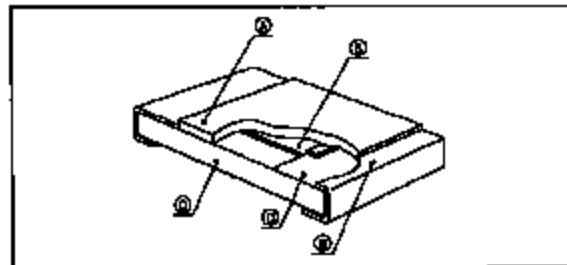
STRUCTURE AND MATERIAL

Code	Structure	Material
A	Coating	Glass or Epoxy
B	Resistor	R ₂ O ₅ Resistor (The same material of termination for chip jumper)
C	Substrate	95% Alumina
D	Termination	Silver
E	Plating	(Ni, Sn, Pb) Plating

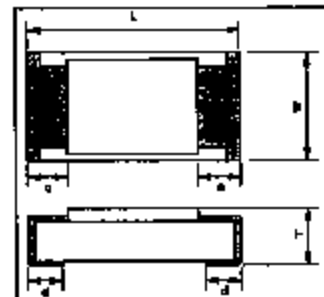
DIMENSIONS

CR03, CR03 (0301)	CR05, CJ05 (0402)	CR10, CJ10 (0603)	CR21, CJ21 (0805)	CR32, CJ32 (1206)
W	0.30±0.03 (0.012±0.001)	0.50±0.05 (0.020±0.002)	0.80±0.10 (0.031±0.004)	1.25±0.15 (0.050±0.006)	1.55±0.15 (0.061±0.006)
L	0.80±0.03	1.00±0.05	1.60±0.10	2.00±0.10 (0.080±0.004)	3.10±0.10 (0.122±0.004)
a	0.005±0.004	0.005±0.004	0.010±0.008	0.35±0.20 (0.014±0.009)	0.45±0.20 (0.018±0.009)
d	0.15±0.05 (0.006±0.002)	0.20±0.10 (0.008±0.004)	0.25±0.10 (0.008±0.004)	0.40±0.20 (0.016±0.009)	0.45±0.20 (0.018±0.009)
T	0.23±0.05 (0.009±0.002)	0.35±0.05 (0.014±0.002)	0.45±0.10 (0.020±0.004)	0.55±0.10 (0.022±0.004)	0.55±0.10 (0.022±0.004)

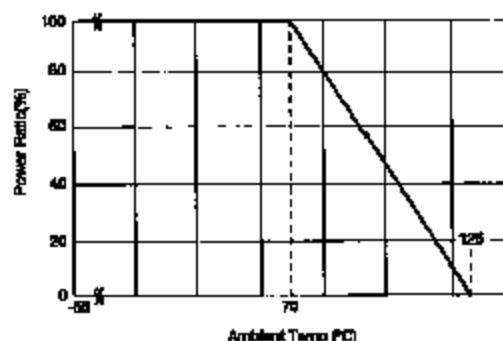
DERATING CURVE

Rated power should be reduced as below when temperature become higher.
 Under high temperature, power derated as follows:

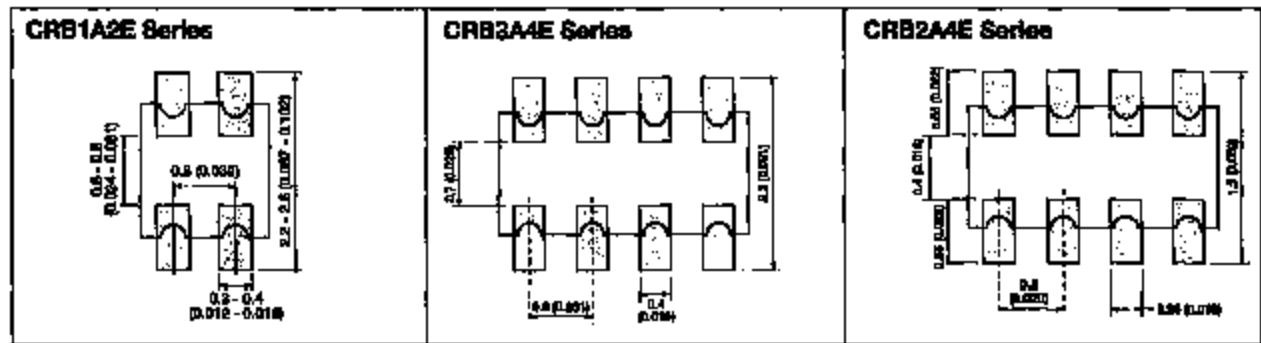
RECOMMENDED LAND PATTERNS IS REFERRED THE FOLLOWING FOR EXAMPLE

millimeters (inches)

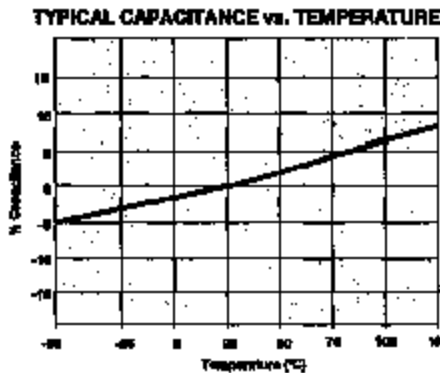
1.1.3 Temperature dependence of capacitance.

The capacitance of a tantalum capacitor varies with temperature. This variation itself is dependant to a small extent on the rated voltage and capacitor size.

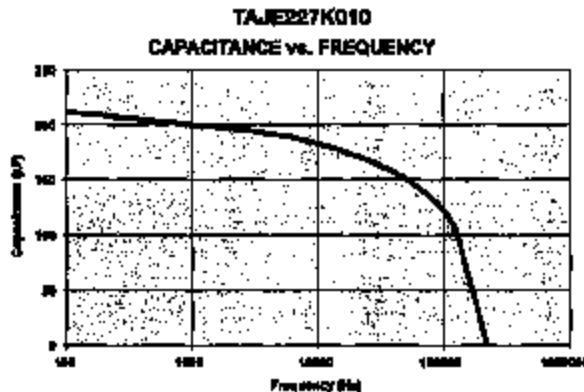
1.1.4 Frequency dependence of the capacitance.

The effective capacitance decreases as frequency increases. Beyond 100KHz the capacitance continues to drop until resonance is reached (typically between 0.5 - 5MHz depending on the rating). Beyond the resonant frequency the device becomes inductive.

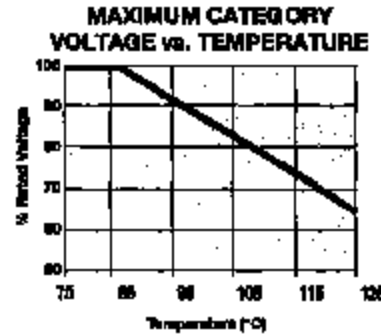
1.2.2 Category voltage (V_C)

This is the maximum voltage that may be applied continuously to a capacitor. It is equal to the rated voltage up to +85°C, beyond which it is subject to a linear derating, to 2/3 V_R at 125°C.

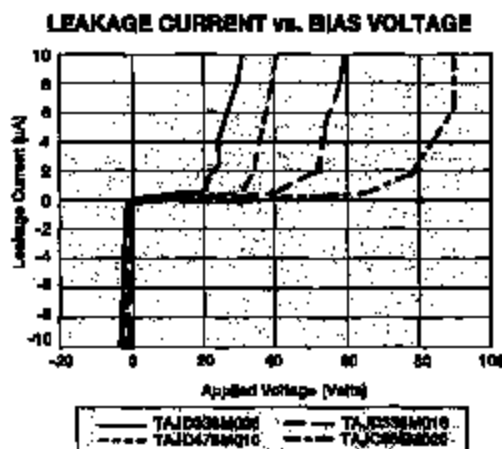
3% of the rated d.c. working voltage to a maximum of 0.5v at 85°C

1% of the category d.c. working voltage to a maximum of 0.1v at 125°C

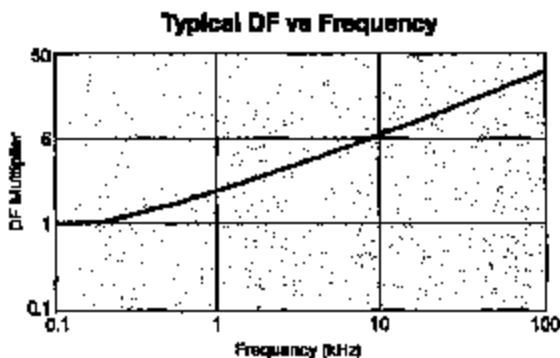
1.3.3 Frequency dependence of Dissipation Factor.

Dissipation Factor increases with frequency as shown in the typical curves:

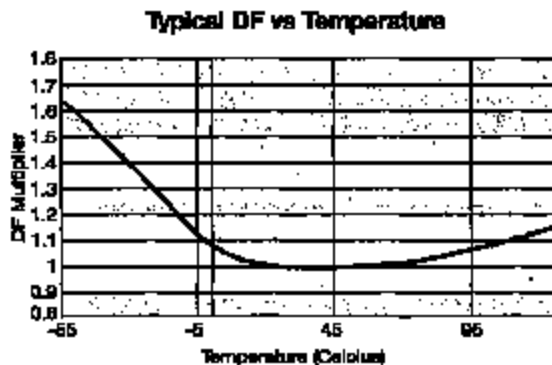
1.3.4 Temperature dependence of Dissipation Factor.

Dissipation factor varies with temperature as the typical curves show. For maximum limits please refer to ratings tables.

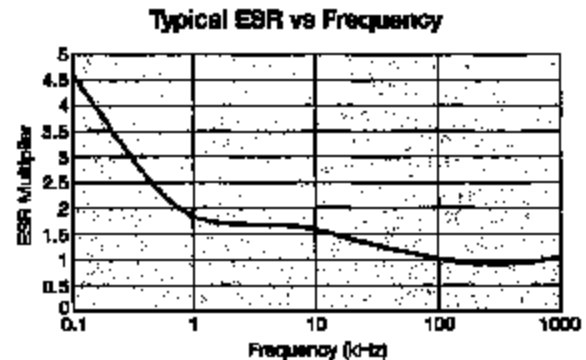
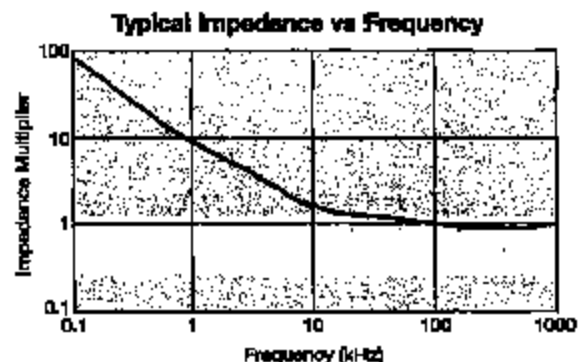
1.4.3 Frequency dependence of Impedance and ESR.

ESR and impedance both increase with decreasing frequency. At lower frequencies the values diverge as the extra contributions to impedance (due to the reactance of the capacitor) become more significant. Beyond 1MHz (and beyond the resonant point of the capacitor) impedance again increases due to the inductance of the capacitor.

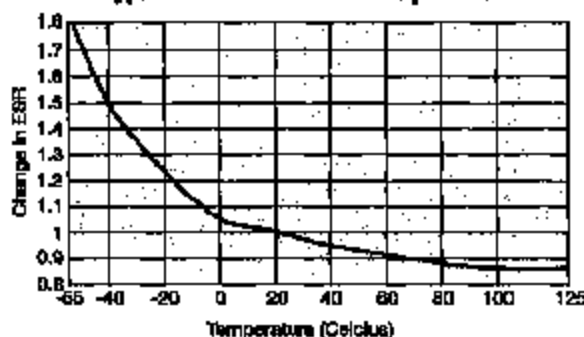
Typical 100kHz ESR vs Temperature

At 100kHz, Impedance and ESR behave identically and decrease with increasing temperature as the typical curves show.

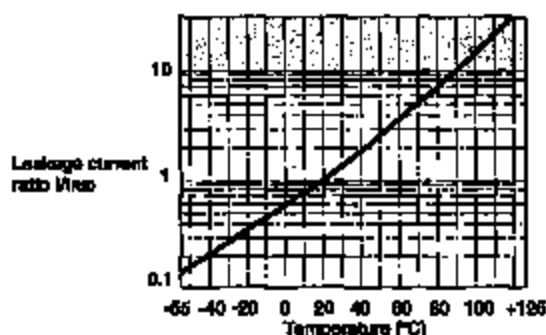
LEAKAGE CURRENT vs. TEMPERATURE

The leakage current increases with higher temperatures, typical values are shown in the graph. For operation between 65°C and 125°C, the maximum working voltage must be derated and can be found from the following formula.

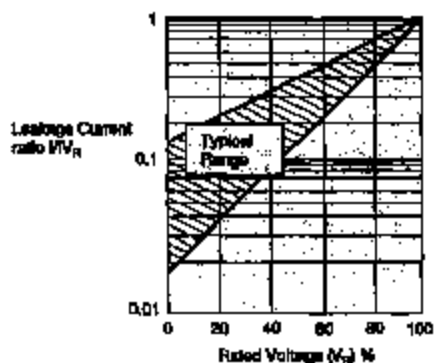
LEAKAGE CURRENT vs. RATED VOLTAGE

The leakage current drops rapidly below the value corresponding to the rated voltage V_R when reduced voltages are applied. The effect of voltage derating on the leakage current is shown in the graph. This will also give a significant increase in the reliability for any application. See Section 3.1 for details.

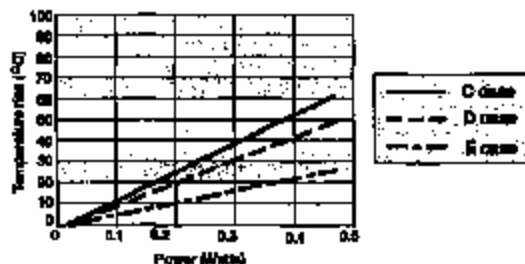
Results for the C, D and E case sizes

A piece of equipment was designed which would pass sine and square wave currents of varying amplitudes through a biased capacitor. The temperature rise seen on the body of the capacitor was then measured using an infra-red probe. This ensured that there was no heat loss through any thermocouple attached to the capacitor's surface.

Several capacitors were tested and the combined results are shown above. All these capacitors were measured on FR4 board, with no other heatsinking. The ripple was supplied at various frequencies from 1KHz to 1MHz.

As can be seen in the figure above, the average P_{max} value for the C case capacitors was 0.11 Watts. This is the same as that quoted in Table I.

From the D case results shown in figure top of previous column, it can be seen that this power would cause the capacitor's surface temperature to rise by about 6°C. For additional information, please refer to the AVX technical publication "Ripple Rating of Tantalum Chip Capacitors" by R.W. Franklin.

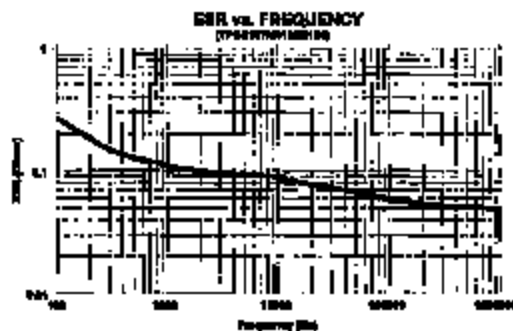
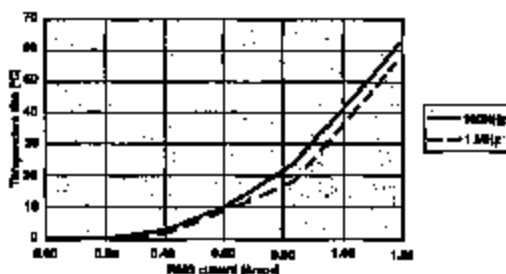
If a typical capacitor's ESR with frequency is considered, e.g. figure below, it can be seen that there is variation. Thus for a set ripple current, the amount of power to be dissipated by the capacitor will vary with frequency. This is clearly shown in figure in top of next column, which shows that the surface temperature of the unit rises less for a given value of ripple current at 1MHz than at 100KHz.

The graph below shows a typical ESR variation with frequency. Typical ripple current versus temperature rise for 100KHz and 1MHz sine wave inputs.

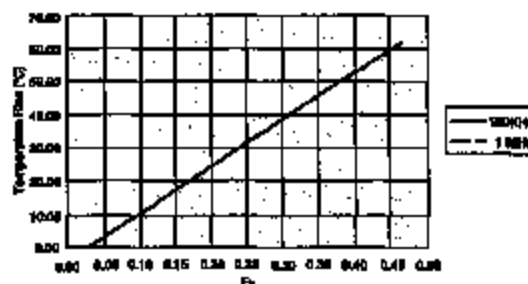
If I^2R is then plotted it can be seen that the two lines are in fact coincident, as shown in figure below.

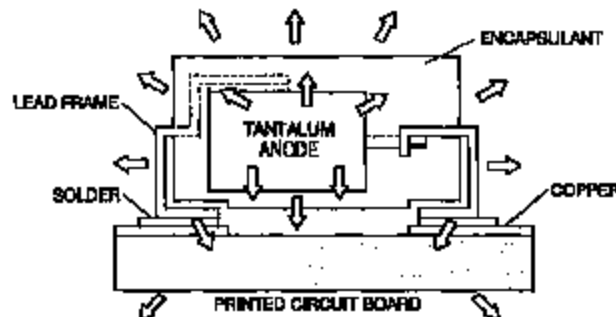
Thermal Dissipation from the Mounted Chip

The heat generated inside a tantalum capacitor in a.c. operation comes from the power dissipation due to ripple current. It is equal to I^2R , where I is the rms value of the current at a given frequency, and R is the ESR at the same frequency with an additional contribution due to the leakage current. The heat will be transferred from the outer surface by conduction. How efficiently it is transferred from this point is dependent on the thermal management of the board.

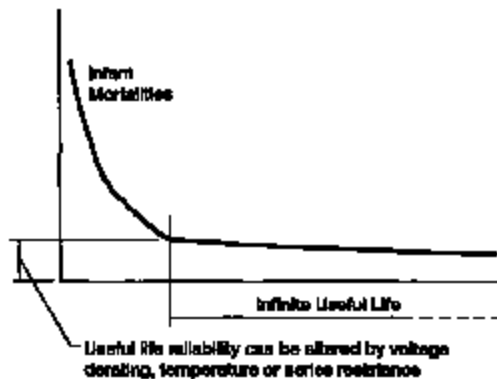
Figure 1. Tantalum Reliability Curve

Tantalum Dielectric has essentially no wear out mechanism and in certain circumstances is capable of limited self healing. However, random failures can occur in operation. The failure rate of Tantalum capacitors will decrease with time and not increase as with other electrolytic capacitors and other electronic components.

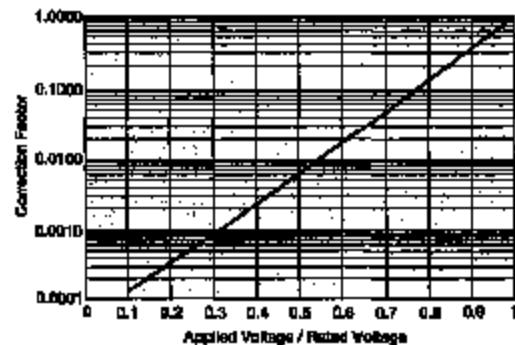
The graph, Figure 2a, shows the relationship between voltage derating (the ratio between applied and rated voltage) and the failure rate. The graph gives the correction factor F_U for any operating voltage.

Figure 2a. Correction factor to failure rate F for voltage derating of a typical component (90% con. level).

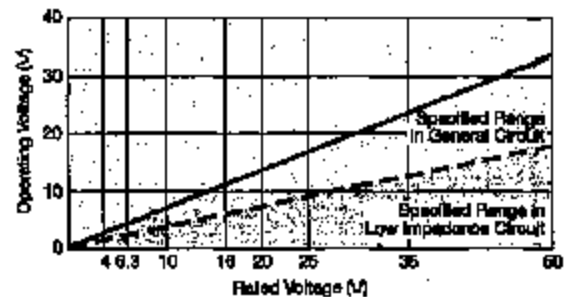
Figure 2b. Give our recommendation for voltage derating to be used in typical applications.

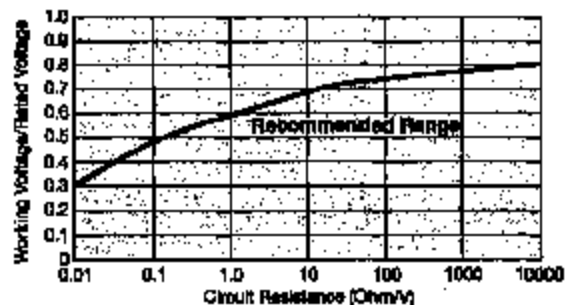
Figure 2c. Gives voltage derating recommendations as a function of circuit impedance.

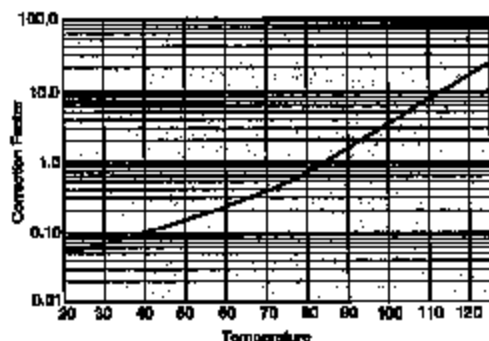
If the operating temperature is below the rated temperature for the capacitor then the operating reliability will be improved as shown in Figure 3. This graph gives a correction factor FT for any temperature of operation.

Figure 3: Correction factor to failure rate F for ambient temperature T for typical component (50% con. level).

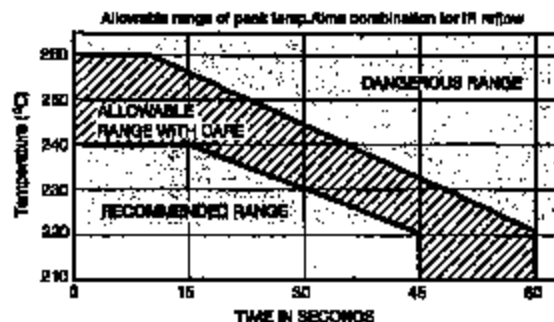
For vapor phase or infra-red reflow soldering the profile below shows allowable and dangerous time/temperature combinations. The profile refers to the peak reflow tempera-

ture and is designed to ensure that the temperature of the internal construction of the capacitor does not exceed 220°C. Preheat conditions vary according to the reflow system used, maximum time and temperature would be 10 minutes at 150°C. Small parametric shifts may be noted immediately after reflow, components should be allowed to stabilize at room temperature prior to electrical testing.

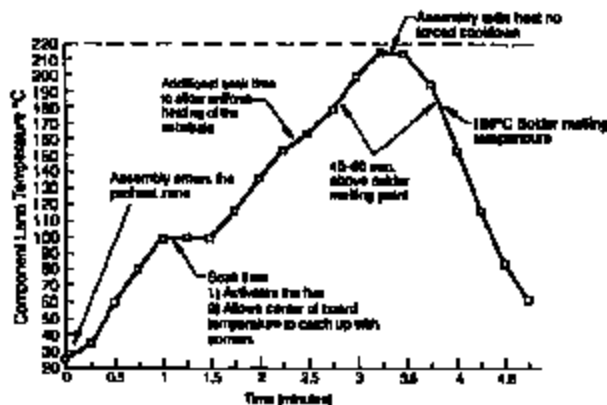
IR REFLOW

Recommended soldering profiles for surface mounting of tantalum capacitors is provided in figure below.

Recommended Ramp Rate Less than 2°C/sec.

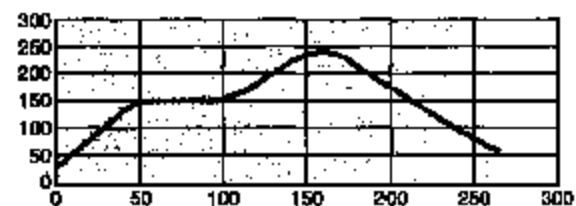
LEAD FREE REFLOW PROFILE

The recommended IR reflow profile is shown below.

- Pre-heating: 150 ±15C / 60-90s
- Max. Peak Gradient 2.5C/s
- Peak Temperature: 240 ±5C
- Time at >230C: 40s Max.

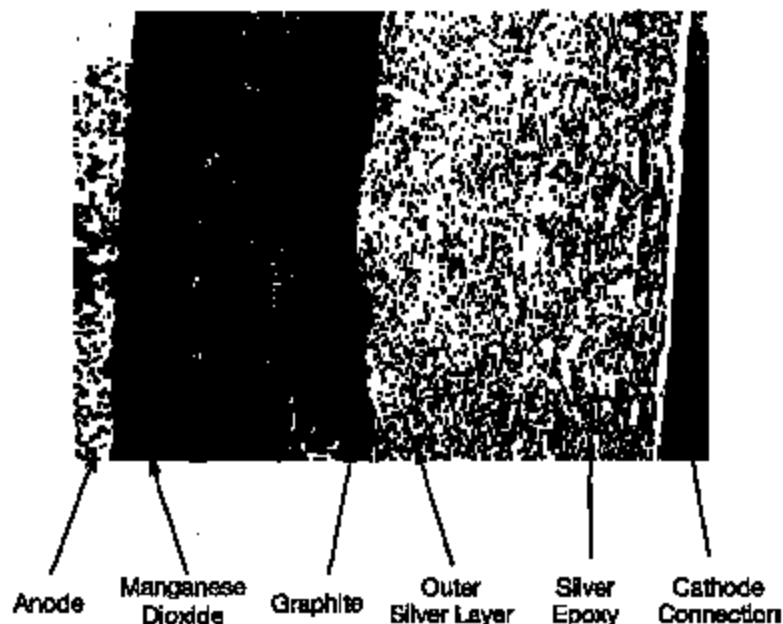
Figure 5.

The "pellet" is then dipped into graphite and silver to provide a good connection to the Manganese Dioxide cathode plate. Electrical contact is established by deposition of carbon onto the surface of the cathode. The carbon is then coated with a conductive material to facilitate connection to the cathode termination (see Figure 5). Packaging is carried out to meet individual specifications and customer requirements. This manufacturing technique is adhered to for the whole range of AVX tantalum capacitors, which can be sub-divided into four basic groups: Chip / Resin dipped / Rectangular boxed / Axial.
