EA02-027

LETTER TO ODI

PolySwitch Surface-mount Resettable Devices

PolySwitch Automotive Resettable Devices

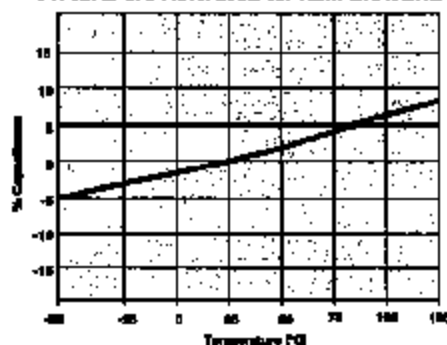
TYPICAL CAPACITANCE vs. TEMPERATURE

The capacitance of a tantalum capacitor varies with temperature. This variation itself is dependent to a small extent on the rated voltage and capacitor size.

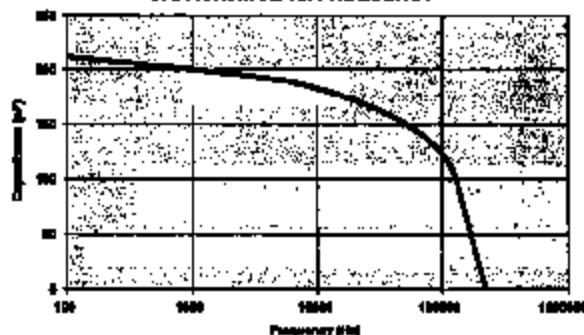
TAJE227K010
CAPACITANCE vs. FREQUENCY

The effective capacitance decreases as frequency increases. Beyond 100kHz the capacitance continues to drop until resonance is reached (typically between 0.5 - 5MHz depending on the rating). Beyond the resonant frequency the device becomes inductive.

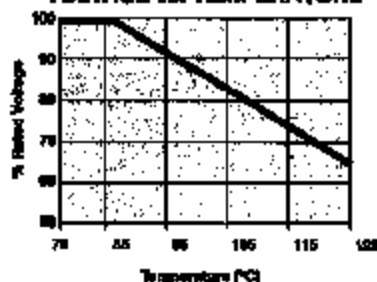
MAXIMUM CATEGORY VOLTAGE vs. TEMPERATURE

This is the maximum voltage that may be applied continuously to a capacitor. It is equal to the rated voltage up to +85°C, beyond which it is subject to a linear derating, to 2/3 V_R at 125°C.

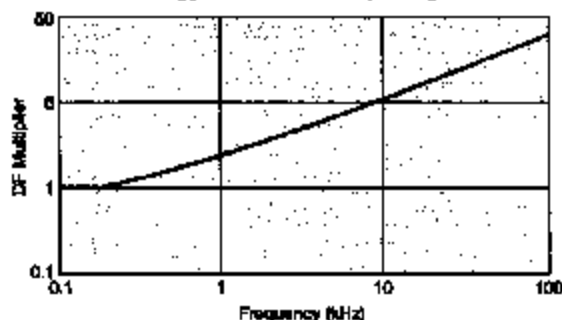
Typical DF vs Frequency

Dissipation Factor increases with frequency as shown in the typical curves:

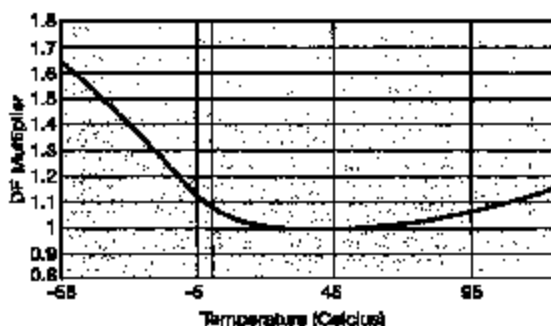
Typical DF vs Temperature

Dissipation factor varies with temperature as the typical curves show. For maximum limits please refer to ratings tables.

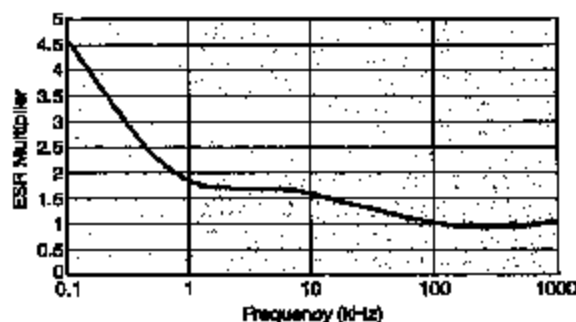
Typical ESR vs Frequency

ESR and impedance both increase with decreasing frequency. At lower frequencies the values diverge as the extra contributions to impedance (due to the reactance of the capacitor) become more significant. Beyond 1MHz (and beyond the resonant point of the capacitor) impedance again increases due to the inductance of the capacitor.

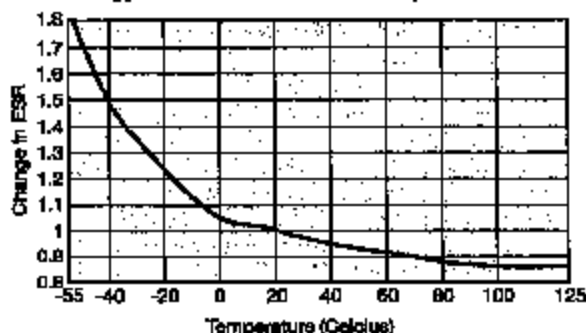
Typical 100kHz ESR vs Temperature

At 100kHz, impedance and ESR behave identically and decrease with increasing temperature as the typical curves show.

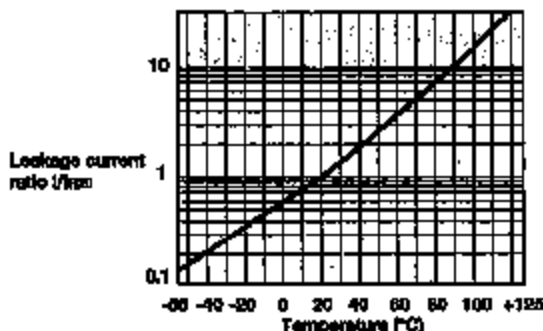
LEAKAGE CURRENT vs. TEMPERATURE

The leakage current increases with higher temperatures, typical values are shown in the graph. For operation between 85°C and 125°C, the maximum working voltage must be derated and can be found from the following formula.

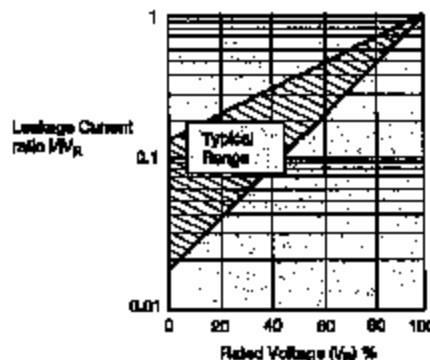
LEAKAGE CURRENT vs. RATED VOLTAGE

The leakage current drops rapidly below the value corresponding to the rated voltage V_R when reduced voltages are applied. The effect of voltage derating on the leakage current is shown in the graph. This will also give a significant increase in the reliability for any application. See Section 3.1 for details.

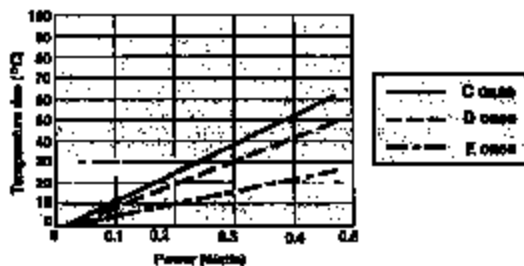
Results for the C, D and E case sizes

A piece of equipment was designed which would pass sine and square wave currents of varying amplitudes through a biased capacitor. The temperature rise seen on the body for the capacitor was then measured using an infra-red probe. This ensured that there was no heat loss through any thermocouple attached to the capacitor's surface.

Several capacitors were tested and the combined results are shown above. All these capacitors were measured on FR4 board, with no other heatsinking. The ripple was supplied at various frequencies from 1KHz to 1MHz.

As can be seen in the figure above, the average P_{max} value for the C case capacitors was 0.11 Watts. This is the same as that quoted in Table I.

From the D case results shown in figure top of previous column, it can be seen that this power would cause the capacitor's surface temperature to rise by about 5°C. For additional information, please refer to the AVX technical publication "Ripple Rating of Tantalum Chip Capacitors" by R.W. Franklin.

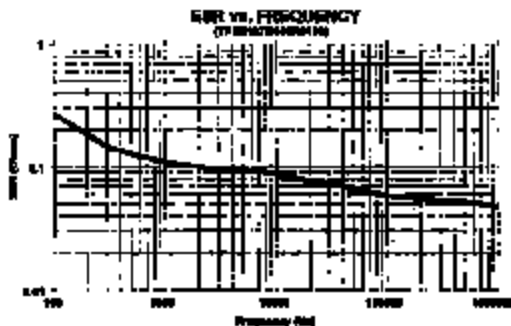
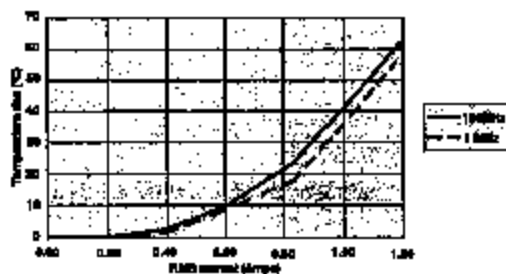
If a typical capacitor's ESR with frequency is considered, e.g. figure below, it can be seen that there is variation. Thus for a set ripple current, the amount of power to be dissipated by the capacitor will vary with frequency. This is clearly shown in figure in top of next column, which shows that the surface temperature of the unit rises less for a given value of ripple current at 1MHz than at 100KHz.

The graph below shows a typical ESR variation with frequency. Typical ripple current versus temperature rise for 100KHz and 1MHz sine wave inputs.

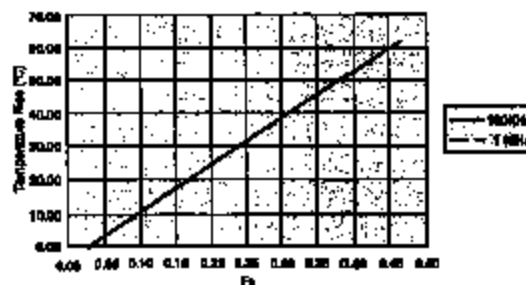
If P_R is then plotted it can be seen that the two lines are in fact coincident, as shown in figure below.

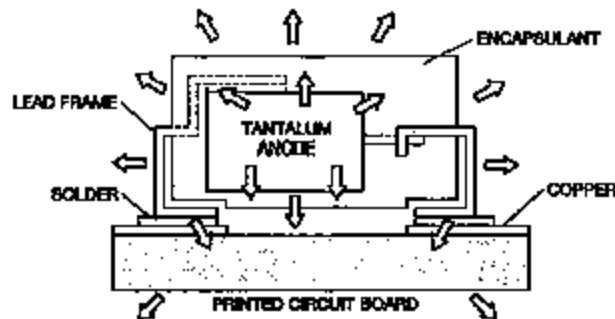
Thermal Dissipation from the Mounted Chip

The heat generated inside a tantalum capacitor in a.c. operation comes from the power dissipation due to ripple current. It is equal to I^2R , where I is the rms value of the current at a given frequency, and R is the ESR at the same frequency with an additional contribution due to the leakage current. The heat will be transferred from the outer surface by conduction. How efficiently it is transferred from this point is dependent on the thermal management of the board.

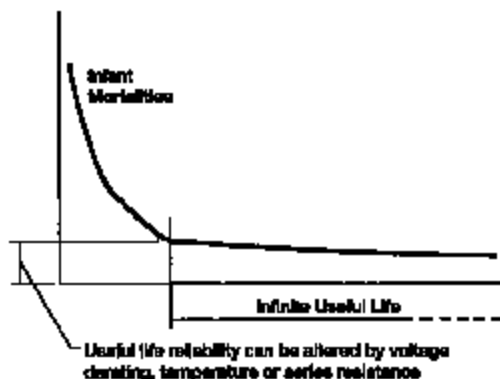
Tantalum Dielectric has essentially no wear out mechanism and in certain circumstances is capable of limited self healing. However, random failures can occur in operation. The failure rate of Tantalum capacitors will decrease with time and not increase as with other electrolytic capacitors and other electronic components.

Figure 1. Tantalum Reliability Curve

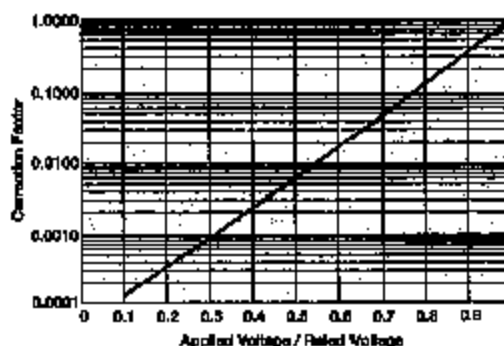
The graph, Figure 2a, shows the relationship between voltage derating (the ratio between applied and rated voltage) and the failure rate. The graph gives the correction factor F_U for any operating voltage.

Figure 2a. Correction factor to failure rate F for voltage derating of a typical component (50% con. level).

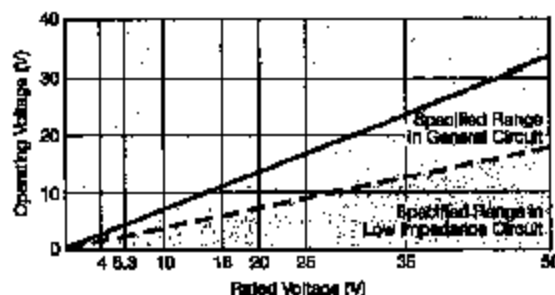
Figure 2b. Gives our recommendation for voltage derating to be used in typical applications.

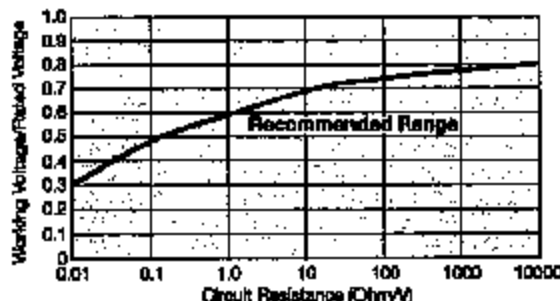
Figure 2c. Gives voltage derating recommendations as a function of circuit impedance.

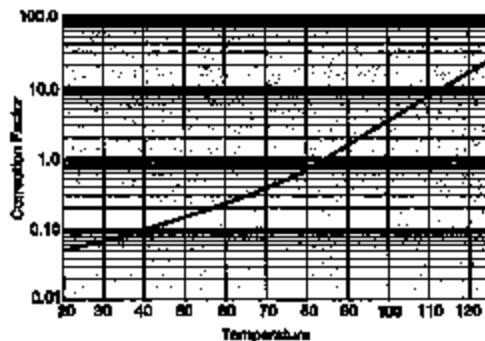
If the operating temperature is below the rated temperature for the capacitor then the operating reliability will be improved as shown in Figure 3. This graph gives a correction factor FT for any temperature of operation.

Figure 3: Correction factor to failure rate F for ambient temperature T for typical component (60% con. level).

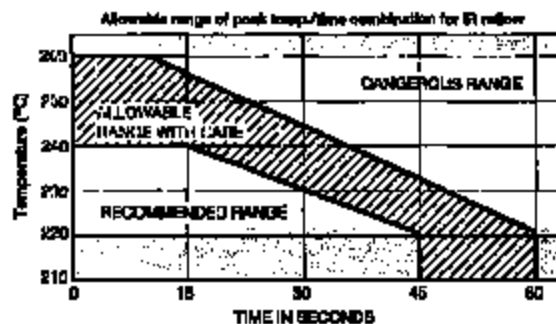
For vapor phase or infra-red reflow soldering the profile below shows allowable and dangerous time/temperature combinations. The profile refers to the peak reflow tempera-

ture and is designed to ensure that the temperature of the internal construction of the capacitor does not exceed 220°C. Preheat conditions vary according to the reflow system used, maximum time and temperature would be 10 minutes at 150°C. Small parametric shifts may be noted immediately after reflow, components should be allowed to stabilize at room temperature prior to electrical testing.

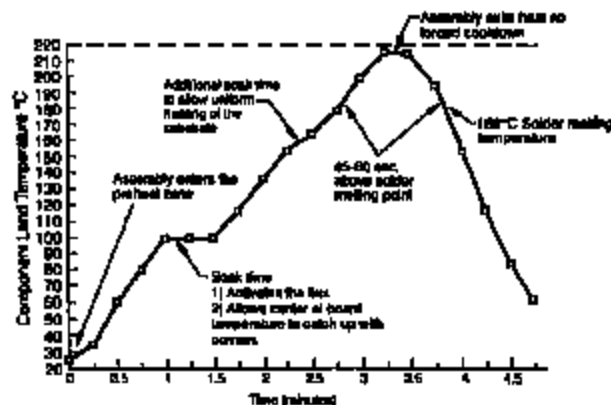
IR REFLOW

Recommended soldering profiles for surface mounting of tantalum capacitors is provided in figure below.

Recommended Ramp Rate Less than 2°C/sec.

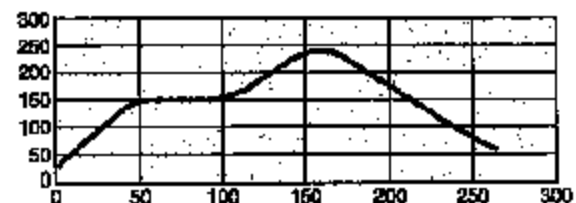
LEAD FREE REFLOW PROFILE

The recommended IR reflow profile is shown below.

- Pre-heating: 150 ±15C / 60-90s
- Max. Peak Gradient 2.5C/s
- Peak Temperature: 240 ±5C
- Time at >230C: 40s Max.

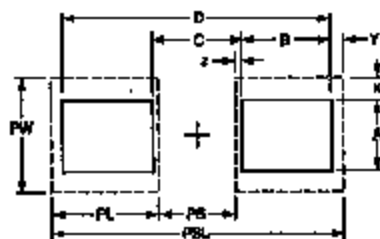
The component footprint is defined as the maximum board area taken up by the terminators. The footprint dimensions are given by A, B, C and D in the diagram, which corresponds to W, max, A max, S min, and L max, for the component. The footprint is symmetric about the center lines.

The dimensions x, y and z should be kept to a minimum to reduce rotational tendencies while allowing for visual inspection of the component and its solder fillet.

Dimensions PS (Pad Separation) and PW (Pad Width) are calculated using dimensions x and z. Dimension y may vary, depending on whether reflow or wave soldering is to be performed.

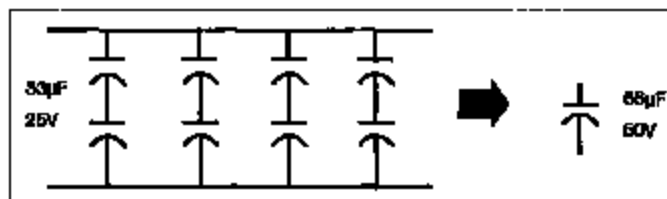
effective capacitance will be halved, so for greater than 80 μ F, four such series combinations are required, as shown.

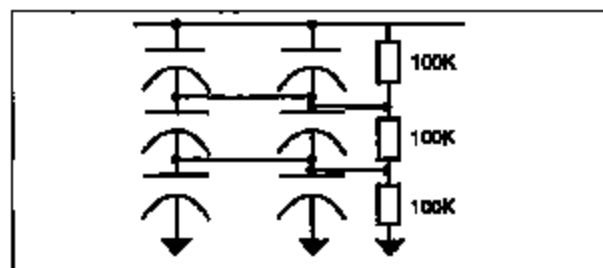
In order to ensure reliable operation, the capacitors should be connected as shown below to allow current sharing of the ac noise and ripple signals. This prevents any one capacitor heating more than its neighbors and thus being the weak link in the chain.

The two resistors are used to ensure that the leakage currents of the capacitors does not affect the circuit reliability, by ensuring that all the capacitors have half the working voltage across them.

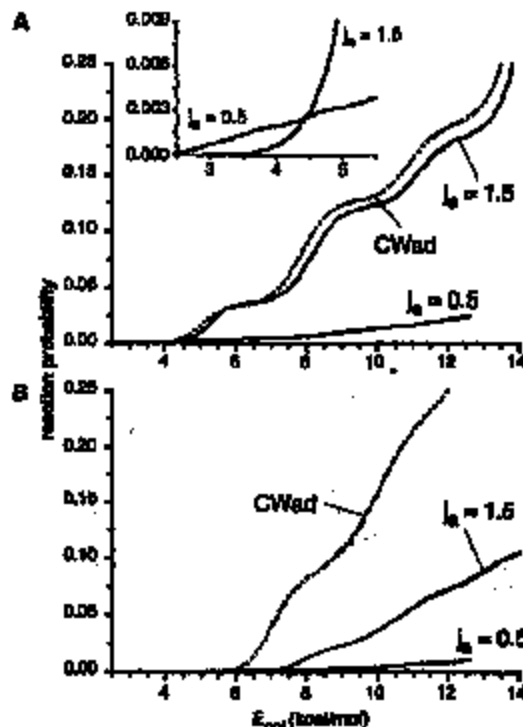
Fig. 2. (A) Probabilities for reaction of Cl in the $j_e = 3/2$ ($^2P_{3/2}$) and $j_e = 1/2$ ($^2P_{1/2}$) SO states with H_2 ($v = 0, j = 0$) for $J = 0.5$. The abscissa is the collision energy. Also shown are reaction probabilities determined from single-state calculations based on the fully adiabatic (CWad) PESs for $J = 0$ but divided by a factor of 2. (Inset) The low-energy behavior of the multistate probabilities. (B) Similar reaction probabilities, but for $J = 17.5$.

The pronounced staircase-like structure in the reaction probability out of the lower (adi-

abatically allowed) SO state corresponds to the successive opening of additional vibrational states at the barrier.

The lower panel of Fig. 2 displays similar reactive transition probabilities, but for $J = 17.5$. Again, the CWad probabilities have been divided by 2. At this higher angular momentum, the centrifugal barrier has increased. Consequently, the threshold for reaction occurs at a higher collision energy. At $J = 17.5$, the multistate reactions are now substantially smaller than those predicted by the single-state CWad calculations, even after division by 2. Similar comparisons at other values of J reveal that as J increases, the multistate reaction probabilities become increasingly smaller than the comparable single-state probabilities. Because the discrepancy grows roughly linearly with J , Coriolis coupling would seem to be responsible.

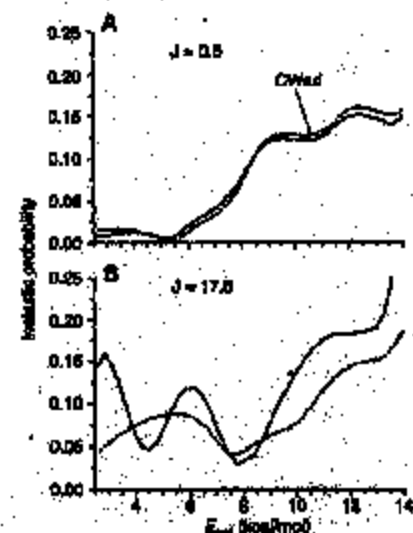
Fig. 3. (A) Speed curve indicates the inelastic transition probabilities for Cl($j = 3/2$) + $H_2(v = 0)$ for $J = 0.5$, summed over all energetically accessible final states. The abscissa is the collision energy. Dashed curve indicates a similar sum, but divided by 2, of inelastic transition probabilities from single-state calculations on the CWad PES for $J = 0$. The abscissa is the collision energy. (B) Similar plot of the inelastic transition probabilities but for $J = 17.5$ ($J = 17$ for the CWad calculations).

gle-state calculations. This is indeed the case, as illustrated in Fig. 3.

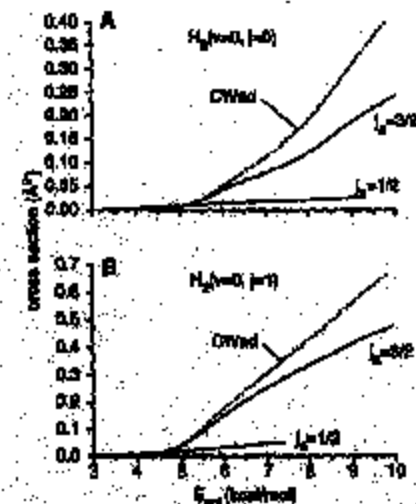
Fig. 4. Integral cross sections for reaction of Cl with $H_2(v = 0, j = 0)$ (A) and $H_2(v = 0, j = 1)$ (B). Solid lines are predictions of single-state calculations based on the fully adiabatic (CWad) PES, divided by a factor of 2.

the sum over J of the transition probabilities weighted by $(2J + 1)(2I)$, is general, as the collision energy increases, successively greater values of J contribute. Because the multistate reaction probabilities are increasingly depressed at higher J (compared to the single-state probabilities), we expect that the increase of the multistate reactive cross sections with increasing collision energy will be smaller than the prediction from single-state calculations on the CWad PES. This is indeed the case, as shown in Fig. 4.

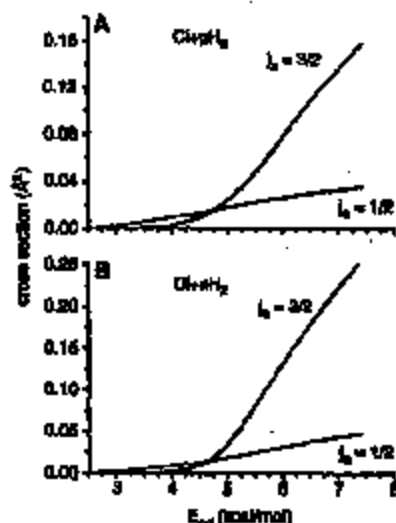
Fig. 5. (A) Integral cross sections for reaction of Cl in its ground ($j_s = 3/2$) and excited ($j_s = 1/2$) SO state with $p\text{-H}_2$. (B) Similar integral cross sections for reaction with $m\text{-H}_2$. The relative rotational state populations of the $j = 0, 1$ and 2 H_2 rotational levels were taken from (4–6).

In the experiments of Lin and co-workers (4-6), only the lowest three ($J = 0, 1,$ and 2) rotational levels of H_2 are present in the beam. By weighting the cross sections of each J level by the experimental populations of these levels, we can obtain reactive cross sections appropriate to the experiments with $p-H_2$ or $s-H_2$ (Fig. 5).

count in Fig. 5, the observed reactivity of the excited SO state will be a factor of 2 less than predicted by Fig. 5.
