SIB 125506, SIB 130208

N54 - Diagnosis for DME FC 29DC/2FBF

E90, E92 with N54 produced from 06/06

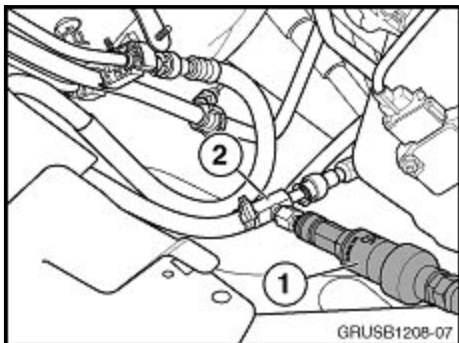
1. Use the current DIS/GT1 diagnosis software (V53 or higher).
2. Perform all applicable DIS/GT1 test plans, **starting with B1214_DI6KNDR** (Low Pressure Fuel System test plan). This test module may be accessed using the following path: Function selection / Drive / Motor Electronics / Low-pressure fuel system / Test Plan.

3. The low pressure fuel test module requires comparison of the pressure reading from the low pressure sensor with the actual pressure value read via DIS/GT1 with the 25 bar pressure transducer.
4. Remove the front underbody panels.
5. Disconnect the fuel supply line and install special tool 135 270 (PN 83 30 0 491 310), indicated as number 2 on the attached illustration.
6. Connect the 25 bar pressure transducer (1) with the DIS tester or GT1 with MIB. (Remember that the displayed pressure value includes 1 bar of atmospheric

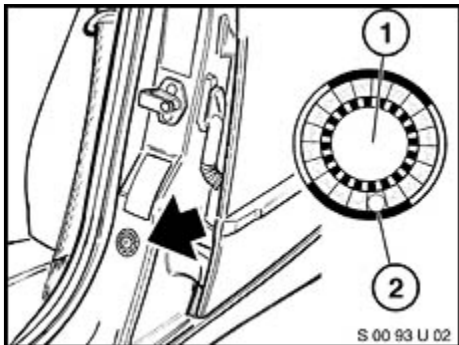
LABEL INSTRUCTIONS

This Service Action has been assigned code number **514**. After the vehicle has been checked and/or corrected, obtain a label (SD 92-335) and:

- A. Emboss your BMW center warranty number in the middle of the label (1);
- B. Punch out code number **514** (2), printed on the label; and
- C. Affix the label to the **B** pillar as shown.

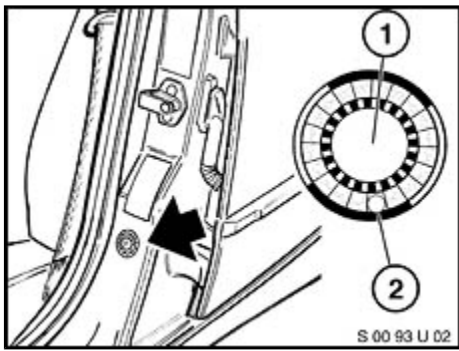
LABEL INSTRUCTIONS

This Service Action has been assigned code number **518**. After the vehicle has been checked and/or corrected, obtain a label (SD 92-335) and:

- A. Emboss your BMW center warranty number in the middle of the label (1);
- B. Punch out code number **518** (2), printed on the label; and
- C. Affix the label to the **B**-pillar as shown.
