FW: NASS Case 2006 81 16

This is a 1995 Jeep Grand Cherokee fatal fire crash that also showed up in the FARS run (Case # 53101 on March 15, 2006, in Washington State) - note the NASS analysis found the fuel leakage came from the filler neck & that there was filler neck separation. The right front passenger suffered AIS 6 burn injuries. The next highest injuries levels were AIS 4. The other passenger (second row left) suffering AIS 6 burn injuries would have died from trauma suffering AIS head, spinal cord & myocardial laceration) injuries. Another passenger (second row right) suffered AIS 5 burn injuries over 50% of the body. The second row middle passenger had AIS 3 burn injuries over 15% of the body. I will be sending imagines in two separate files. We will be making submissions to our defect petition on 1993-04 Jeep Grand Cherokee shortly. In the meantime, please consider this NASS case as part of the petition file. Note also that FARS did not classify this as a MHE fire case.

1 Case 2006-81-16

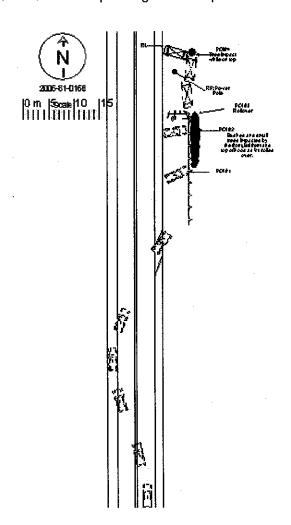
Vehicle 1, a 1995 Jeep Grand Cherokee, was traveling north in lane one of a straight, wet, bituminous, two lane undivided roadway which had a downhill grade in the crash area. For unknown reasons, V1 crossed into the oncoming lane, exited the roadway onto the west shoulder, then steered to the right, and departed the right side of the roadway in a clockwise yaw, and struck an embankment with its front plane. V1 continued and struck bushes with the front before the vehicle tripped and rolled over with the left side leading. Vehicle 1 then traveled another 18 meters on the top plane before it ramped up an embankment, became airborne, and struck a large tree with its back plane while inverted. Vehicle 1 rotated clockwise off of the tree and came to rest on its top facing generally north. After the impact to the back plane, a fuel leak occurred and V1 had a major fire event. V1 was towed from the scene due to damage. The driver was hospitalized overnight for observation of loss of consciousness and released with scalp laceration. The left front seat passenger was fatal at the scene with total body burn as well as multiple injuries. The left second seat passenger was fatal at the scene with crushed skull, spinal cord transection and heart lacerations as well as multiple other injury and total body burn. The middle second seat passenger was hospitalized with 15
