# Volkswagen of America, Inc.

**Objective:** This procedure describes changing the ignition coils on 1.8 liter & 2.8 liter engines in New Beetle, GTI & Jetta vehicles, 1.8 liter & 4.0 liter engines in Passat vehicles, and on 2.8 liter engines in Eurovan vehicles.

### **Subject: 2001–2003 Model Year Volkswagen Vehicles Replace Ignition Coils**

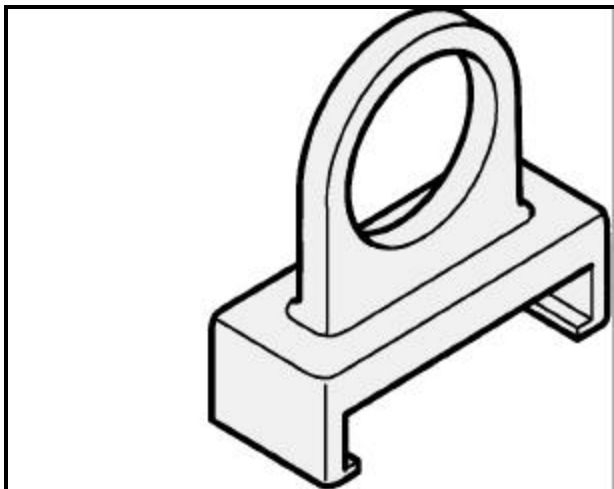
⇐ **Puller T40039** - must be used to avoid damaging ignition coils during removal

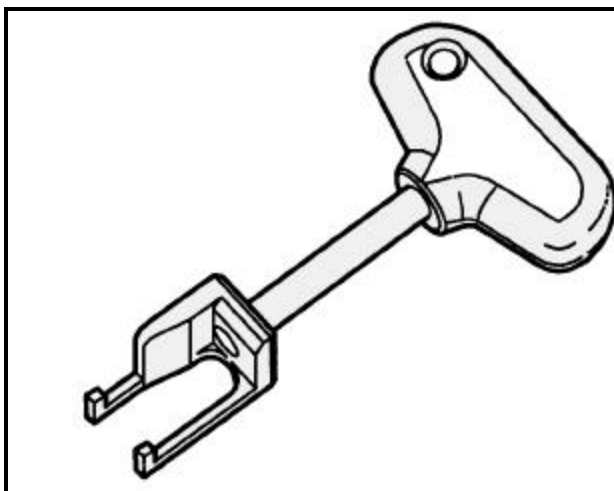
⇐ **Puller T0095** - must be used to avoid damaging ignition coils during removal

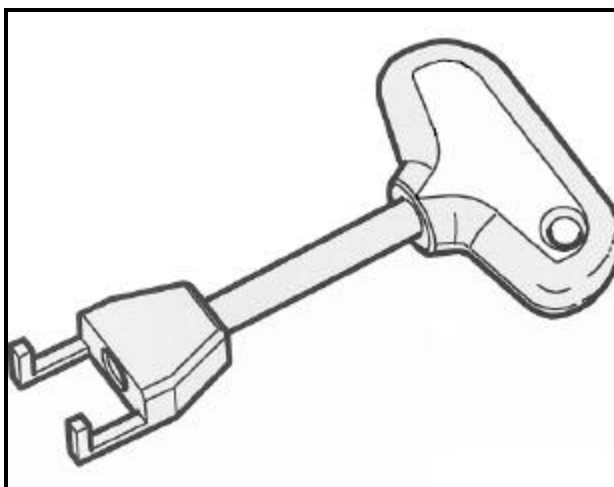
⇐ **Puller T10094** - must be used to avoid damaging ignition coils during removal

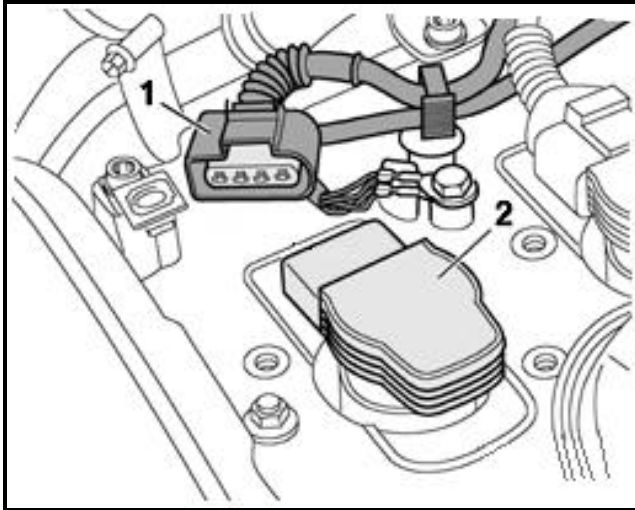
⇐ Disconnect connectors -1- from all ignition coils -2-

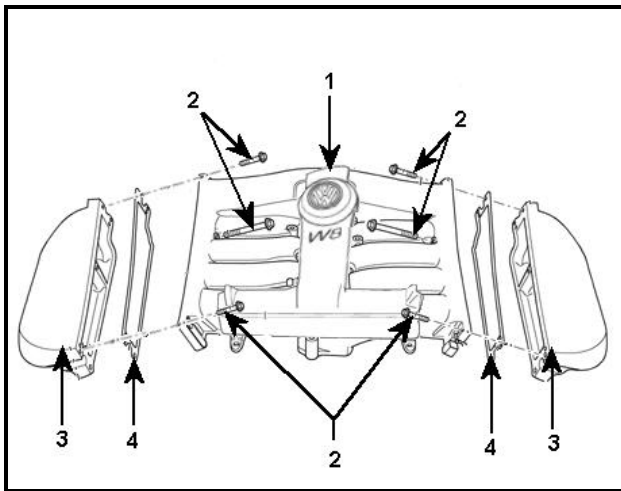
⇐ Open hood and remove center manifold cover -1-

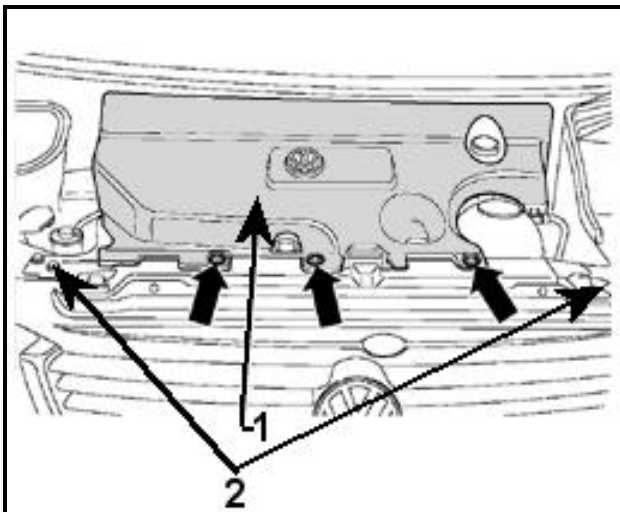
- If applicable, connect VAS5051 and check DTCs
- ⇐ Open hood and remove three T30 torx® screws -arrows- securing engine cover -1- and remove engine cover
- ⇐ Remove bolts -2- on left and right side of vehicle and pivot radiator forward to service position

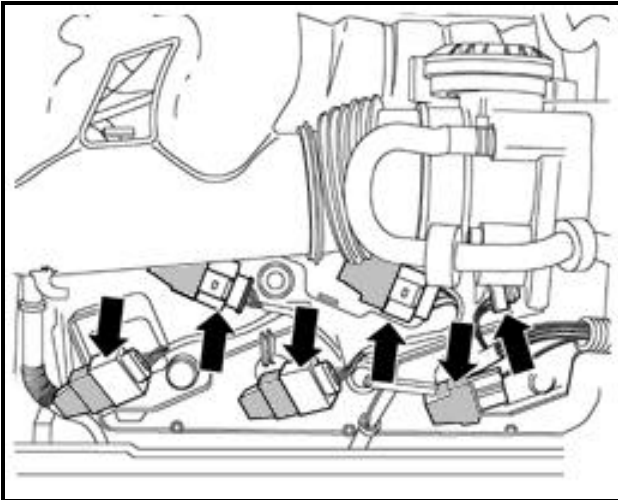
⇐ Disconnect connectors -arrows- from all ignition coils

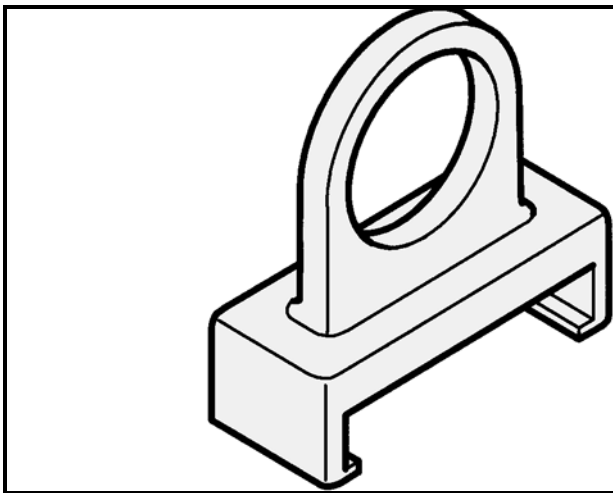
⇐ **Puller T40039** - must be used to avoid damaging ignition coils during removal

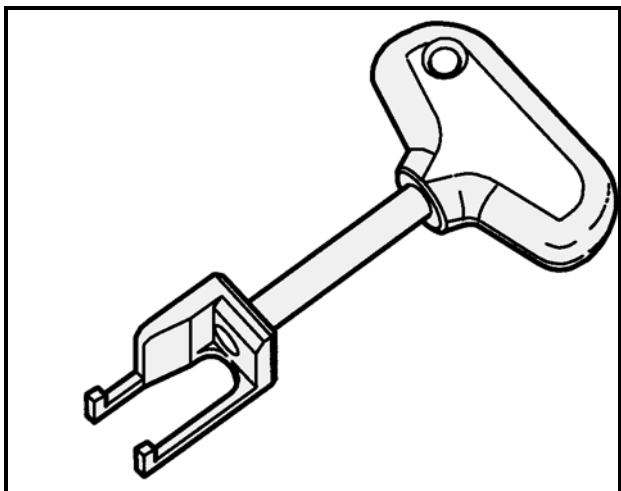
⇐ **Puller T10095** - must be used to avoid damaging ignition coils during removal

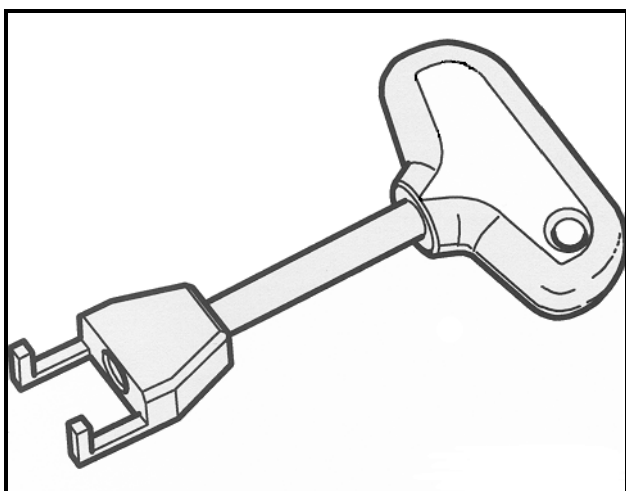
⇐ **Puller T10094** - must be used to avoid damaging ignition coils during removal

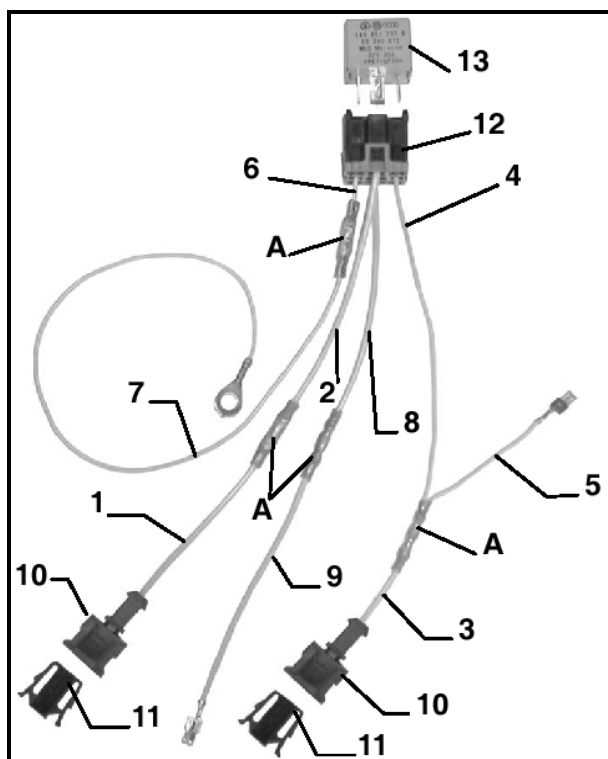
Note: If assembled harness kit (1J0 971 658 N ) is not available from parts, then the individual parts listed below can be assembled.

- ⇐ Using a repair wire -2- (000 927 227), cut wire approx. 100 mm from terminal, insert wire in butt connector -A- (111 971 939 B) and crimp butt connector with the VAS 1978/2 crimper
- ⇐ Using a repair wire -1- (000 979 220), cut wire approx. 100 mm from terminal, insert wire in butt connector -A- and crimp butt connector
- Seal the butt connector using the electric hot air blower from the VAS 1978 repair kit
- ⇐ Insert terminal end of wire -2- into position 2 -arrow- of relay connector -12- and wire end -1- into a terminal housing -10- (191 972 761)

- ⇐ Using a repair wire -4- (000 979 114), cut wire approx. 150 mm from terminal
- ⇐ Using a repair wire -5- (000 979 135), cut wire approx. 80 mm from terminal
- ⇐ Insert ends of wire -4- & -5- into butt connector A- and crimp connector
- ⇐ Using a repair wire -3- (000 979 130), cut wire approx. 70 mm from terminal, insert wire in butt connector -A- and crimp butt connector
- Seal the butt connector using the electric hot air blower
- ⇐ Insert terminal end of wire -4- into position 4 arrow- of relay connector -12- and terminal end of wire -5- into terminal housing -10- (191 972 761)

- ⇐ Using repair wire -6- (000 979 114), cut wire approx. 30 mm from terminal, insert into butt connector -A- and crimp connector
- ⇐ Using repair wire -7- (000 979 137), cut wire approx. 330 mm from eyelet, insert into butt connector -A- and crimp connector
- Seal the butt connector using the electric hot air blower
- ⇐ Insert terminal end of wire -6- into position 6 of relay connector -12-

- ⇐ Using repair wire -8- (000 979 227), cut wire approx. 110 mm from eyelet, insert into butt connector -A- and crimp connector
- ⇐ Using repair wire -9- (000 979 227), cut wire approx. 110 mm from eyelet, insert into butt connector -A- and crimp connector
- Seal both ends of the butt connector using the electric hot air blower
- ⇐ Insert terminal end of wire -8- into position 8 of relay connector -12-
- Go to Section A2 for harness installation

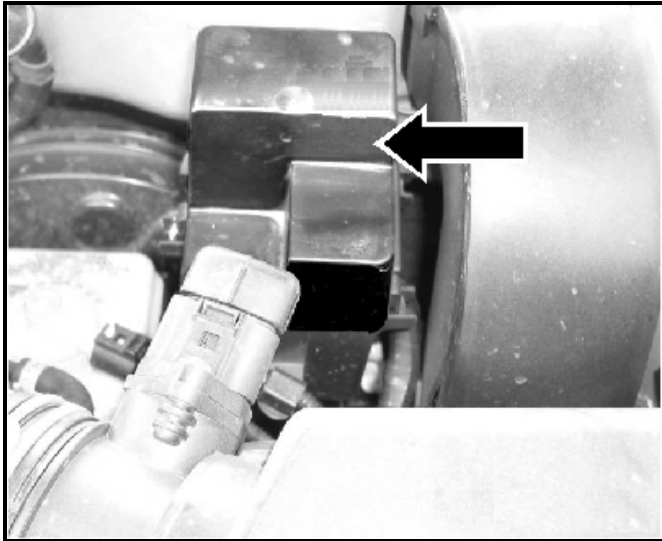
⇐ Remove relay cover -arrow- for relay panel  
(located next to brake booster) in engine  
compartment

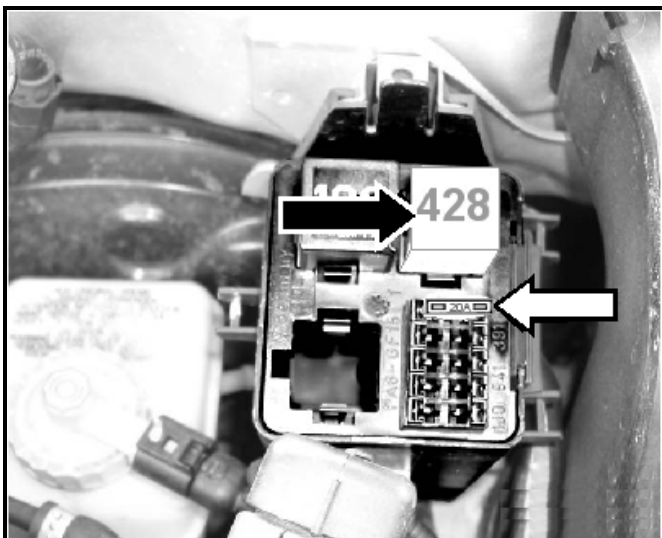
⇐ Remove fuse (S51) -white arrow- for vacuum pump  
from fuse holder

⇐ Remove relay #428 for the main power supply to the  
engine control module (ECM) -black arrow-

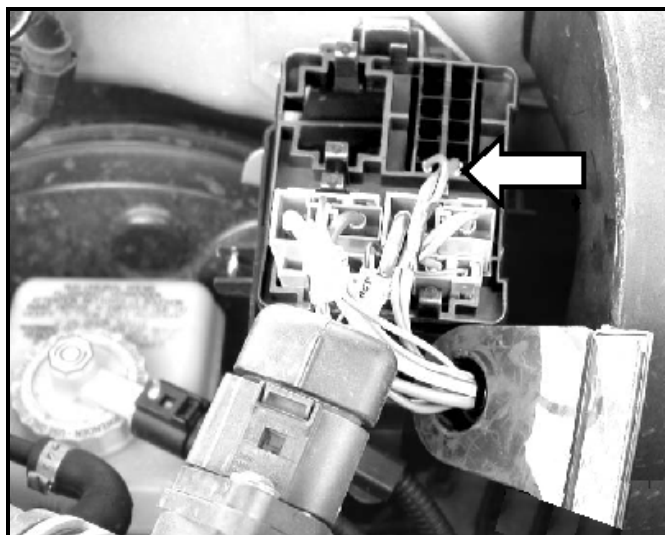
⇐ Remove large wire from cavity #1 for fuse (S51)  
-arrow-

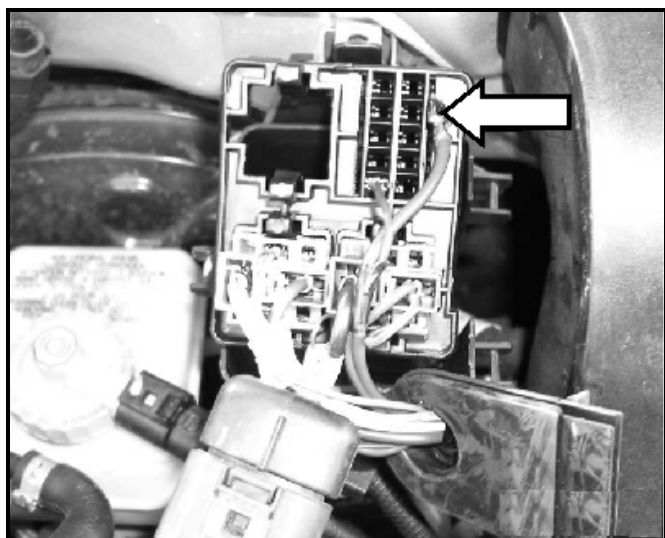
⇐ Illustration to the right shows large wire –arrow-  
removed from cavity #1

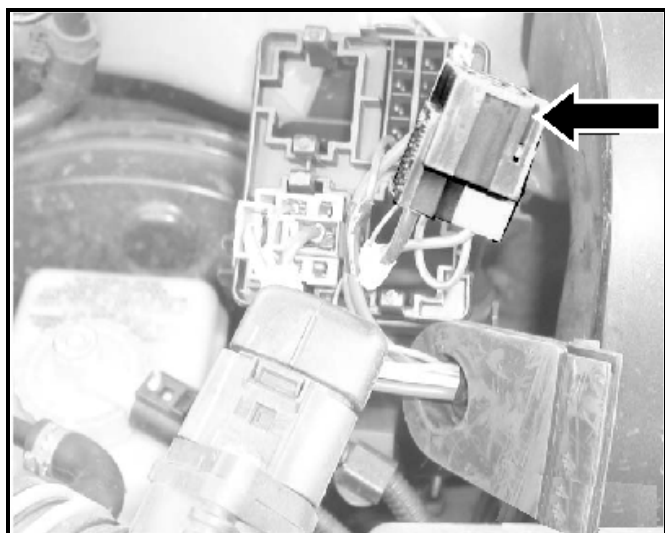
⇐ Remove red connector block (for relay #428)  
-arrow- from the relay housing

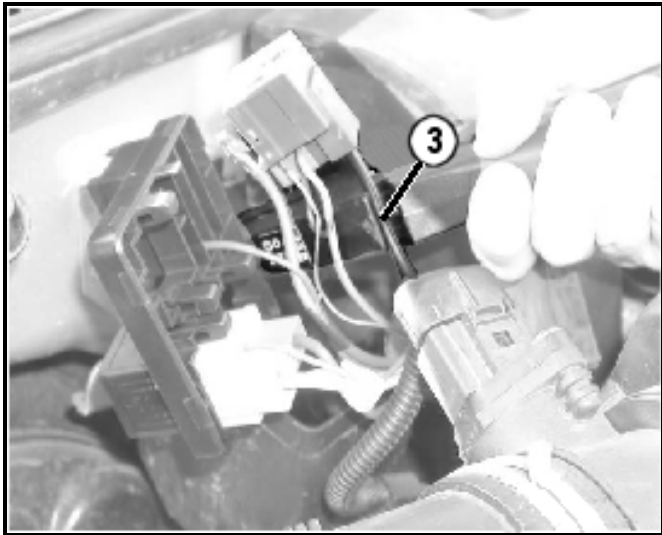
- ⇐ Locate large wire -3- from cavity 2 of the red connector for relay #428 and cut wire approximately 30 mm from terminal

Note: Cavity numbers are located on the connector at the terminal insertion points

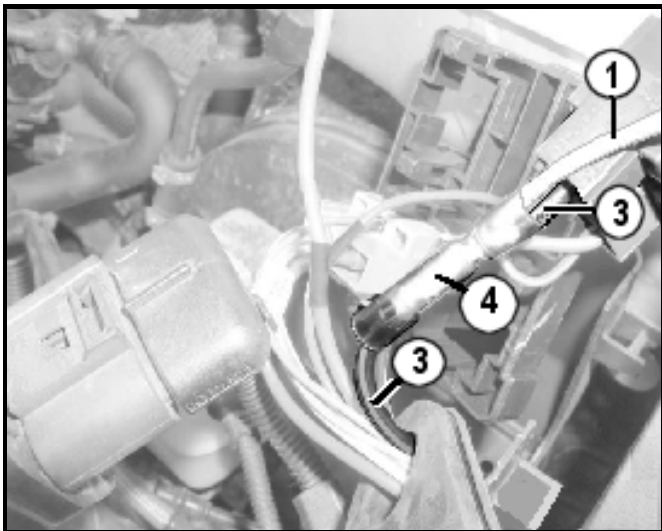
- Using new repair wire (000 979 227), cut wire approximately 100 mm from the terminal and strip the insulation from the wire (other end of the repair wire is not needed)
- ⇐ Insert the new 100 mm long repair wire -1- along with the end (30 mm length) of the previously cut wire -3- (from connector block cavity 2) into one end of a butt connector -4- (111 971 938 A)
- Crimp the butt connector using the VAS 1978/2 crimper from the VAS 1978 repair kit
  - Insert remaining end of previously cut wire -3- into the other end of the butt connector -4- and crimp using the wire crimper
  - Seal the butt connector using the electric hot air blower
  - If the large wire was removed from the relay connector housing cavity #2 to do this modification, reinstall wire at this time

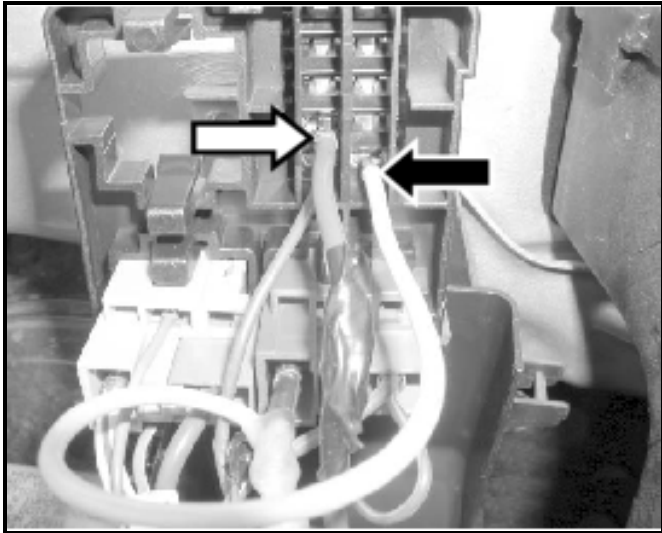
⇐ Note: In this illustration, cavity #4 was used - white arrow- however, your vehicle may be different

- ⇐ Install terminal from the 100 mm repair wire into the cavity #1 -black arrow- of the fuse holder
- Reinstall red connector block for relay into relay panel
- Reinstall relay panel into lower housing
- Reinstall relay #428 and fuse (S51) into relay panel
- Reinstall relay cover
- Reconnect battery ground (GND) cable and tighten nut to 6 Nm (53 in. lbs.)
- Go to Section A3

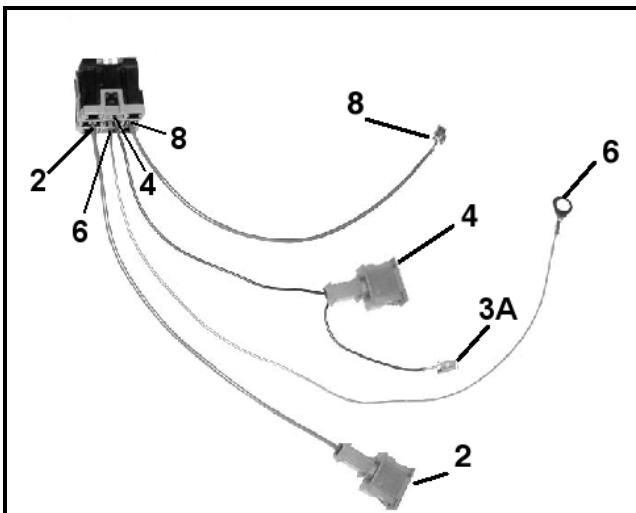
Note: Use harness kit (1J0 971 658 N). If not obtainable, the harness can be assembled. Some parts are in the VAS 1978 wiring harness repair kit other parts need to be ordered (Reference "Parts" on page 3.) Instructions for harness assembly are in Section A4

⇐ **Important! The terminal ends on the wire harness from the kit or from the assembled harness are shown to correspond to the terminal connection numbers on the relay connector**

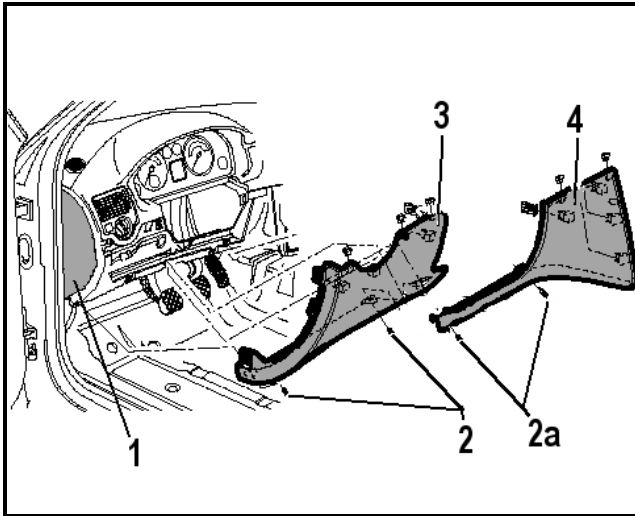
- ⇐ Open drivers door, remove instrument panel side cover -1-
- ⇐ Remove 2 screws -2- unclip trim panel -3- and remove
- ⇐ Remove 2 screws -2a- unclip trim panel -4 and remove

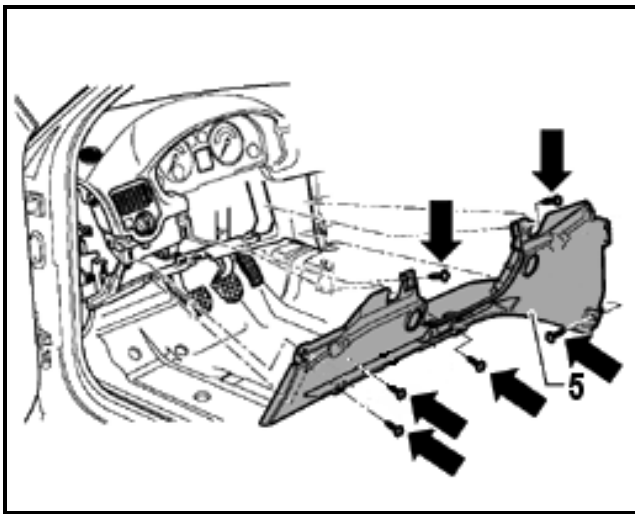
- ⇐ Remove (6) screws -arrows- and remove reinforcement -5-

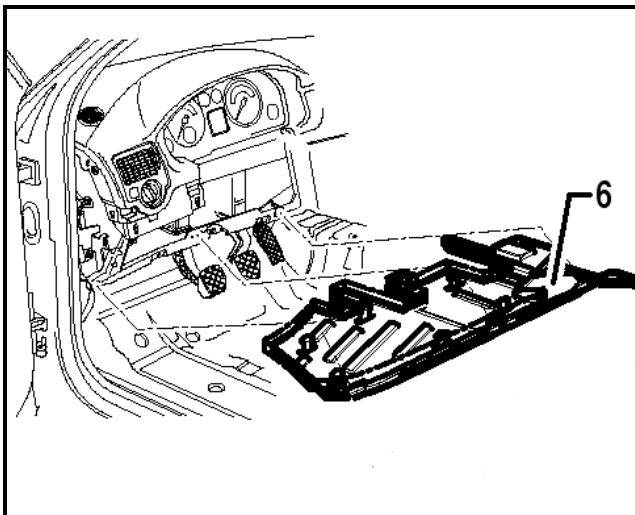
- ⇐ Unclip and remove lower cover -6- by sliding rearward out of clips

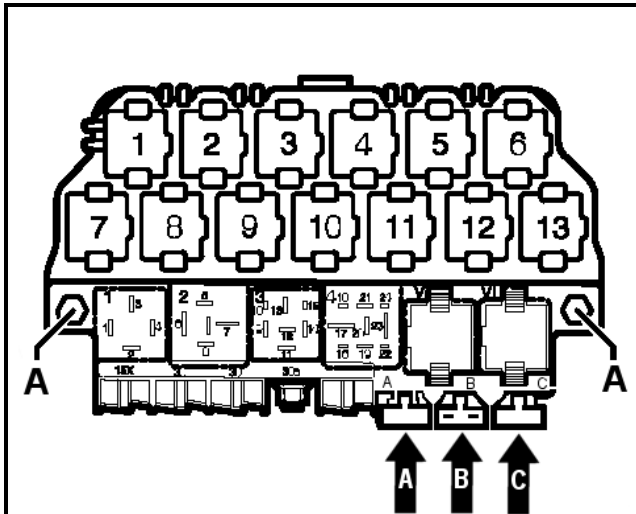
- ⇐ Using a volt meter, check the terminal contacts of the 15 amp fuse in position B -arrow- for (12 volts or B+ power) and make note of terminal position in fuse housing
- Under hood, remove battery cover and disconnect battery ground (GND) cable
- ⇐ Remove fuse/relay holders -A- and -C- (arrows) at the bottom of the lower relay panel
- ⇐ Remove fuse holder -B- from the bottom of lower relay panel -arrow- and remove fuse from holder
- ⇐ Remove (2) nuts -A- and pull lower relay carrier rearward and down to remove

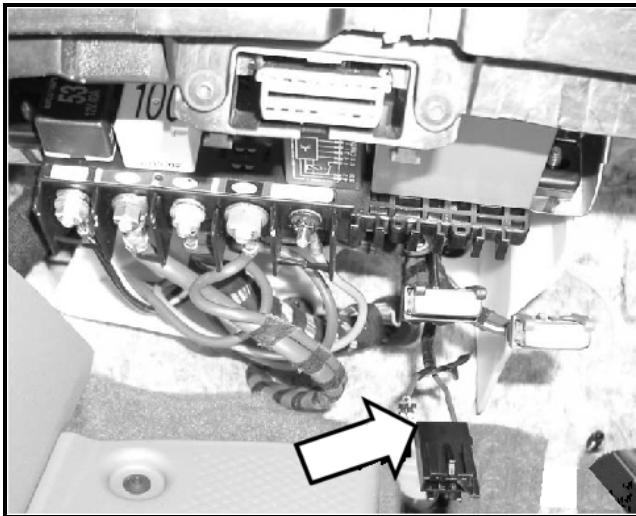
- ⇐ Remove the B+ terminal (as previously found) from fuse holder B -arrow-

Note: The illustration shows the wire removed from position #2, however, your vehicle could be different

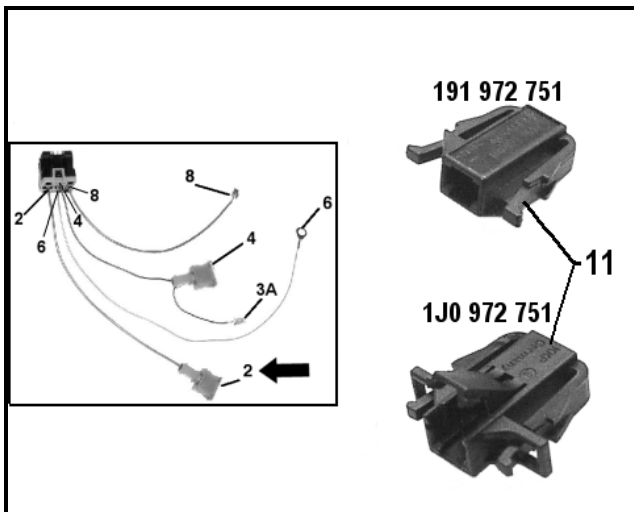
- ⇐ Insert the B+ terminal (removed from fuse holder) into terminal housing -11- (191 972 751 or 1J0 972 751)

**Important! To insert the B+ terminal into the 1J0 972 751 housing, the side clip needs to be opened**

Note: This terminal housing -11- will be connected to a terminal housing -2- on the new wiring harness later in the procedure

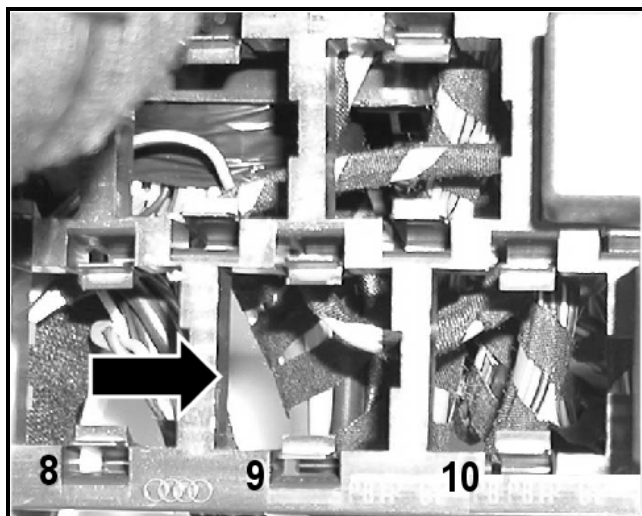
⇐ From the rear of the upper half of the relay panel, insert the new relay connector block on the new harness assembly into position #9 -arrow-

Note: The new relay must be removed from the relay connector on the new harness assembly before installing

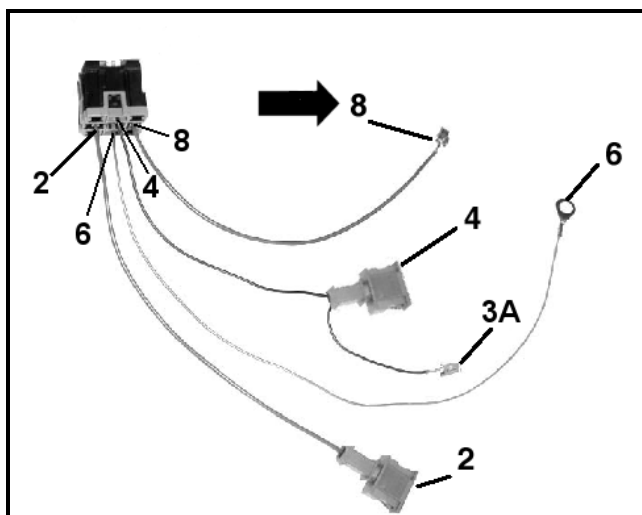
⇐ Locate terminal -8- (arrow) on the new wiring harness assembly

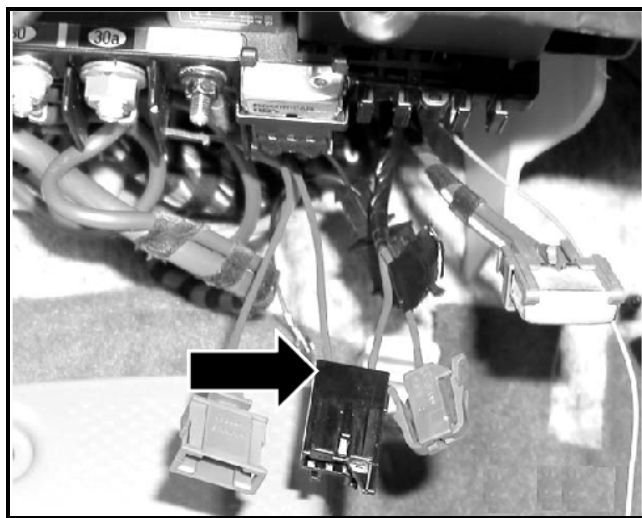
⇐ Insert terminal 8 on the new wire harness into the empty (B+) location in the 15 amp fuse holder -arrow-

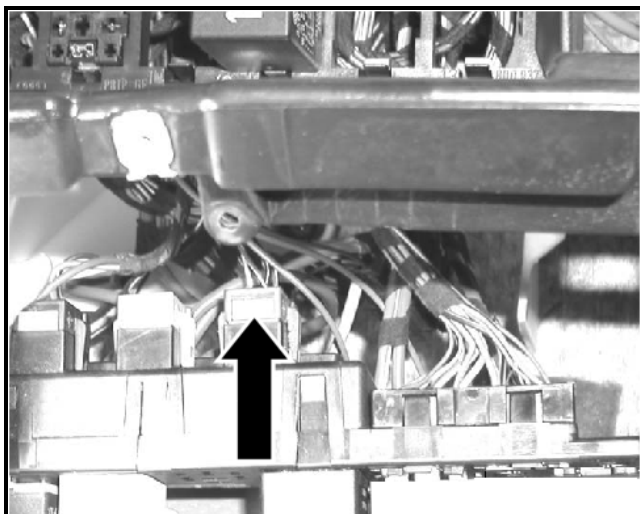
⇐ Remove (red) connector block -arrow- (for relay position 3) on reverse side of lower relay carrier

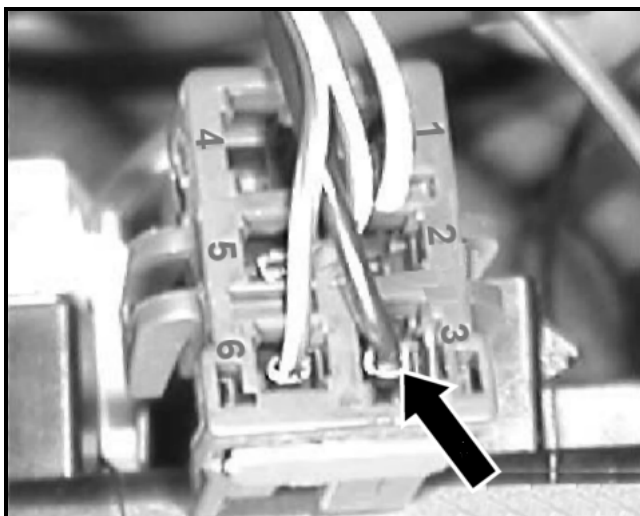
⇐ Remove terminal from position number 3 -arrow- of red connector block

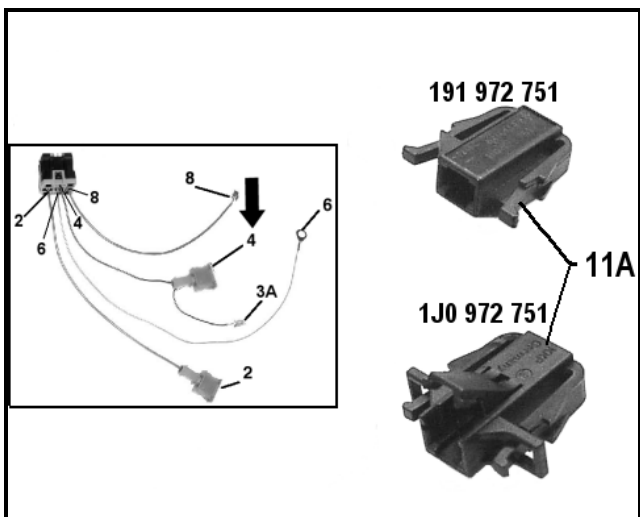
⇐ Insert this terminal -3- into connector housing -11A- (191 972 751 or 1J0 972 751)

**Important! To insert terminal -3- into the 1J0 972 751 housing, the side clip needs to be opened**

⇐ Connect the housing -11A- to the connector housing -4- on the new harness assembly

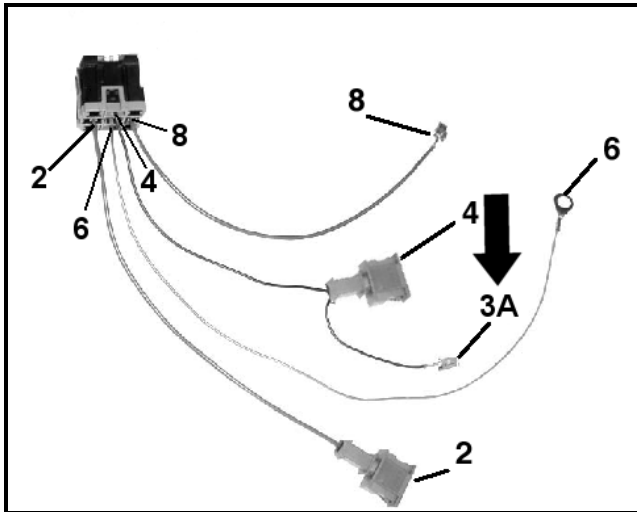
⇐ Locate terminal -3A- (arrow) (short wire from connector housing -4-) on new harness assembly

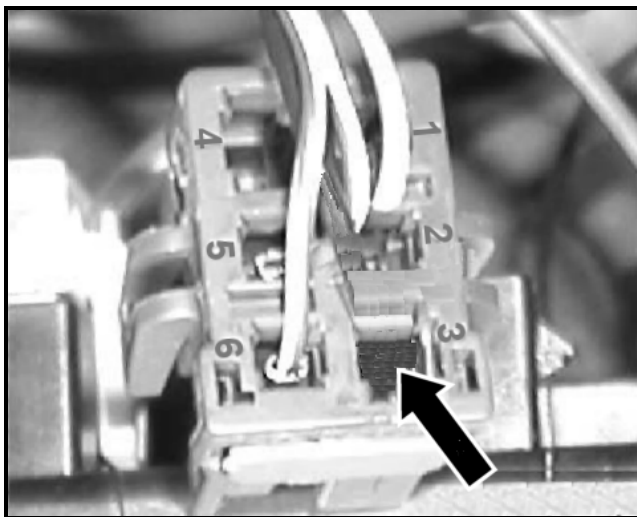
- ⇐ Insert terminal -3A- into the empty position number 3 -arrow- of red connector
- Reinstall red connector block to reverse side of relay panel (behind relay position 3)

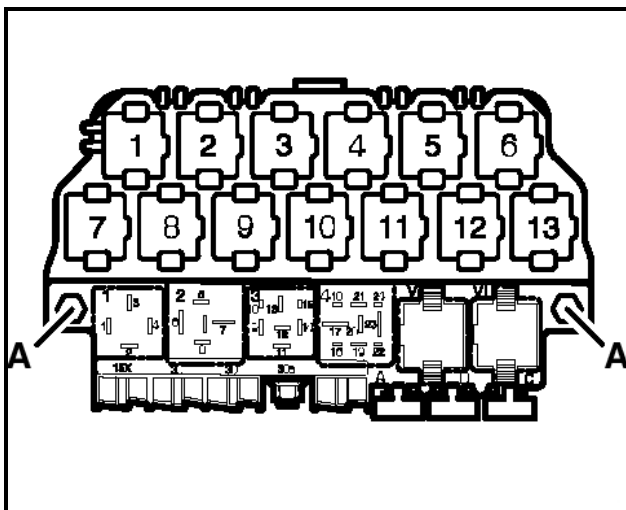
⇐ Reinstall relay carriers, secure with (2) nuts -A- and tighten to 2 Nm (18 in. lbs.)

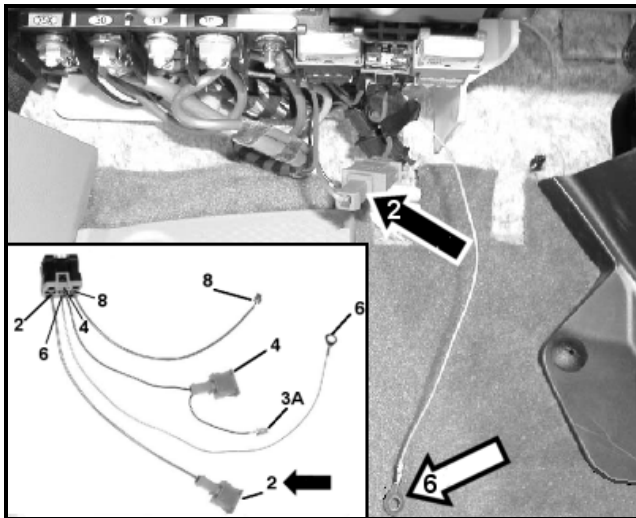
- ⇐ Insert the connector -11- (contains terminal removed from B+ fuse connector at the start of this procedure) to connector -2- (arrow) on the new wire harness assembly
- Reinstall fuse holder to location B on the lower relay block
- Reinstall 15 amp fuse
- Reinstall fuse/relay holders -A- & -C- into proper location on lower relay block
- ⇐ Locate ground (GND) wire -6- (eyelet terminal on the new wiring harness assembly)

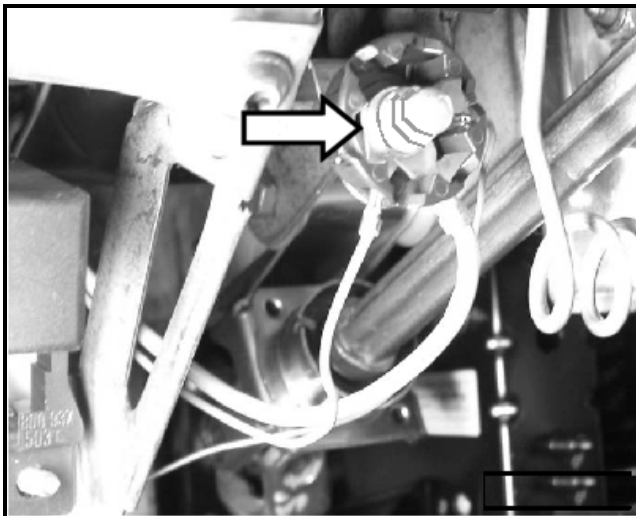
- ⇐ Remove cap nut at ground point -arrow- near steering column, install ground wire eyelet -6- from new harness assembly, secure with cap nut and tighten to 6 Nm (53 in. lbs.)

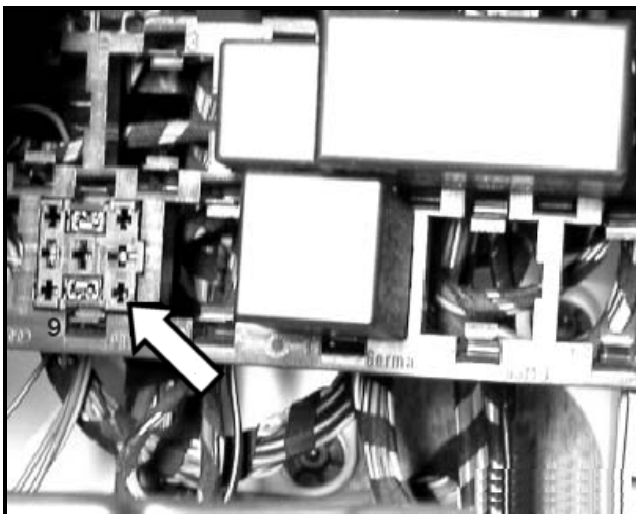
- ⇐ Install new (141 951 253 B) relay into upper relay block position 9 -arrow-
- Reinstall instrument panel lower cover
- Reinstall reinforcement and secure with (6) screws
- Reinstall lower trim panels
- Reinstall instrument panel side cover
- Reconnect battery ground (GND) cable and tighten to 6 Nm (53 in. Lbs)
- Reinstall battery cover
- Proceed to Section A3

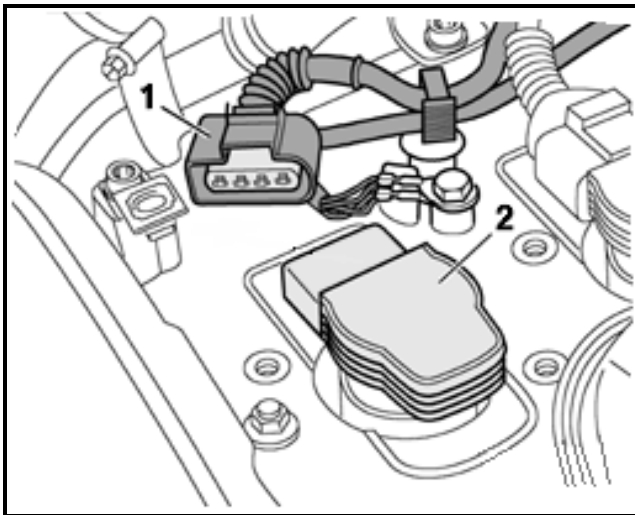
⇐ Disconnect connectors -1- from all ignition coils -2-

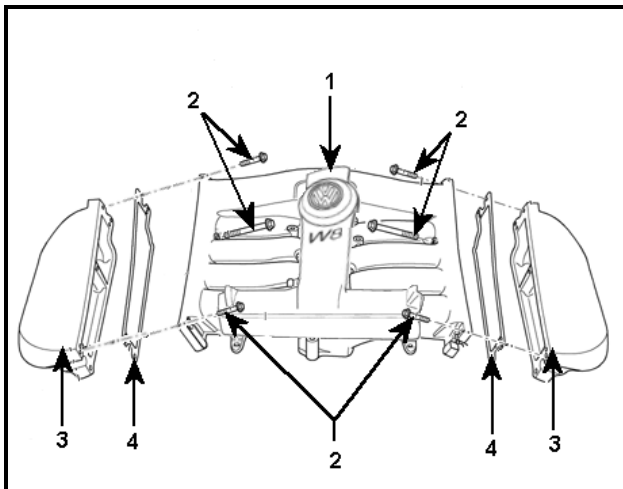
- If applicable, connect VAS5051 and check DTCs
- ⇐ Open hood and remove center manifold cover -1-
- ⇐ Remove bolts -2- securing left and right intake manifold side parts -3- and remove side part with gaskets -4-
- Disconnect connectors on all ignition coils

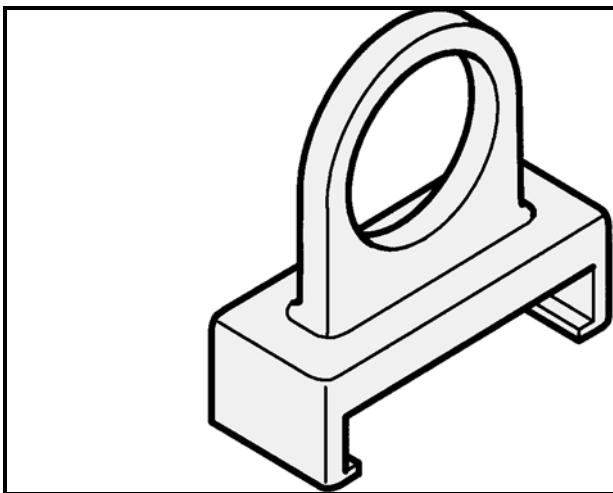
⇐ **Puller T40039** - must be used to avoid damaging ignition coils during removal

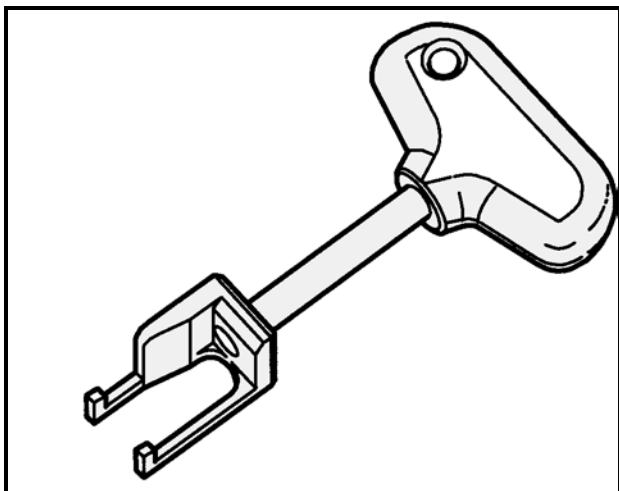
⇐ **Puller T0095** - must be used to avoid damaging ignition coils during removal

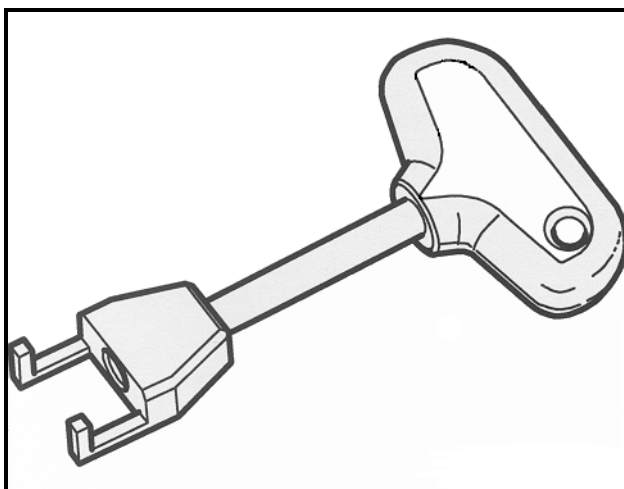
⇐ **Puller T10094** - must be used to avoid damaging ignition coils during removal

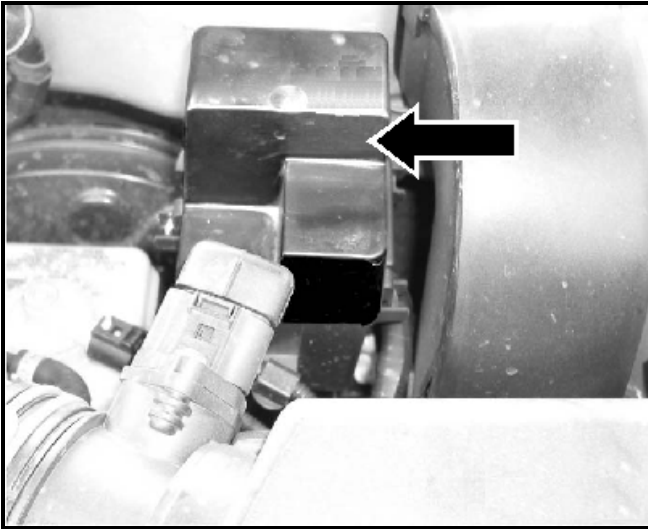
⇐ Remove relay cover -arrow- for relay panel  
(located next to brake booster) in engine  
compartment

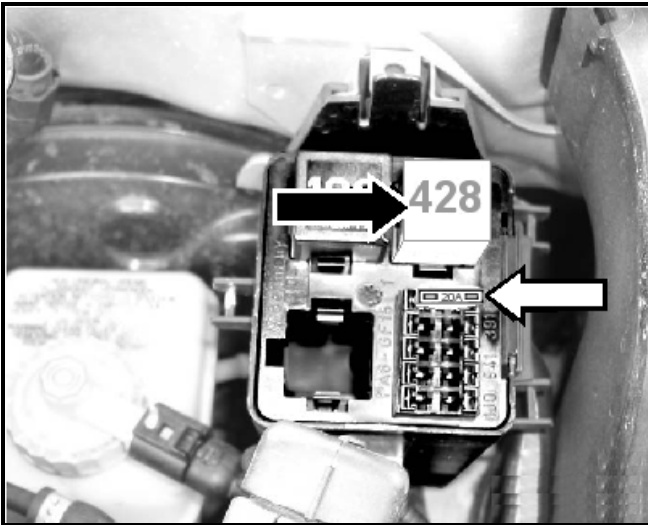
- ⇐ Remove fuse (S51) -white arrow- for vacuum pump  
from fuse holder
- ⇐ Remove relay #428 for the main power supply to the  
engine control module (ECM) -black arrow-
- Lift out relay panel from the lower housing

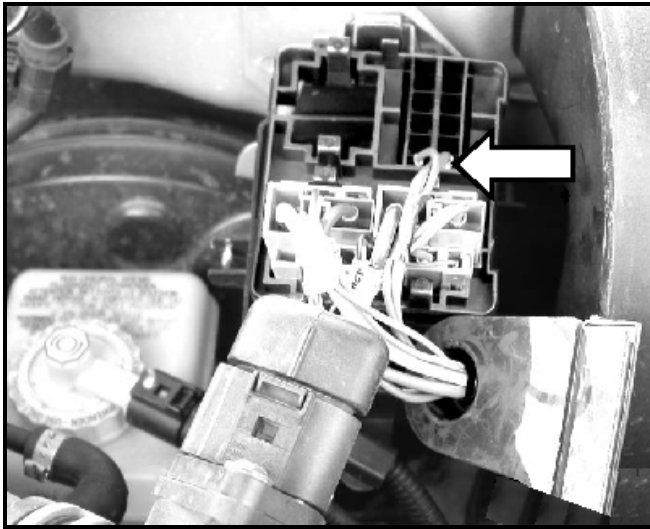
⇐ Remove large wire from cavity #1 for fuse (S51)  
-arrow-

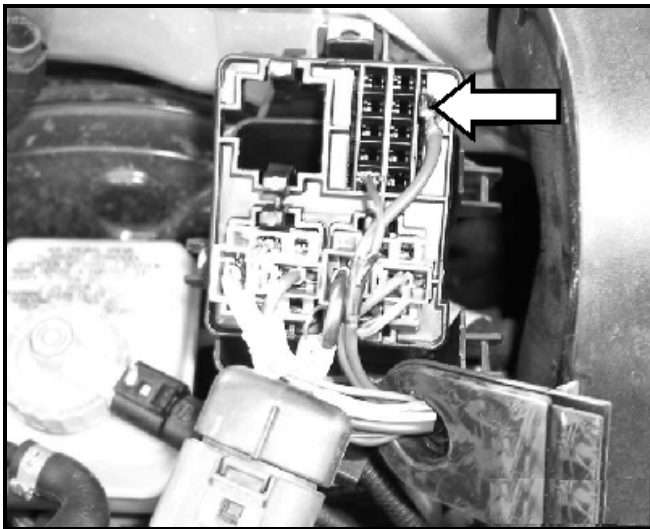
⇐ Illustration to the right shows large wire removed from cavity #1

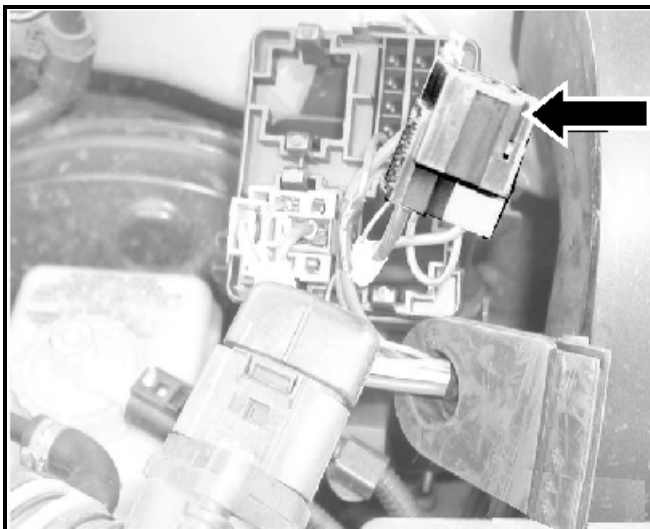
⇐ Remove the red connector block (for relay #428)  
-arrow- from the relay panel

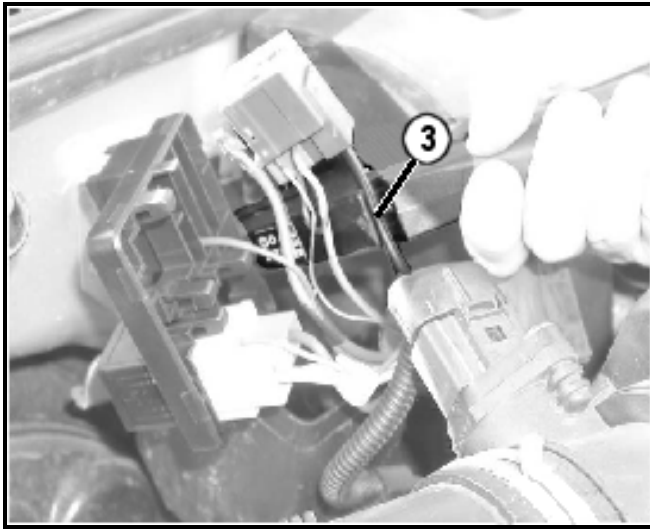
- ⇐ Locate large wire -3- from cavity 2 of the red connector for relay #428 and cut wire approximately 30 mm from the terminal end

Note: The illustrations show the large wire still installed in the relay connector housing, it may be easier to remove this terminal from the relay connector housing for the modification

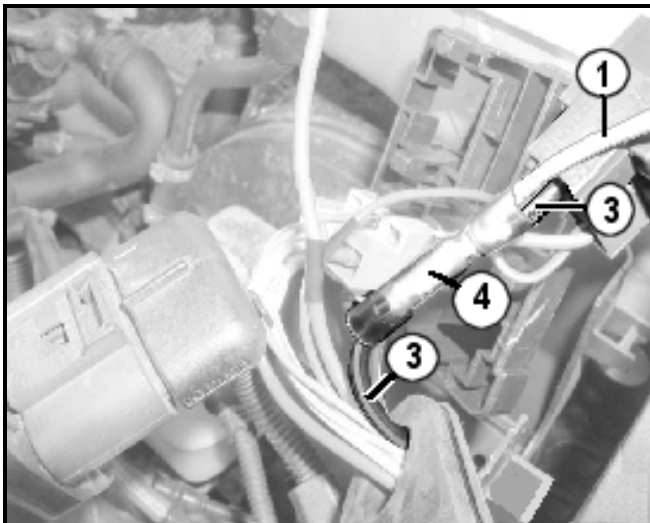
- ⇐ Insert the new 100mm long repair wire -1- along with the end of the previously cut wire -3- (from connector block cavity 2) into one end of the butt connector -4- (111 971 938 A)

- ⇐ Insert remaining end of previously cut wire -3- into other end of the butt connector -4- and crimp using the wire crimper

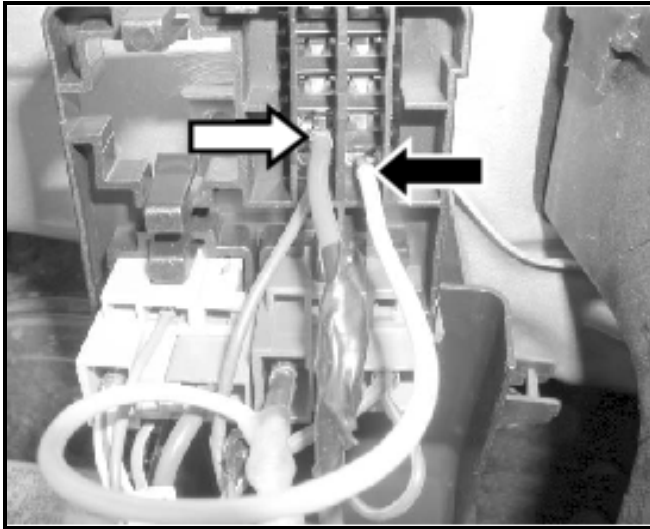
⇐ Note: In this illustration, cavity #4 was used –white arrow- however, your vehicle can be different

⇐ Install terminal from the new 100 mm repair wire into cavity #1 -black arrow- of the fuse holder

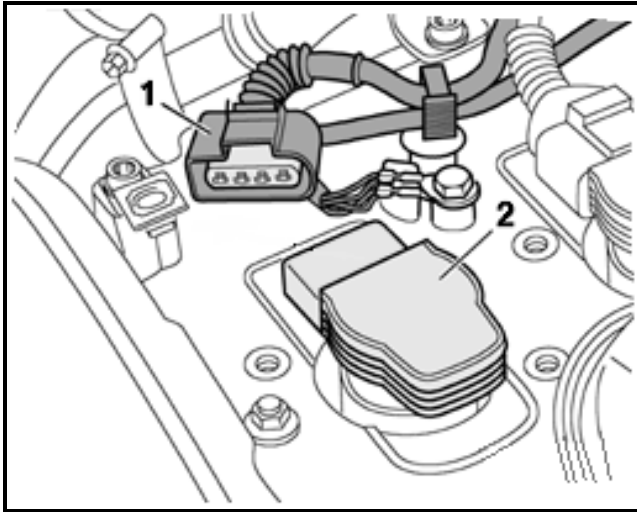
⇐ Disconnect connectors -1- from all ignition coils -2-

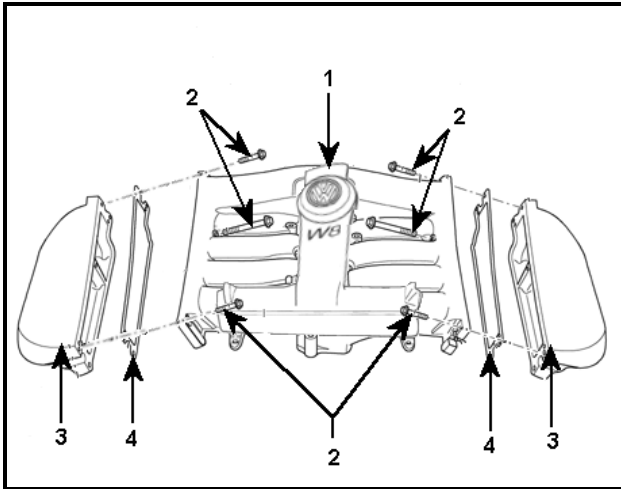
⇐ Open hood and remove center manifold cover -1-

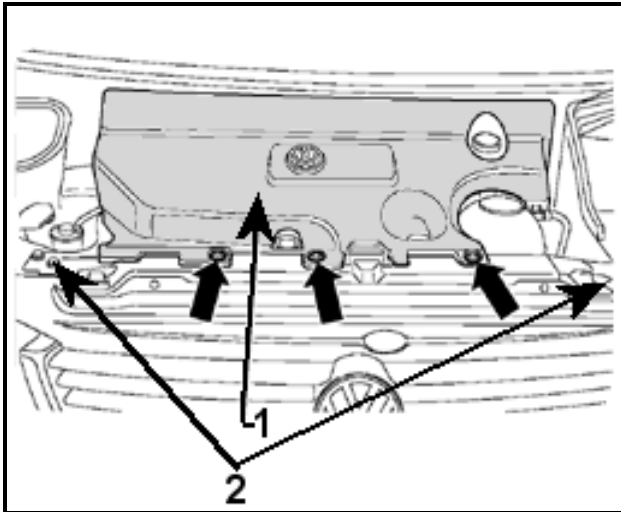
- If applicable, connect VAS5051 and check DTCs
- ⇐ Open hood and remove three T30 torx® screws -arrows- securing engine cover -1- and remove engine cover
- ⇐ Remove bolts -2- on left and right side of vehicle and pivot radiator forward to service position

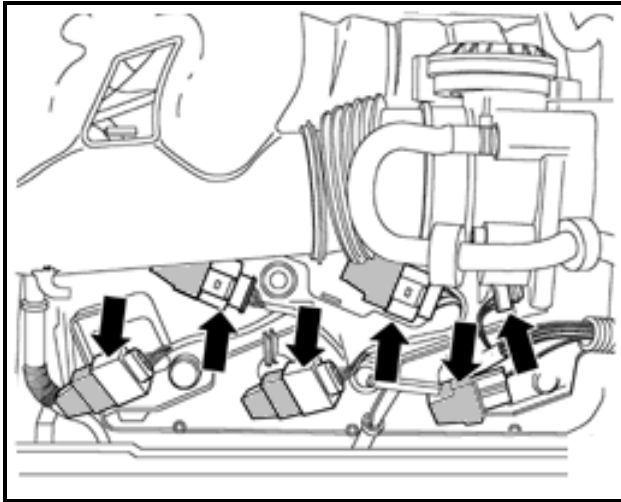
⇐ Disconnect connectors -arrows- from all ignition coils

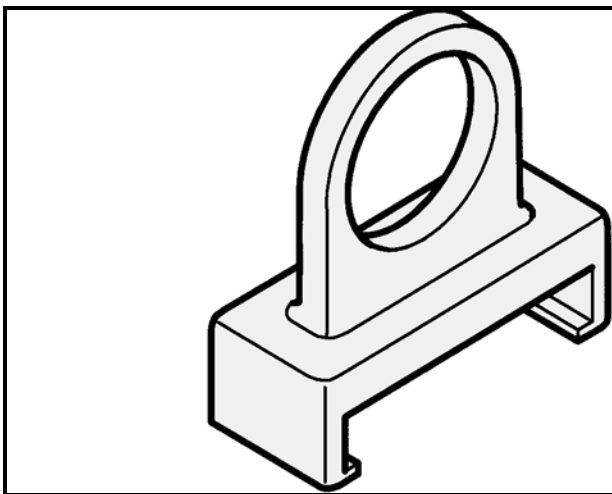
⇐ **Puller T40039** - must be used to avoid damaging ignition coils during removal

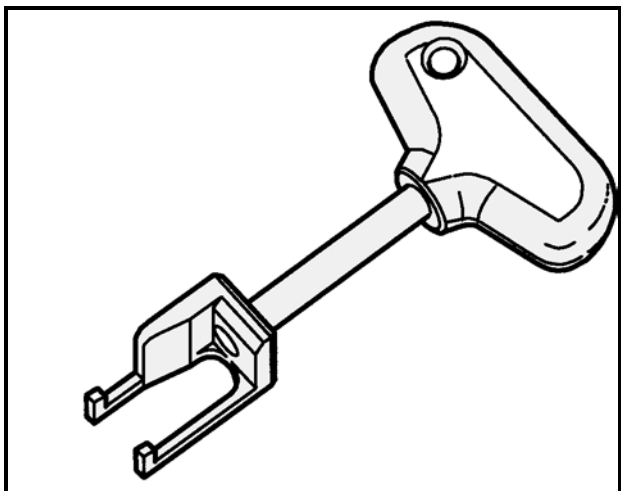
⇐ **Puller T10095** - must be used to avoid damaging ignition coils during removal

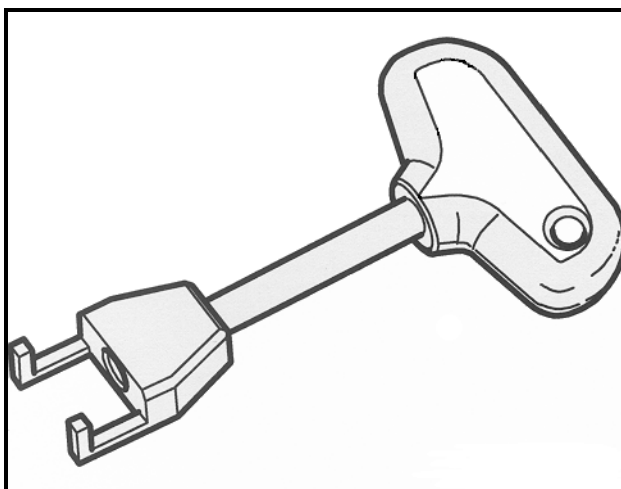
⇐ **Puller T10094** - must be used to avoid damaging ignition coils during removal

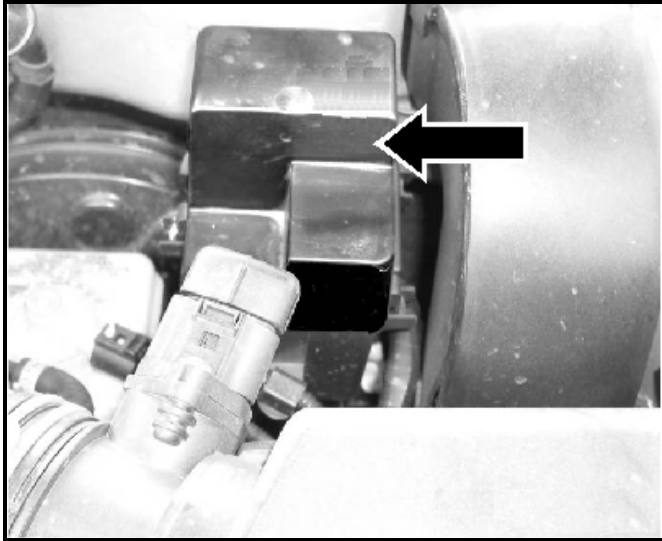
⇐ Remove relay cover -arrow- for relay panel  
(located next to brake booster) in engine  
compartment
