# Volkswagen of America, Inc.

**Objective:** This procedure describes changing the ignition coils on 1.8 liter & 2.8 liter engines in New Beetle, GTI & Jetta vehicles, 1.8 liter & 4.0 liter engines in Passat vehicles, and on 2.8 liter engines in Eurovan vehicles.

### **Subject: 2001–2003 Model Year Volkswagen Vehicles Replace Ignition Coils**

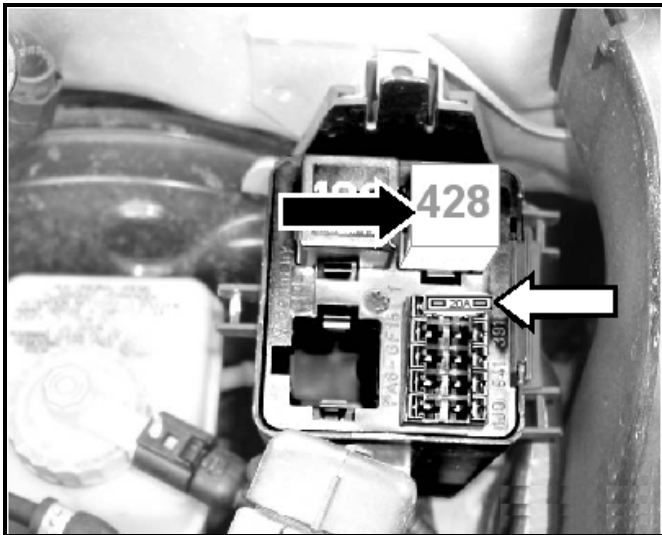
⇐ Remove fuse (S51) -white arrow- for vacuum pump  
from fuse holder

⇐ Remove relay #428 for the main power supply to the  
engine control module (ECM) -black arrow-

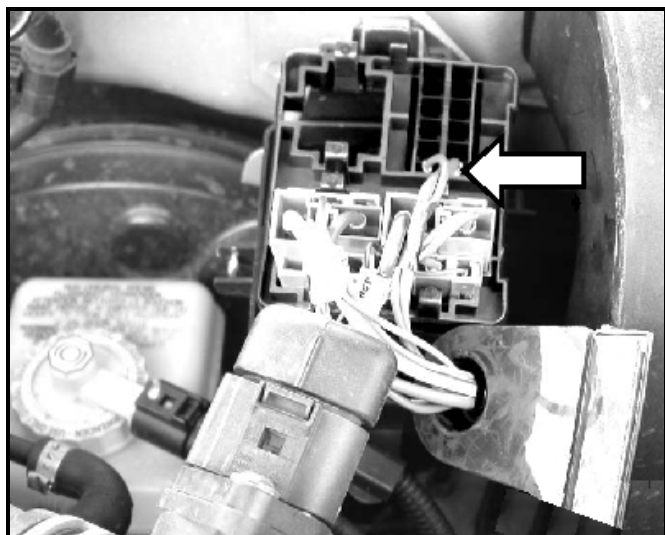
⇐ Remove large wire from cavity #1 for fuse (S51)  
-arrow-

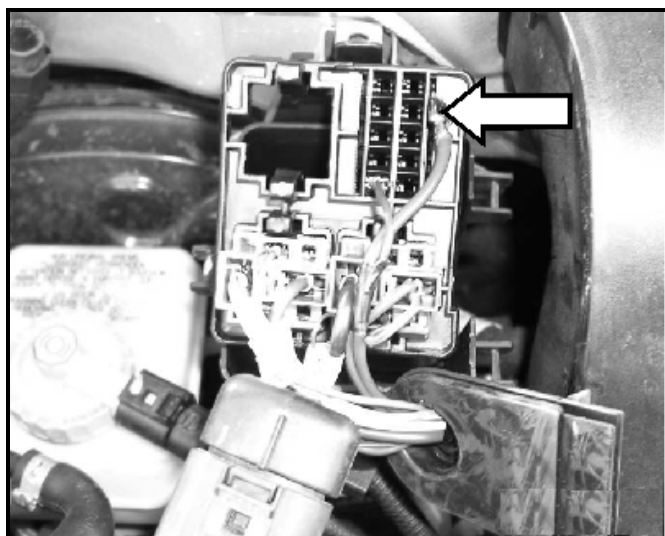
⇐ Illustration to the right shows large wire –arrow-  
removed from cavity #1

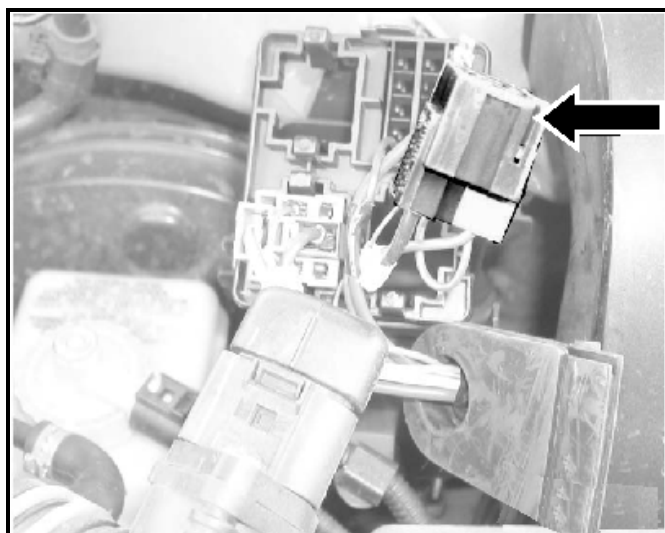
⇐ Remove red connector block (for relay #428)  
-arrow- from the relay housing

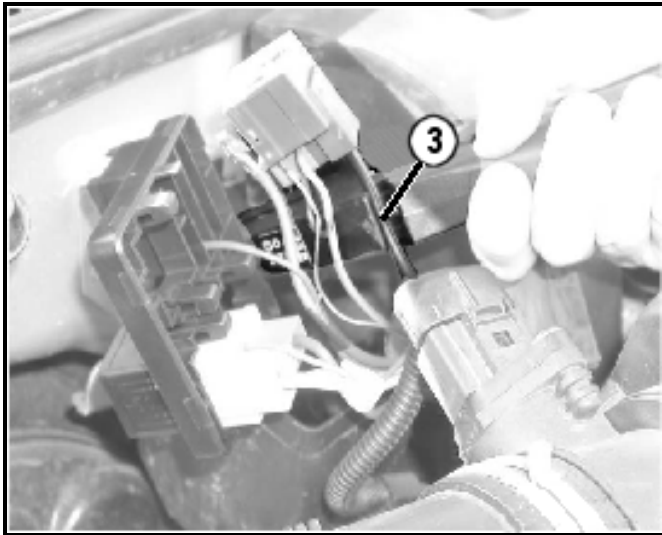
- ⇐ Locate large wire -3- from cavity 2 of the red connector for relay #428 and cut wire approximately 30 mm from terminal

Note: The illustrations show the large wire installed in the relay connector housing. It may be easier to remove this terminal from the relay connector housing for the following modification

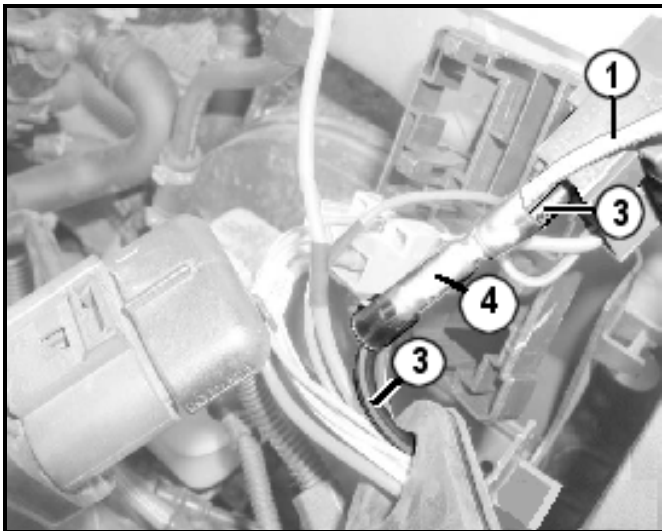
- Using new repair wire (000 979 227), cut wire approximately 100 mm from the terminal and strip the insulation from the wire (other end of the repair wire is not needed)
- ⇐ Insert the new 100 mm long repair wire -1- along with the end (30 mm length) of the previously cut wire -3- (from connector block cavity 2) into one end of a butt connector -4- (111 971 938 A)
- Crimp the butt connector using the VAS 1978/2 crimper from the VAS 1978 repair kit
  - Insert remaining end of previously cut wire -3- into the other end of the butt connector -4- and crimp using the wire crimper
  - Seal the butt connector using the electric hot air blower
  - If the large wire was removed from the relay connector housing cavity #2 to do this modification, reinstall wire at this time

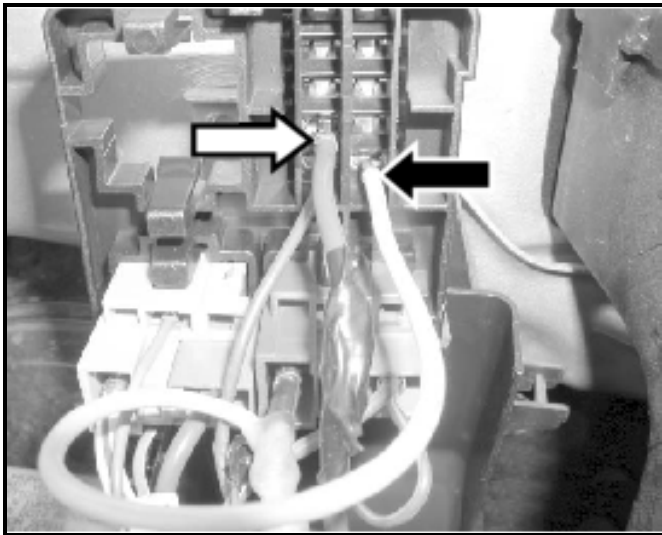
⇐ Note: In this illustration, cavity #4 was used - white arrow- however, your vehicle may be different

- ⇐ Install terminal from the 100 mm repair wire into the cavity #1 -black arrow- of the fuse holder
- Reinstall red connector block for relay into relay panel
- Reinstall relay panel into lower housing
- Reinstall relay #428 and fuse (S51) into relay panel
- Reinstall relay cover
- Reconnect battery ground (GND) cable and tighten nut to 6 Nm (53 in. lbs.)
- Go to Section A3

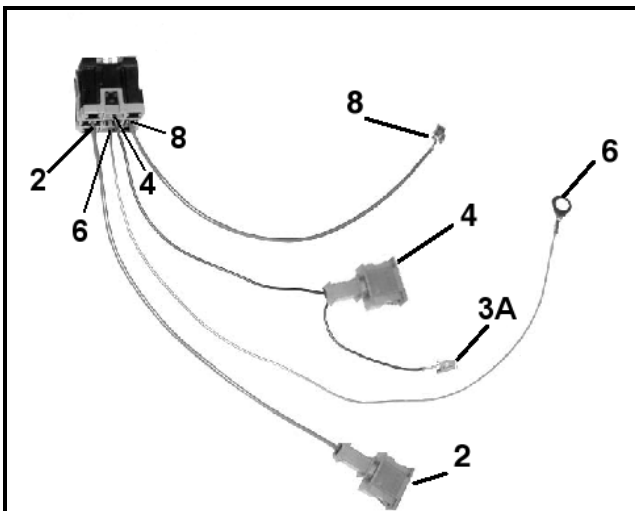
Note: Use harness kit (1J0 971 658 N). If not obtainable, the harness can be assembled. Some parts are in the VAS 1978 wiring harness repair kit other parts need to be ordered (Reference "Parts" on page 3.) Instructions for harness assembly are in Section A4

⇐ **Important! The terminal ends on the wire harness from the kit or from the assembled harness are shown to correspond to the terminal connection numbers on the relay connector**

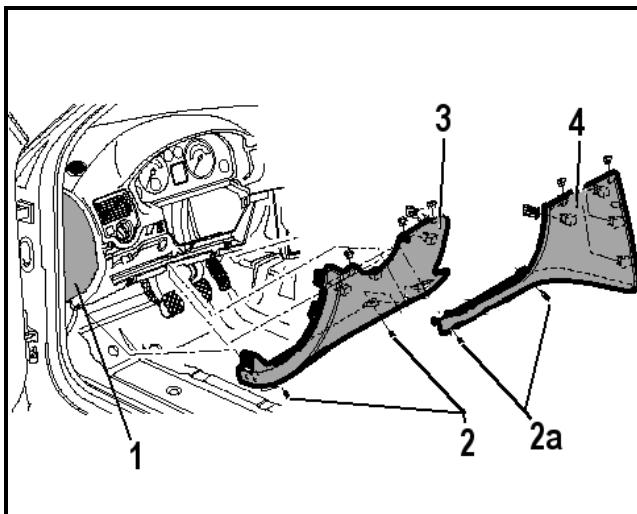
- ⇐ Open drivers door, remove instrument panel side cover -1-
- ⇐ Remove 2 screws -2- unclip trim panel -3- and remove
- ⇐ Remove 2 screws -2a- unclip trim panel -4 and remove

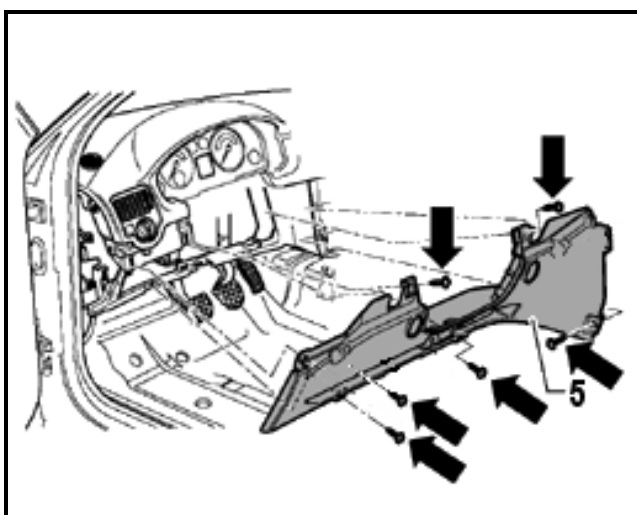
- ⇐ Remove (6) screws -arrows- and remove reinforcement -5-

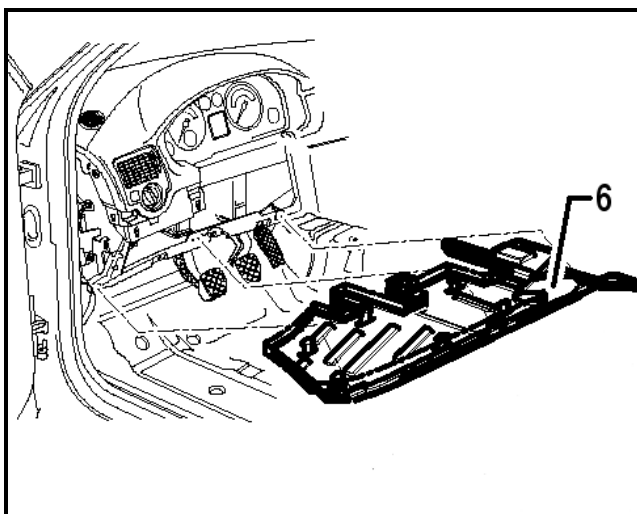
- ⇐ Unclip and remove lower cover -6- by sliding rearward out of clips

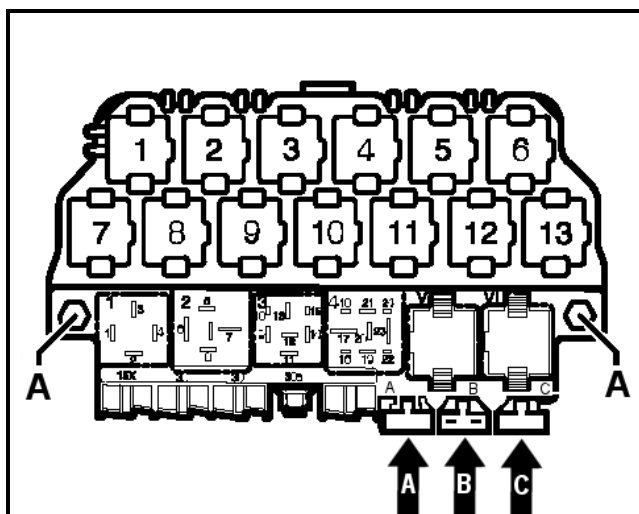
- ⇐ Using a volt meter, check the terminal contacts of the 15 amp fuse in position B -arrow- for (12 volts or B+ power) and make note of terminal position in fuse housing
- Under hood, remove battery cover and disconnect battery ground (GND) cable
- ⇐ Remove fuse/relay holders -A- and -C- (arrows) at the bottom of the lower relay panel
- ⇐ Remove fuse holder -B- from the bottom of lower relay panel -arrow- and remove fuse from holder
- ⇐ Remove (2) nuts -A- and pull lower relay carrier rearward and down to remove

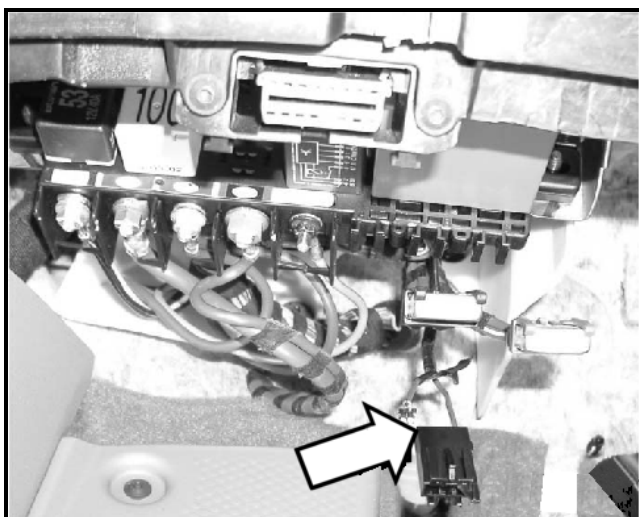
- ⇐ Remove the B+ terminal (as previously found) from fuse holder B -arrow-

Note: The illustration shows the wire removed from position #2, however, your vehicle could be different

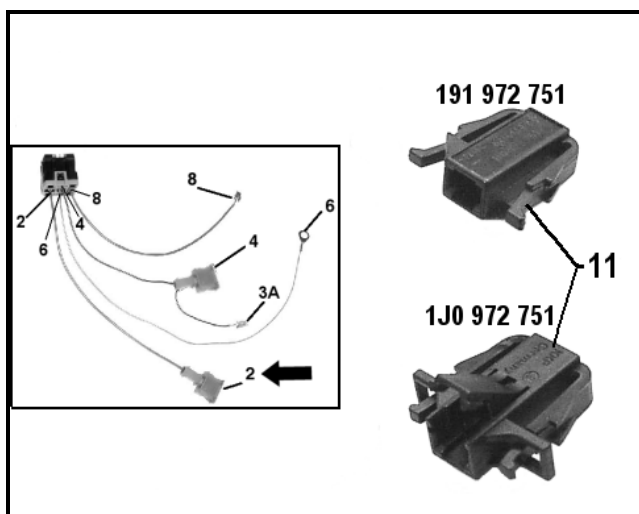
- ⇐ Insert the B+ terminal (removed from fuse holder) into terminal housing -11- (191 972 751 or 1J0 972 751)

Note: The terminal housing 1J0 972 751 comes with the wiring harness assembly.

**Important! To insert the B+ terminal into the 1J0 972 751 housing, the side clip needs to be opened**

Note: This terminal housing -11- will be connected to a terminal housing -2- on the new wiring harness later in the procedure

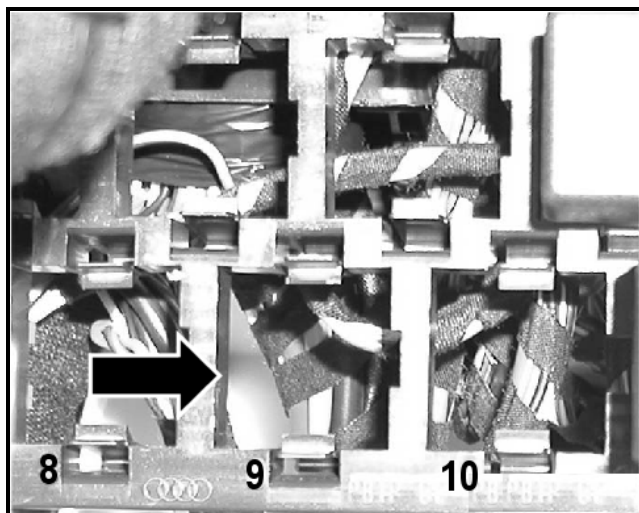
⇐ From the rear of the upper half of the relay panel, insert the new relay connector block on the new harness assembly into position #9 -arrow-

Note: The new relay must be removed from the relay connector on the new harness assembly before installing

- Route wires 2, 6 & 8 on the new harness assembly behind the fuse/relay panels

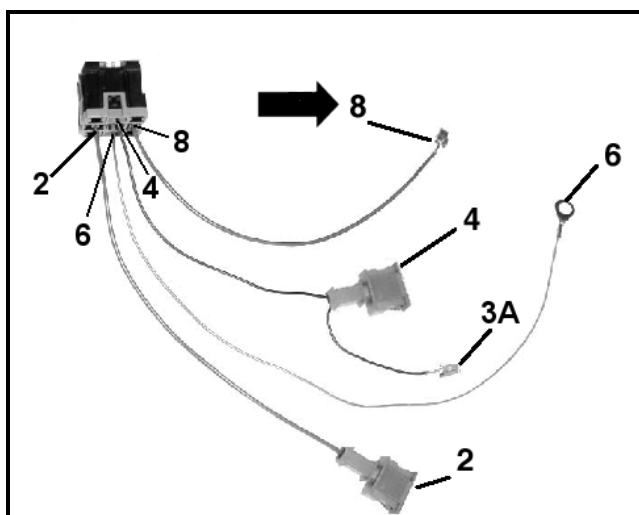
⇐ Locate terminal -8- (arrow) on the new wiring harness assembly

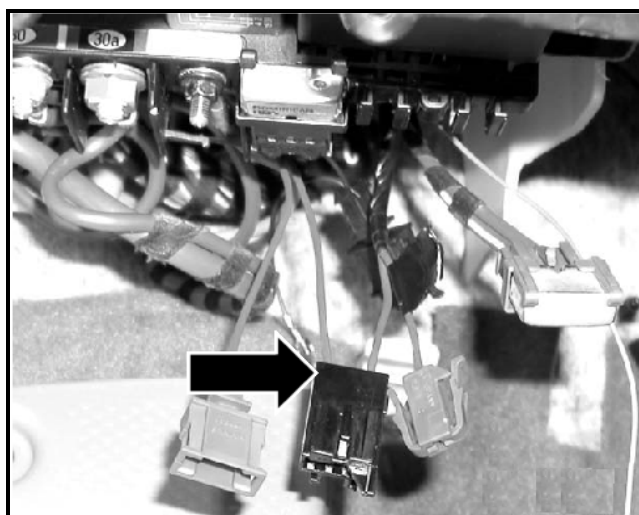
⇐ Insert terminal 8 on the new wire harness into the empty (B+) location in the 15 amp fuse holder -arrow-

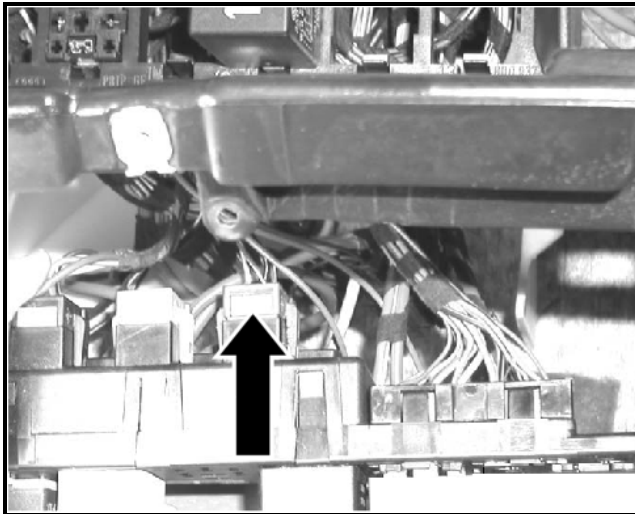
⇐ Remove (red) connector block -arrow- (for relay position 3) on reverse side of lower relay carrier

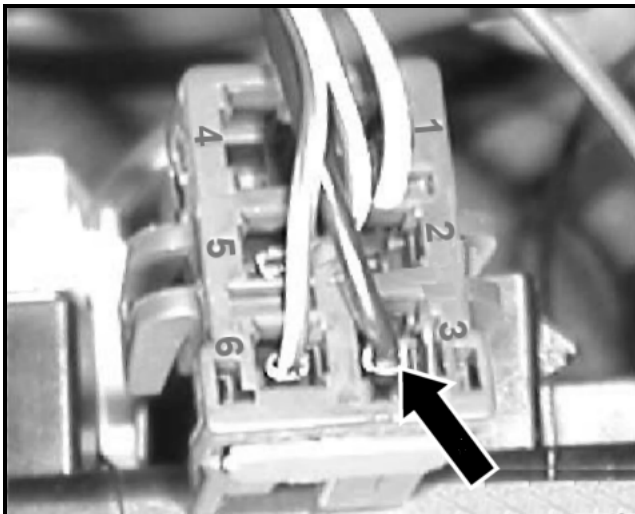
⇐ Remove terminal from position number 3 -arrow- of red connector block

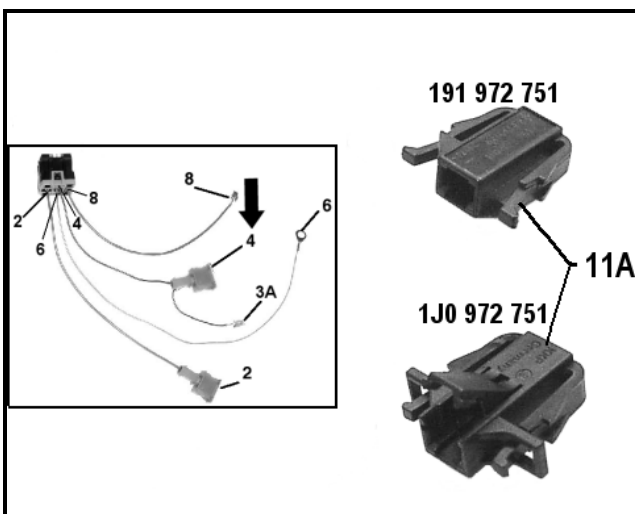
⇐ Insert this terminal -3- into connector housing -11A- (191 972 751 or 1J0 972 751)

**Important! To insert terminal -3- into the 1J0 972 751 housing, the side clip needs to be opened**

⇐ Connect the housing -11A- to the connector housing -4- on the new harness assembly

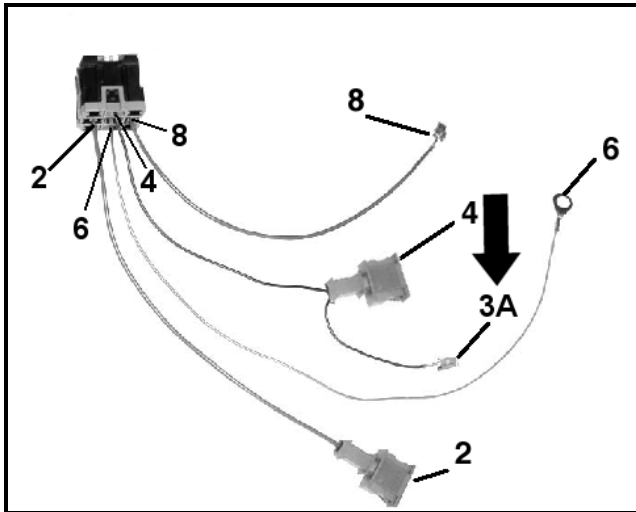
⇐ Locate terminal -3A- (arrow) (short wire from connector housing -4-) on new harness assembly

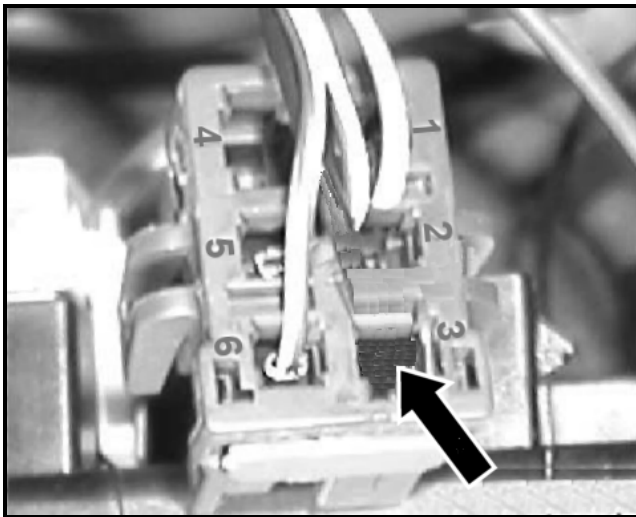
- ⇐ Insert terminal -3A- into the empty position number 3 -arrow- of red connector
- Reinstall red connector block to reverse side of relay panel (behind relay position 3)

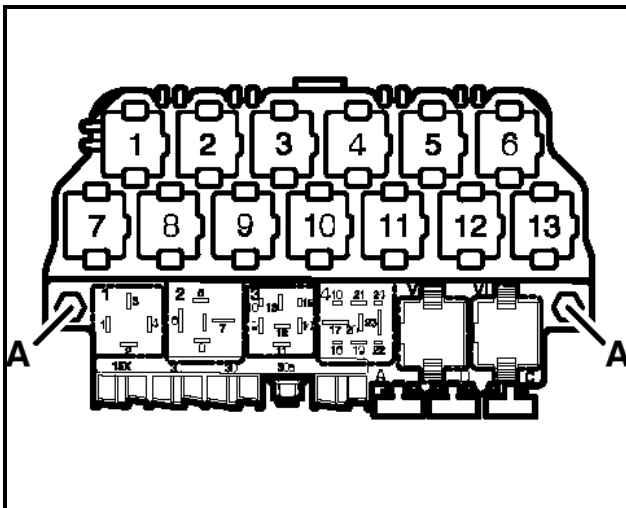
⇐ Reinstall relay carriers, secure with (2) nuts -A- and tighten to 2 Nm (18 in. lbs.)

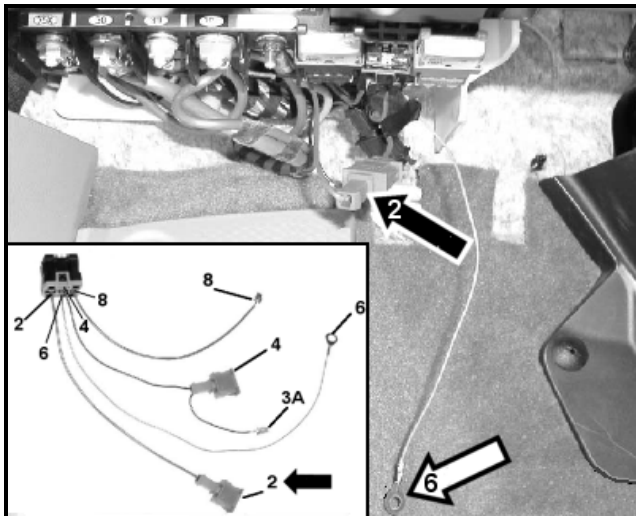
- ⇐ Insert the connector -11- (contains terminal removed from B+ fuse connector at the start of this procedure) to connector -2- (arrow) on the new wire harness assembly
- Reinstall fuse holder to location B on the lower relay block
- Reinstall 15 amp fuse
- Reinstall fuse/relay holders -A- & -C- into proper location on lower relay block
- ⇐ Locate ground (GND) wire -6- (eyelet terminal on the new wiring harness assembly)

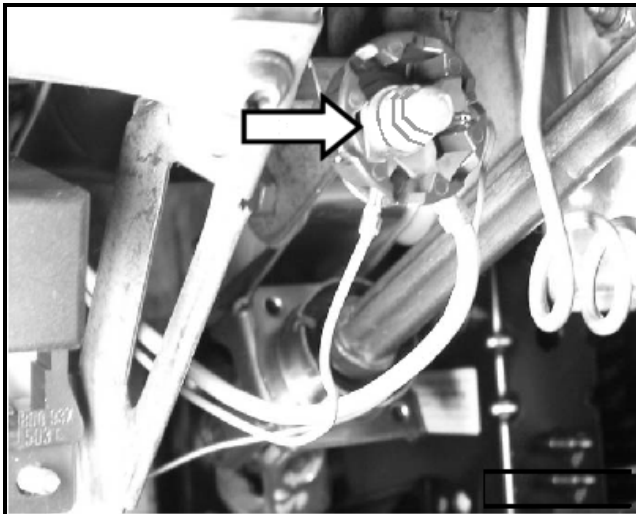
- ⇐ Remove cap nut at ground point -arrow- near steering column, install ground wire eyelet -6- from new harness assembly, secure with cap nut and tighten to 6 Nm (53 in. lbs.)

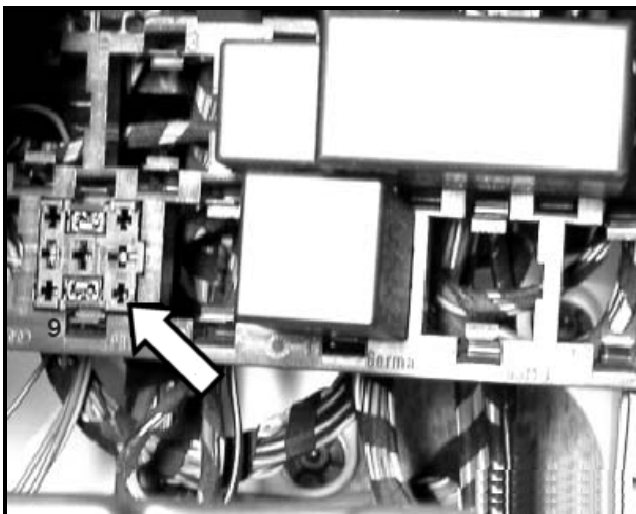
- ⇐ Install new (141 951 253 B) relay into upper relay block position 9 -arrow-
- Reinstall instrument panel lower cover
- Reinstall reinforcement and secure with (6) screws
- Reinstall lower trim panels
- Reinstall instrument panel side cover
- Reconnect battery ground (GND) cable and tighten to 6 Nm (53 in. Lbs)
- Reinstall battery cover
- Proceed to Section A3

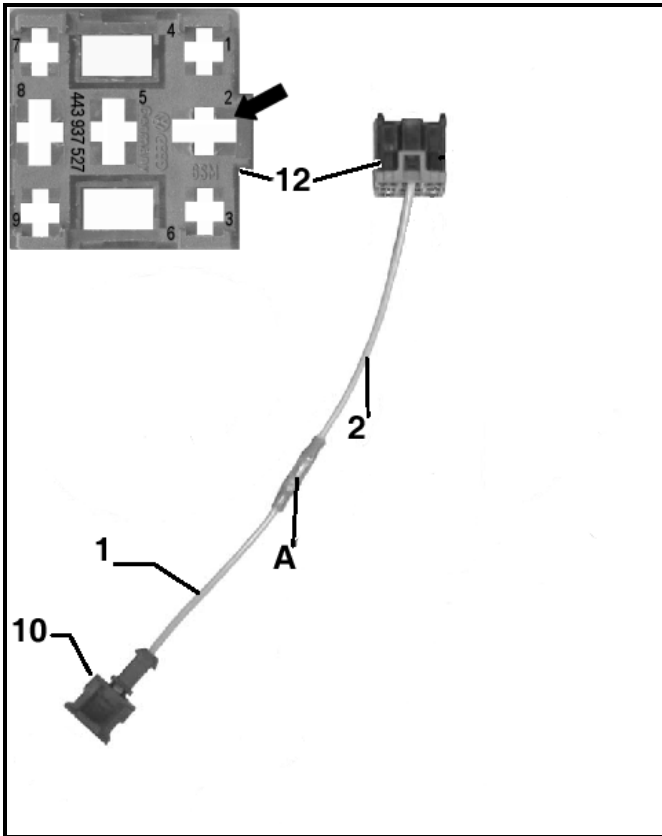
- ⇐ Using a repair wire -2- (000 927 227), cut wire approx. 100 mm from terminal, insert wire in butt connector -A- (111 971 939 B) and crimp butt connector with the VAS 1978/2 crimper
- ⇐ Using a repair wire -1- (000 979 220), cut wire approx. 100 mm from terminal, insert wire in butt connector -A- and crimp butt connector
- Seal the butt connector using the electric hot air blower from the VAS 1978 repair kit
- ⇐ Insert terminal end of wire -2- into position 2 -arrow- of relay connector -12- and wire end -1- into a terminal housing -10- (191 972 761)

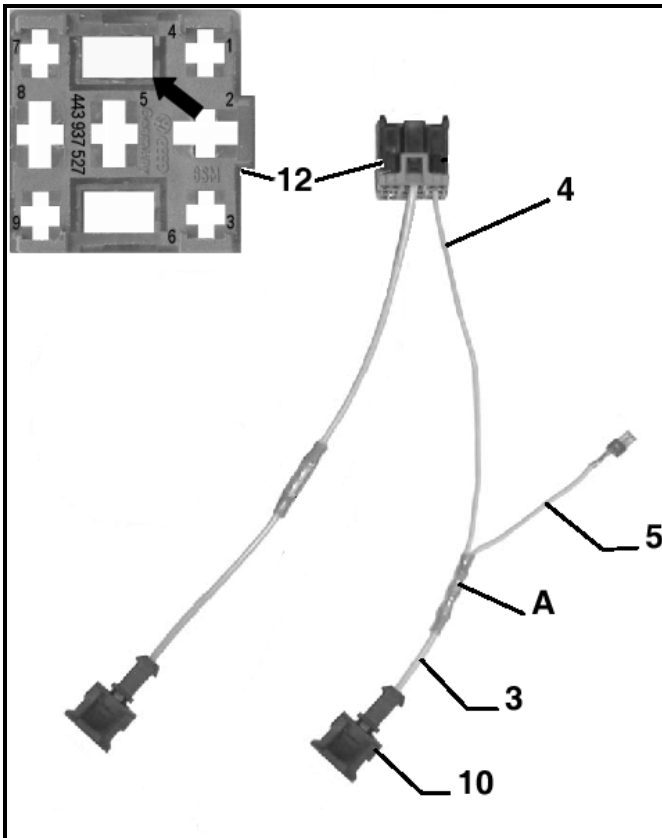
- ⇐ Using a repair wire -4- (000 979 114), cut wire approx. 150 mm from terminal
- ⇐ Using a repair wire -5- (000 979 135), cut wire approx. 80 mm from terminal
- ⇐ Insert ends of wire -4- & -5- into butt connector A- and crimp connector
- ⇐ Using a repair wire -3- (000 979 130), cut wire approx. 70 mm from terminal, insert wire in butt connector -A- and crimp butt connector
- Seal the butt connector using the electric hot air blower
- ⇐ Insert terminal end of wire -4- into position 4 arrow- of relay connector -12- and terminal end of wire -5- into terminal housing -10- (191 972 761)

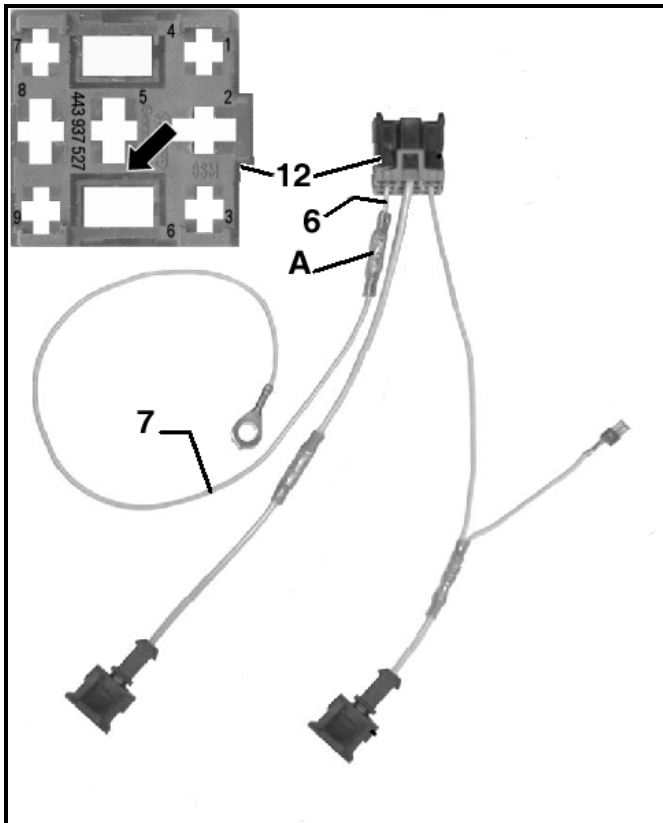
- ⇐ Using repair wire -6- (000 979 114), cut wire approx. 30 mm from terminal, insert into butt connector -A- and crimp connector
- ⇐ Using repair wire -7- (000 979 137), cut wire approx. 330 mm from eyelet, insert into butt connector -A- and crimp connector
- Seal the butt connector using the electric hot air blower
- ⇐ Insert terminal end of wire -6- into position 6 of relay connector -12-

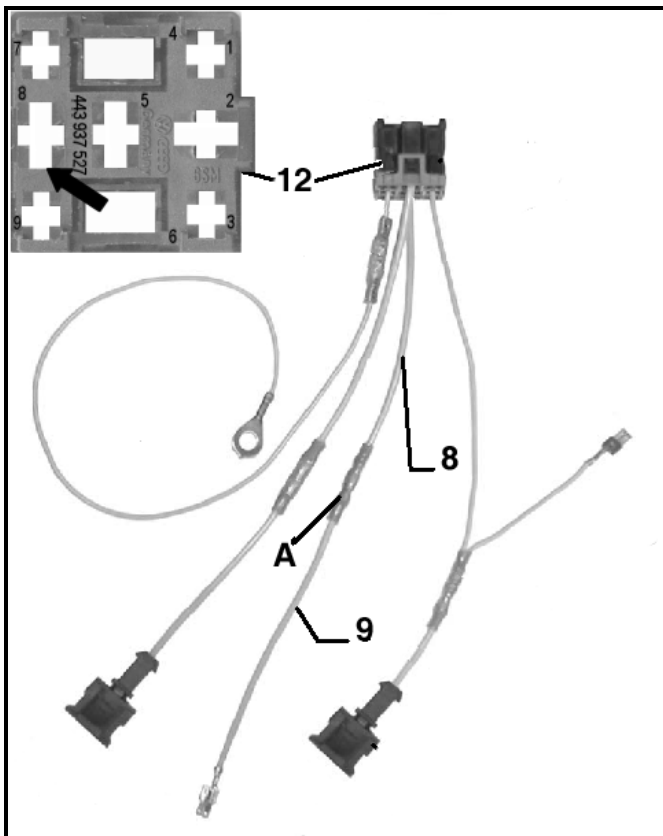
- ⇐ Using repair wire -8- (000 979 227), cut wire approx. 110 mm from eyelet, insert into butt connector -A- and crimp connector
- ⇐ Using repair wire -9- (000 979 227), cut wire approx. 110 mm from eyelet, insert into butt connector -A- and crimp connector
- Seal both ends of the butt connector using the electric hot air blower
- ⇐ Insert terminal end of wire -8- into position 8 of relay connector -12-
- Go to Section A2 for harness installation

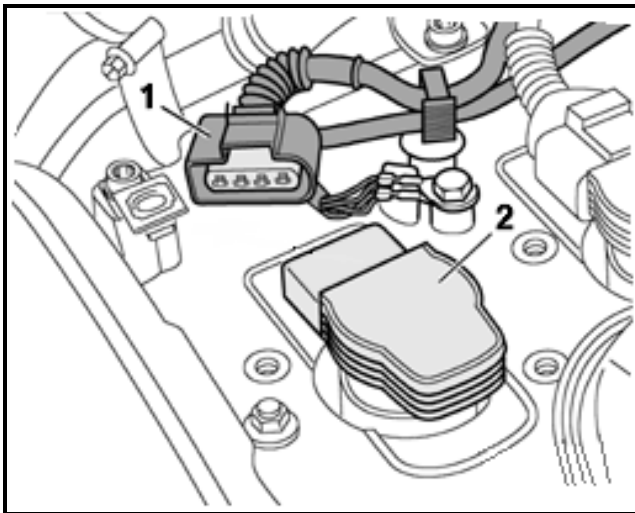
⇐ Disconnect connectors -1- from all ignition coils -2-

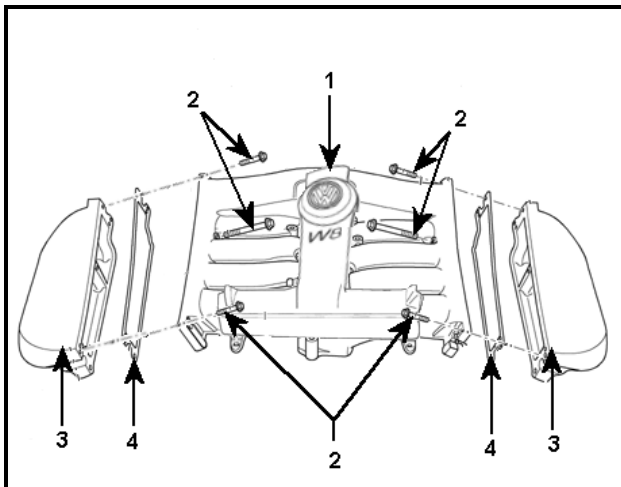
- If applicable, connect VAS5051 and check DTCs
- ⇐ Open hood and remove center manifold cover -1-
- ⇐ Remove bolts -2- securing left and right intake manifold side parts -3- and remove side part with gaskets -4-
- Disconnect connectors on all ignition coils

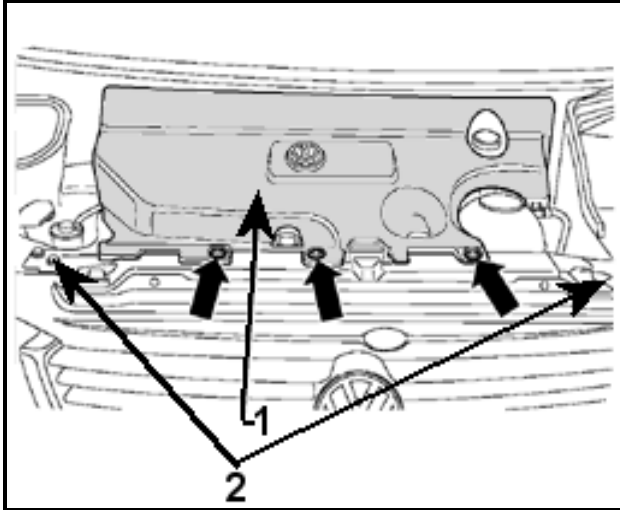
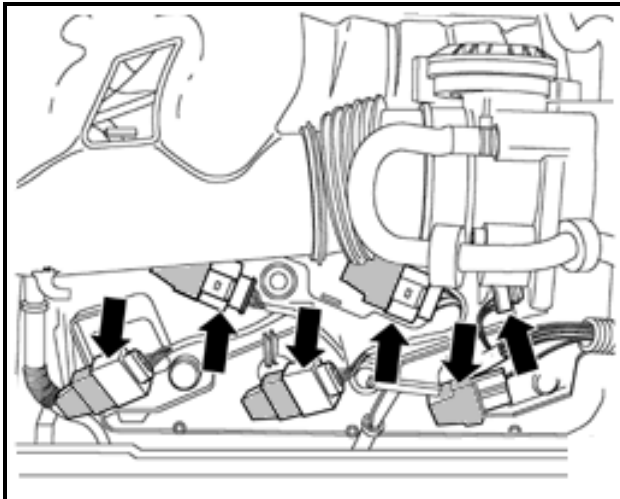
⇐ Open hood and remove three T30 torx® screws -arrows- securing engine cover -1- and remove engine cover

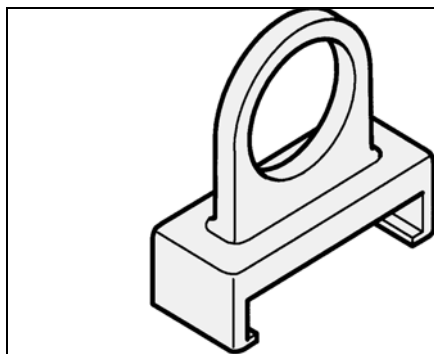
⇐ **Puller T40039** - must be used to avoid damaging ignition coils during removal

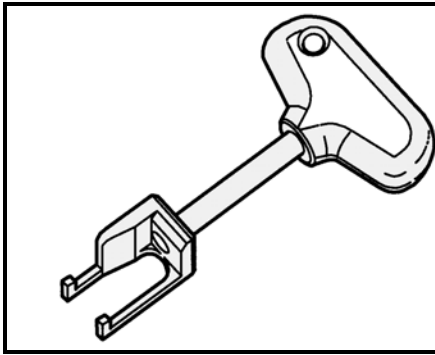
⇐ **Puller T10095** - must be used to avoid damaging ignition coils during removal

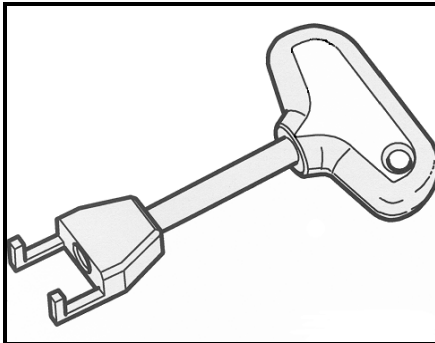
⇐ **Puller T10094** - must be used to avoid damaging ignition coils during removal

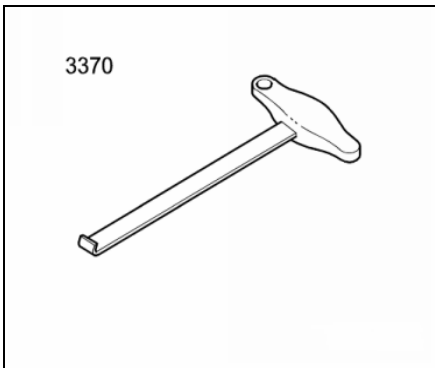
⇐ **3370 - Hook tool** (or equivalent)

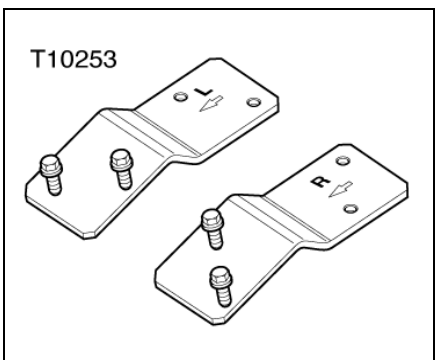
⇐ **T10253 - Latch tool with bolts**

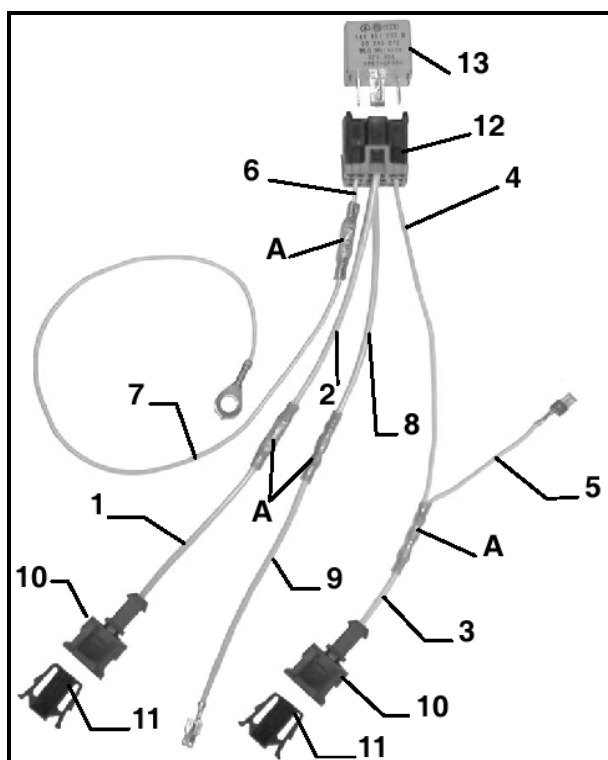
Note: If assembled harness kit (1J0 971 658 N ) is not available from parts, then the individual parts listed below can be assembled.

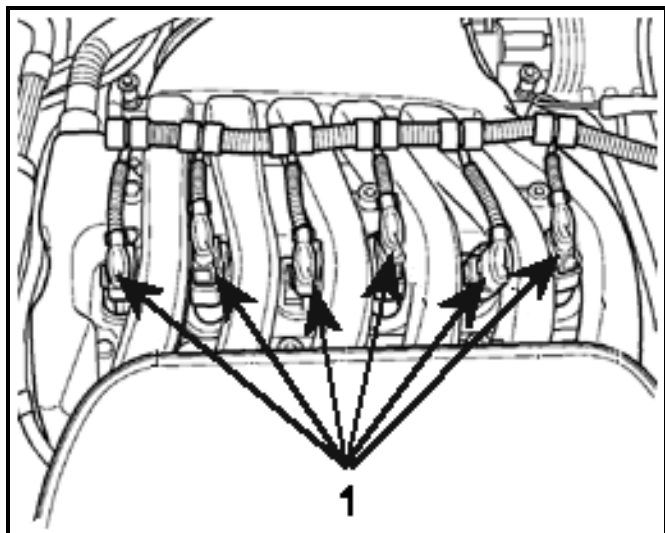
⇐ Disconnect connector from all ignition coils -1-

- Using **Puller T10095**, remove ignition coils

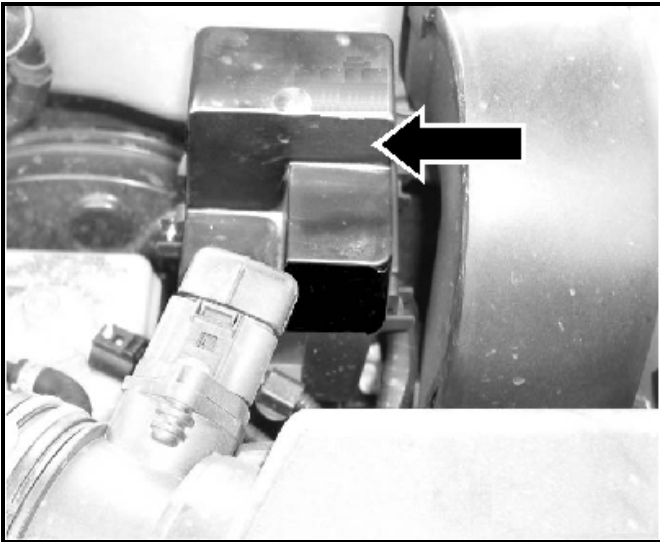
- Disconnect battery ground (GND) cable
- ⇐ Remove relay cover -arrow- for relay panel (located next to brake booster) in engine compartment

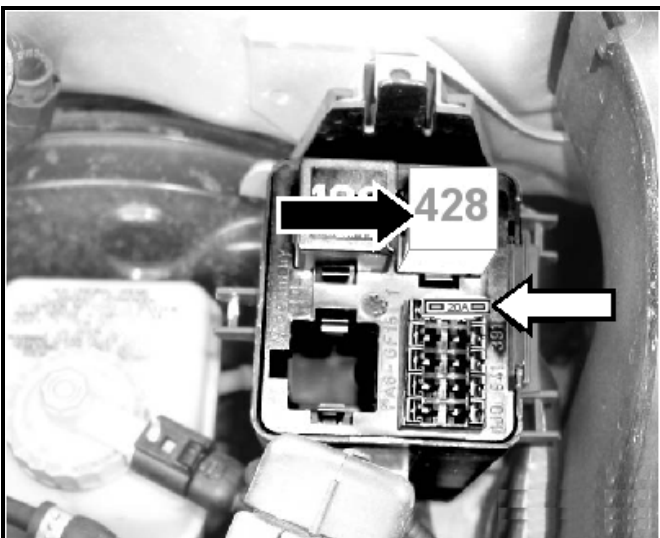
- ⇐ Remove fuse (S51) -white arrow- for vacuum pump from fuse holder
- ⇐ Remove relay #428 for the main power supply to the engine control module (ECM) -black arrow-
- Lift out relay panel from the lower housing

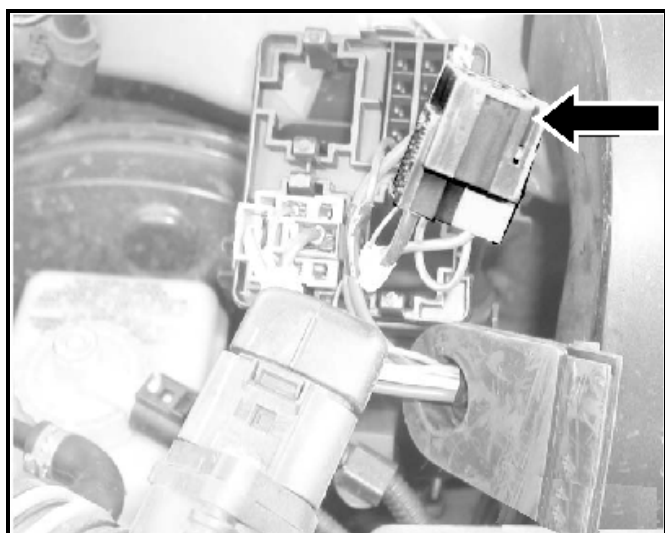
- ⇐ Remove red connector block (for relay #428)  
-arrow- from the relay housing

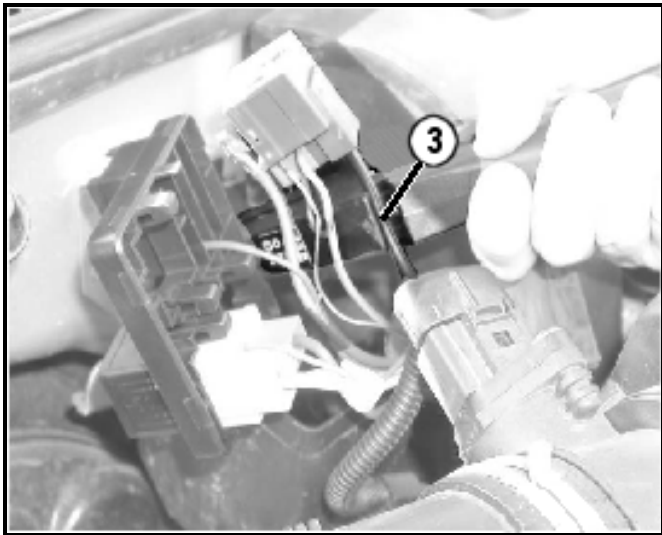
- ⇐ Locate large wire -3- from cavity 2 of the red connector for relay #428 and cut wire approximately 30 mm from terminal

Note: Cavity numbers are located on the connector at the terminal insertion points

Note: The illustrations show the large wire installed in the relay connector housing. It may be easier to remove this terminal from the relay connector housing for the following modification

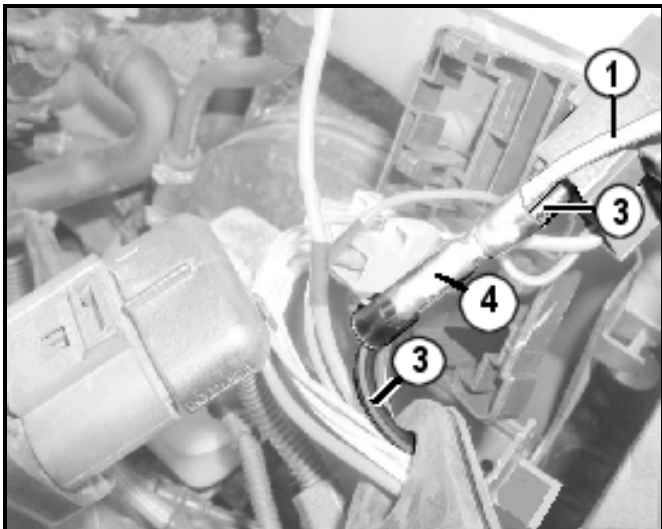
- Using new repair wire (000 979 227), cut wire approximately 100 mm from the terminal and strip the insulation from the wire (other end of the repair wire is not needed)
- ⇐ Insert the new 100 mm long repair wire -1- along with the end (30 mm length) of the previously cut wire -3- (from connector block cavity 2) into one end of a butt connector -4- (111 971 938 A)
- Crimp the butt connector using the VAS 1978/2 crimper from the VAS 1978 repair kit
- Insert remaining end of previously cut wire -3- into the other end of the butt connector -4- and crimp using the wire crimper
- Seal the butt connector using the electric hot air blower
- If the large wire was removed from the relay connector housing cavity #2 to do this modification, reinstall wire at this time

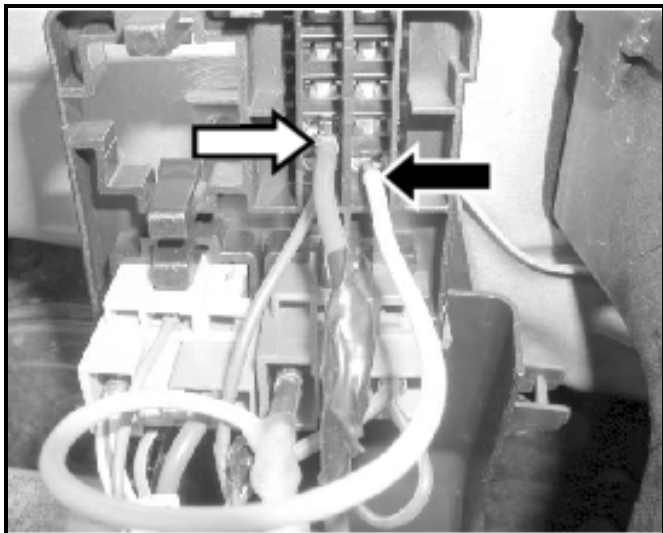
- Install the wire previously removed from the fuse holder (for fuse S51) cavity #1 into an unused cavity of the fuse holder (this wire is no longer used)

Note: In this illustration, cavity #4 was used -white arrow- however, your vehicle may be different

- ⇐ Install terminal from the 100 mm repair wire into the cavity #1 -black arrow- of the fuse holder
- Reinstall red connector block for relay into relay panel
- Reinstall relay panel into lower housing
- Reinstall relay #428 and fuse (S51) into relay panel
- Reinstall relay cover
- Reconnect battery ground (GND) cable and tighten nut to 6 Nm (53 in. lbs.)
- **Proceed to Section A3**

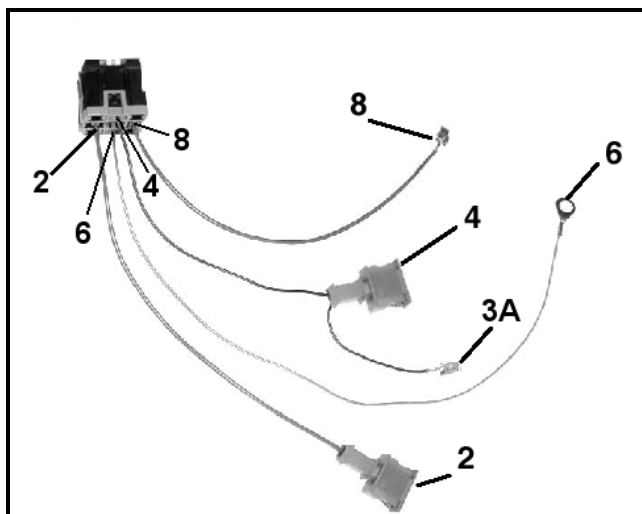
**IMPORTANT!** The terminal ends on the wire harness from the kit or from the assembled harness are shown to correspond to the terminal connection numbers on the relay connector

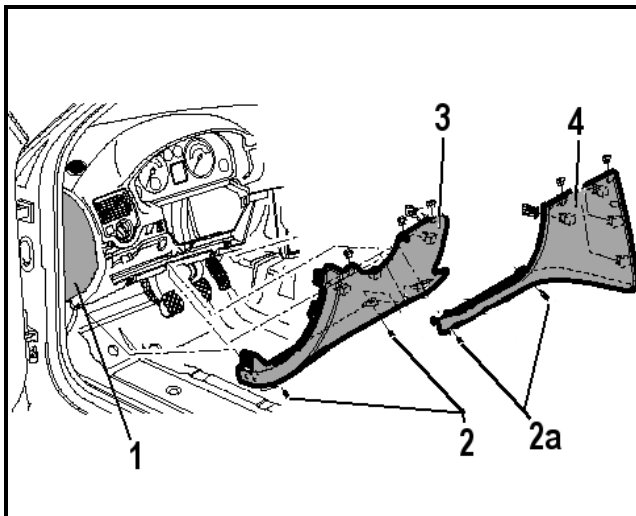
- ⇐ Open driver's door, remove instrument panel side cover -1-
- ⇐ Remove 2 screws -2- unclip trim panel -3- and remove
- ⇐ Remove 2 screws -2a- unclip trim panel -4- and remove

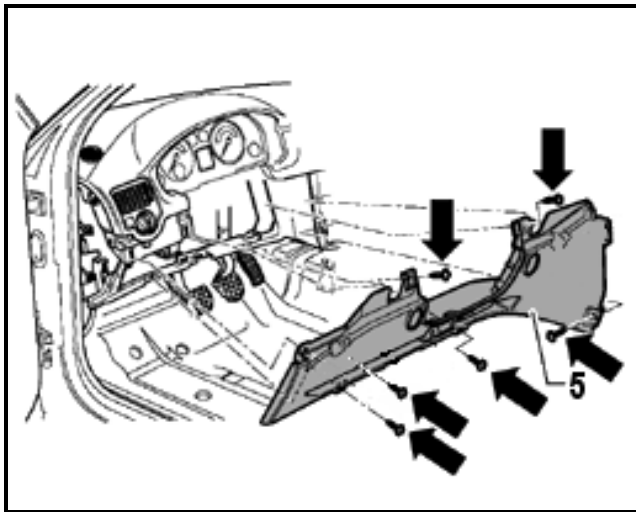
- ⇐ Remove (6) screws -arrows- and remove reinforcement -5-

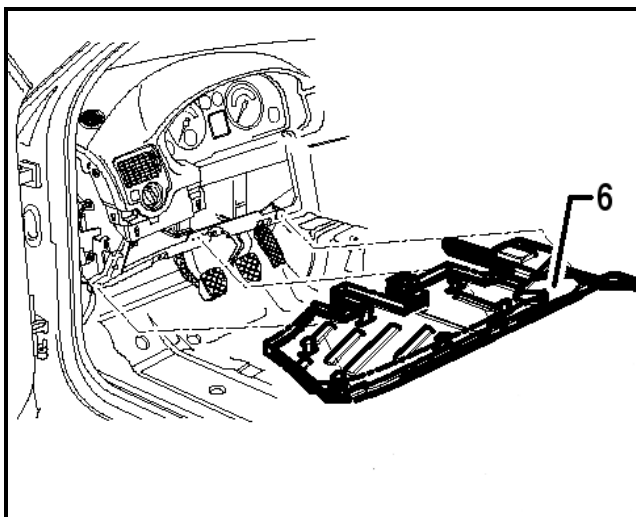
- ⇐ Unclip and remove lower cover -6- by sliding rearward out of clips

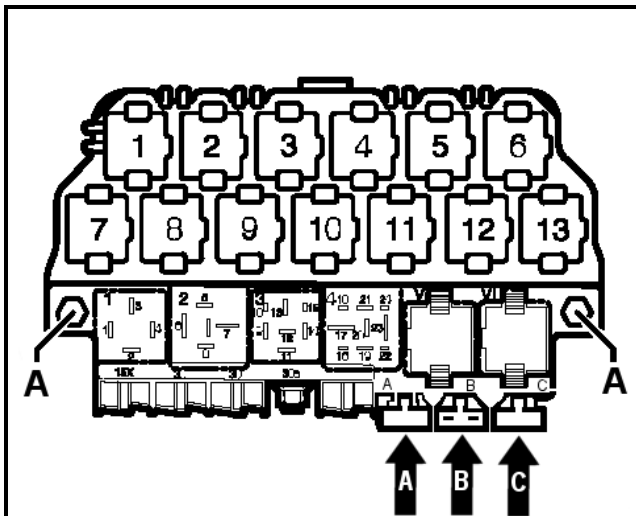
- ⇐ Using a volt meter, check the terminal contacts of the 15 amp fuse in position B -arrow- for (12 volts or B+ power) and make note of terminal position in fuse housing
- Under hood, remove battery cover and disconnect battery ground (GND) cable
- ⇐ Remove fuse/relay holders -A- and -C- (arrows) at the bottom of the lower relay panel
- ⇐ Remove fuse holder -B- from the bottom of lower relay panel -arrow- and remove fuse from holder
- ⇐ Remove (2) nuts -A- and pull lower relay carrier rearward and down to remove

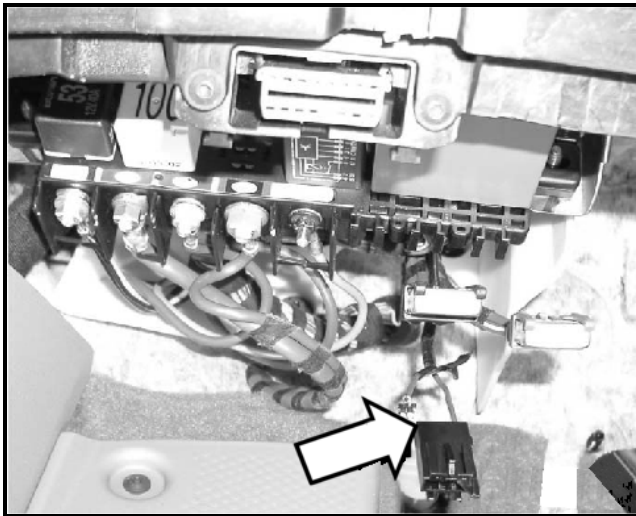
- ⇐ Remove the B+ terminal (as previously found) from fuse holder B -arrow-

Note: The illustration shows the wire removed from position #2, however, your vehicle could be different

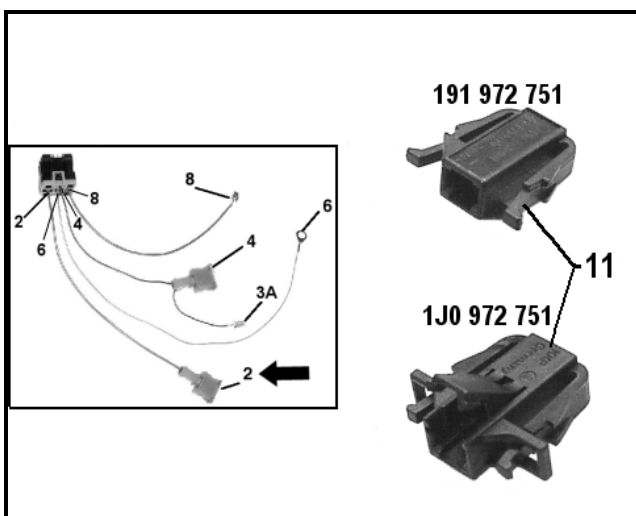
- ⇐ Insert the B+ terminal (removed from fuse holder) into terminal housing -11- (191 972 751 or 1J0 972 751)

Note: The terminal housing 1J0 972 751 comes with the wiring harness assembly.

**IMPORTANT! To insert the B+ terminal into the 1J0 972 751 housing, the side clip needs to be opened**

Note: This terminal housing -11- will be connected to a terminal housing -2- on the new wiring harness later in the procedure

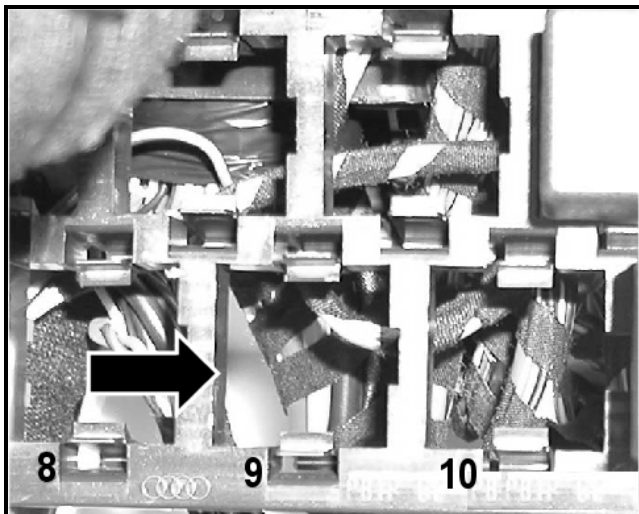
- ⇐ From the rear of the upper half of the relay panel, insert the new relay connector block on the new harness assembly into position #9 -arrow-

Note: The new relay must be removed from the relay connector on the new harness assembly before installing

- Route wires 2, 6 and 8 on the new harness assembly behind the fuse/relay panels

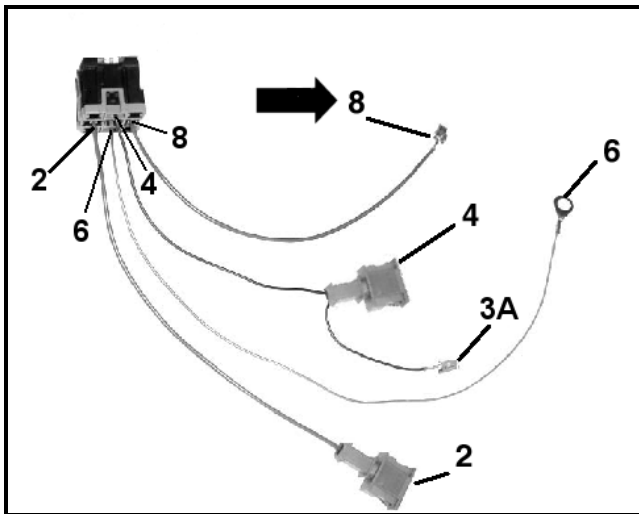
- ⇐ Locate terminal -8- (arrow) on the new wiring harness assembly

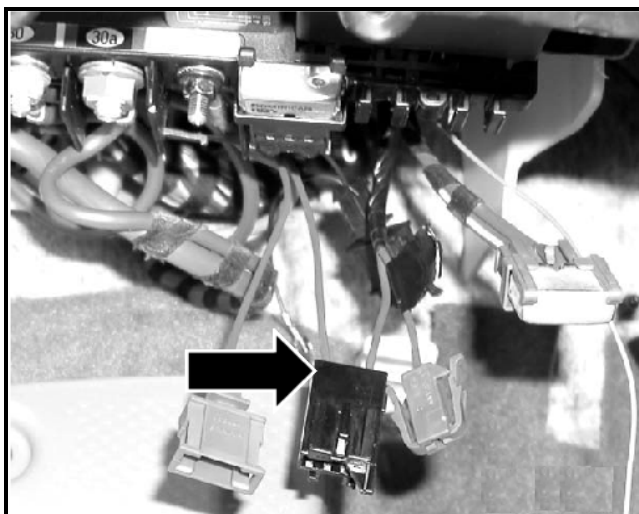
- ⇐ Insert terminal 8 on the new wire harness into the empty (B+) location in the 15 amp fuse holder -arrow-
