# Volkswagen of America, Inc.

**Objective:** This procedure describes changing the ignition coils on 1.8 liter & 2.8 liter engines in New Beetle, GTI & Jetta vehicles, 1.8 liter & 4.0 liter engines in Passat vehicles, and on 2.8 liter engines in Eurovan vehicles.

### **Subject: 2001–2003 Model Year Volkswagen Vehicles Replace Ignition Coils**

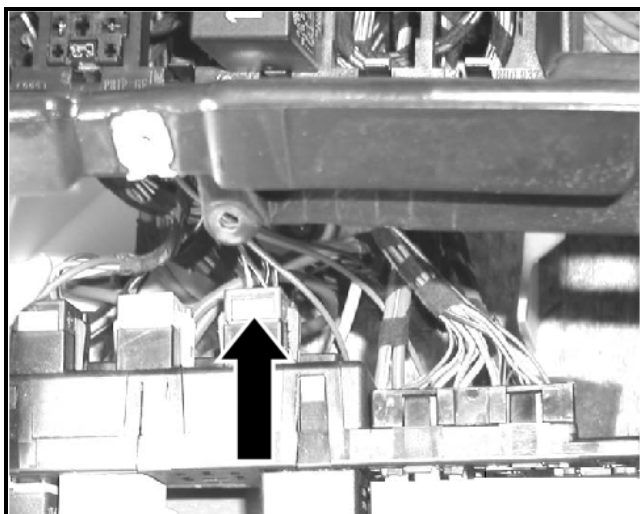
- ⇐ Remove (red) connector block -arrow- (for relay position 3) on reverse side of lower relay carrier

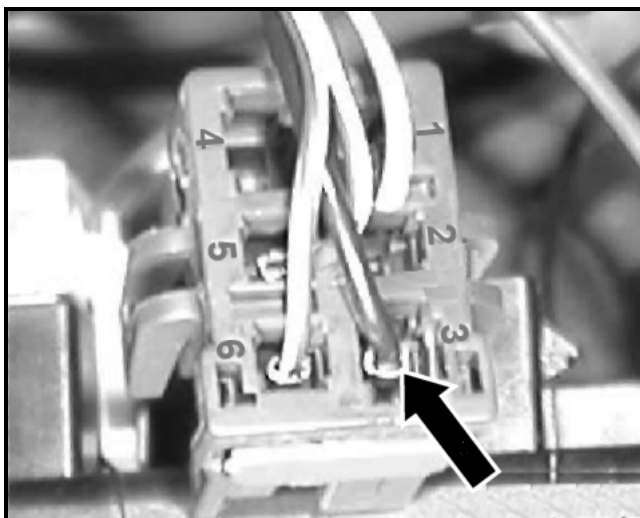
- ⇐ Remove terminal from position number 3 -arrow- of red connector block

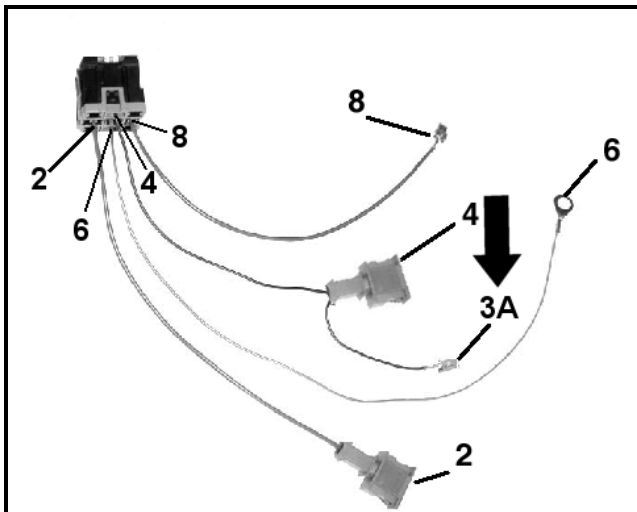
⇐ Locate terminal -3A- (arrow) [short wire from connector housing -4-] on new harness assembly

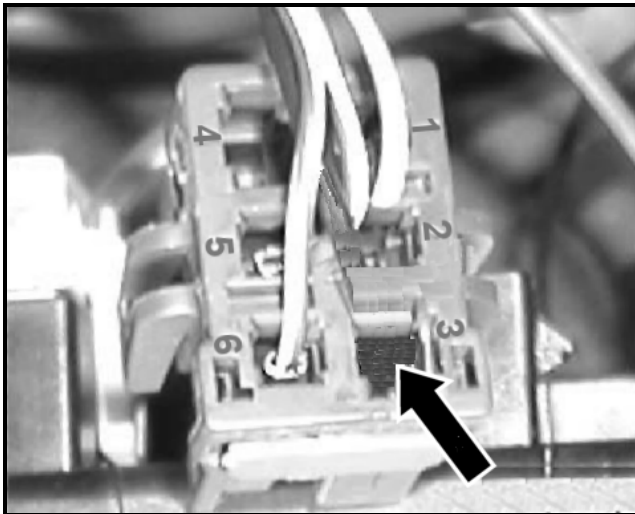
- ⇐ Insert terminal -3A- into the empty position number 3 -arrow- of red connector
- Reinstall red connector block to reverse side of relay panel (behind relay position 3)

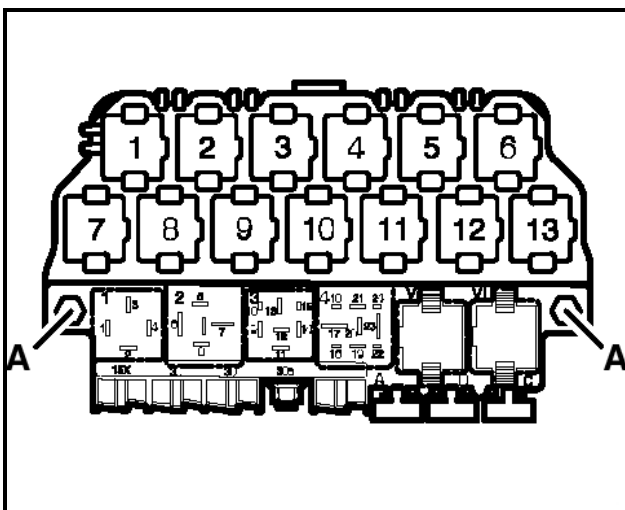
⇐ Reinstall relay carriers, secure with (2) nuts -A- and tighten to 2 Nm (18 in. lbs.)

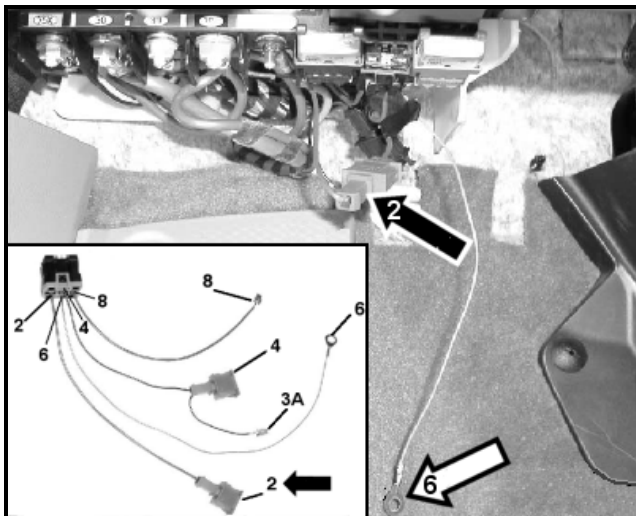
⇐ Insert the connector -11- (contains terminal removed from B+ fuse connector at the start of this procedure) to connector -2- (arrow) on the new wire harness assembly

- Reinstall fuse holder to location -B- on the lower relay block
- Reinstall 15 amp fuse
- Reinstall fuse/relay holders -A- & -C- into proper location on lower relay block

⇐ Locate ground (GND) wire -6- (eyelet terminal on the new wiring harness assembly)

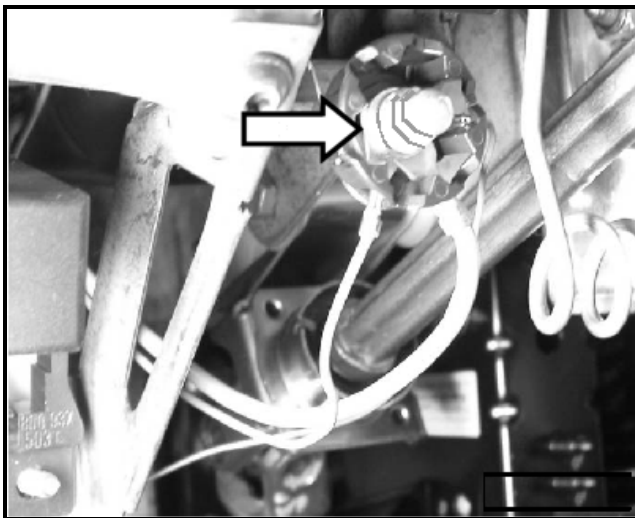
⇐ Remove cap nut at ground point -arrow- near steering column, install ground wire eyelet -6- from new harness assembly, secure with cap nut and tighten to 6 Nm (53 in. lbs.)

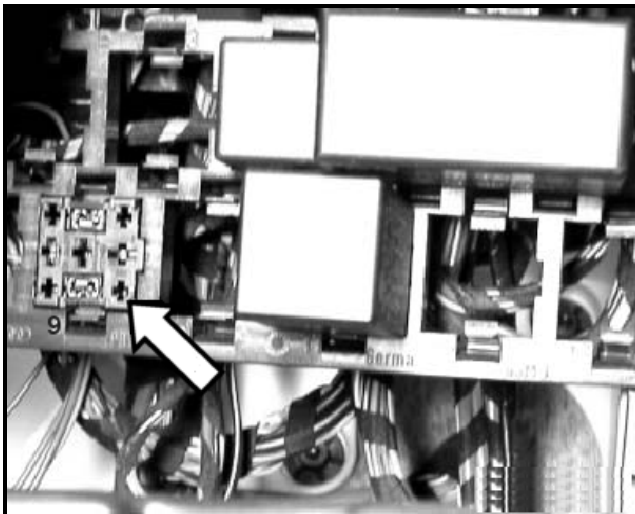
⇐ Install new (141 951 253 B) relay into upper relay block position 9 -arrow-

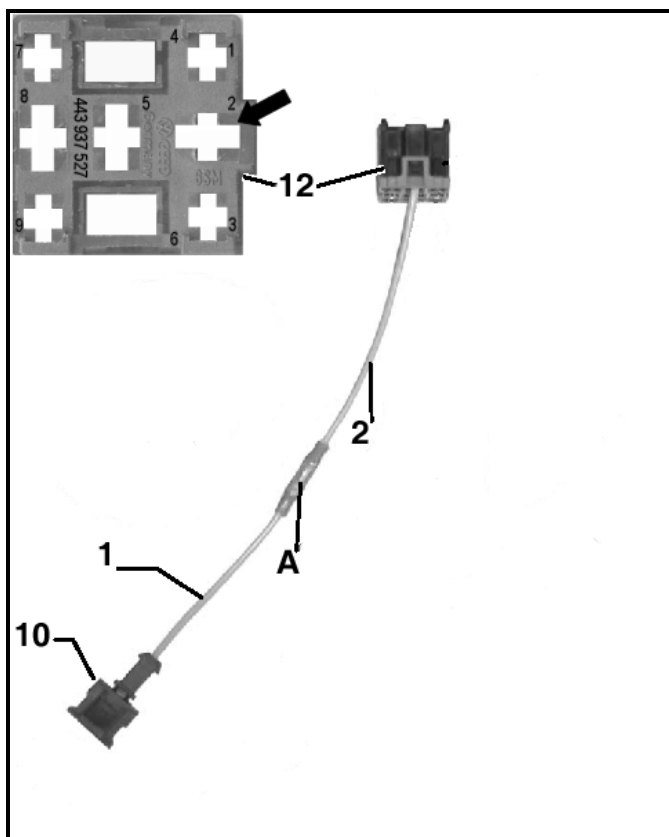
- ⇐ Using a repair wire -2- (000 979 227), cut wire approx. 100 mm from terminal, insert wire in butt connector -A- (111 971 939 B) and crimp butt connector with the VAS 1978/2 crimper
- ⇐ Using a repair wire -1- (000 979 220), cut wire approx. 100 mm from terminal, insert wire in butt connector -A- and crimp butt connector
- Seal the butt connector using the electric hot air blower from the VAS 1978 repair kit
- ⇐ Insert terminal end of wire -2- into position 2 -arrow- of relay connector -12- and wire end -1- into a terminal housing -10- (191 972 761)

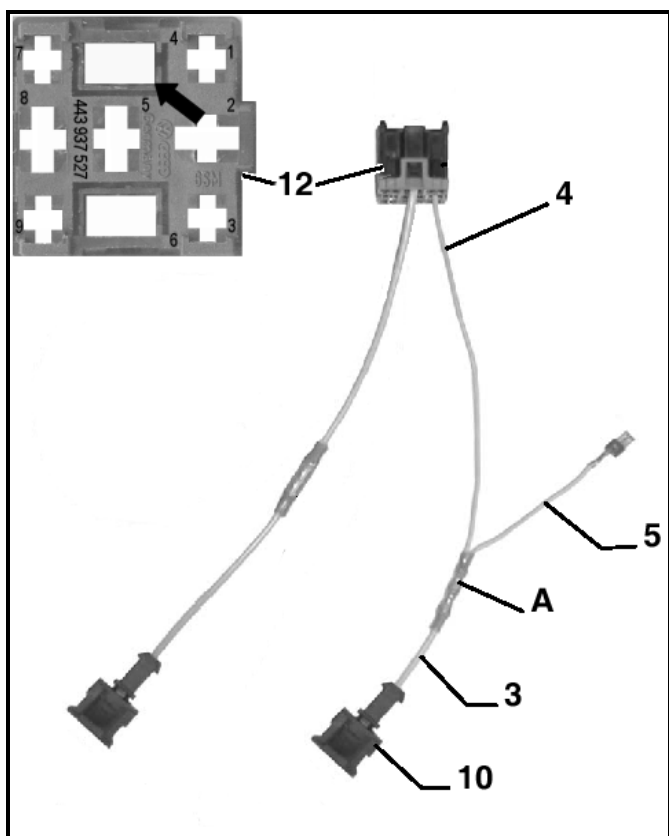
- ⇐ Using a repair wire -4- (000 979 114), cut wire approx. 150 mm from terminal
- ⇐ Using a repair wire -5- (000 979 135), cut wire approx. 80 mm from terminal
- ⇐ Insert ends of wire -4- and -5- into butt connector -A- and crimp connector
- ⇐ Using a repair wire -3- (000 979 130), cut wire approx. 70 mm from terminal, insert wire in butt connector -A- and crimp butt connector
- Seal the butt connector using the electric hot air blower
- ⇐ Insert terminal end of wire -4- into position 4 -arrow- of relay connector -12- and terminal end of wire -5- into terminal housing -10- (191 972 761)

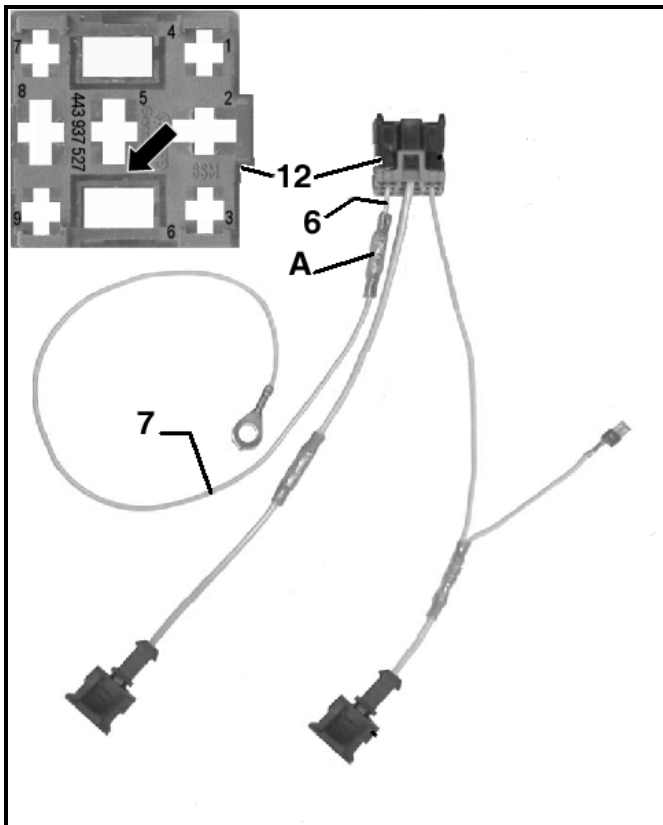
- ⇐ Using repair wire -6- (000 979 114), cut wire approx. 30 mm from terminal, insert into butt connector -A- and crimp connector
- ⇐ Using repair wire -7- (000 979 137), cut wire approx. 330 mm from eyelet, insert into butt connector -A- and crimp connector
- Seal the butt connector using the electric hot air blower
- ⇐ Insert terminal end of wire -6- into position 6 of relay connector -12-

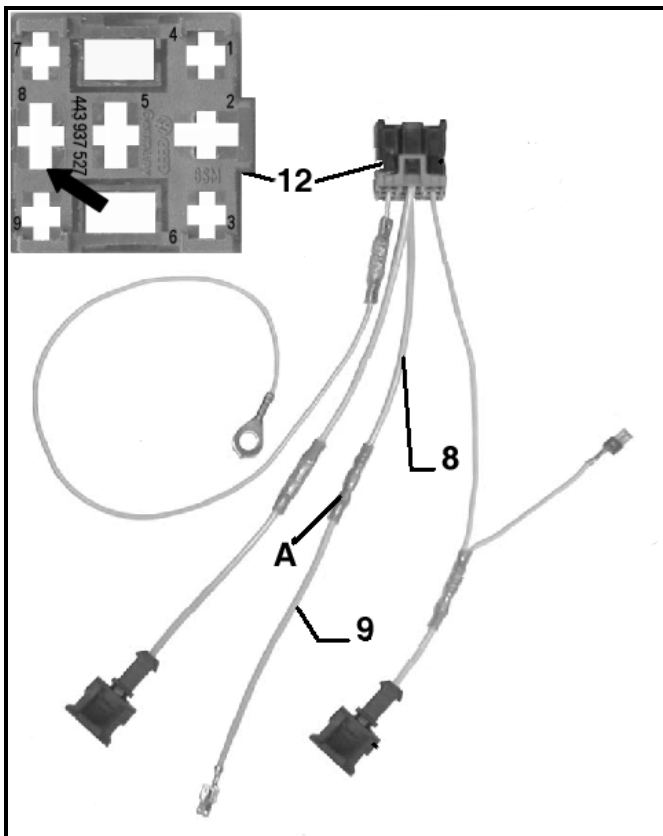
- ⇐ Using repair wire -8- (000 979 227), cut wire approx. 110 mm from eyelet, insert into butt connector -A- and crimp connector
- ⇐ Using repair wire -9- (000 979 227), cut wire approx. 110 mm from eyelet, insert into butt connector -A- and crimp connector
- Seal both ends of the butt connector using the electric hot air blower
- ⇐ Insert terminal end of wire -8- into position 8 of relay connector -12-
- **Go to Section A2 for harness installation**

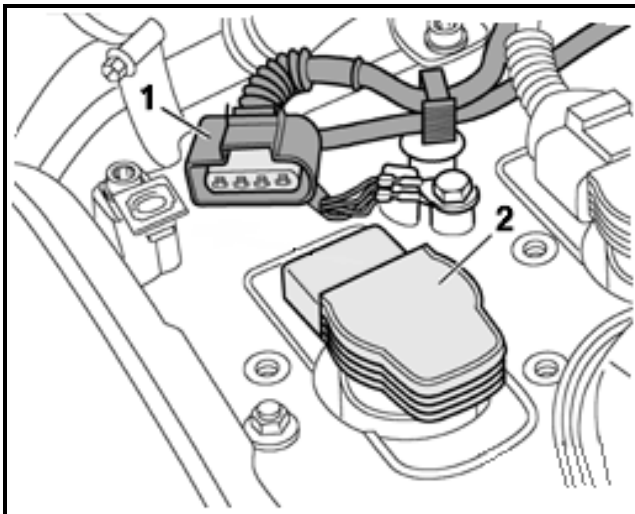
⇐ Disconnect connectors -1- from all ignition coils -2-

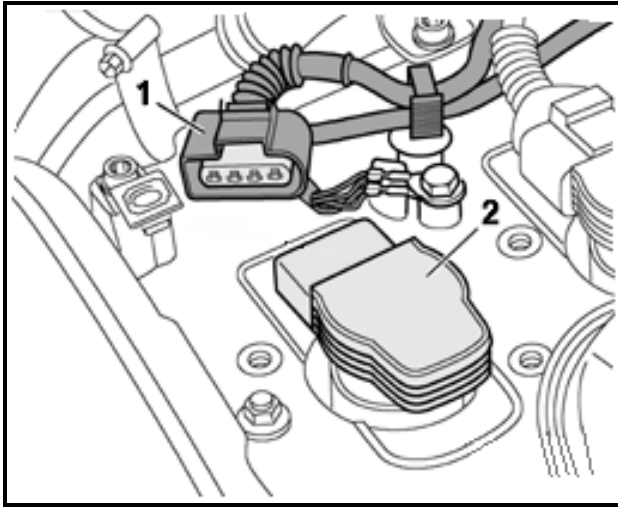
- Reconnect connectors to ignition coils
- If applicable, reinstall plate with turbo boost valve
- Reinstall vacuum reservoir and secure with bolt
- Reinstall engine cover and close hood
- If the MIL light was on and cylinder misfire DTCs were present, printed and erased, use VAS5051 and set engine readiness code
- Attach a copy of print out for diagnostic log (showing cylinder misfire DTCs) and readiness code "Test Complete" to repair order

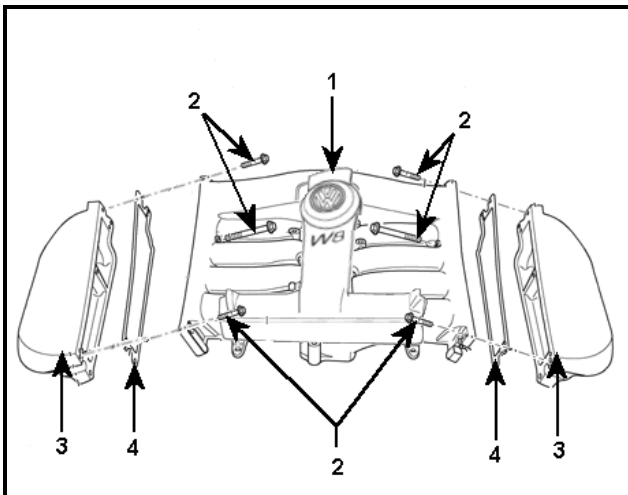
- If applicable, connect VAS5051 and check DTCs
- ⇐ Open hood and remove center manifold cover -1-
- ⇐ Remove bolts -2- securing left and right intake manifold side parts -3- and remove side part with gaskets -4-
- Disconnect connectors on all ignition coils

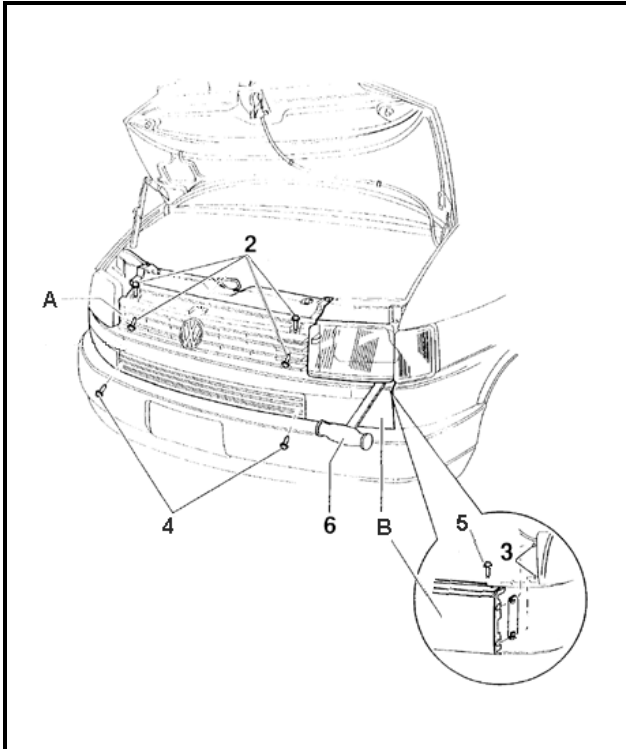
⇐ Remove screws -2- and remove radiator grille -A-

⇐ Remove screws -4- and -5-

⇐ Use special hook tool 3370 -6- and pull trim panel -B- off guide tabs -3- on left and right sides

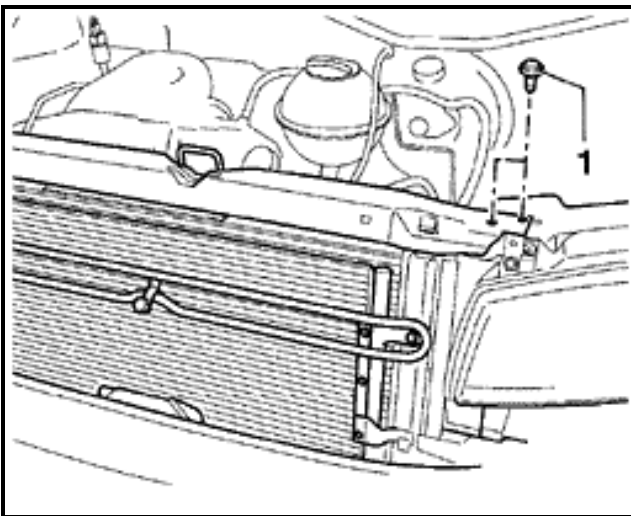
⇐ Remove lock carrier bolts -1- on left and right sides

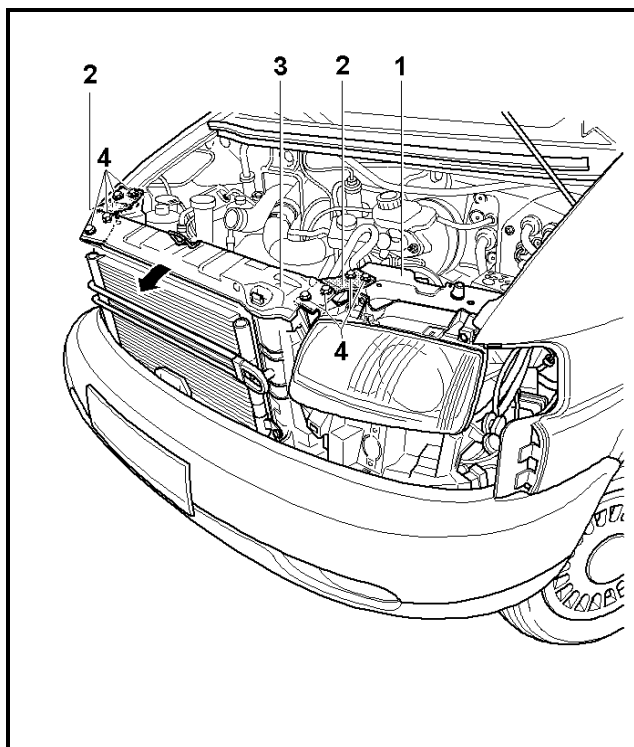
- ⇐ Pivot the lock carrier -3- with radiator in the forward direction -arrow-
- ⇐ Attach latch tool T10253 -2- between lock carrier -3- and mounting panel for headlight -1- on both left and right sides using bolts -4-

Note: Each holding tool is marked "R" for right side or "L" for left side

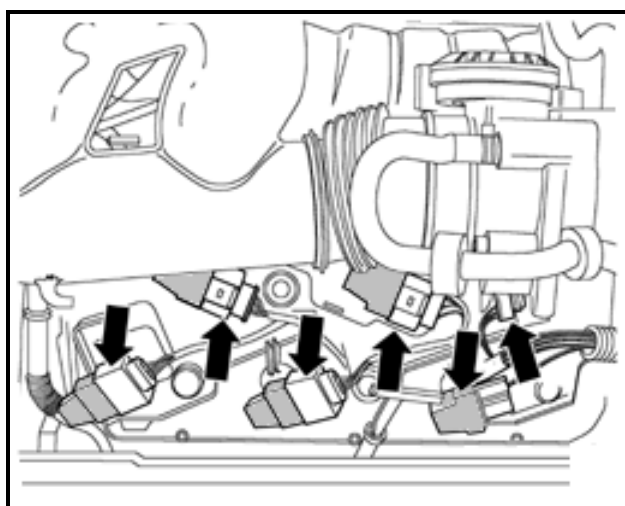
- ⇐ Disconnect connectors -arrows- from all ignition coils
