VOLKSWAGEN

Subject: PE10-034 NVS-213hkb: Engine Stall and/or Loss of Motive Power;
TDI Clean Diesel Engine

Please find attached Volkswagen's response to your letter dated September 14, 2010 requesting information concerning engine stalling and/or loss of motive power, on certain 2009-2010 MY Volkswagen Jetta, 2010 MY Volkswagen Golf and 2010 MY Audi A3 vehicles equipped with the TDI Clean Diesel engine.

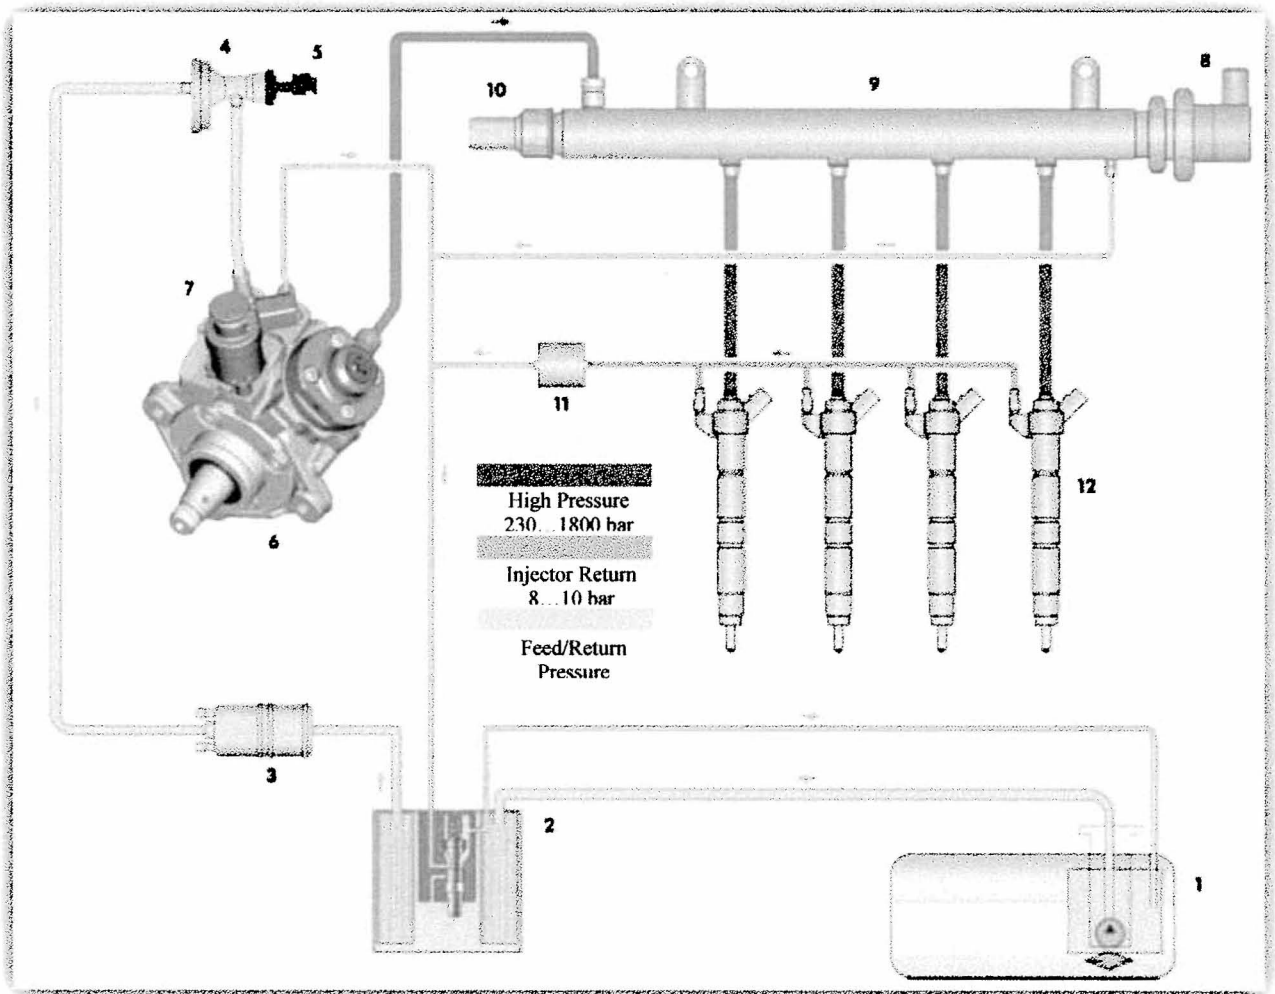
Image 1 – Fuel System Schematic

Image 1 displays the schematic of Volkswagen’s TDI Clean Diesel “common rail” system. (Please note that “fuel” always refers to diesel fuel unless otherwise stated.)

The principal components of the TDI Clean Diesel fuel system are (Reference – Image 1):

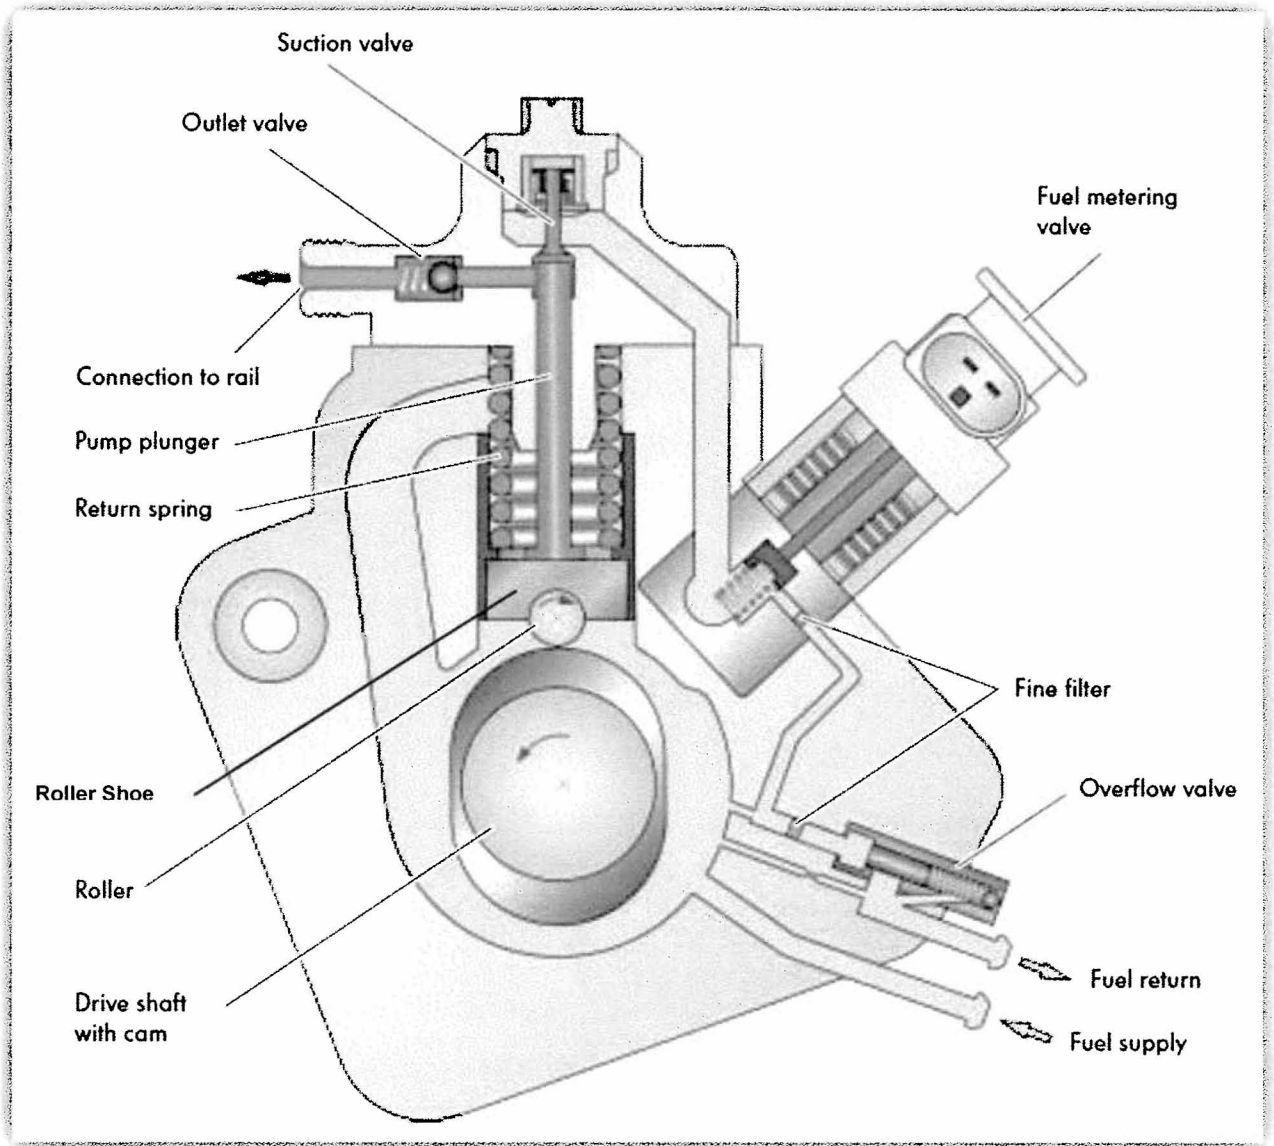
Image 3 – High Pressure Fuel Pump - Schematic

Image 3 displays the operation of the HPFP.

Gasoline contamination destroys the lubricity of the diesel fuel required by the HPFP and will lead to damage and failure of the component. As discussed above, active parts of the HPFP such as the camshaft lobe, roller and roller shoe require lubrication by the diesel fuel. The roller spins on the camshaft lobe and slides in the roller shoe building up a hydrodynamic lubrication film that separates the components' surfaces. Without the proper lubrication of these surfaces, the components will grind and wear. With increasing wear, the roller will no longer slide in the roller shoe and instead stick or bind. The roller will then also no longer spin on the camshaft lobe and similarly start to slide and bind. The resulting failure is excessive wear and flat spots on the roller and camshaft lobe surfaces. Part analyses indicate a sticking roller may also turn the roller shoe out of position in relation to the camshaft lobe, leading to further acceleration of roller wear. With progression of the wear, metallic particles can be shaved off and the return lines will circulate those particles throughout the fuel system. Such HPFP failures require a complete replacement of the fuel system because this metallic debris could spread to the pumps, filters, injectors, and fuel tank.
