Subject: Subject: Teleconference on the topic "HPP failure V6 TDI in USA"
Importance: High

The lubricity of diesel fuels

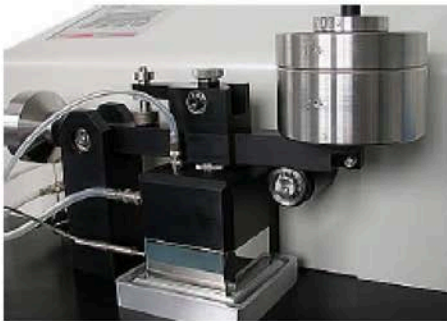
lubricity – SL-BOCLE test

- **SL-BOCLE is currently not included in any Diesel fuel standard**
- test setup is a ball on a rotating (525rpm) cylinder (25°C, 50% rh)
- the tribological contact is lubricated by the fuel
- seizure is detected by continuously evaluated friction coefficient
- seizure load is assessed by weight placed on ball in [g]
(high SL-BOCLE value -> high seizure load -> good seizure protection)

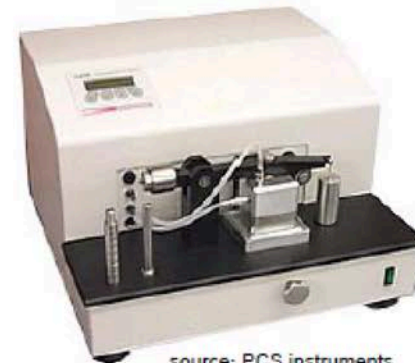
batch of weights for regulating seizure load

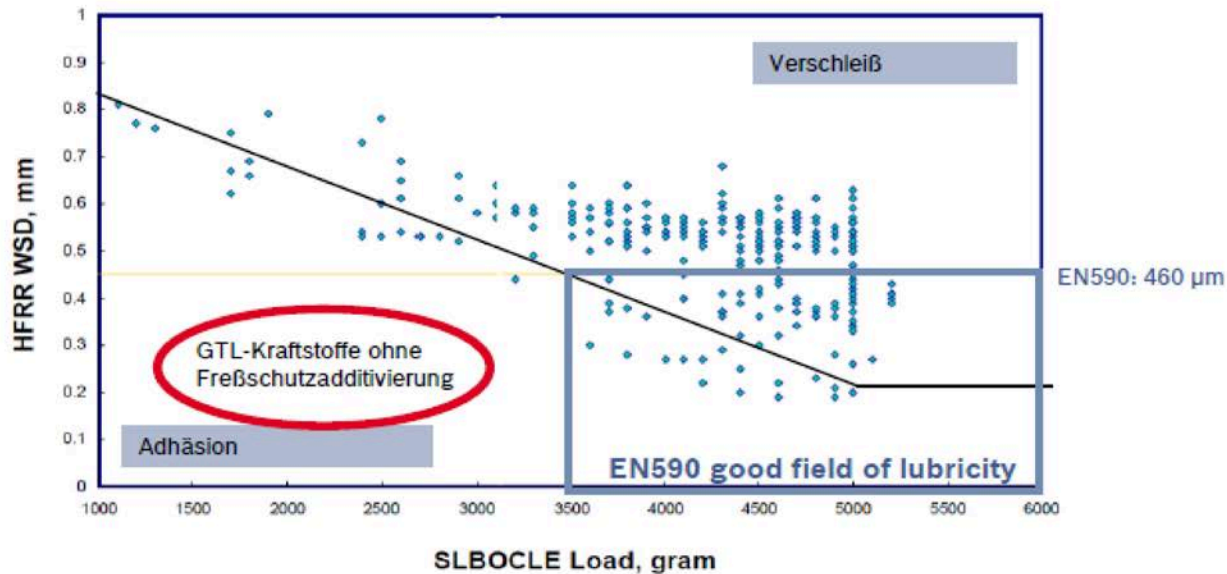
2-dimensional field of lubricity, field fuels

Wear

GTL fuels without anti-seizure additives
