Service Request Activity

Timeline

EAssist TAC Call Summary

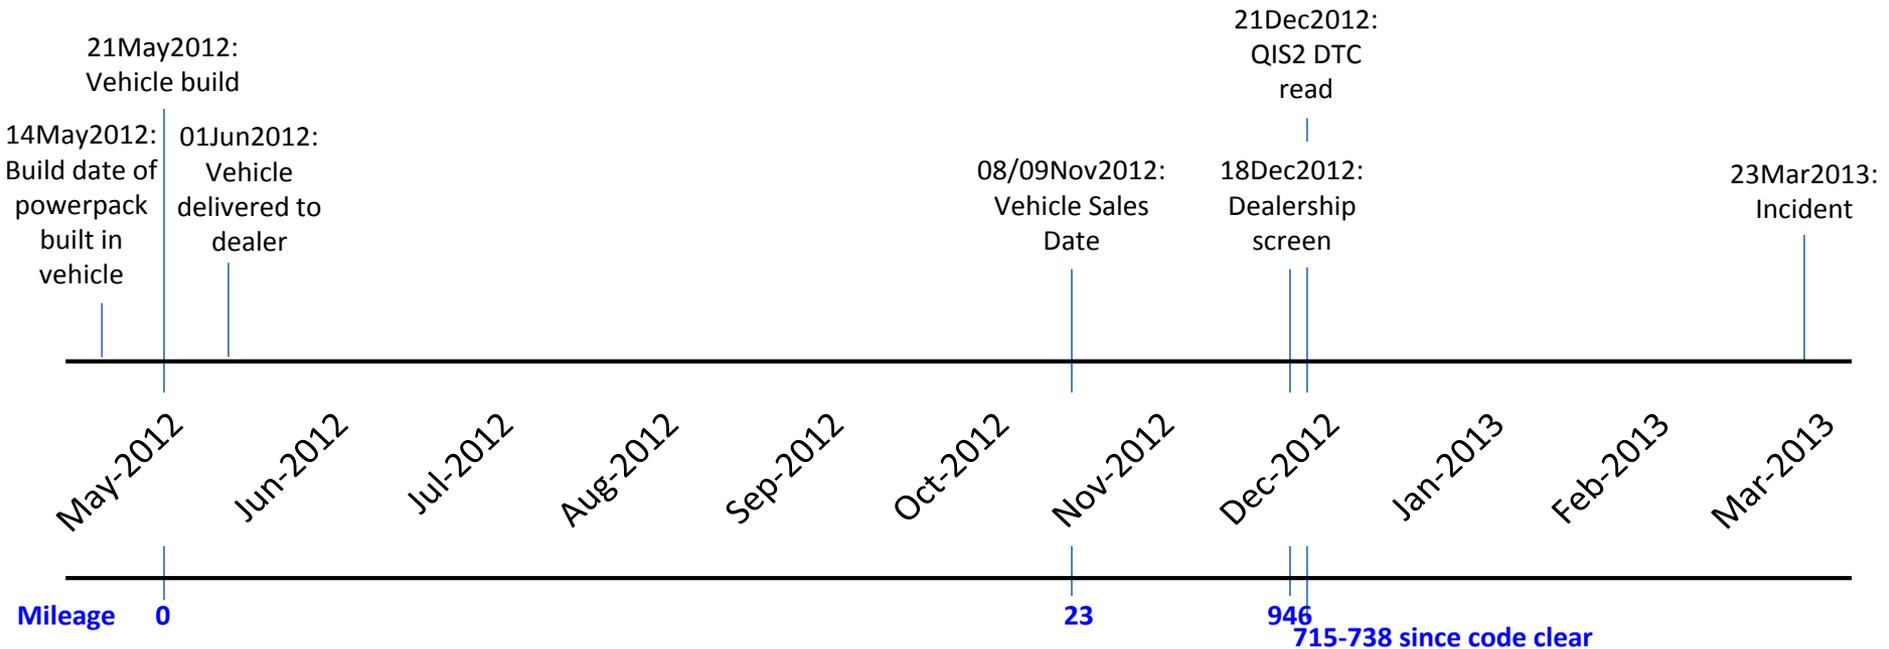
- PP built in vehicle build date: 14May2012
- Vehicle Build Date: 21May2012
- Vehicle Delivery to Dealer: 01Jun012
- Vehicle Sale Date: 08/09Nov2012 with 27 miles (to be confirmed)
- Dealership screen: 18Dec2012 with 946 miles
- QIS2 DTC Read: 21Dec2013 with 715-738 miles since code clear
- Incident date: 23Mar2013

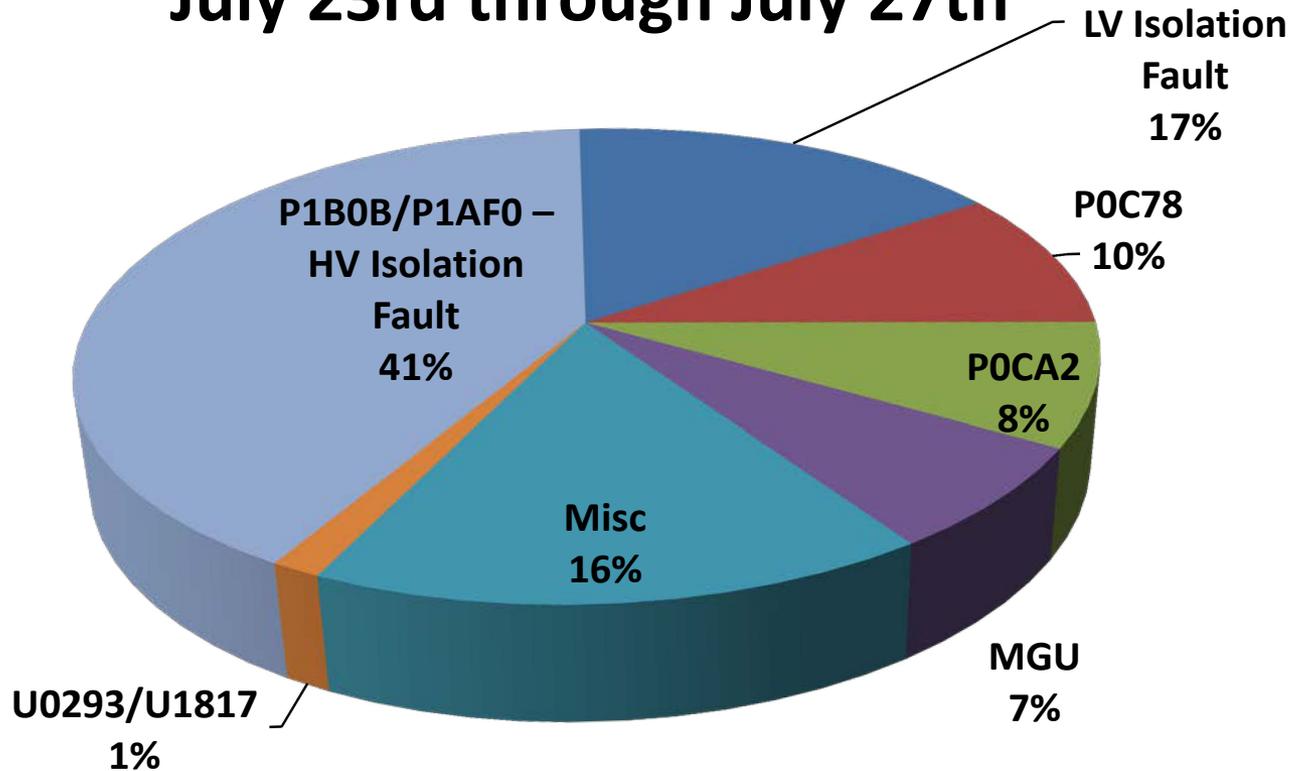
July 23rd through July 27th

- 73 technician calls into eAssist TAC Team
- 19,214 LUK vehicles sold as of July 23rd
- 38,334 LUK vehicles built up to July 23rd

TAC Calls Week of July 23rd – July 27th
