Kia Motors America
Field Product Quality Report

Report No.: EA2014SJ00083

Subject/Title: Sunroof panel shattered.

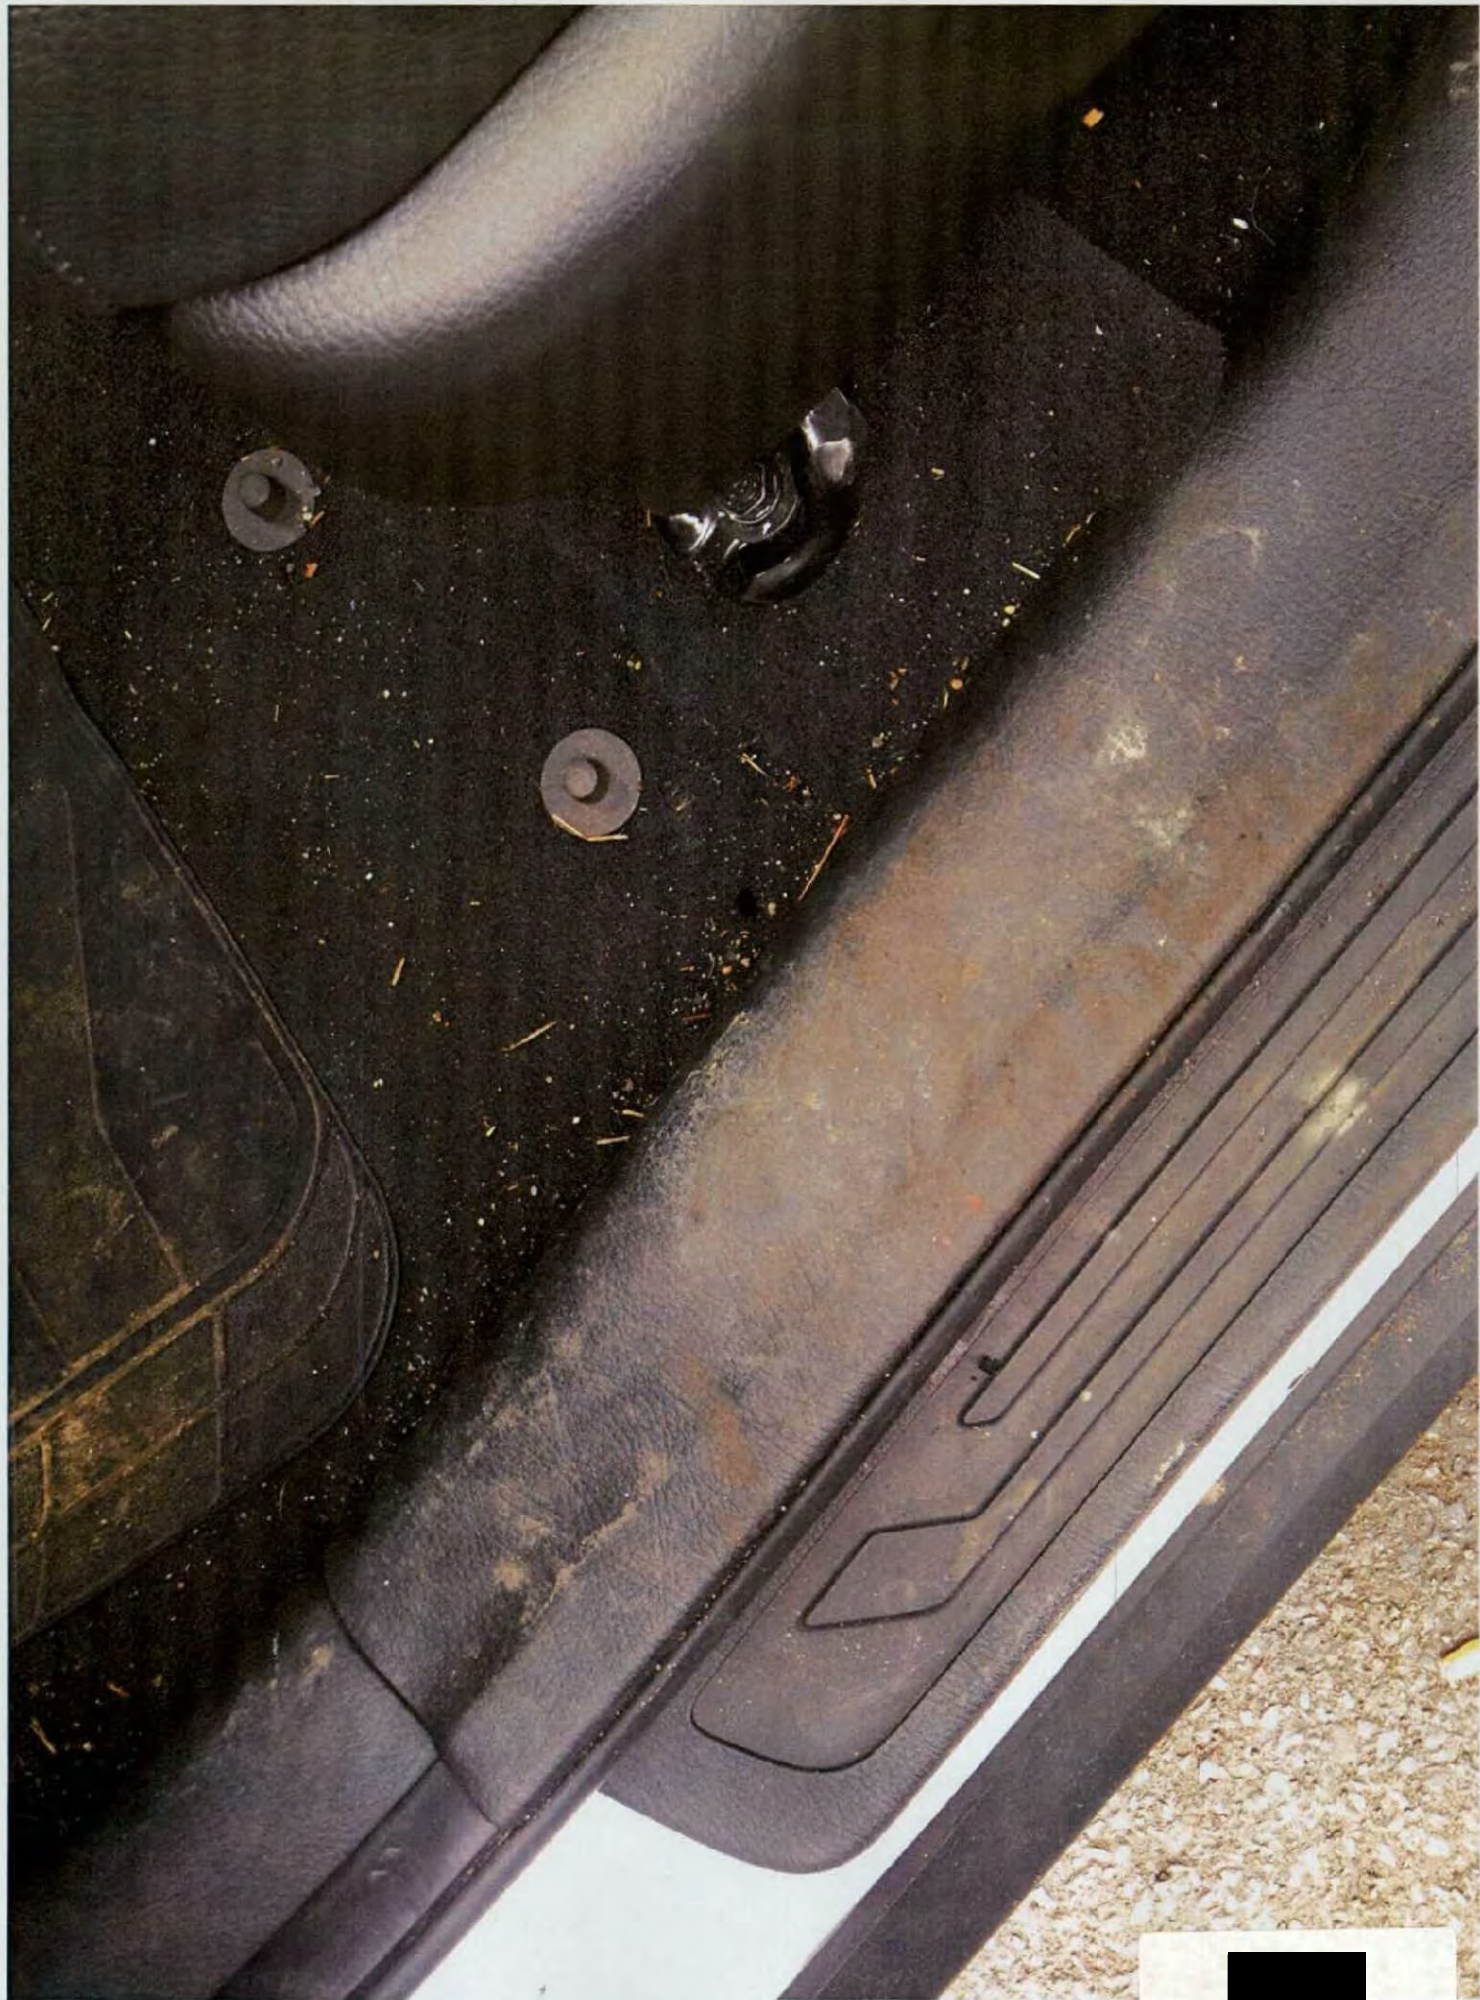
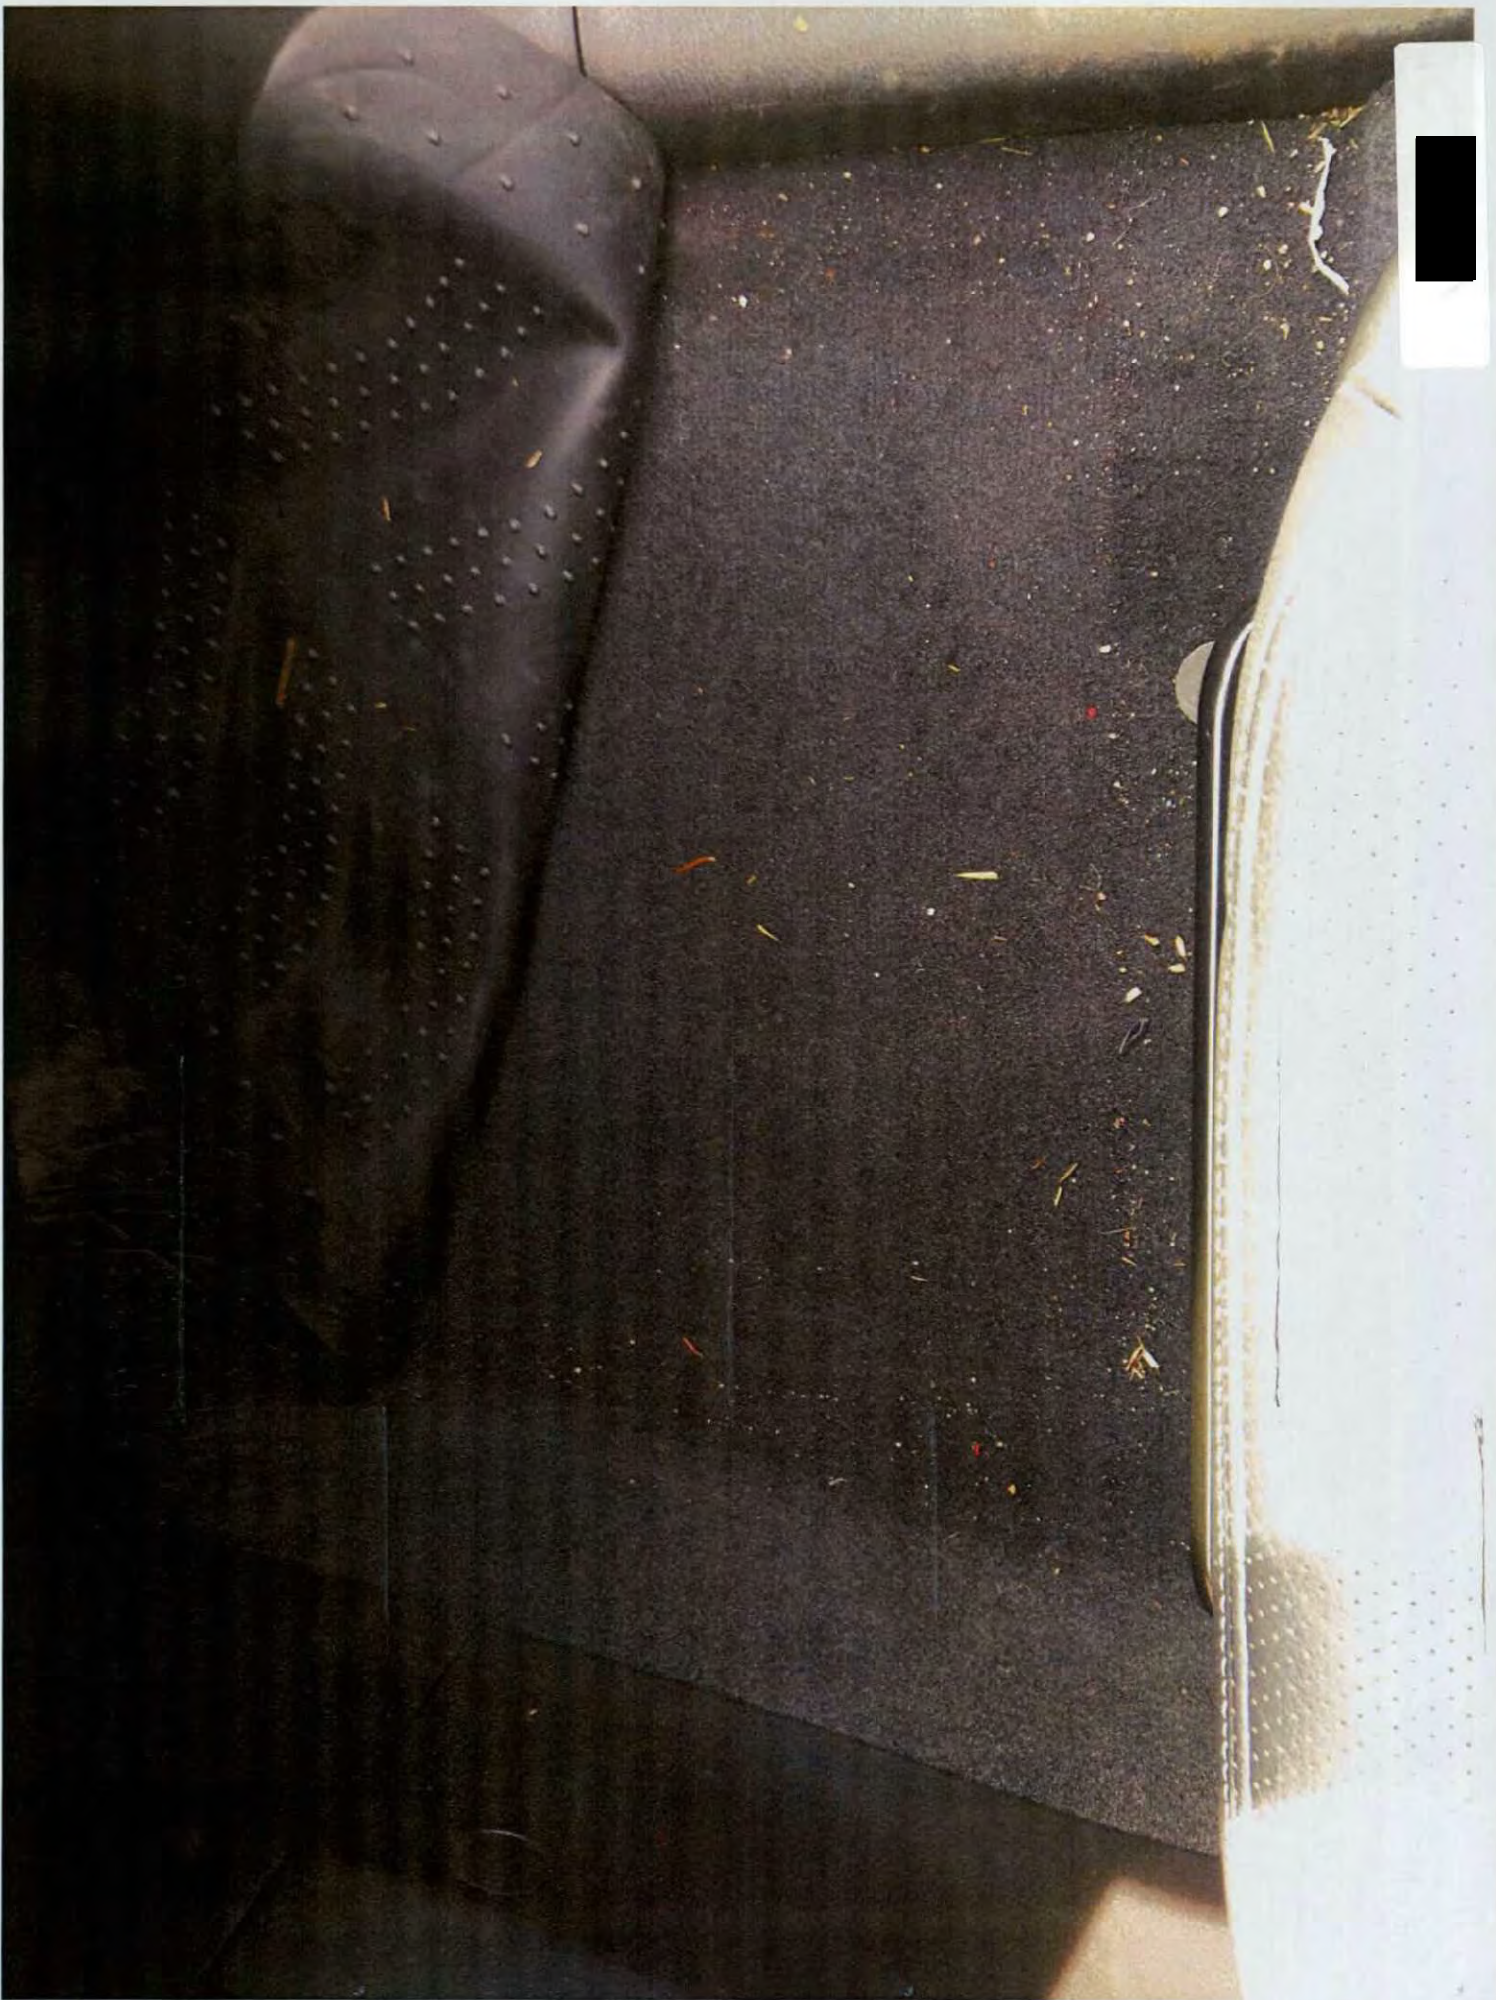
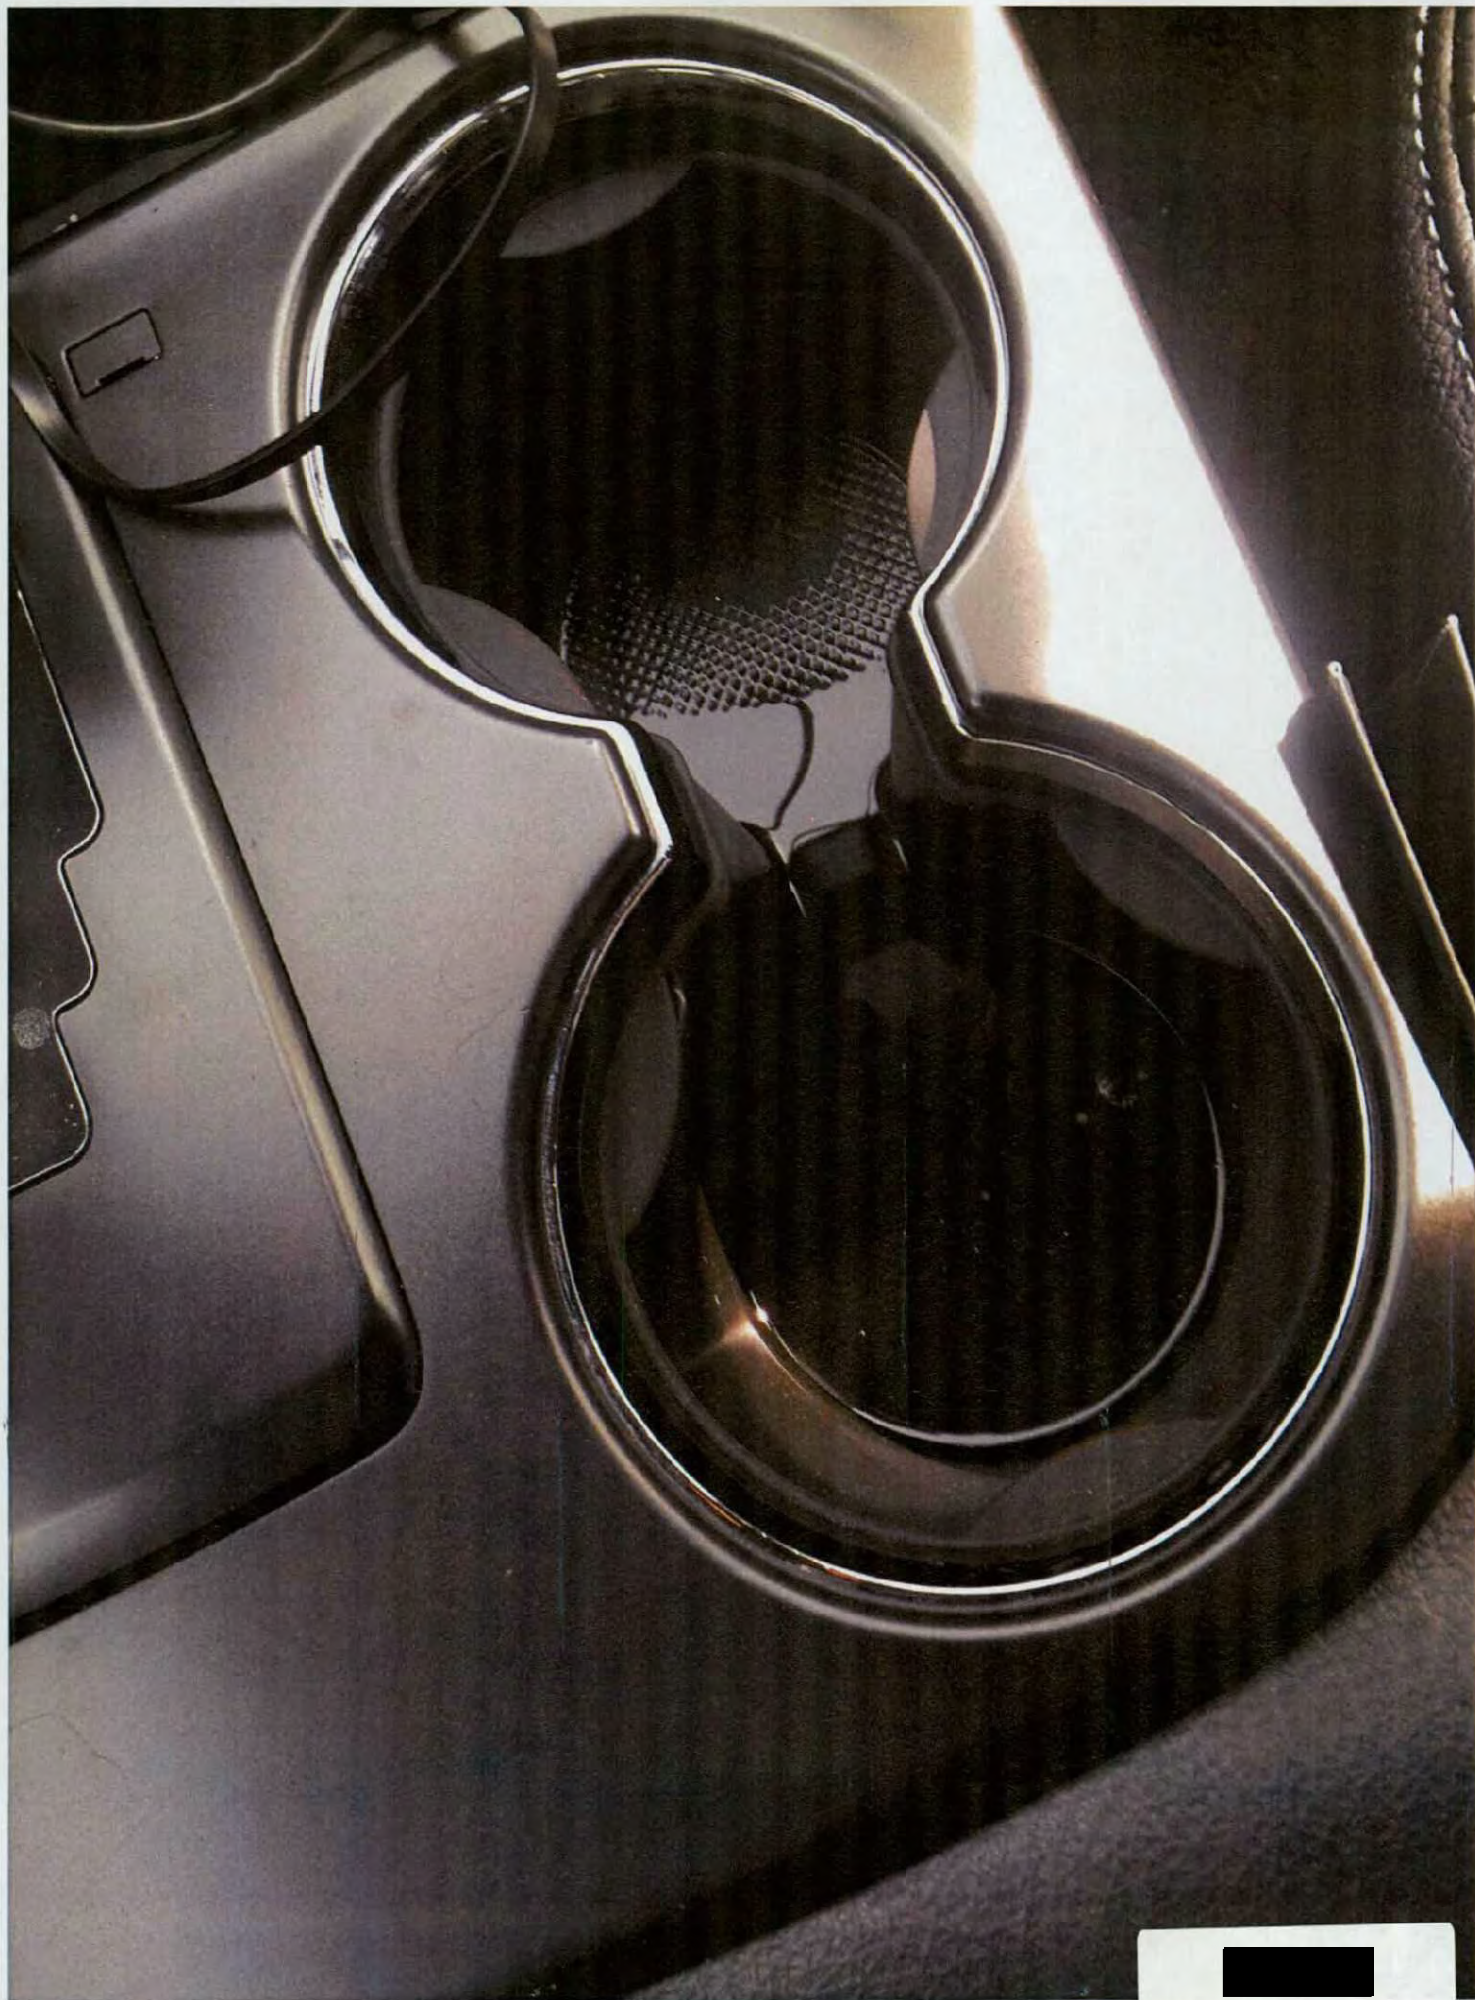
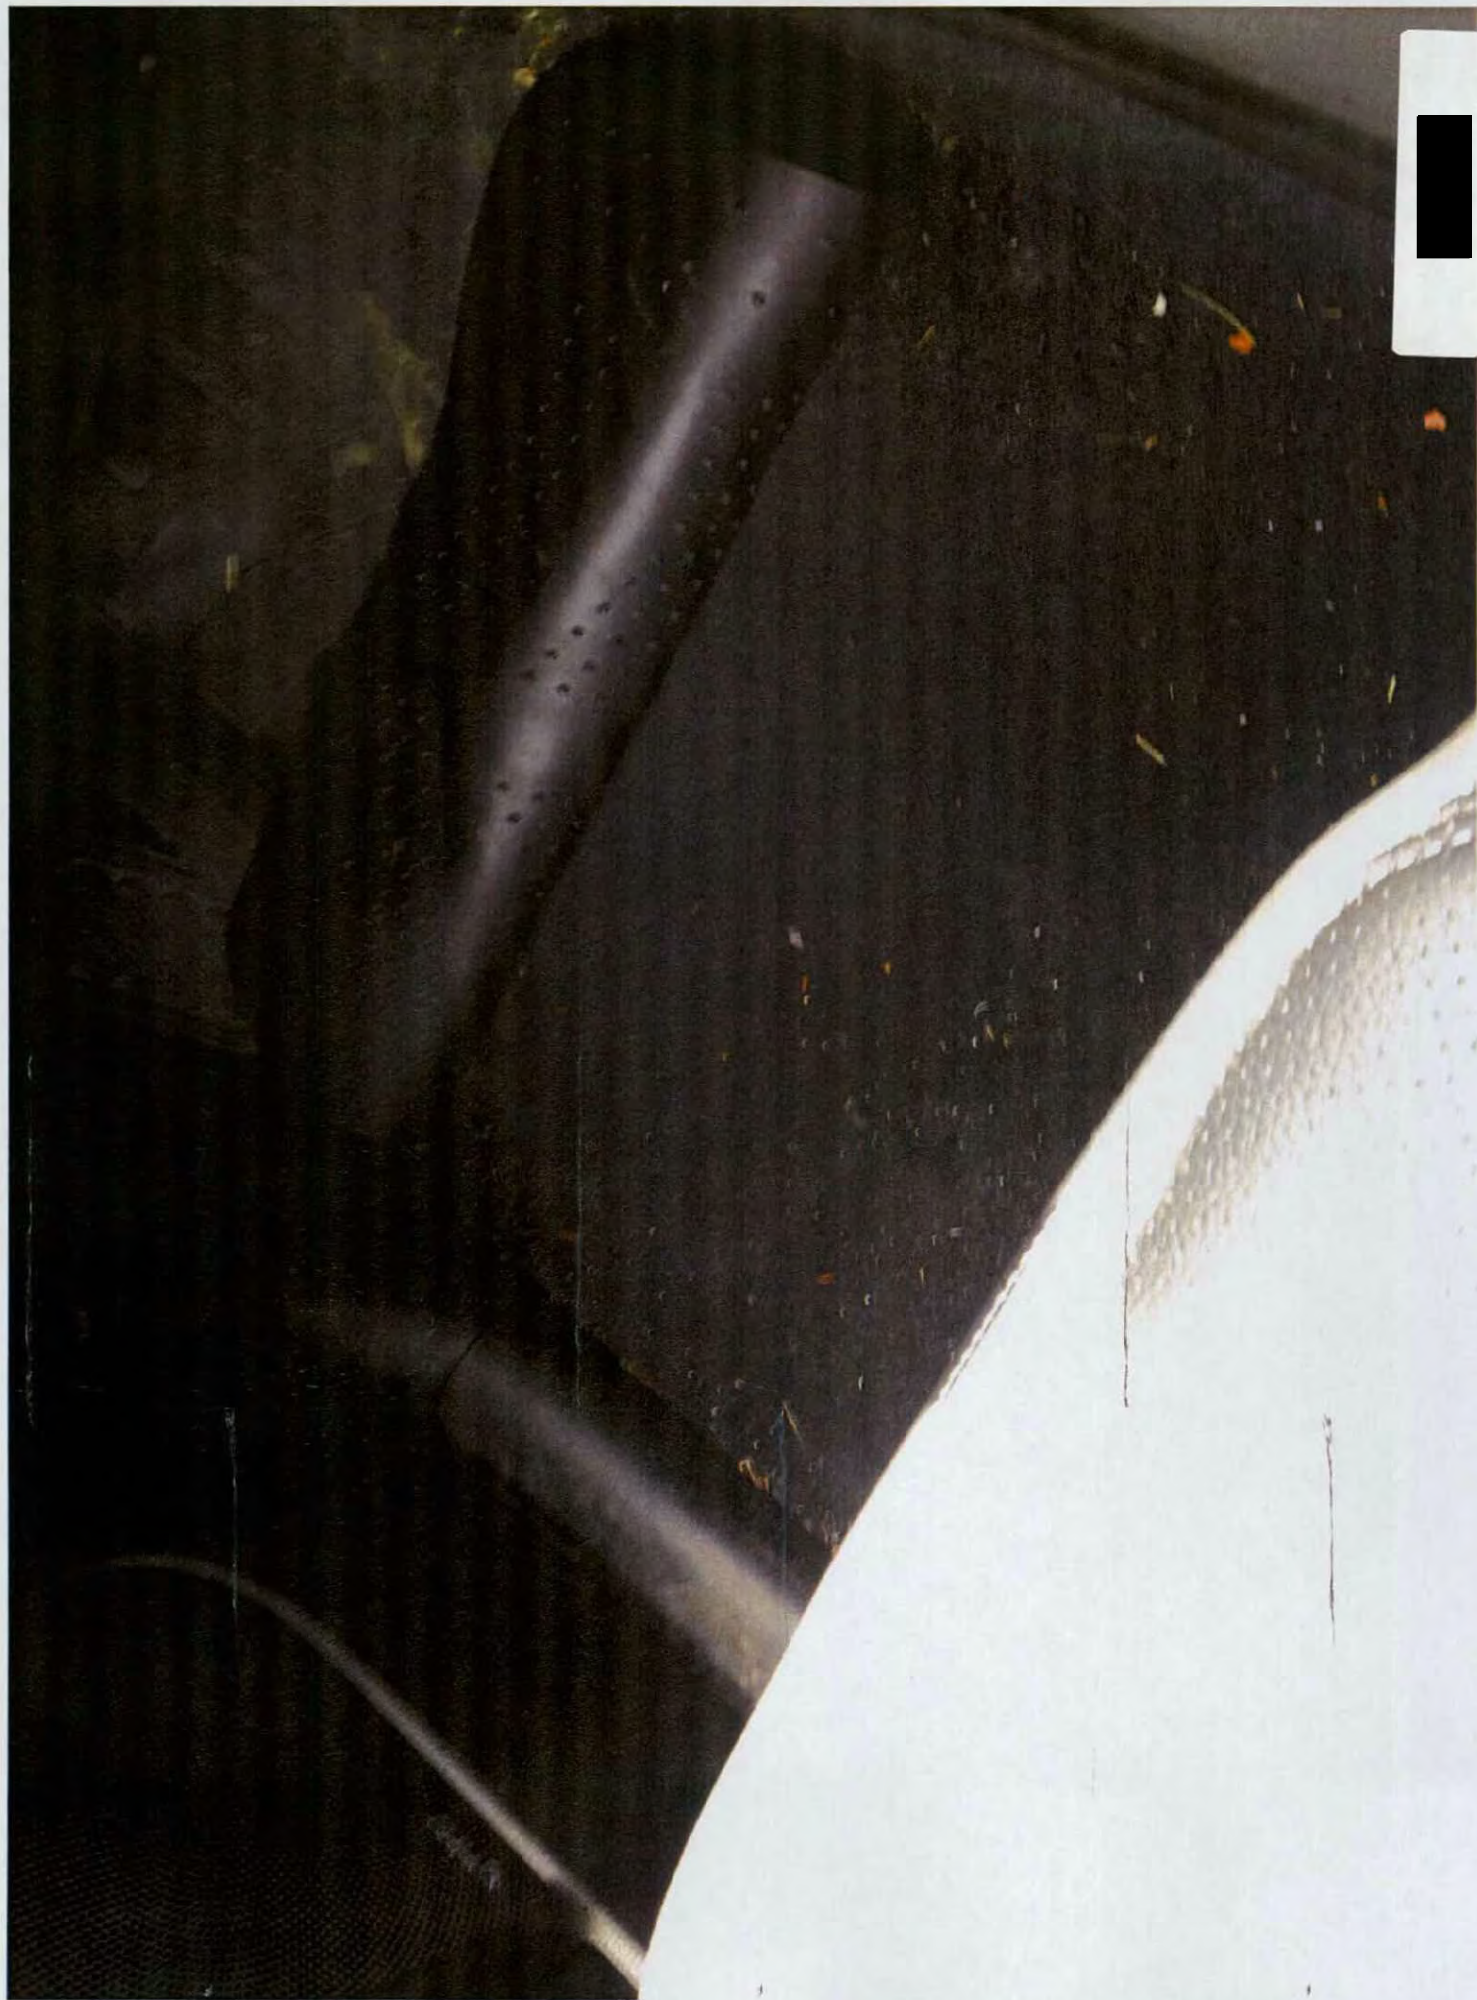
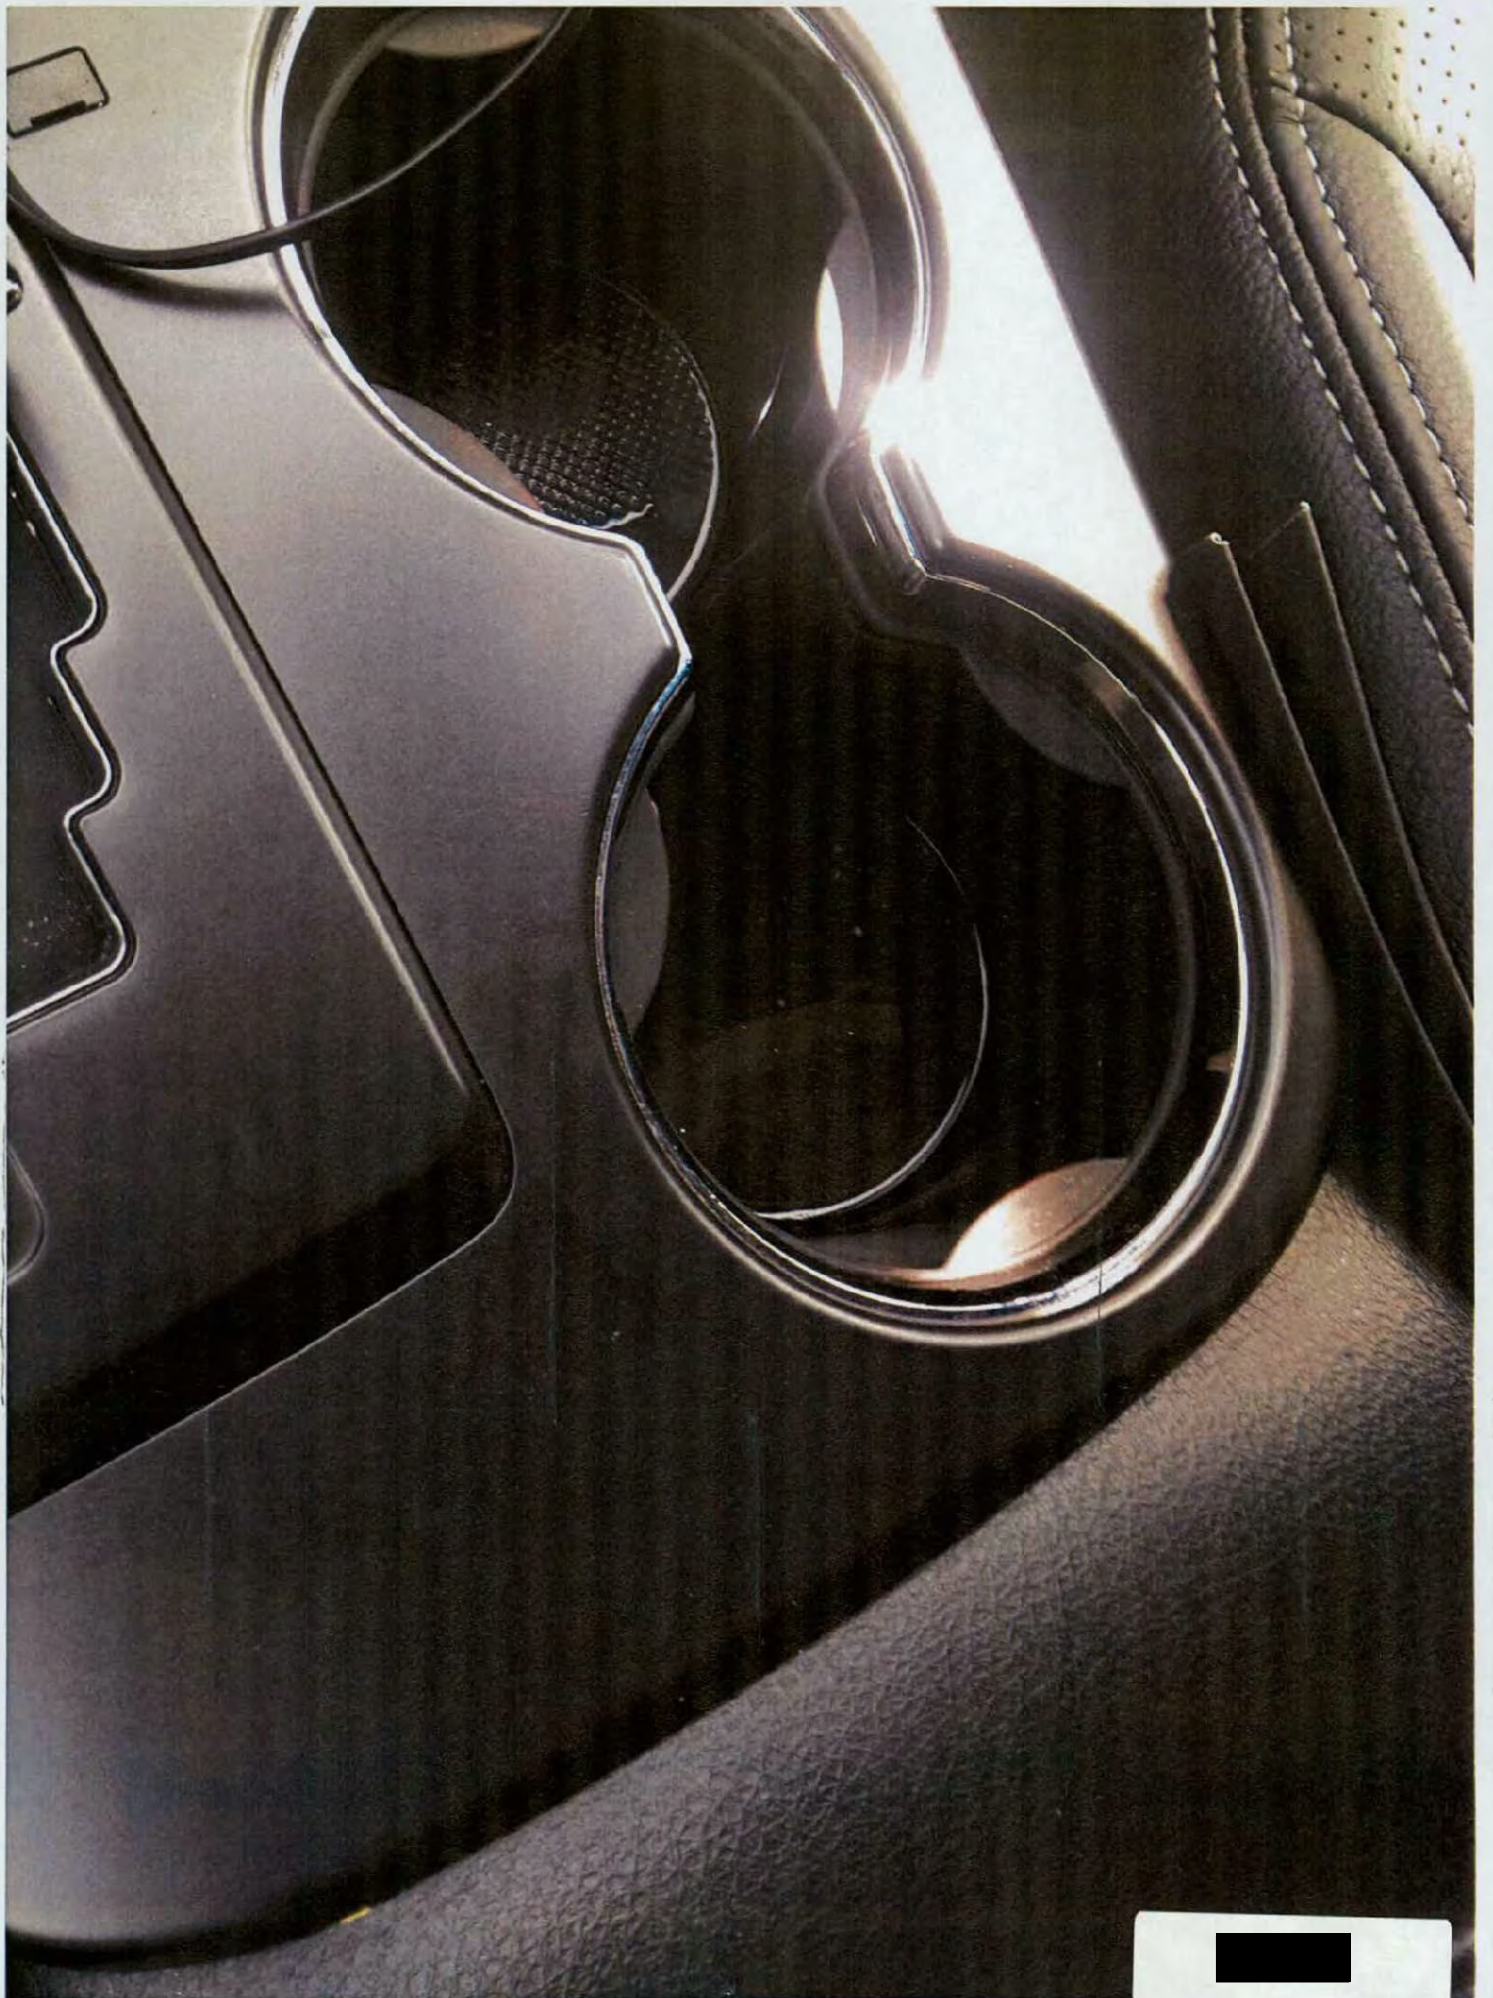
Sunroof panel completely shattered and the deflector was missing, the only pieces left were the pieces attached to the sunroof rails. I did find small chips in the windshield. I noticed a mark on the right side hood panel that looks like something hit and skip across it. Also found a chip in the front of the rear glass roof panel. Notice a small amount of paint chips on the rear air deflector. I noticed water intrusions in the vehicle. The customer allegedly drove the vehicle in the rain and did not cover up the roof panel were the sunroof shattered. Dealer is not sure the customer covered the panel after or just before they brought the vehicle to the dealer. The headliner and the carpet are still damp and water is sitting in the cup holder and top of the front shade that covers the sunroof panel.

Only the outside edge of the sunroof is left and water is sitting on the sunroof shade. Water was sitting the cup holders too.
