# THE FOURTEENTH INTERNATIONAL TECHNICAL CONFERENCE ON ENHANCED SAFETY OF VEHICLES

# The Fourteenth International Technical Conference on Enhanced Safety of Vehicles

This paper provides a description of "Unintended Acceleration" (*UA*) in passenger cars, provides data pertaining to the scope of the problem (number of accidents and injuries reported annually to NHTSA), identifies the known causes of *UA*, discusses countermeasures to reduce the incidence of *UA*, and provides analysis to assess the reductions in the *UA* accident rates which have resulted from the use of automatic shift locks.

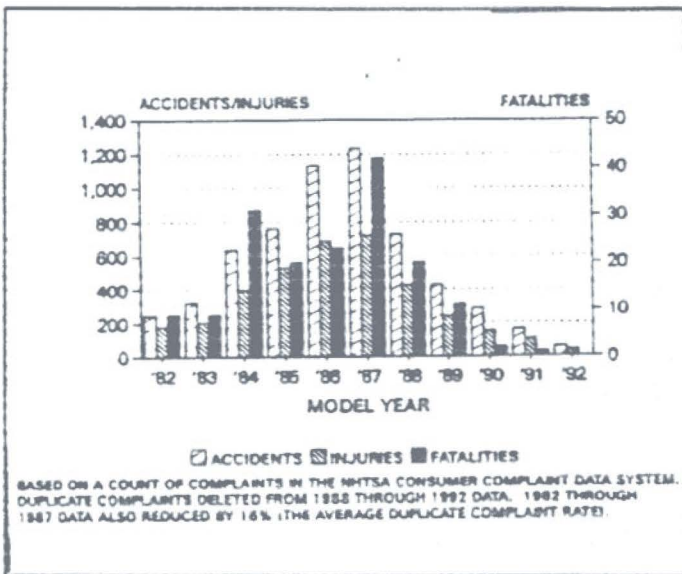
Figure 1. Reported *UA* Accidents Per Model year.

Figure 1 shows the number of *UA* accidents which have been entered into NHTSA's computerized consumer complaint data system. This file only contains reports of accidents which were submitted voluntarily (Information obtained directly from manufacturers during specific investigations is not included in the data base.) but it is useful for making comparisons among different groups of vehicles. Figure 1 is based on reports received prior to March 31, 1993, which allege that an accident occurred, and which were entered under a fault code for "Engine Runaway/Sudden Acceleration or Surge." Only reports of accidents, rather than all incident reports, were considered because some of the reports of "Engine Runaway" or "Surge" contained in the file involve incidents which do not meet the criteria for *UA*. For example, an engine surging incident in which the driver was able to control the vehicle sufficiently to avoid an accident, probably did not involve the high engine power accompanied by ineffective brakes

Figure 1 does not provide a completely accurate comparison between different model years, because it is cumulative data, and the older cars have had greater exposure. Exposure, however, does not by itself account for all of the apparent decline in the *UA* accident rate, because most of the complaints for a given model year are obtained during the first 2 years on the road, and the annual complaint rate continues to decline as the vehicles become older. The exceptionally high rates for 1986 and 1987 model years appear to have resulted partially from an increased "reporting" rate resulting from

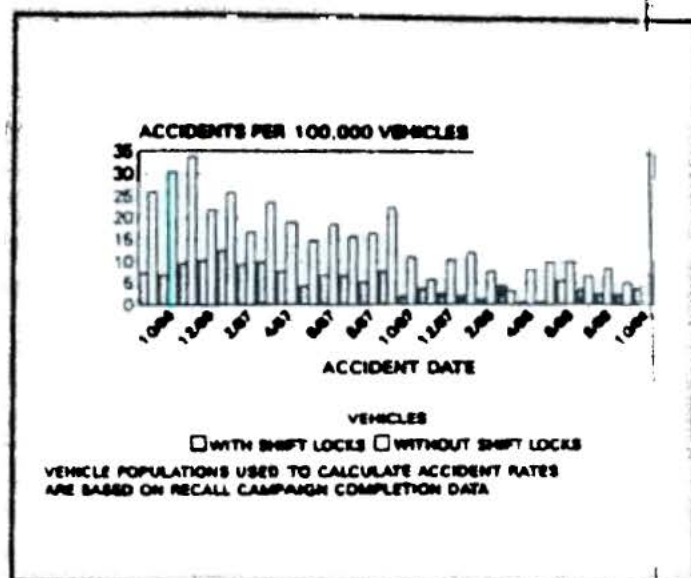
Figure 3. Effect of Retrofitting shift locks on the monthly reported UA accident rates for 1978 through 1986 Audi 5000 passenger cars.

After the dates of the reported UA accidents were compared to the dates when shift locks were installed in each specific vehicle, it was found that cars without shift locks had experienced an average of 2.8 times the UA accident rate of cars equipped with shift locks. This data is shown in Figure 3.

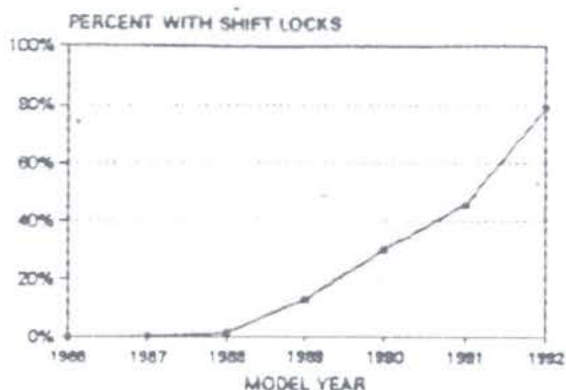
Figure 4. Percent of automatic transmission passenger cars sold in the U.S. equipped with shift locks.

The 1987 model year Audi passenger cars were the first cars which were sold in the United States equipped with factory installed shift locks. Nissan also began to install shift locks in 1987 Nissan 300ZX cars,\* and the Japan Automobile Manufacturers Association agreed in December 1987 that its members would begin to phase in shift locks until all cars with automatic transmissions produced in Japan for sale in Japan would have shift locks. Toyota introduced shift locks in its 1988 Corolla models, and Honda, Mazda, and Nissan produced several 1989 models with shift locks. The Ford Motor Company began to install shift locks in some 1990 Ford models, and General Motors Corporation began to install them in some 1991 models. Appendix A lists all 1988 through 1992 passenger car models which were sold in the United States equipped with shift locks. Figure 4 shows the increase in shift lock installations.
