Reference: NVS-213swm; PE15-030

Attached is FCA US LLC's ("FCA US") response of the referenced information request. The attached constitutes a full submission to PE15-030.

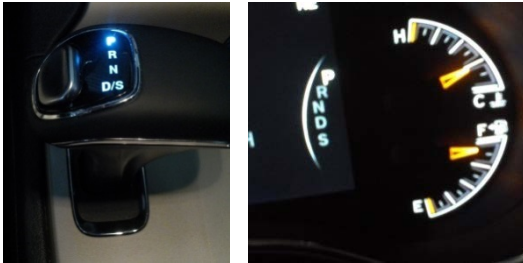
First, the display of "P" (for Park) occurs in the lighted cluster in full view of the operator through the PRND/S indicator. The "P" is bolded in the cluster PRND/S indicator to clearly indicate to the operator the transmission is in Park. Second, the illuminated shift lever also displays "P" (for Park) when the transmission park lock is engaged. The illumination of "P" in shift lever is brighter and is a contrasting color. These two visual cues inform the driver of the actual transmissions gear that was selected (see Figure 1: PRND/S and Cluster Position Displays.) These actual gear position displays fully comply with FMVSS 101 (Controls and Displays) and FMVSS 102 (Transmission Shift Lever Sequence, Starter Interlock and Transmission Braking Effect.)

Figure 1: PRND/S and Cluster Position Displays
