**From:** McElmeel, Edward (E.F.)  
**Sent:** Tuesday, November 28, 2017 12:49 PM  
**To:** Surella, Matthew (M.M.)  
**Cc:** Matti, Alvin (.); Singh, Hardeep (H.); Lawless, Gabriel (G.J.)  
**Subject:** FW: Once Again Feds Investigate Ford Models For Dangerous Power Steering Loss - Forbes

Please see below. What was the root cause and the fix for high friction detection DTC P07AE:09 in 2010 Fusion?  
This is very hot.

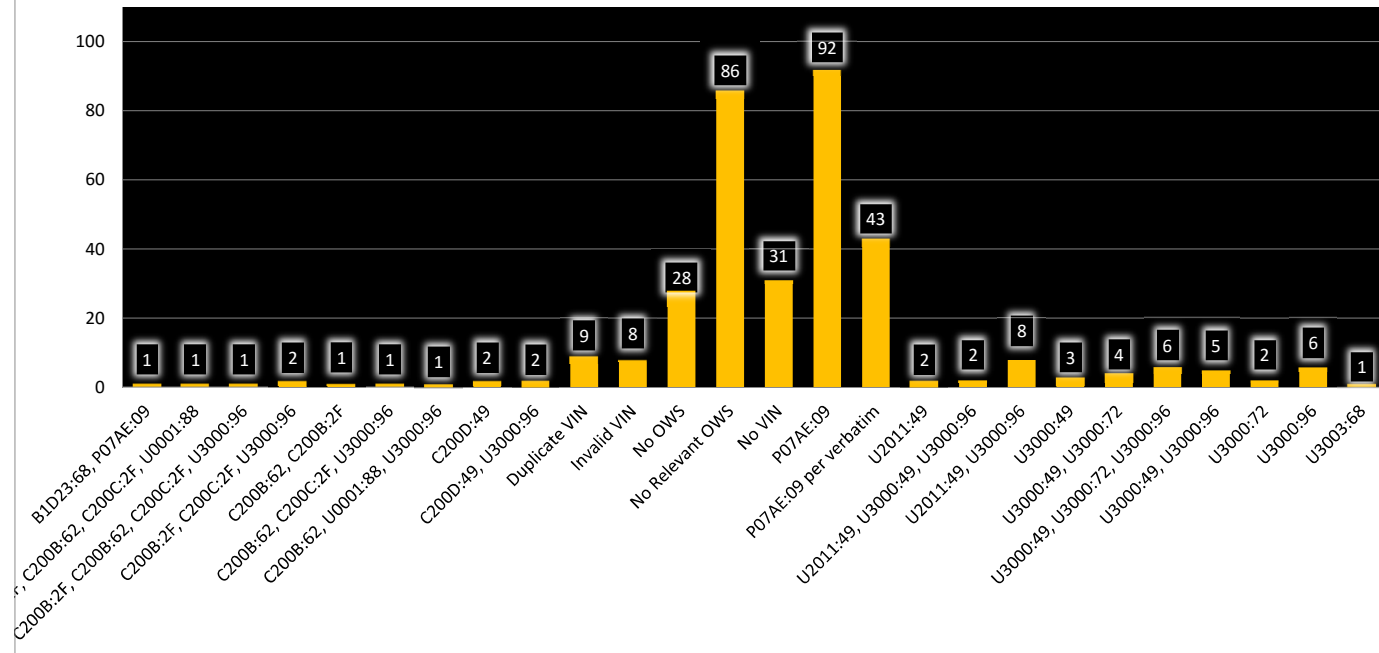
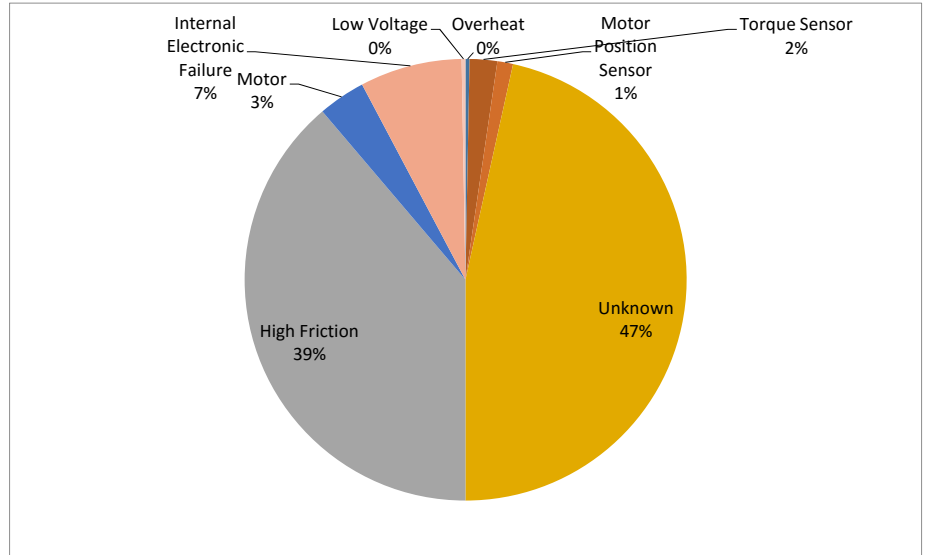
**Count of Claims with Identical DTCs**

Count of ODINO Row Labels	Column Labels		Grand Total
	N	Y	
moving	73	166	239
moving - returns after key cycled	25	41	66
start up-after prior warning msg	12	23	35
start up	8	22	30
	9	21	30
moving - repeat repair	8	9	17
start up - returns after key cycled	3	14	17
returns after key cycled	3	14	17
moving - returns after clearing codes	9	5	14
moving-low tire	2	10	12
moving - after flat tire	3	3	6
start up - after flat tire	2	4	6
repeat repair	1	3	4
STARTED PULLING HARD TO THE RIGHT		4	4
returns after clearing codes		2	2
start up - repeat repair	1	1	2
moving - THE PRESSURE ON TIRE WAS GOOD BUT STILL SHOWING LOW TIRE PRESSURE		1	1
start up-low tire	1		1
DEPRESSED THE BRAKE PEDAL AND THE STEERING RETURNED-moving		1	1
moving - fuse loose, control arms, gear		1	1
steering brakes airbags-driving		1	1
after flat tire-start up-repeat repair		1	1
start up - returns after key cycled-low tire		1	1
<b>Grand Total</b>	<b>160</b>	<b>348</b>	<b>508</b>

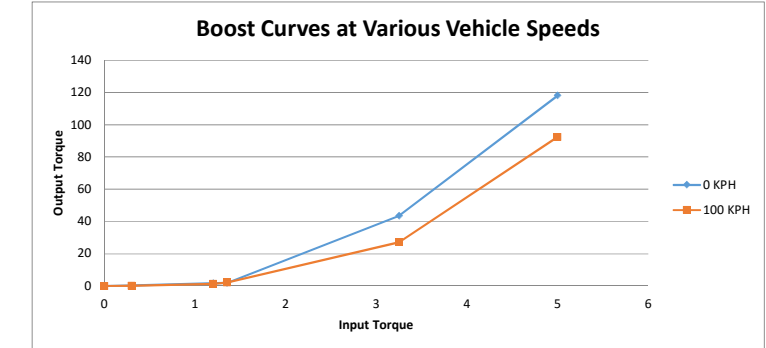
Linear interpolated Values

Speed (kph)												
	0	8	16	26	36	46	56	70	90	100	110	140	190
P0	0.38	0.5	0.54	0.56	0.58	0.6	0.62	0.64	0.66	0.67	0.68	0.7	0.55
P1	0.75	1.15	1.15	1.15	1.15	1.15	1.15	1.15	1.15	1.15	1.15	1.15	1.15
P2	3.9	3.7	3.55	3.35	3.25	3.15	3.05	2.95	2.85	2.83	2.8	2.75	2.7
P3	1.33	1.65	1.69	1.71	1.73	1.75	1.77	1.79	1.81	1.82	1.83	1.85	1.87
P4	1.4	1.65	1.8	1.95	2.05	2.1	2.15	2.2	2.25	2.28	2.3	2.35	2.4
P5	43.8	28.8	24.4	21.6	20	18.8	17.8	16.8	15.4	14.90	14.4	13.6	13
PD	0.64	0.33	0.33	0.33	0.33	0.33	0.33	0.33	0.33	0.33	0.33	0.32	0.3

Section 1	<	0.30	0.30	0.30	0.30	0.25	0.20	0.15	0.10	0.05	0.05	0.05	0.05	0.05
Section 2	<	1.20	1.20	1.80	1.80	1.75	1.70	1.70	1.70	1.70	1.73	1.75	2.00	2.00
Section 3	<	1.35	1.70	2.00	2.00	2.10	2.30	2.30	2.50	2.60	2.63	2.65	2.90	3.00
Section 4	<	3.25	3.60	3.85	3.80	3.85	4.00	3.95	4.10	4.20	4.23	4.25	4.45	4.55
Section 5	>	3.25	3.60	3.85	3.80	3.85	4.00	3.95	4.10	4.20	4.23	4.25	4.45	4.55

TD	Ta	0	100	Input Torque			
				0	0.30	3.25	5.00
0.30	0	0	0	0.2	43.6	118.1	
1.20	1.668	1.296		0.1	27.1	92.5	
1.35	1.923	2.146		0	0.1	16.5	25.6
3.25	43.585	27.06836		0	48%	38%	22%
5.00	118.135	92.51836
