HYUNDAI Technical Service Bulletin	GROUP	NUMBER
	CAMPAIGN	18-01-027
	DATE	MODEL(S)
	AUGUST 2018	SONATA (LF)
SUBJECT: SONATA ECM & CLUSTER UPDATE – ENGINE MONITORING LOGIC PRODUCT IMPROVEMENT (SERVICE CAMPAIGN 953)

Applicable Vehicles: Certain 2015 MY Sonata (LF) vehicles with 2.4L and 2.0L Turbo engines

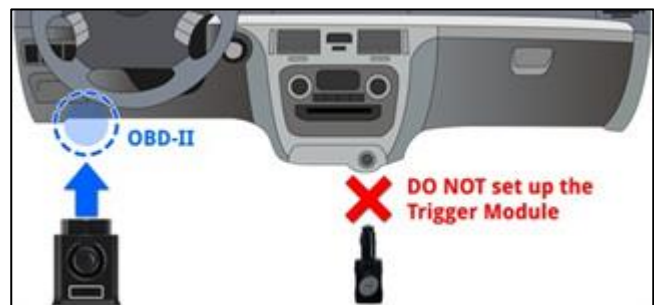
1. Connect the VCI-II into the vehicle's DLC connector under the driver side instrument panel.

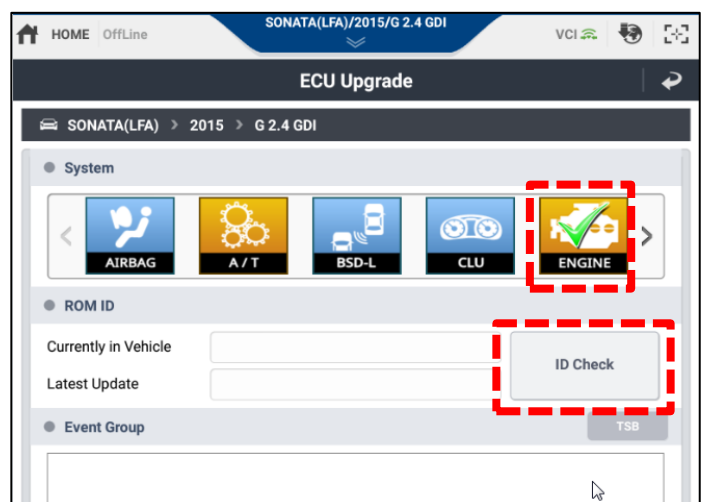
4. Under **System**, select **Engine** to update the engine ECM. Then select **ID Check** to search for available updates.

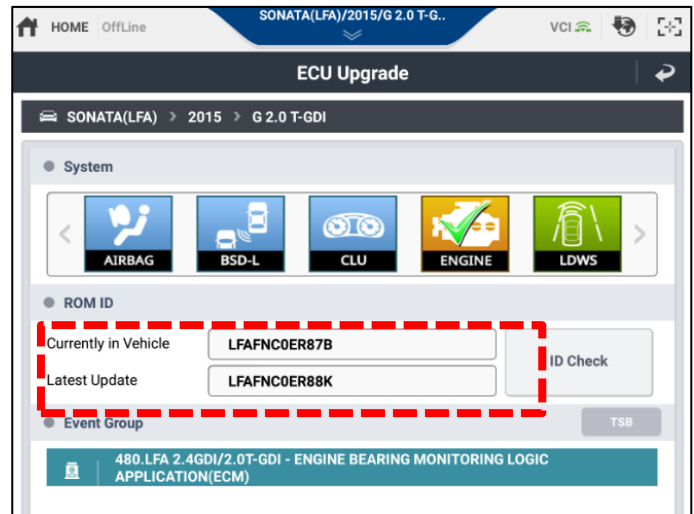
5. Confirm the ROM IDs match those in the ROM Information table for the vehicle specification. Select the event under **Event Group** and then select **Upgrade** to start the update.

The update is performed in two parts. Follow the prompts on the GDS to complete the update.

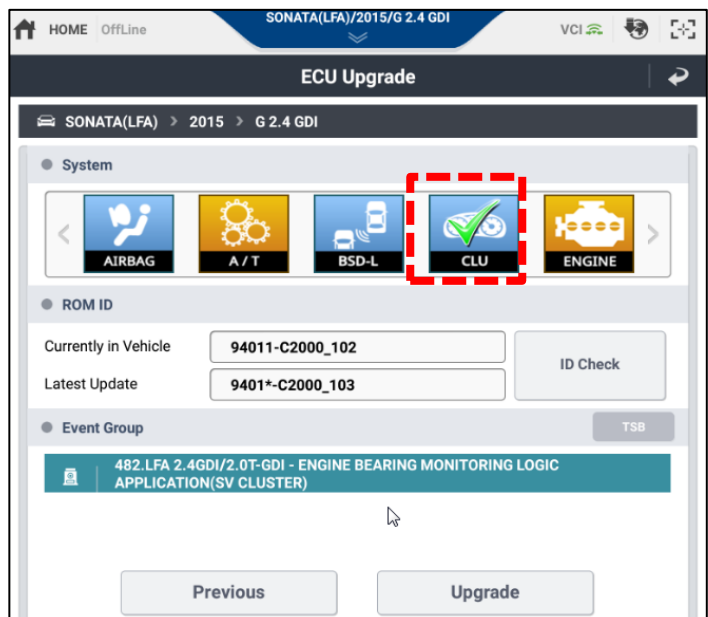
7. Next update the cluster software starting with the process outlined in Step 3. Under **System** in the **ECU Upgrade** menu, select **CLU** to update the cluster.

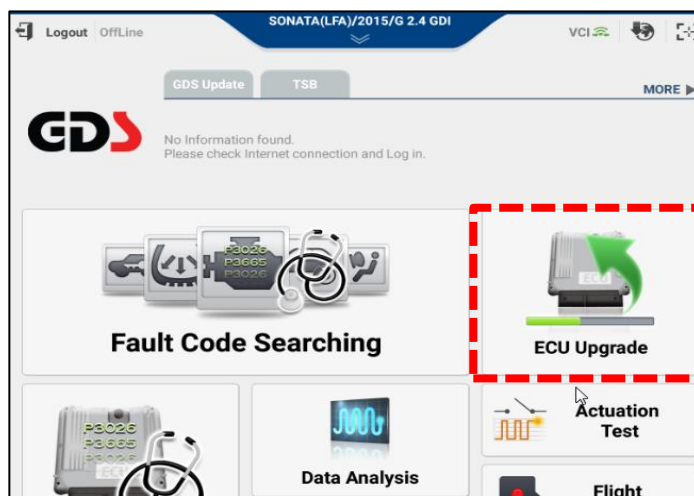
1. Select **ECU Upgrade** from the GDS main screen and then select **Manual Mode**.

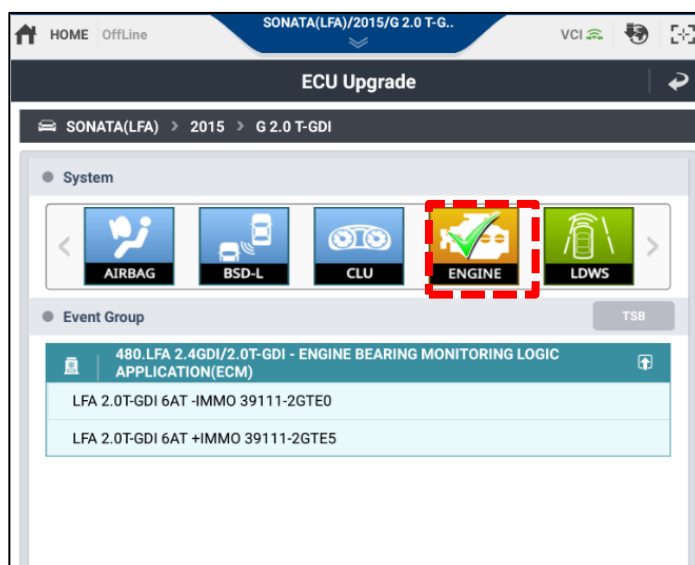
2. Under **System**, select **Engine** to update the engine ECM and **CLU** to update the cluster. Select the appropriate update by referencing the ROM ID Information and password tables. Select **Upgrade** and follow the prompts on the GDS to complete the update.
