<b>HYUNDAI</b> <small>c</small> <b>Technical Service Bulletin</b>	GROUP <b>CAMPAIGN</b>	NUMBER <b>18-01-027-1</b>
	DATE <b>NOVEMBER 2018</b>	MODEL(S) <b>SONATA (LF) SANTA FE SPORT (AN)</b>
<b>SUBJECT:</b> ECM & CLUSTER UPDATE – ENGINE MONITORING LOGIC PRODUCT IMPROVEMENT (SERVICE CAMPAIGN 953)

**Description:** Hyundai is conducting a product improvement campaign to enhance the knock sensor software to detect abnormal engine bearing noise before potentially severe engine damage occurs. If abnormal engine bearing noise is detected, the Malfunction Indicator Lamp (MIL) will blink continuously, a chime will sound, and the vehicle will be placed in Limp Home Mode allowing the customer to drive to the nearest Hyundai dealer for diagnosis and repair. In addition, DTC P132600 will be recorded in the ECM. The vehicle can continue to be operated for a limited time in Limp Home Mode, but it will accelerate slower and have a reduced maximum speed. Engine RPMs will be limited to approximately 1800-2000 RPM.

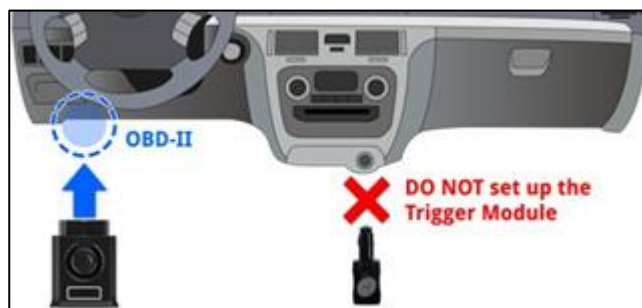
1. Connect the VCI-II into the vehicle's DLC connector under the driver side instrument panel.

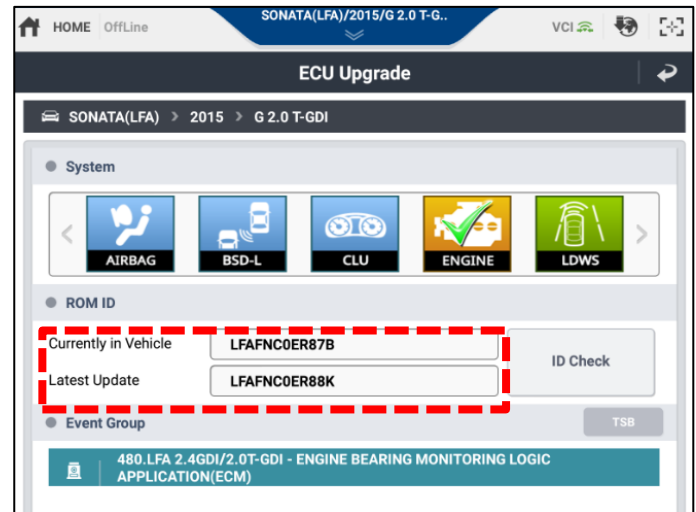
5. Confirm the ROM IDs match those in the ROM Information table for the vehicle specification. Select the event under **Event Group** and then select **Upgrade** to start the update.

The update is performed in two parts. Follow the prompts on the GDS to complete the update.

Do not touch the GDS buttons ('Back', 'Home', etc) while performing the update. Do not start the engine.

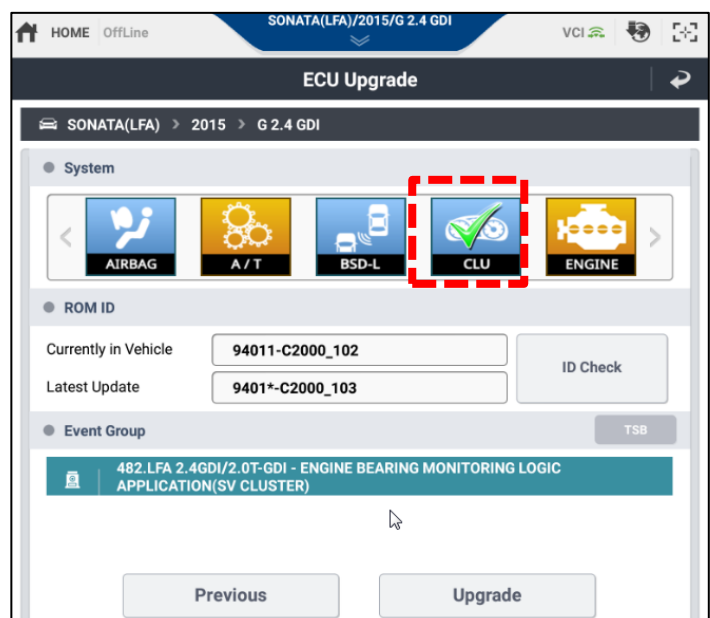
7. Next update the cluster software starting with the process outlined in Step 3. Under **System** in the **ECU Upgrade** menu, select **CLU** to update the cluster.

Ensure **BOTH** the Engine ECM and Cluster are updated to complete this TSB.

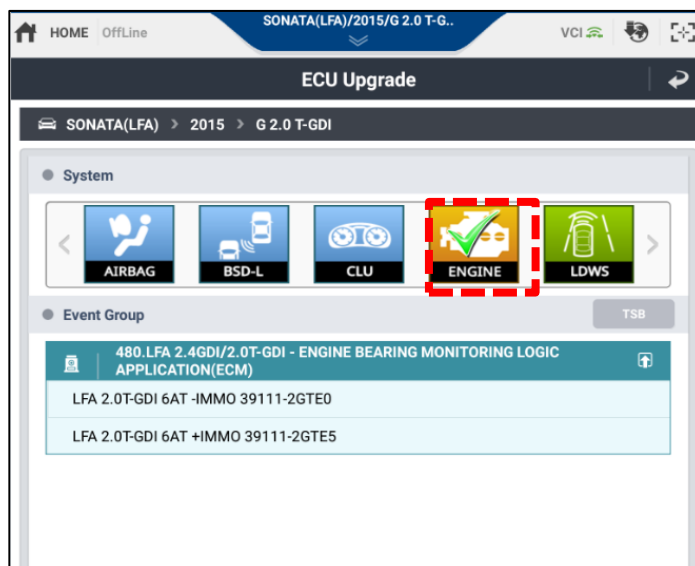
2. Under **System**, select **Engine** to update the engine ECM and **CLU** to update the cluster. Select the appropriate update by referencing the ROM ID Information and password tables. Select **Upgrade** and follow the prompts on the GDS to complete the update.

Ensure the correct update is performed by using the ROM ID Info tables. Any attempt to update using an incorrect ROM ID may cause the ECU to be inoperative.
