## WMA5 - Updating Software for Various Control Units (Workshop Campaign)

**Model Line:** Taycan (Y1A)

**Concerns:** Software update (software version VR12.1.1)

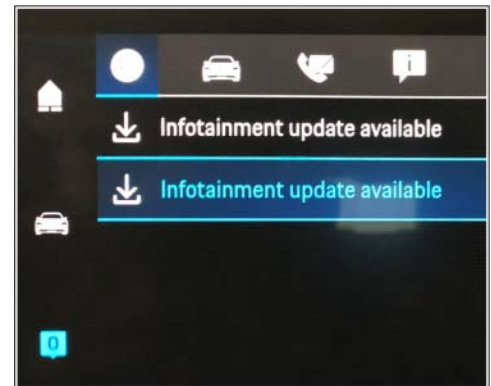
*Infotainment update in central display*

After carrying out the campaign, please inform customers that Infotainment updates are available via the central computer (PCM) and provide them with any help and support they need during installation ⇒ *Infotainment update in central display*.

These updates are only available if the customer has logged in on the vehicle using his/her main user credentials (Porsche ID). Several updates are available depending on equipment and these must be installed one after the other in steps. It can take several minutes to install these. New functions can only be used when all updates have been completed and the vehicle has established bus idle for at least 15 minutes.

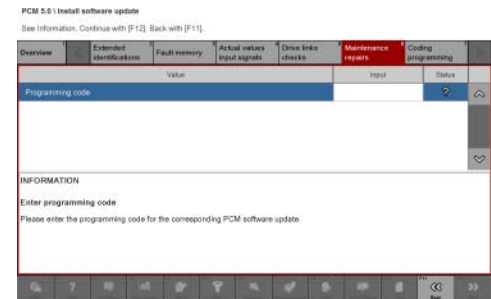
- 5.10 Enter the programming code **K4M4S** in the relevant column ⇒ *Entering PCM 6.0 programming code* and press •F12 “ ('Next') to confirm ⇒ *Entering PCM 6.0 programming code*.

- 5.11 Press •F8 “ ('Start') to start.

- 5.12 After checking the software data, press •F8 “ ('Start') to start programming.

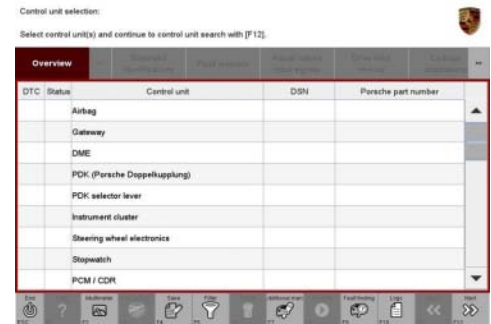
*Control unit selection*

9.6 Once you have erased the fault memories, select the **'Overview'** menu to return to control unit selection ⇒ *Control unit selection*.

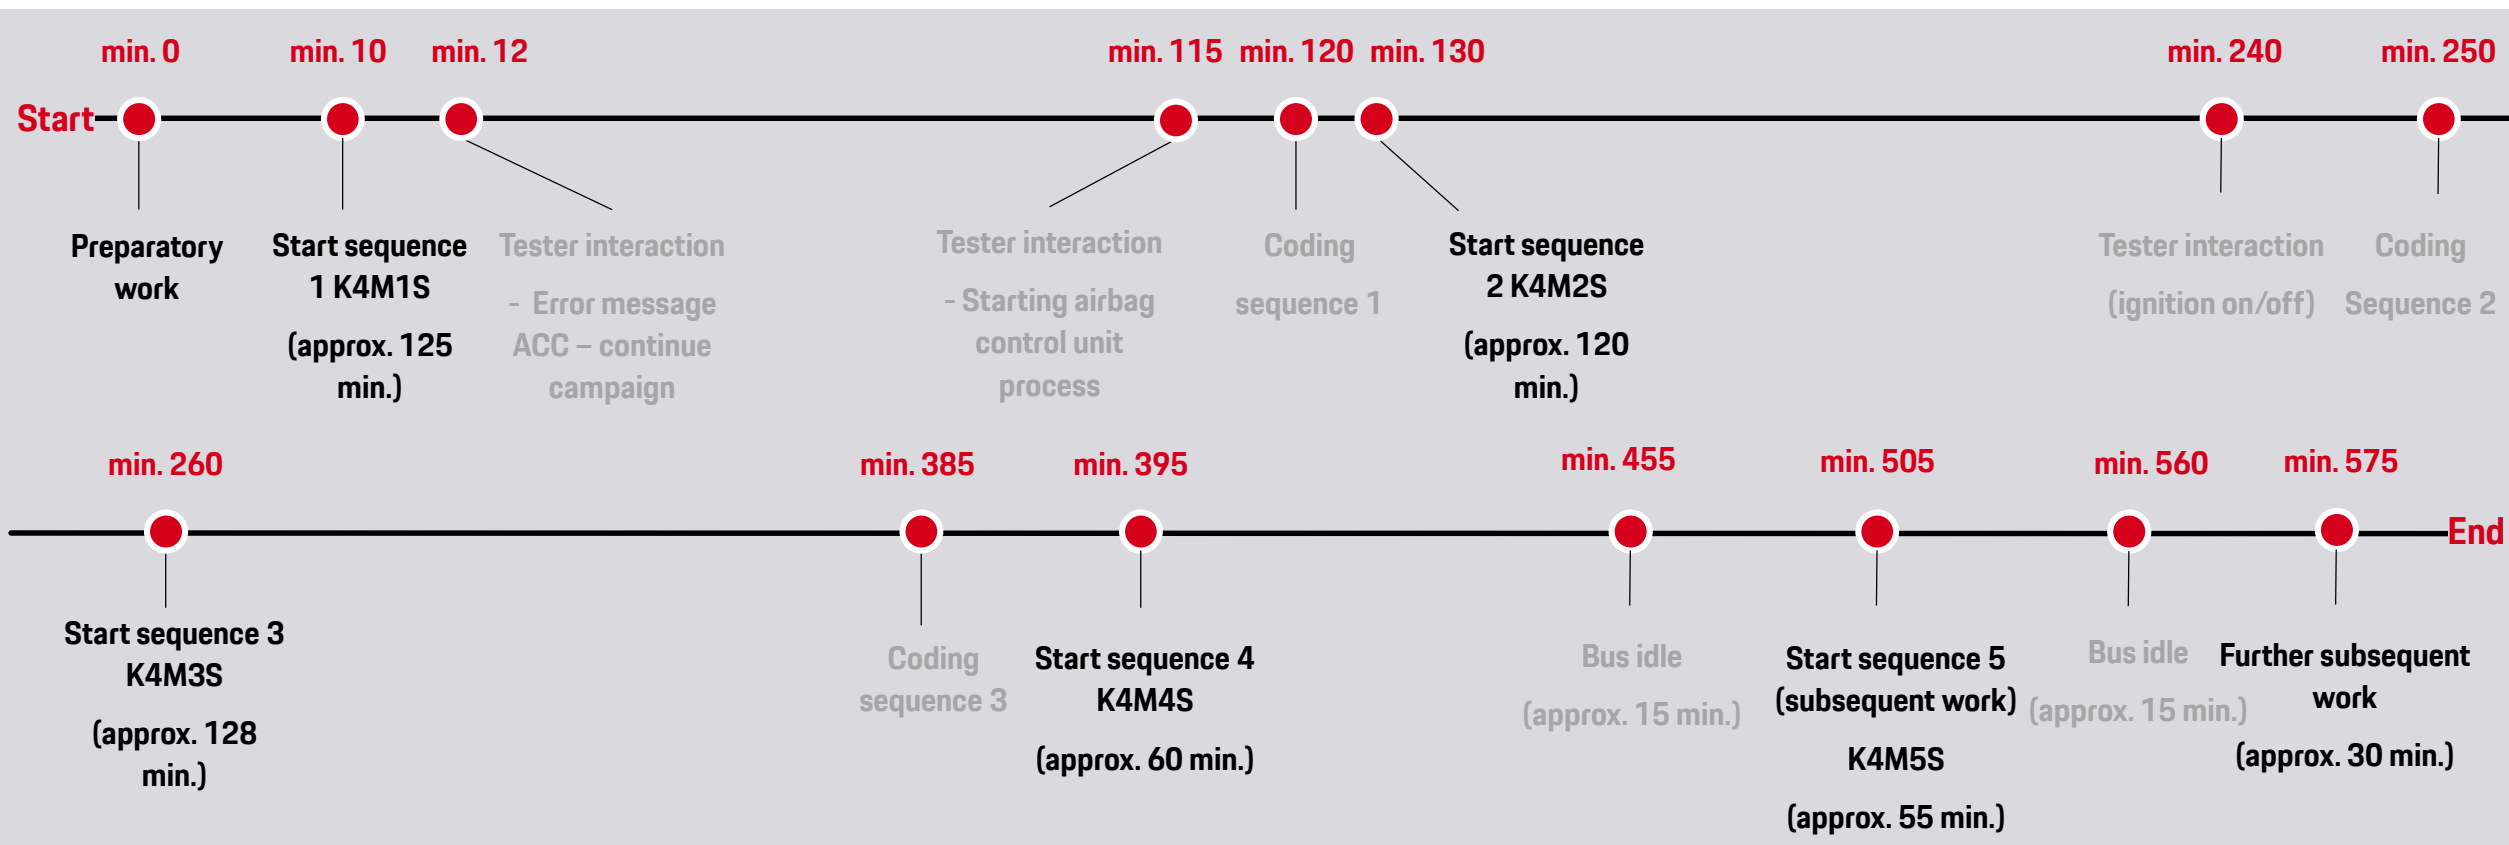
# Rough time schedule supplement for workshop campaign WMA5 – Scope 3

Please note that this chart only represents a supplement to Technical Information WMA5 (TI 15/21). The listed times are for orientation purposes only and may vary depending on vehicle equipment. The Porsche Mobile Charger Connect (WMA7) update must be performed promptly after carrying out campaign WMA5.
