## WMA5 - Updating Software for Various Control Units (Workshop Campaign)

Model Line: **Taycan (Y1A)**

Concerns: **Software update (software version VR12.1.1)**

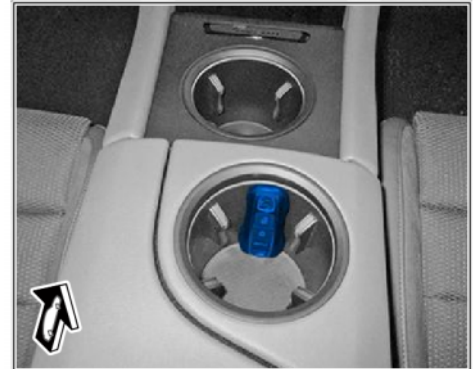
*Emergency start tray*

- 2 Position the **driver's key** with the back facing forward upright between the holding struts in the rear cupholder (**emergency start tray**) to guarantee a permanent radio link between the vehicle and remote control ⇒ *Emergency start tray*.
