### AMB5 Stop Delivery / Recall campaign - Re-programming power electronics

Model line: **Taycan (Y1A)**  
**Taycan Cross Turismo (Y1B)**

Concerns: **Power electronics and engine electronics (DME)**

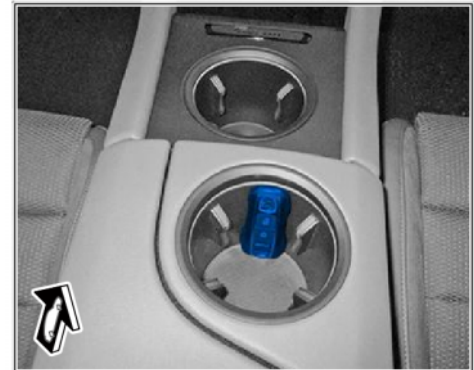
*Emergency start tray*

- 2 Position the **driver's key** with the back facing forward upright between the holding struts in the rear cupholder (**emergency start tray**) to guarantee a permanent radio link between the vehicle and remote control ⇒ *Emergency start tray*.
- 3 Connect **9900 - PIWIS Tester 3** to the vehicle communication module (VCI) via the **USB cable**. Then, connect the communication module to the vehicle and switch on the PIWIS Tester. Operate the PIWIS Tester **via the power supply unit**.

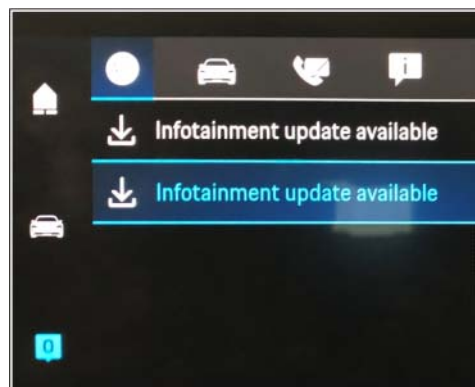
*Infotainment update in central display*

After carrying out the campaign, please inform customers that Infotainment updates are available via the central computer (PCM) and provide them with any help and support they need during installation ⇒ *Infotainment update in central display*.

These updates are only available if the customer has logged in on the vehicle using his/her main user credentials (Porsche ID). Several updates are available depending on equipment and these must be installed one after the other in steps. It can take several minutes to install these. New functions can only be used when all updates have been completed and the vehicle has established bus idle for at least 15 minutes.

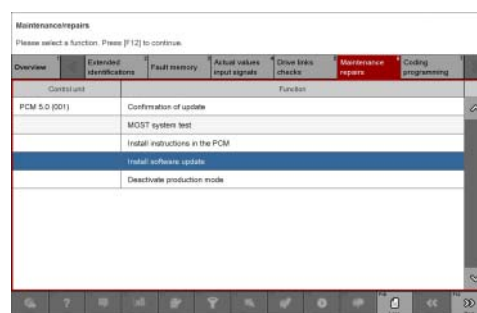
*Installing PCM 6.0 software update*

- 5.7 Once the PCM central computer control unit has been found and is displayed in the 'Overview', select the '**Maintenance / repairs**' menu.
- 5.8 Select the '**Install software update**' function and press •F12 " ('Next') to perform the software update ⇒ *Installing PCM 6.0 software update*.

Once the update has started, the PCM is restarted in the Update menu and the individual components are then updated.

**The update can take up to 60 minutes.**

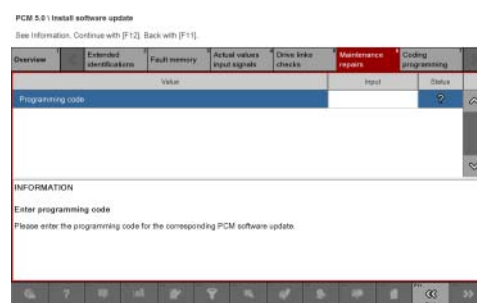
*Entering PCM 6.0 programming code*

Read and follow the instructions displayed on the PIWIS Tester during the update. The PCM is restarted several times. **The PCM screen (central display) remains dark for a long time.**

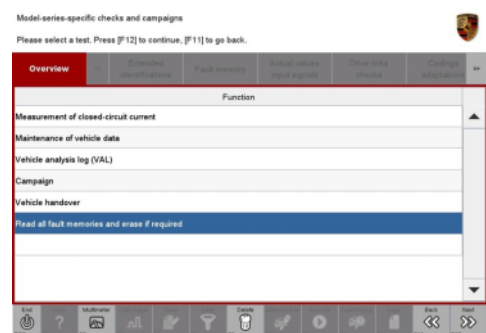
*Erasing fault memories*

- 10.4 Press **•F8** " to delete fault memory entries.

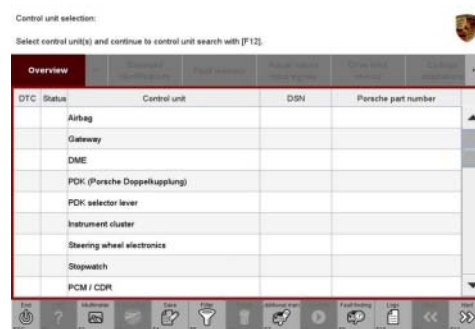
*Control unit selection*

- 11 Create vehicle analysis log (VAL) using the PIWIS Tester.

Mark the vehicle analysis log you have just created with the attribute "Final VAL" and after carrying out the campaign, return it using the PIWIS Tester.

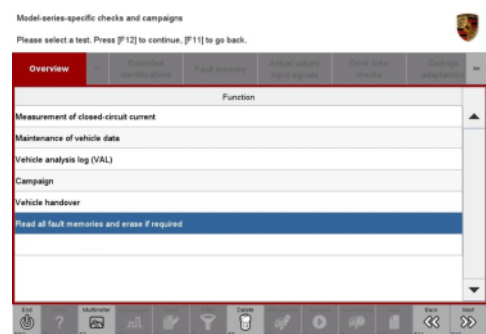
*Erasing fault memories*

- 2.4 Press •F8 " to delete fault memory entries.
- 2.5 Press •F12 " ('Yes') in response to the question as to whether you really want to delete all fault memory entries.

The faults stored in the fault memories of the various control units are deleted.

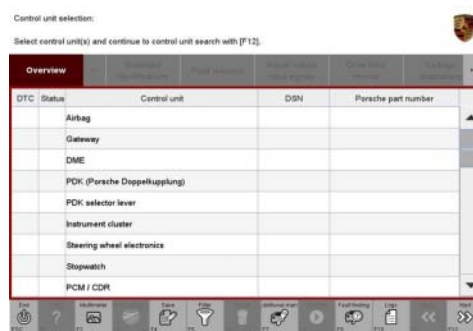
*Control unit selection*

2.6 Once you have erased the fault memories, select the **'Overview'** menu to return to the control unit selection screen  
⇒ *Control unit selection*.
