## Clattering/rattling engine noise on deceleration

| Topic number | LI03.10-P-060916 |
| Function group | 03.10 - Connecting rods, pistons |
| Validity | Engine 274.920 (LS) |

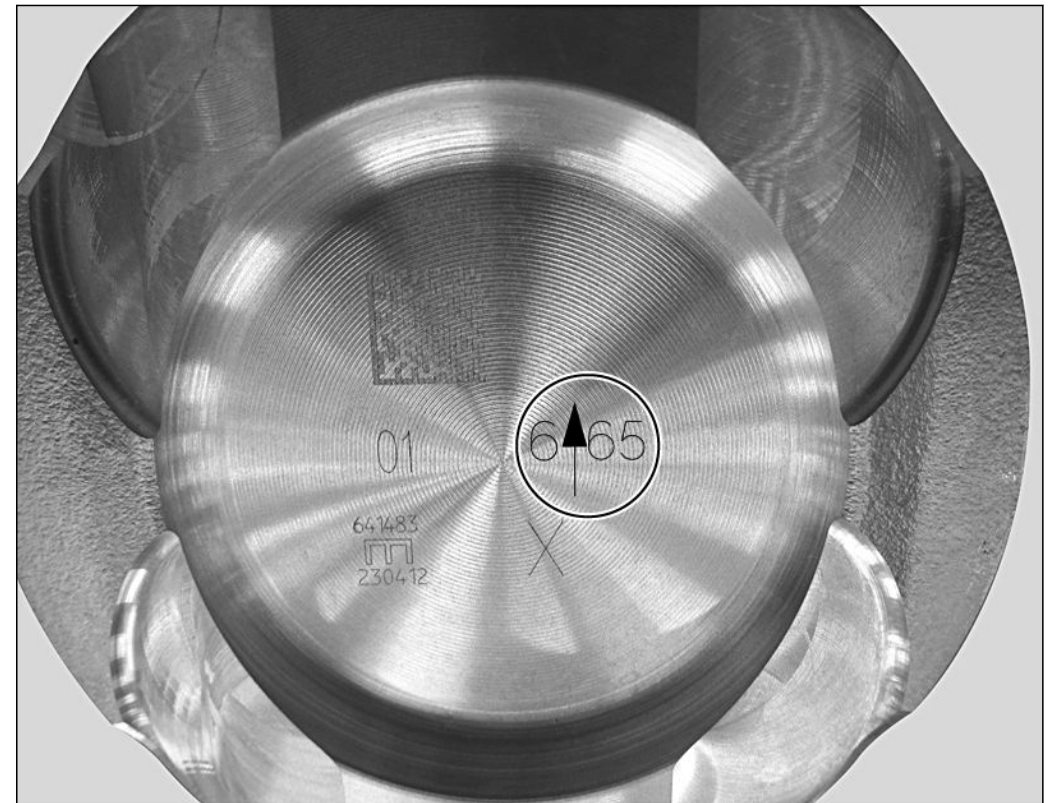
P03.10-2147-11

**Piston with driving direction arrow**

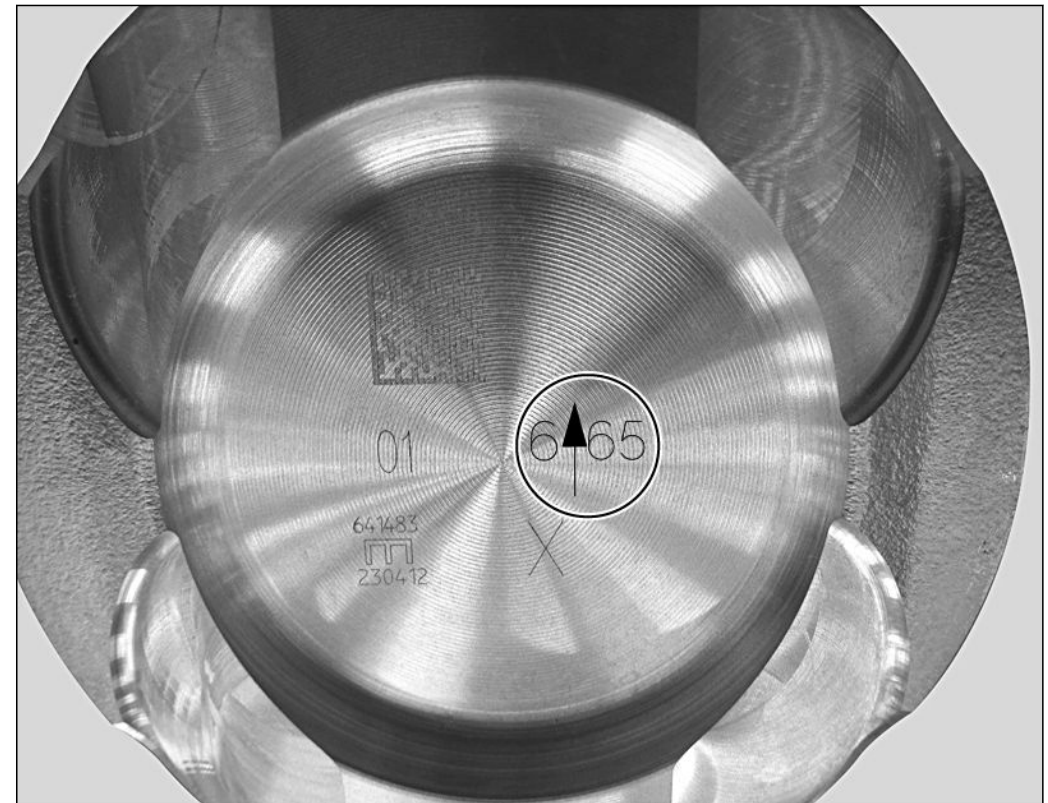
P03.10-2147-11

**Piston with driving direction arrow**
