## Motor Vehicle Defect Petition to Recall All Tesla Vehicles Due to Sudden Unintended Acceleration

# How Brakes Can Fail During a Sudden Acceleration Incident

**Abstract:** NHTSA's 1989 report by Pollard and Sussman entitled "An Examination of Sudden Acceleration" (aka, the "Silver Book") defines sudden acceleration incidents (SAI) as "unintended, unexpected, high-power accelerations from a stationary position or a very low initial speed accompanied by an apparent loss of braking effectiveness". When Audi drivers in the 1980's reported that during their incidents the brakes lacked effectiveness, NHTSA tested the brakes under simulated conditions and found that they remained fully operable after the incidents. Therefore, NHTSA's report concluded that "no plausible mechanisms could be identified for temporary, self-correcting brake failure which are relevant to SAI". This led them to conclude that the cause of SAI in Audi 5000 vehicles was the driver confusing the accelerator pedal for the brake pedal when trying to stop the vehicle after the idle stabilizer initiated the SAI by suddenly opening to create an acceleration of less than 0.3 g for less than 2 seconds (excessive creep)

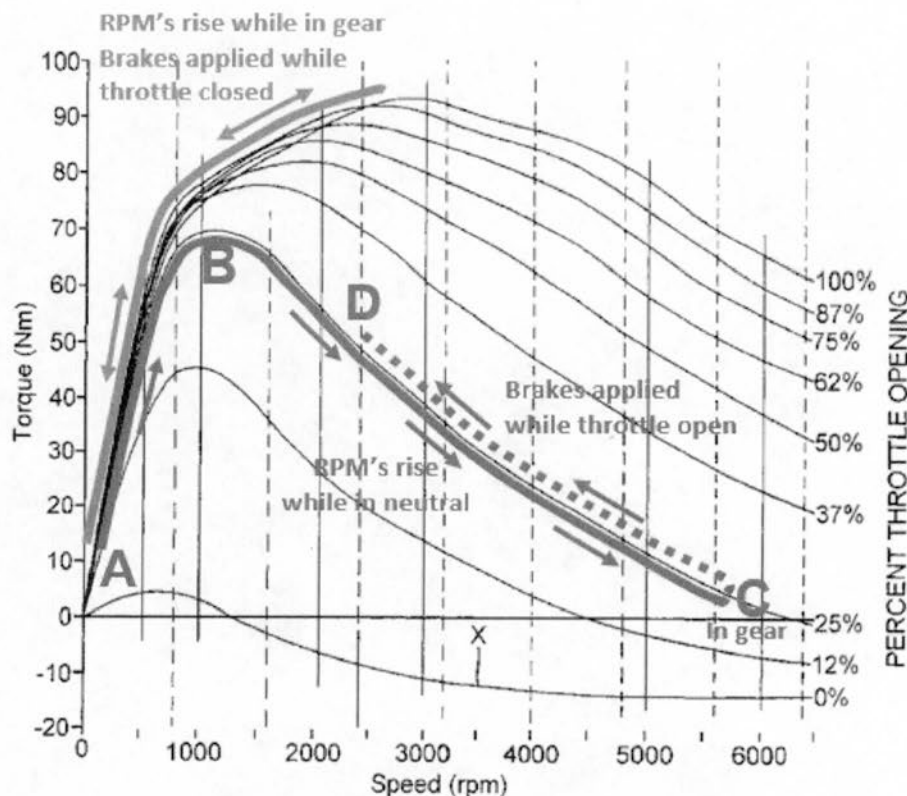
Figure 1. Engine torque versus engine speed for an ICE vehicle. During normal operation the engine follows the green curve to the left of the maximum points in the throttle opening curves. The engine torque increases as the engine RPM's increase and decreases as the engine RPM's decrease while braking with the accelerator pedal released and the throttle closed. During sudden acceleration, the engine RPM's increase rapidly following the red curve while the transmission remains in neutral due to delayed engagement. At point C the transmission drops into the lowest gear to begin vehicle motion. When the brakes are applied during sudden acceleration, the engine torque increases as the engine RPM's decrease because of the increased load on the engine produced by the brakes as a result of the engine operating to the right of the maximum torque position while the throttle remains open. The resulting increase in engine torque counters the braking torque, giving the driver the impression that the brakes are failing. In vehicles with engines that produce a lot of torque the driver may even perceive that the vehicle speeds up as the driver presses on the brake pedal during sudden acceleration.

In all ICE vehicles, both gasoline-powered and diesel-powered, engine torque varies with engine RPM as shown in Figure 1. Normal engine operation is shown in green. Normally, the driver starts from a stop by shifting the transmission into DRIVE and then pressing on the accelerator pedal to increase the throttle opening. This causes the engine RPM to increase and the engine torque to rise. The vehicle transmission starts out in the lowest forward gear, which produces the greatest torque to the drive wheels. The engine RPM's increase slowly because of the load placed on the engine by the drive train. As the engine RPM's slowly increase, the vehicle velocity increases, and the transmission shifts from the lowest gear into the next higher gear to keep the engine RPM's low while continuing to apply torque without going past the RPM at which the maximum torque occurs. This constrains operation along the green path shown in the figure, with the engine RPM's never exceeding the RPM at which the maximum torque occurs.

When the driver applies the brakes to try to stop the sudden acceleration, the load on the engine increases further, causing the engine RPM's to decrease. But as the engine RPM's decrease, the engine torque increases as a result of operating between points C and D to the right of the curve maximum where the curve slopes upward with decreasing engine RPM's. If the increase in the engine torque is low, then the increase in engine torque opposes or neutralizes the applied braking torque, causing the driver to perceive that the brakes are less effective or have failed completely. If the increase in the engine torque is higher than the applied braking torque because of a powerful engine, then the increase in engine torque causes the vehicle to accelerate as the driver applies the brakes. This is the reason many drivers involved in sudden acceleration incidents say that the brakes have failed or that pressing on the brake pedal caused the vehicle to accelerate. It is the perception of the driver-- resulting from the vehicle acceleration-- that the brakes are failing, and not the actual failing of the brakes. This perception of brake failure is correct because while the engine is operating to the right of the maximum RPM value, the engine torque increases as the engine RPM's decrease when the brakes are applied. This increase in engine torque counters the applied braking torque, making the driver perceive that the brakes are ineffective. The harder one presses on the brake pedal, the faster the engine RPM's decrease and the faster the engine torque increases to oppose the brake torque or to cause the vehicle to accelerate.

Note that all of these tests on ICE vehicles were done while the engine was operating in the green region of Figure 1. Therefore, they did not simulate the case when the vehicle is operating in the red region of Figure 1, which is the case when the engine torque increases as the brakes are being applied while stopping during sudden acceleration with the transmission in the lowest gear. This is the case that causes the drivers to perceive that the brakes are failing because the engine torque increases in response to the brake torque being applied, which does not happen in the green region. Therefore, these tests failed to reproduce how the Audi 5000 vehicles really behaved during the original sudden acceleration incidents and what the drivers of these vehicles perceived as a result.

4. Some readers may argue that the RPM's created by the idle stabilizer in an Audi 5000 vehicle are not high enough to achieve operation in the red region of Figure 1. However, these readers should consult Figure B-4 on page B-5 in Appendix H of the Pollard and Sussman report, which shows the following figure:

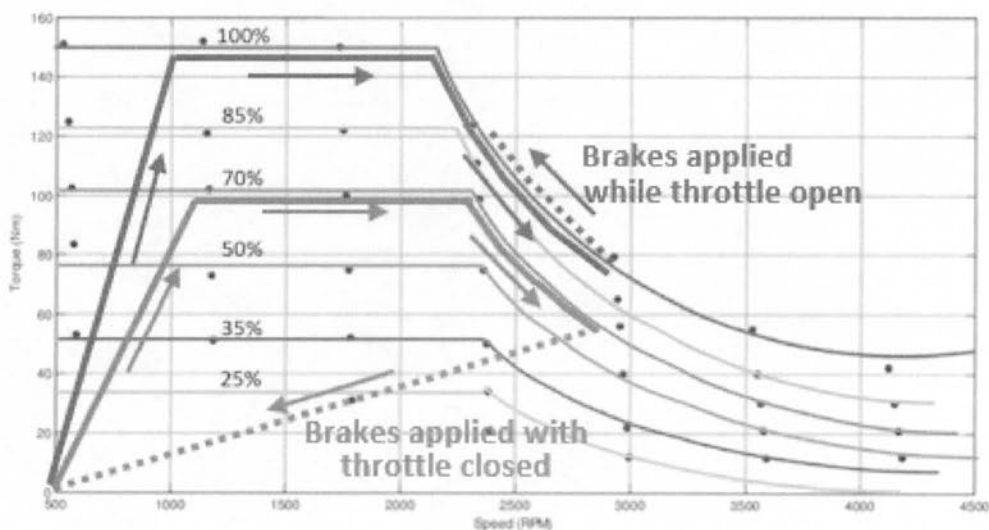
Figure 2. Motor torque versus motor speed for the drive motor of an electric vehicle. During normal operation the drive motor follows the green curve, causing the motor torque to decrease as the motor RPM's decrease while braking with the accelerator pedal released and no current applied to the motor. During sudden acceleration the motor follows the red curve, causing the motor torque to increase as the motor RPM's decrease while braking as current continues to be applied to the motor.<sup>[Endnote 1]</sup> The increased motor torque counters the braking torque, giving the driver the impression that the brakes are failing.

In vehicles powered by electric drive motors, the motor torque varies with motor RPM as shown in Figure 2. The torque in the base region varies with the battery current as controlled by the driver pressing on the accelerator pedal, and remains constant as the motor RPM's increase up to the base speed of around 2000 RPM. At motor RPM's higher than the base speed the drive motor torque decreases with increasing motor RPM's.

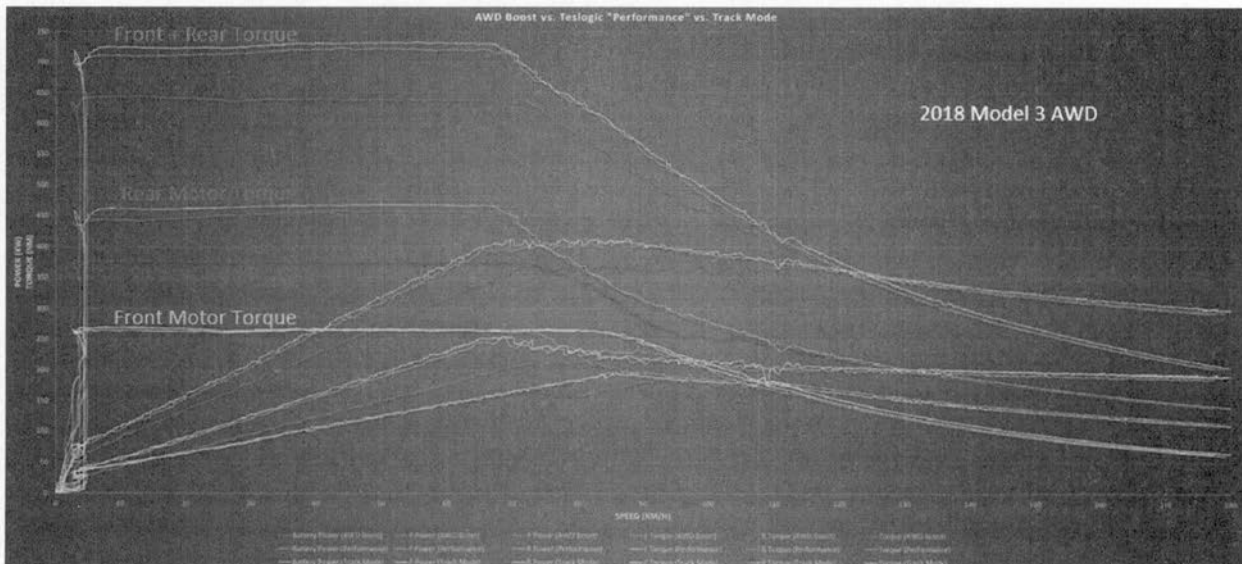
Figure 3. Motor torque versus vehicle speed for the two drive motors of a 2018 Model 3 Tesla with AWD. Only the maximum torques (100% throttle) are shown. Lower torques are obtained by using lower accelerator pedal settings that apply proportionally lower currents to the motors.

In some electric vehicles the drive wheels are directly connected to the drive motor without a geared transmission. In these vehicles, the vehicle speed is directly proportional the motor RPM as shown in Figure 3. This difference in drive train design causes the following differences between ICE vehicles and electric vehicles during sudden acceleration:

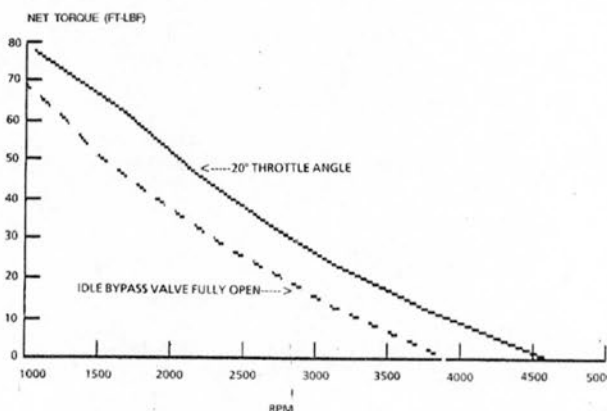
FIGURE B-4. NET ENGINE TORQUE (WARM)

Note that the engine torque in this figure decreases with increasing RPM's, implying that the engine is operating in the red region of Figure 1 when the idle stabilizer valve is fully open. This figure would be more recognizable if it did not omit the 0 to 1000 RPM region in which the engine torque increases with increasing RPM's, which includes the green region of Figure 1. It should also be noted that a turbocharger causes the peak RPM value to decrease compared to the peak RPM value of a non-turbocharged Audi 5000 engine.
