<b>GROUP</b> <b>Safety Recall Campaign</b>	<b>MODEL</b> <b>2015-2016MY Soul EV (PS EV)</b>
	<b>NUMBER</b> <b>SC191</b>	<b>DATE</b> <b>August 2020</b>
<b>SAFETY RECALL CAMPAIGN</b>		
<b>SUBJECT: ELECTRONIC PARKING BRAKE (EPB) LOGIC IMPROVEMENT (SC191)</b>

This bulletin provides the procedure to improve the logic of the Electronic Parking Brake (EPB) system on 2015-2016MY Soul EV (PS EV) vehicles, produced from July 15, 2014 through June 24, 2016. If the driver moves the gear shift lever into “P” (Park) prior to coming to a complete stop, the vehicle’s parking mechanism can be damaged. If the parking mechanism is damaged, even though the gear shift lever is in the “P” (Park) position, unintended vehicle movement may occur when the parking brake is not used. With the updated software logic, the EPB will automatically activate if the POWER button is turned OFF and the gear shift lever is in ‘P’ (Park) position.

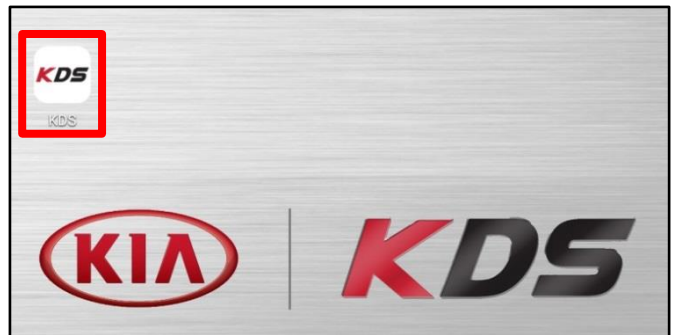
2. With the ignition ON, turn ON the KDS tablet. Select **KDS** from the home screen.
