# Safety Recall

## Code: 20Y6

<b>Subject</b>	<b>Suction Pump</b>
<b>Release Date</b>	December 21, 2016
<b>Revision Summary</b>	<b>Certain work instruction steps have been modified to help technicians avoid consequential damage during this repair.</b>
<b>Affected Vehicles</b>	<b>U.S.A. &amp; CANADA: 2015-2016 MY Volkswagen Golf, GTI &amp; Golf SportWagen</b> <i>Check Campaigns/Actions screen in Elsa on the day of repair to verify that a VIN qualifies for repair under this action. Elsa is the <u>only</u> valid campaign inquiry &amp; verification source.</i> <ul style="list-style-type: none"><li>✓ Campaign status must show "open."</li><li>✓ If Elsa shows other open action(s), inform your customer so that the work can also be completed at the same time the vehicle is in the workshop for this campaign.</li></ul>
<b>Problem Description</b>	The suction pump inside the fuel tank designed to purge fuel from the evaporative emissions (EVAP) system may have been damaged during assembly. This could cause fuel to flow directly into the EVAP system which could, over time, accumulate and cause a leak through the charcoal canister filter element. Leaking fuel, in the presence of an ignition sour

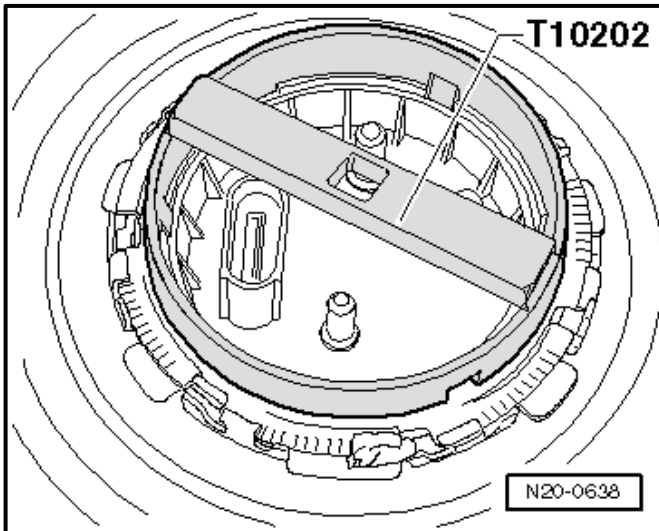
- Wrench - Fuel Sending Unit -T10202-

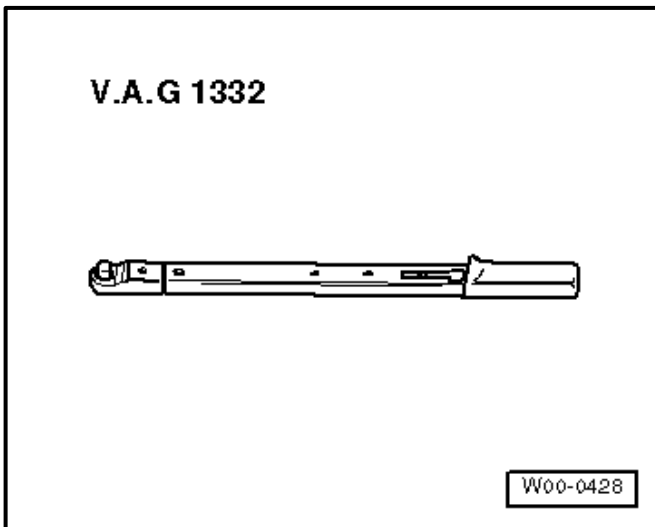
- Torque Wrench 1332 40-200Nm -VAG1332- (or equivalent)

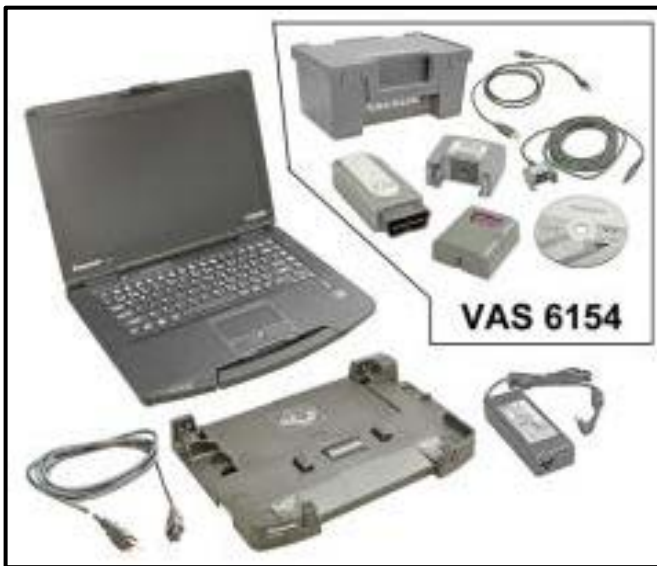
- VAS6150D - Diagnostic Tester (or equivalent)
- VAS6154 - Vehicle Communication Interface (or equivalent)

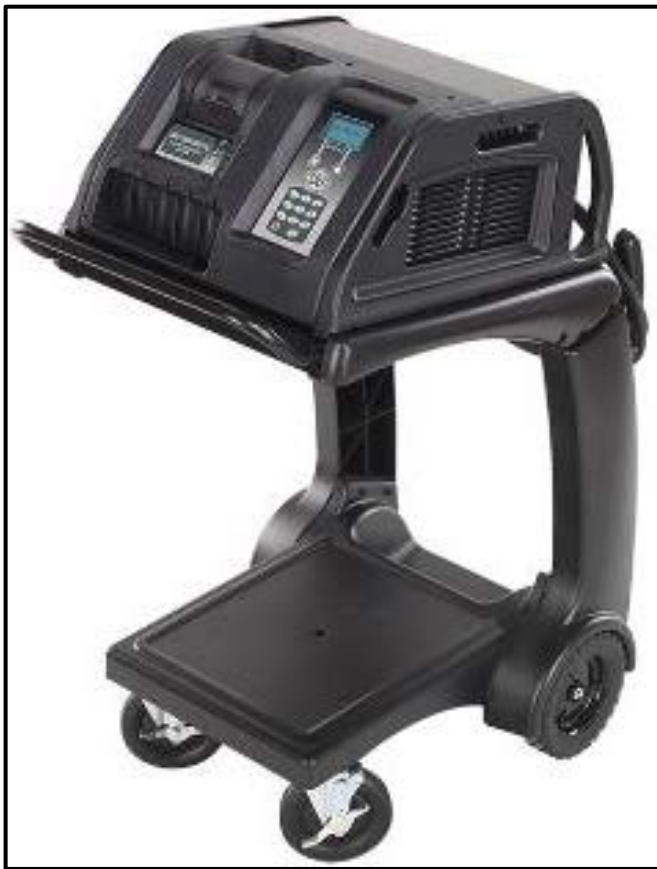
- GRX3000VAS – Battery Tester/Charger (or equivalent)

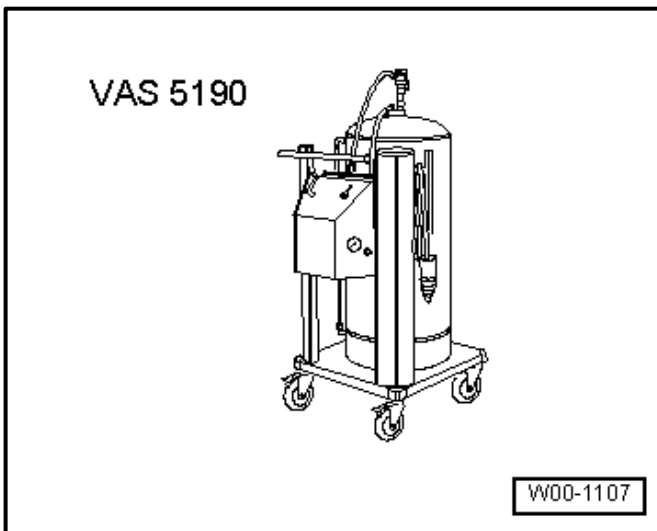
- Fuel Extractor VAS5190A -VAS5190-

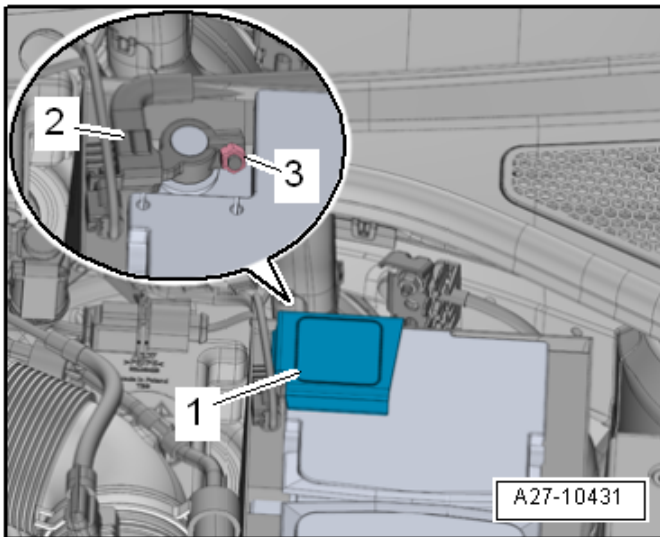
- Open the vehicle hood.
- Open the battery heat protection sleeve cover to access the cover <1> on the battery ground terminal <2>.
- Loosen the nut <3> several turns and remove the battery ground terminal <2> from the negative battery post and isolate the terminal.

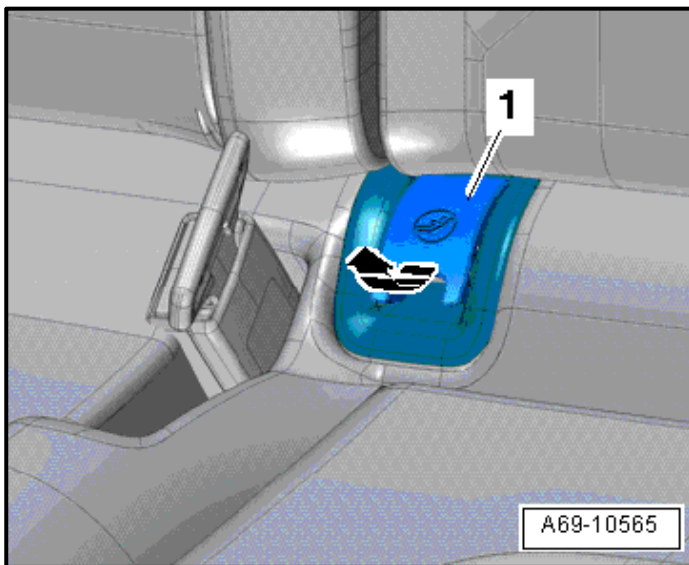
- Unclip and remove the covers <1> from the LATCH child seat anchors <arrow>.

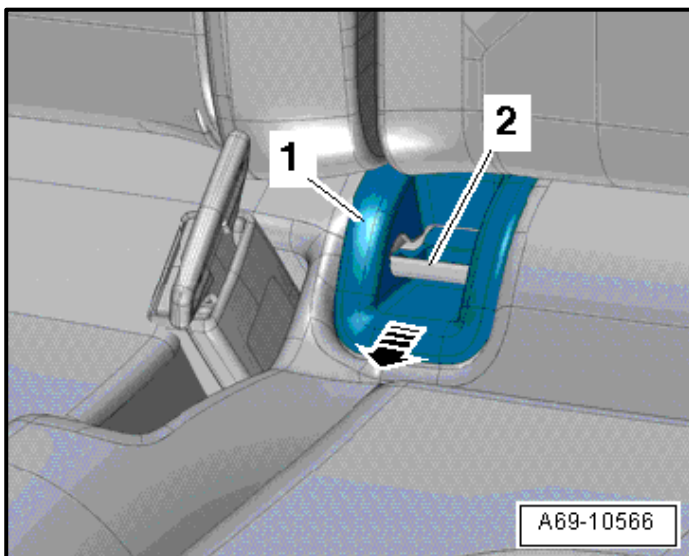
- Push the guides <1>, corresponding to cut-out, downward and disengage them from the LATCH child seat anchors <2>.

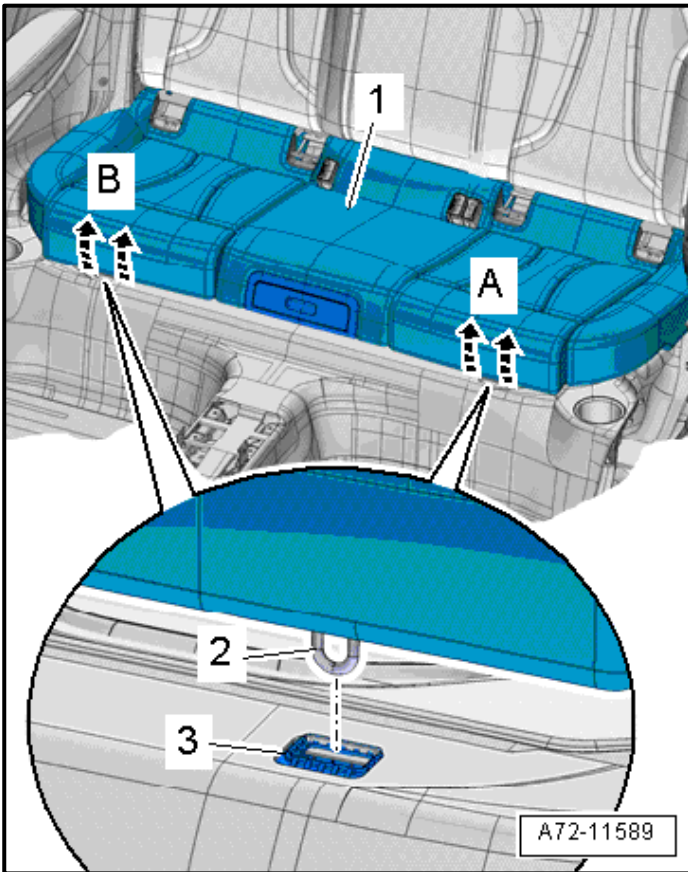
- With both hands, grasp the rear bench seat under the seat frame.
- Pull the rear bench seat <1> up forcefully with both hands <arrows A> so the wire hooks <2> on the rear bench seat release from the mounting grommet <3>.
- Repeat the procedure on the other side of the rear bench seat <arrows B>.

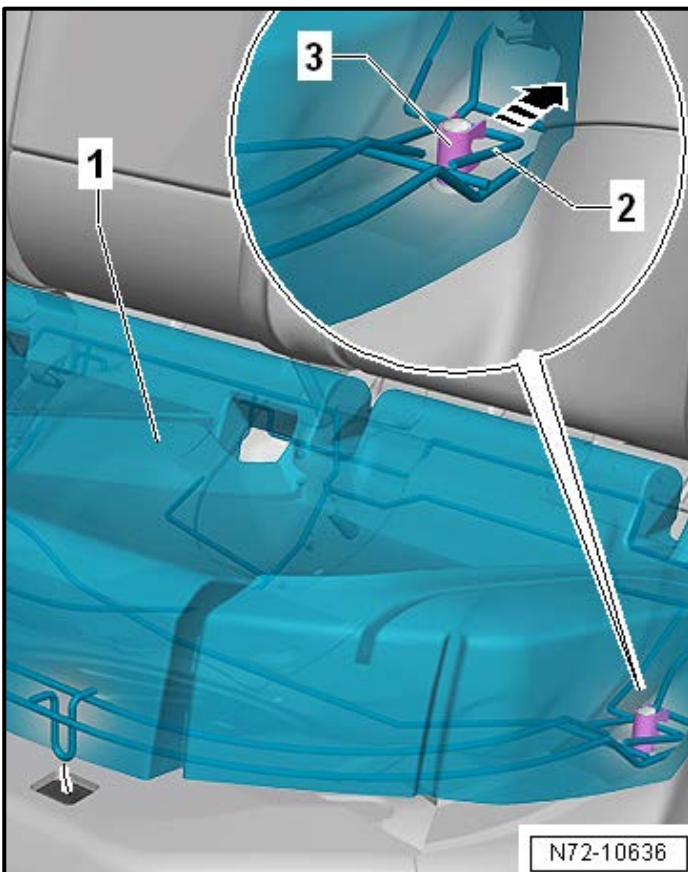
- Gently lift the rear bench seat <1> at front and slide the wire frame <2> out of the hook <3> toward the rear.
- Remove the rear bench seat from the vehicle.

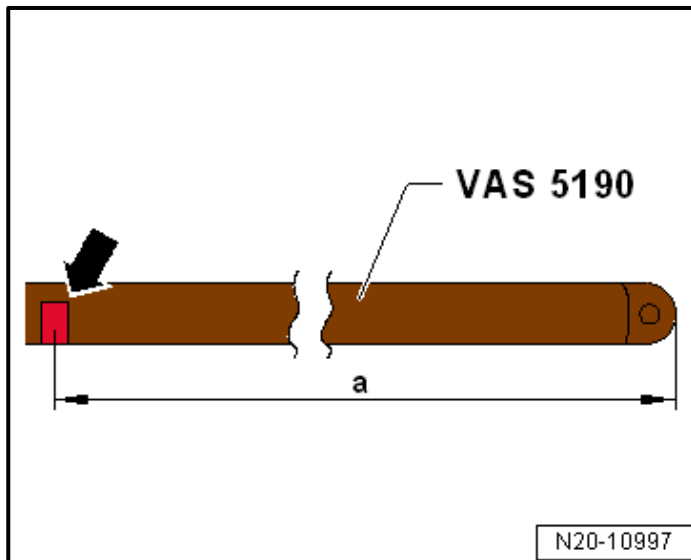
- Use insulating tape to mark the hose <arrow> at the distance <a> from the end of the suction hose on the -VAS5190-.

Rear Axle	Distance of <a>
Multi-link	945 mm
Torsion Beam Rear Suspension	1010 mm

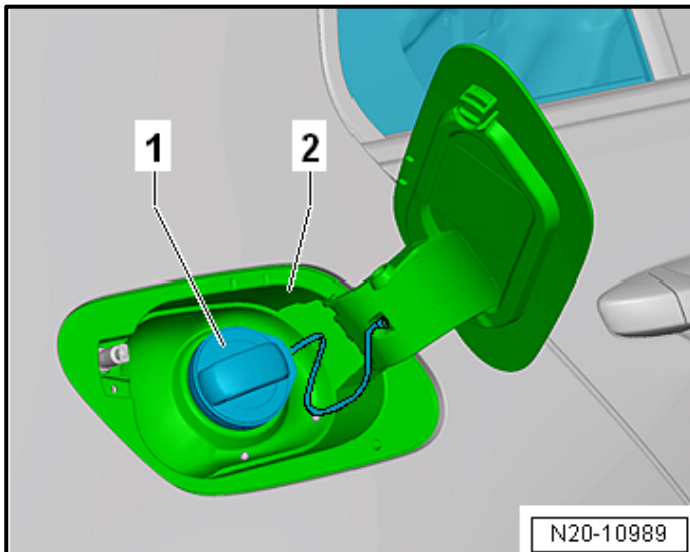
- Open the fuel filler door unit.
- Clean the area around the fuel filler neck <2>.
- Remove the cap <1> for the fuel filler neck.
- Attach the ground wire from the -VAS5190A- to a bare area on the body.

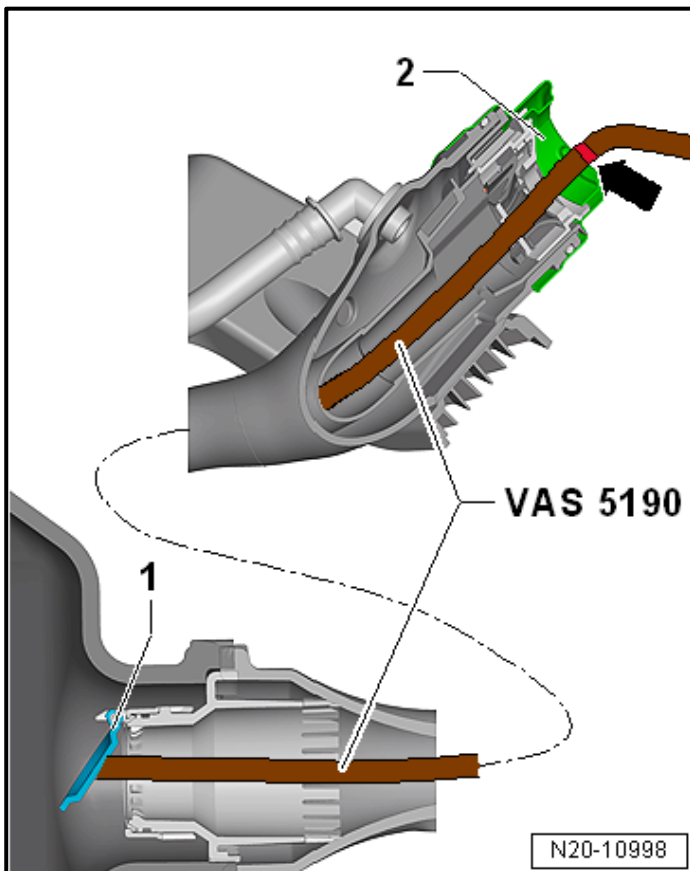
- Slide the suction hose from the -VAS5190A- into the fuel tank until the previously made mark -arrow- meets the filler neck <2>.
- Drain the fuel tank as much as possible through the filler neck.

- A valve <1> is located in the fuel tank on the lower end of the filler neck. It must not be damaged by the suction hose. Only slide the hose in as far as the mark that was made earlier <arrow>.
- When no more fuel can be extracted, the fuel tank has been emptied enough so that the sensor flange can be opened safely.

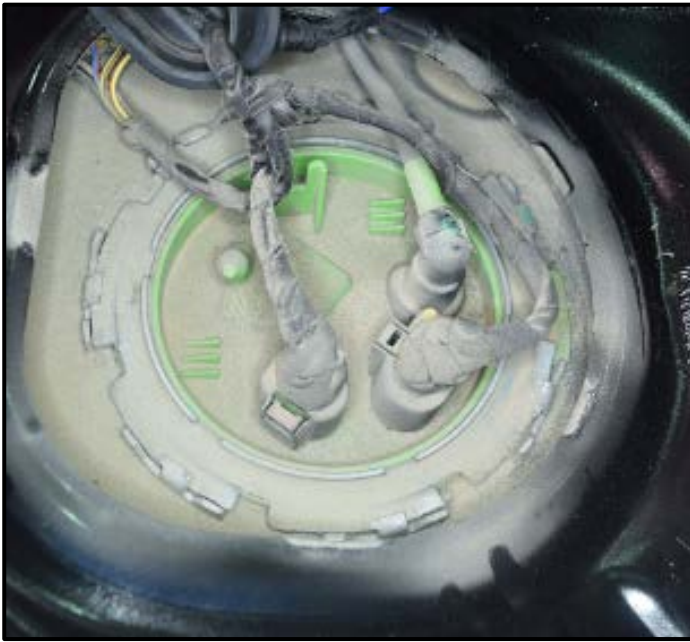
- Prior to disassembly, the fuel delivery unit **MUST** be clean. If excessive dirt or debris is present <as shown>, clean and dry the fuel delivery unit and surrounding areas as necessary.

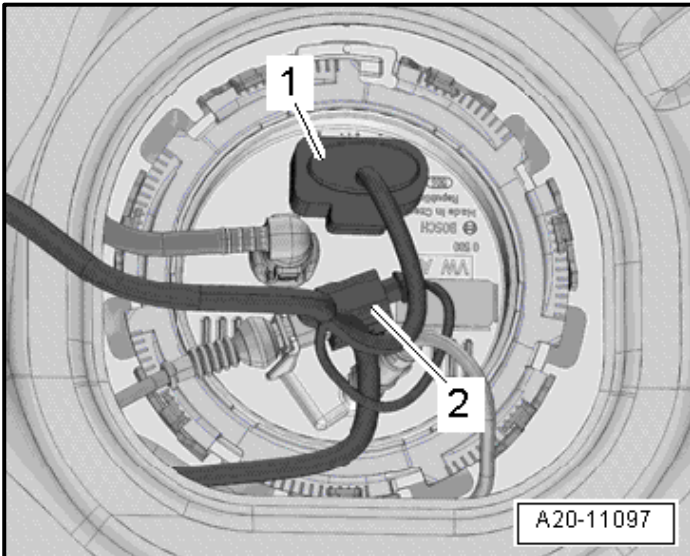
- Unlock and disconnect the connector <1> from the sealing flange.
- If equipped, disengage the connector <2> for the parking heater Metering Pump -V54- on the sealing flange and move it to the side.

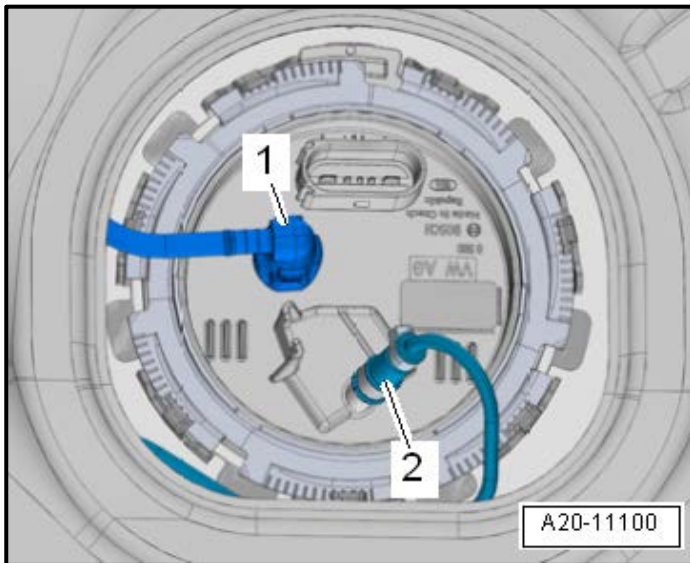
- Remove the fuel line connector <1> from the locking flange by pushing down on the connector, squeezing the release tab between the finger and thumb, then lifting up.
- If equipped, remove the fuel line <2> to the Metering Pump -V54- for the parking heater on the sealing flange by loosening the lower hose clamp.

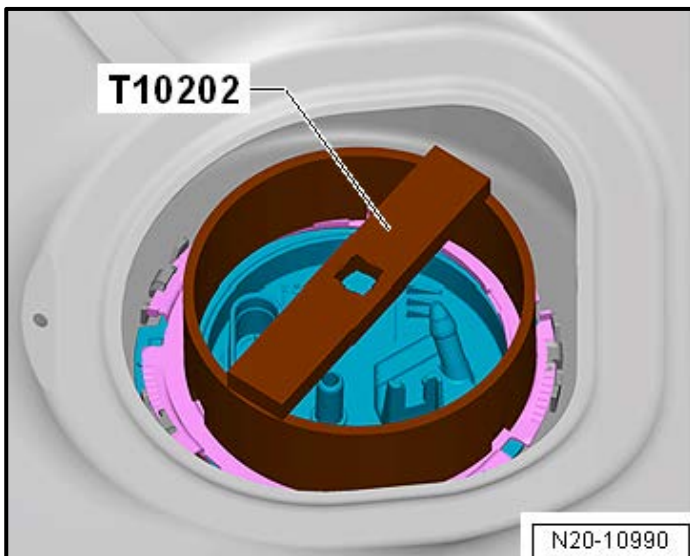
- Remove the locking ring using the Wrench - Fuel Sending Unit -T10202-.
- Carefully lift the fuel delivery unit flange.

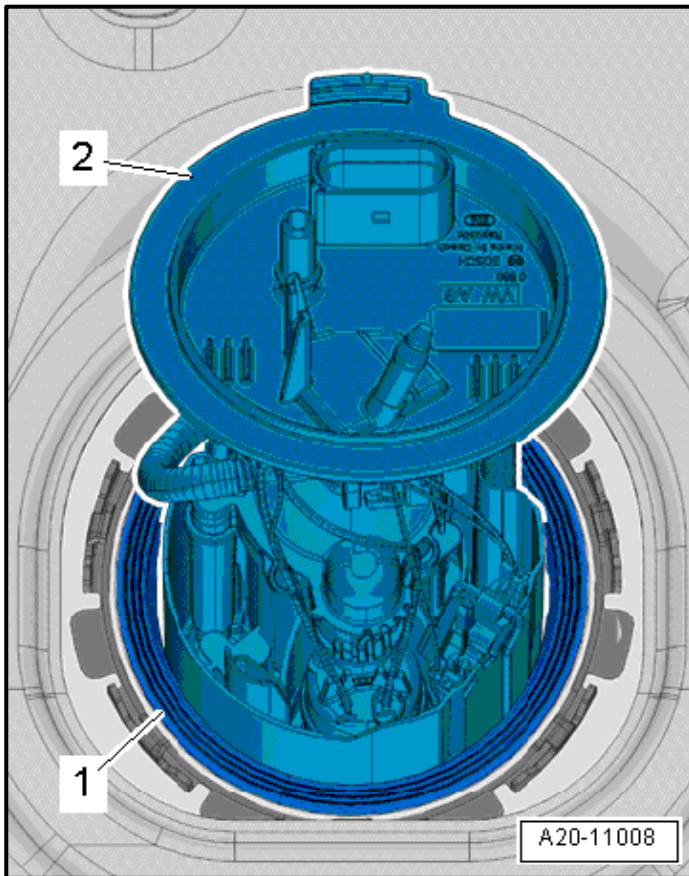
- Pull the sealing flange <2> out of the opening in the fuel tank slightly.
- Remove the seal <1> and slightly lift the fuel delivery unit flange again carefully.

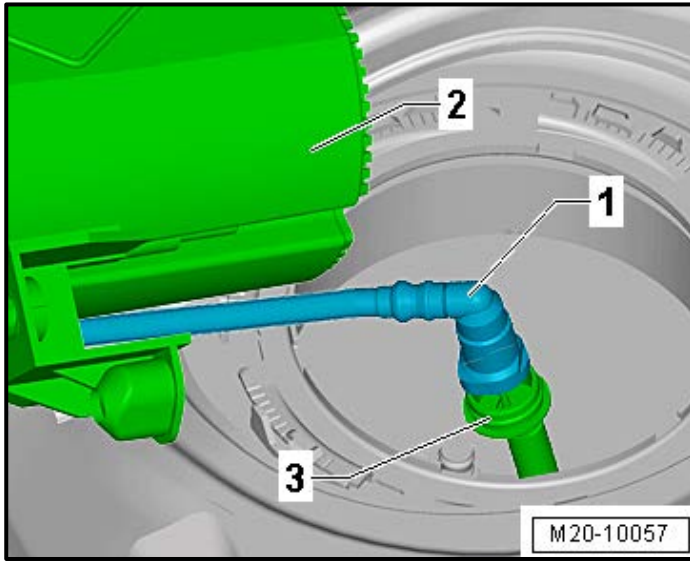
- Place a cloth underneath to catch the residual fuel, since the fuel delivery unit may still be partially filled.
- Carefully pull the fuel delivery unit <2> out of the fuel tank, release the fuel line <1> and disconnect it from the front suction line <3>.
- Lay a cloth inside the vehicle to absorb any residual fuel.

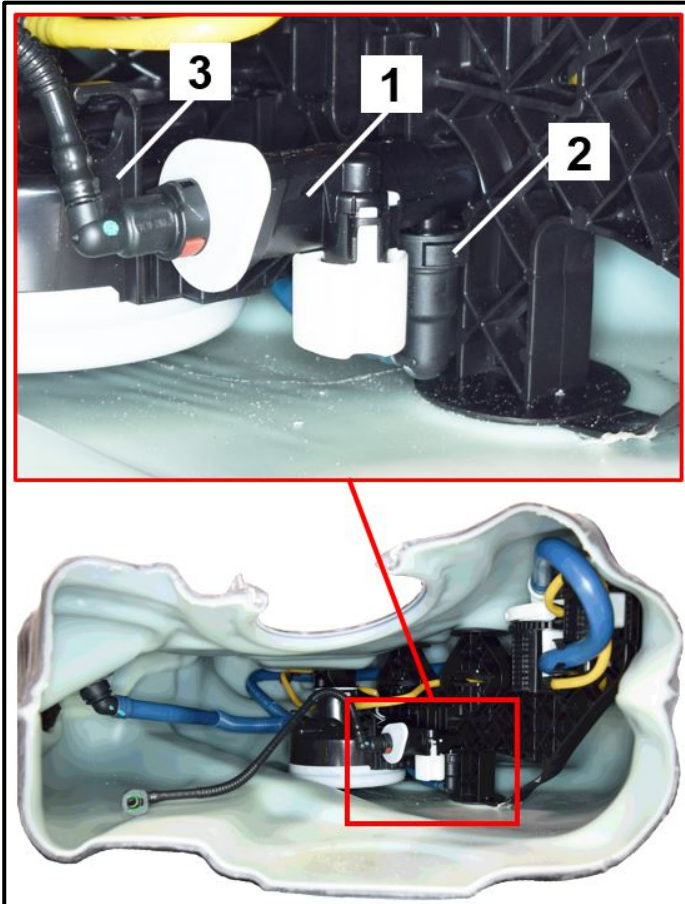
- The fuel tank in the illustration below has been sectioned to provide a clear view of the suction valve.
- Under no circumstances should the fuel tank be altered or modified as shown below.

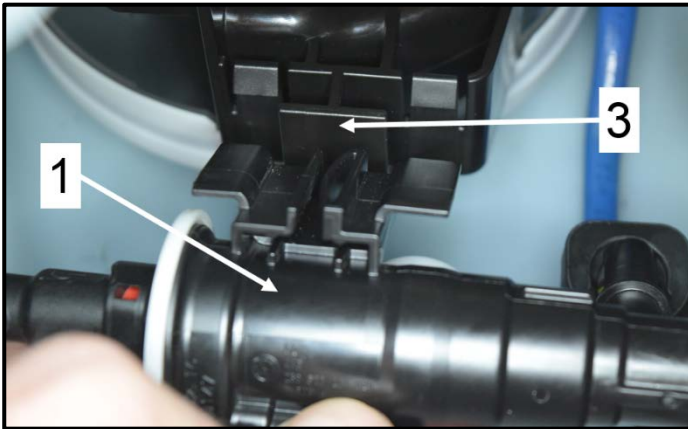
- Remove the suction pump <1> off the retainer bracket <3>:
  - Slightly rotate suction pump <1> away from the bracket <3>
  - Remove the pump <1> from the fuel tank by gently rocking it back and forth between the fingers and thumb.
  - Use caution not to damage the attached front suction line.

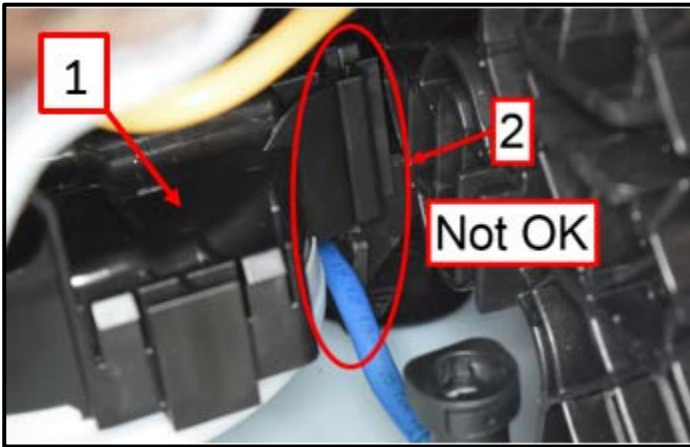
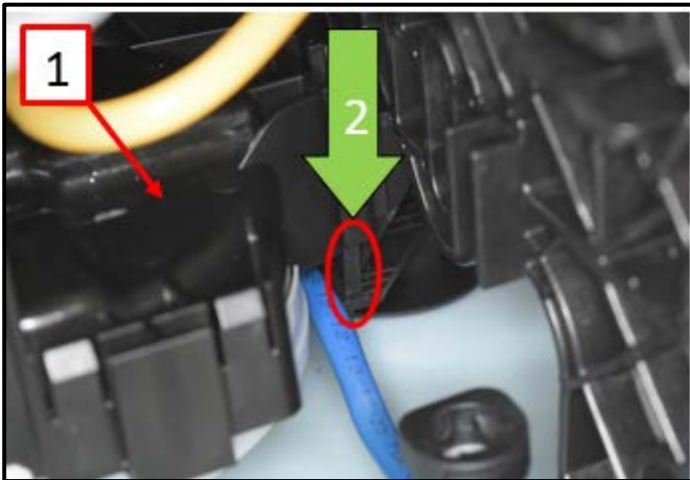
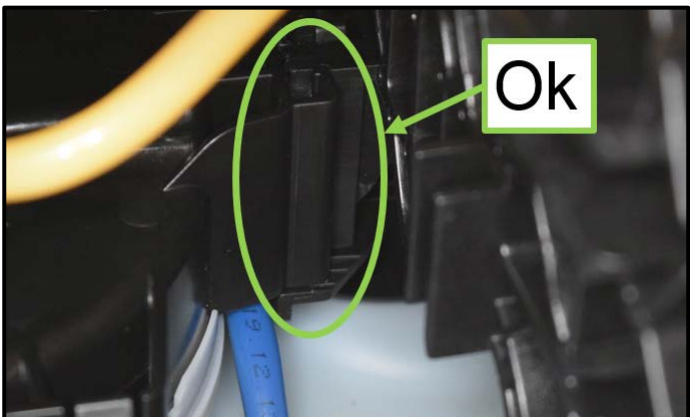
- Take care that the Liquid-Vapor Separator Assembly <1> does not come off of its attachment bracket when removing the Suction Jet Pump.

- If the Liquid-Vapor Separator <1> comes loose and is not reinstalled onto the mounting bracket, a customer comeback for rattling in the fuel tank, or EVAP system faults may occur.
- The Liquid-Vapor Separator <1> can be reinstalled onto its mounting bracket <2>.
- Replacement of the fuel tank for the Liquid-Vapor Separator dislodging from the mounting bracket are not covered under this campaign.

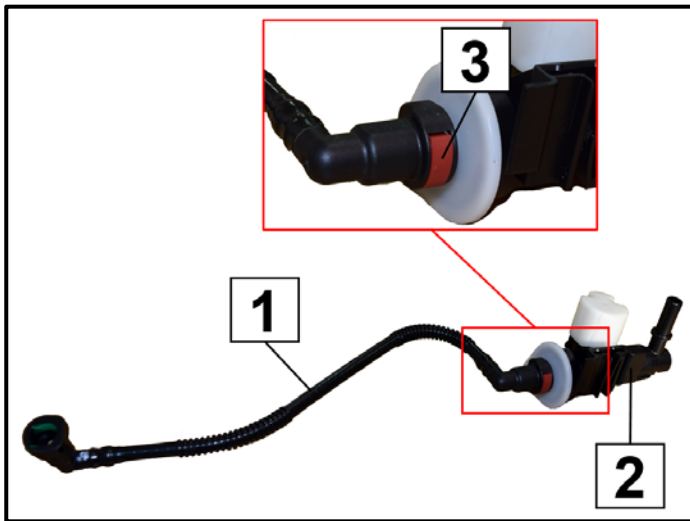
- Disconnect the front suction line <1> from the suction pump:
  - Push the front suction line <1> further onto the suction pump <2>.
  - Press the release <3> with the thumb, then pull the front suction line <3> off of the suction pump <2>.
- Transfer the front suction line <1> from the old suction pump <2> to the new suction pump, ensuring that the locking of the retention clip <3> is felt and/or heard.

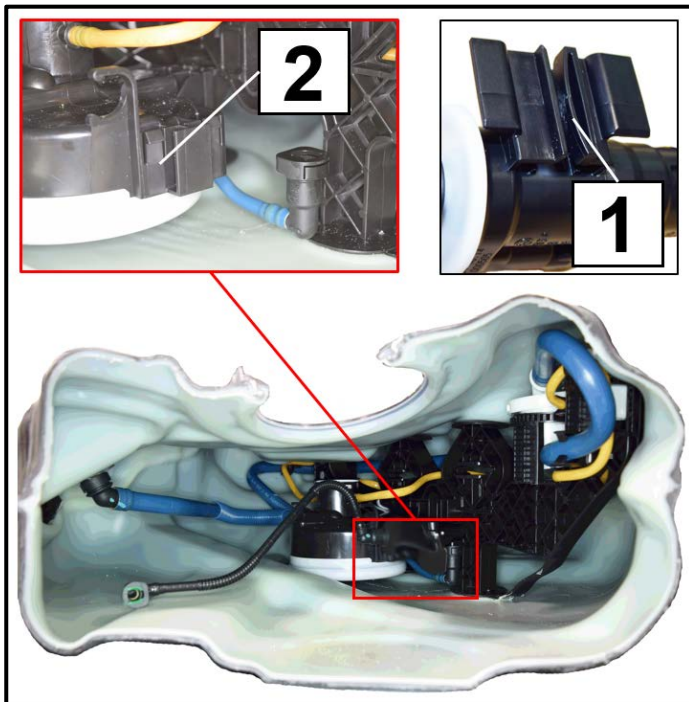
- Insert the new suction pump <1> into the fuel tank.
- Align the retention clip on the new suction pump <1> to the bracket <2> on the liquid-vapor separator.
- Slide the new suction pump <1> downward onto the bracket <2>.
- Ensure that the pump is secured firmly on the bracket <2>.

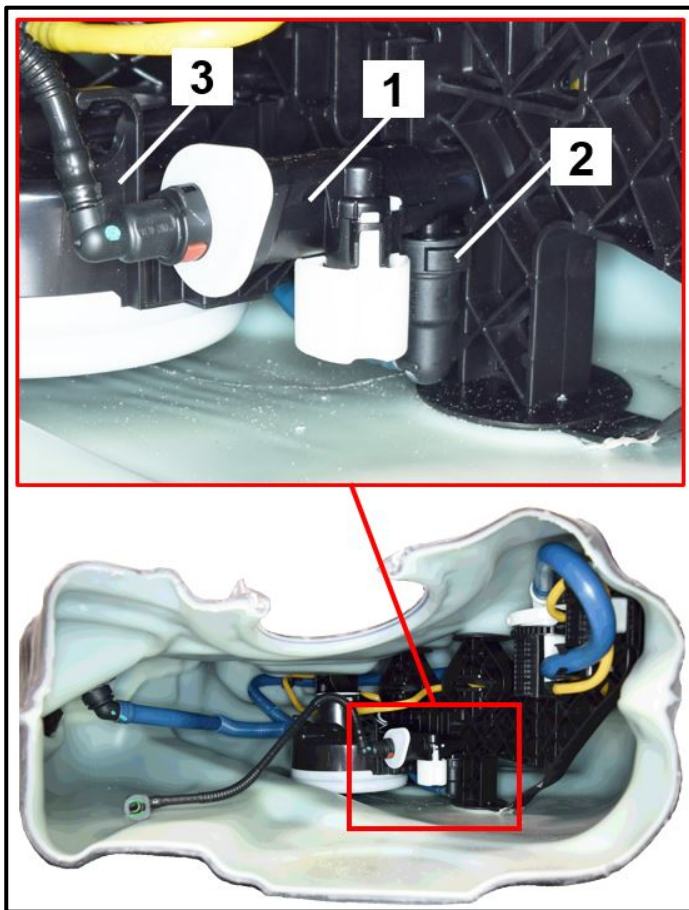
- Reconnect the rear suction line <2> to the suction pump <1>, ensuring that the locking of the retention clip is felt and/or heard.
- Ensure that the front suction line <3> and rear suction line <2> are firmly seated and secure by gently pulling the lines away from the suction pump.

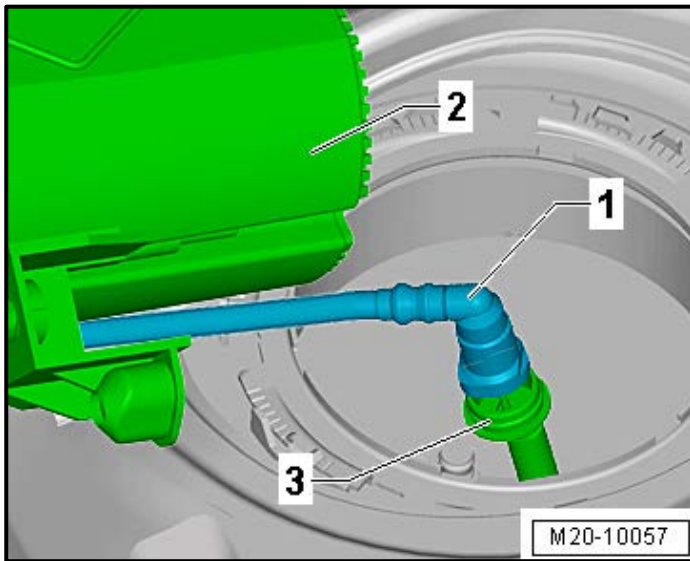
- Carefully align the fuel delivery unit <2> to the fuel tank and reconnect the fuel line <1> to the front suction line <3>.

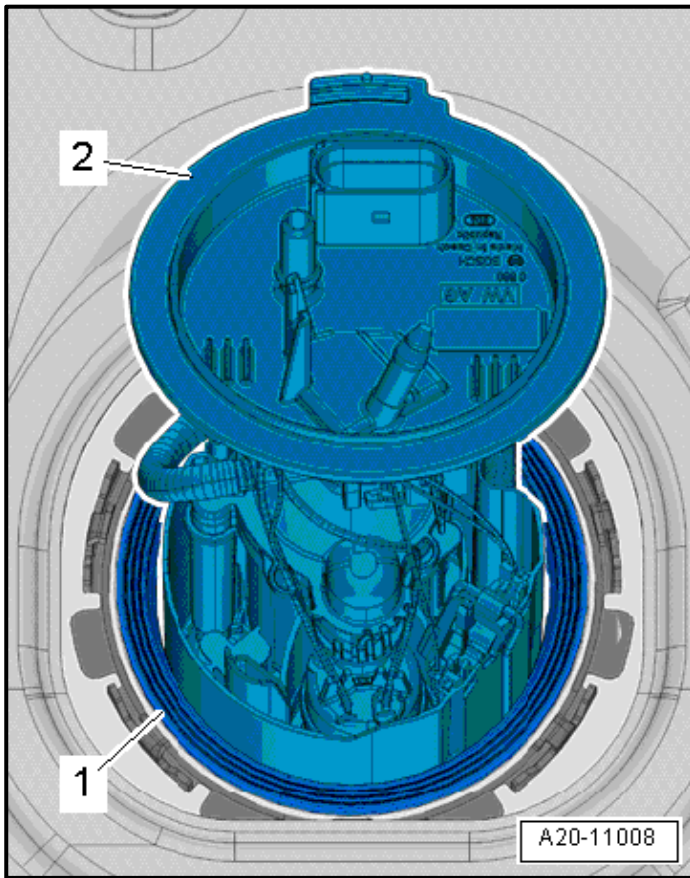
- Be careful not to bend the fuel level sensor when installing the fuel delivery unit.
- Consequential damage to the fuel level sensor is not covered under this campaign.
- Carefully install the dry fuel delivery unit seal <1> into the opening in the fuel tank.

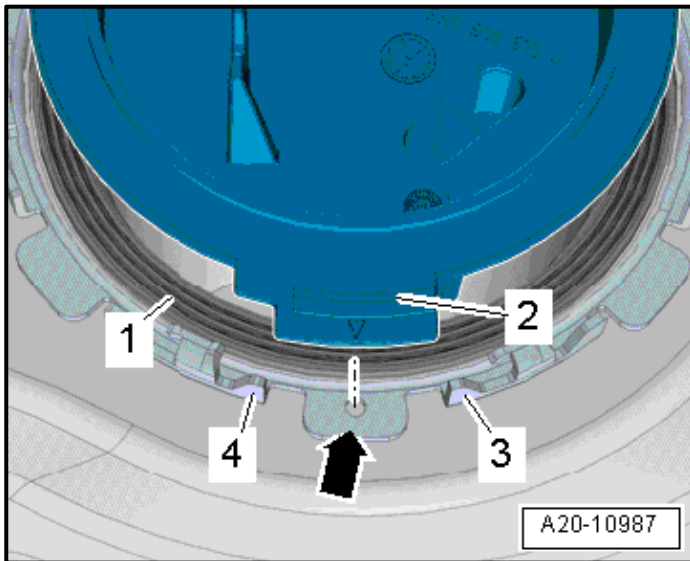
When inserting the sealing flange, the seal must not be damaged or crushed.

- Push the sealing flange <2> down against the spring force.
- Bring the sealing flange into its installation position.

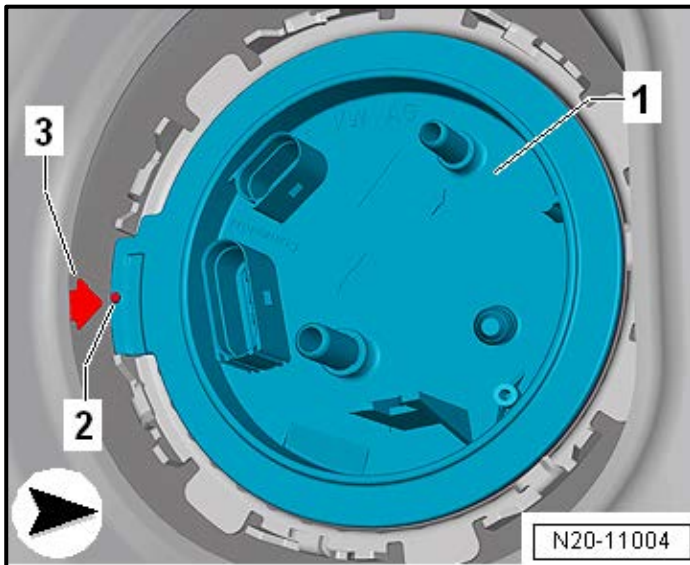
- The arrow <3> on the fuel tank must point to the mark <2> on the sealing flange <1>.

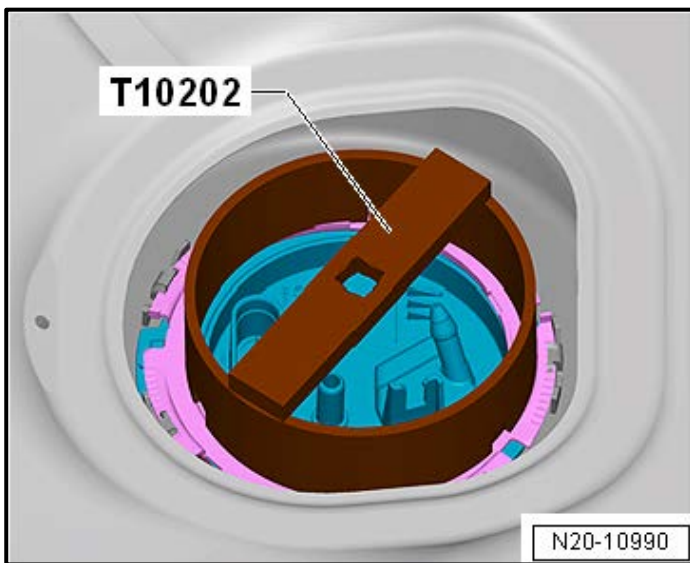
- Using the -T10202-, tighten the locking ring to 110 Nm.

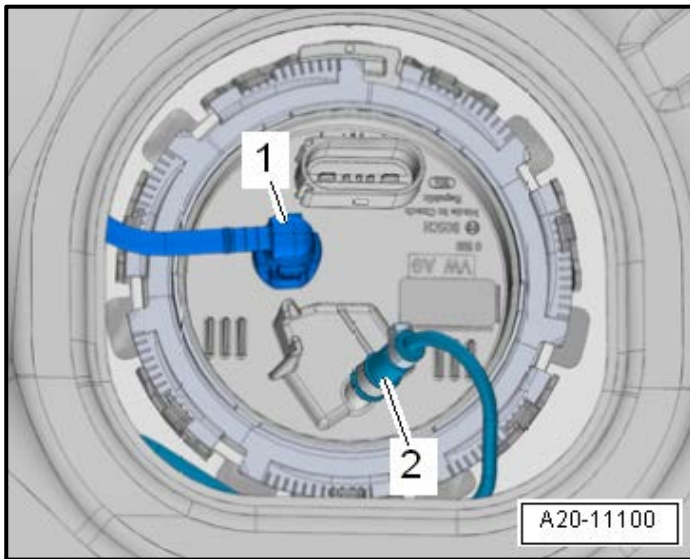
- Attach the fuel line <1> to the sealing flange until it clicks into place.
- If equipped, install the fuel line <2> to the Metering Pump -V54- for the parking heater on the sealing flange.

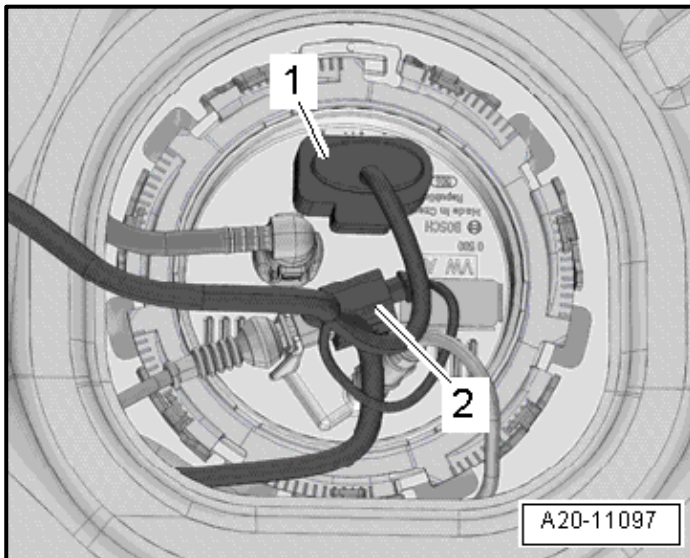
- Connect the connector <1>.
- If equipped, engage the connector <2> for the parking heater Metering Pump -V54- on the sealing flange.
- Gently pull on the connectors to make sure they are secure.

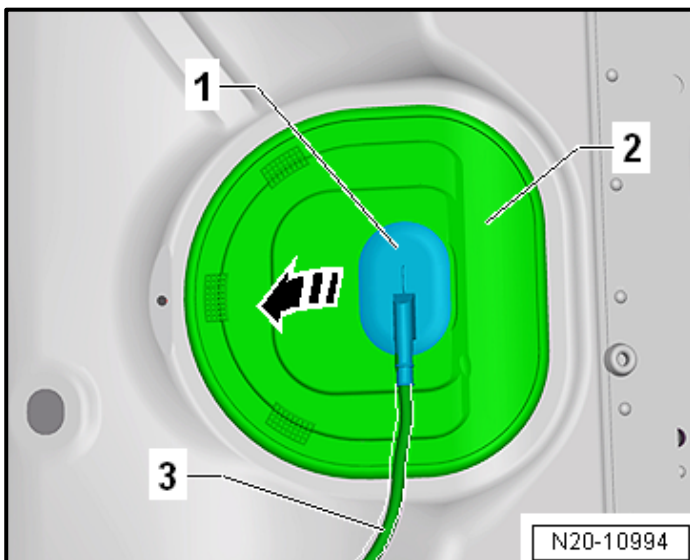
- Reattach the grommet <1> into the cover <2>.

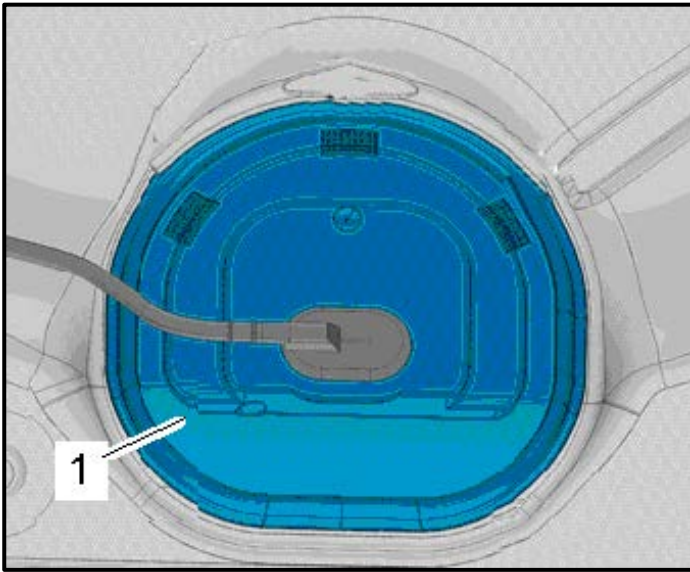
- Reattach the sealing flange cover <1>.

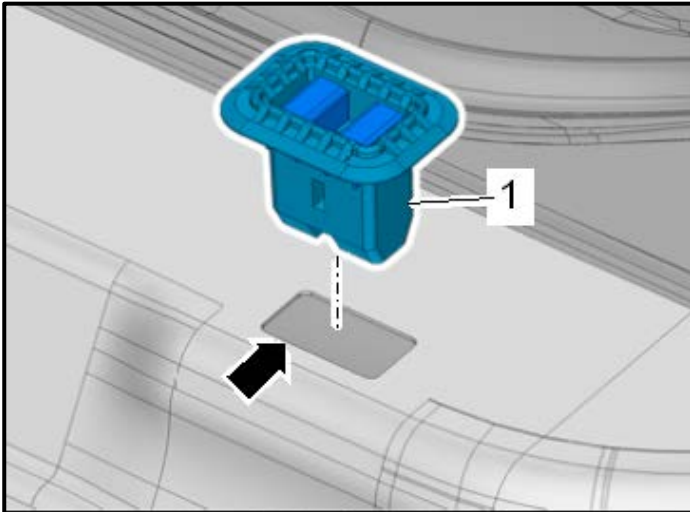
- Prior to reinstalling the rear seat, remove the grommets <1> and check the body openings <arrow> for deformations.
  - If deformation is found, readjust the panel with a plastic hammer.
- Lift the carpet <2> and press in the mounting grommets <1> until they engage audibly in body opening <arrow>.
- Ensure the carpet does not cover the grommet.

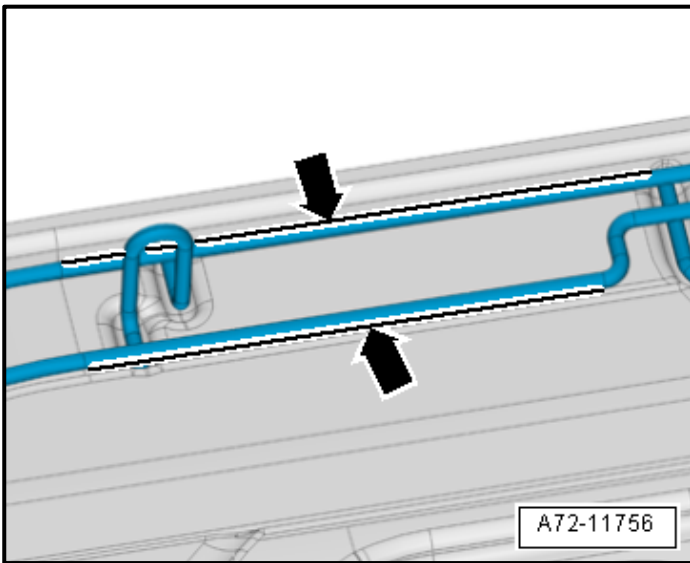
- Check if the wire frame is aligned in the marked area <arrows> before installing the rear bench seat.
- If the wire frame is bent, bend it back far enough until it is realigned.

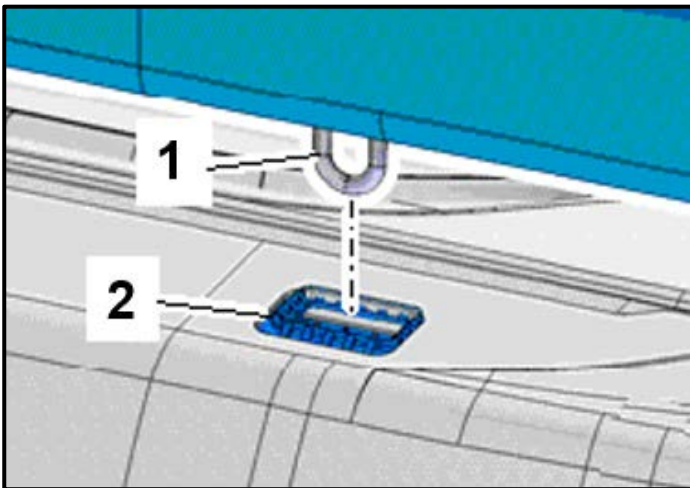
- Install the rear bench seat and push the wire hooks <1> into the mounting grommets <2>.

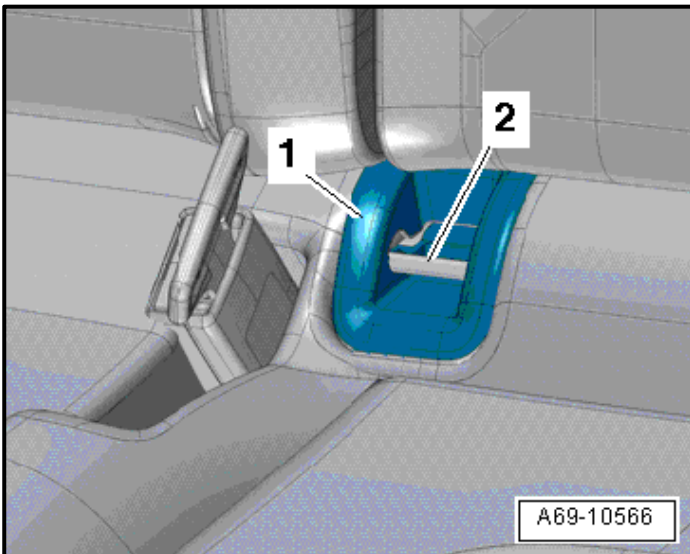
- Reinstall the guides <1> to the LATCH child seat anchors <2>.

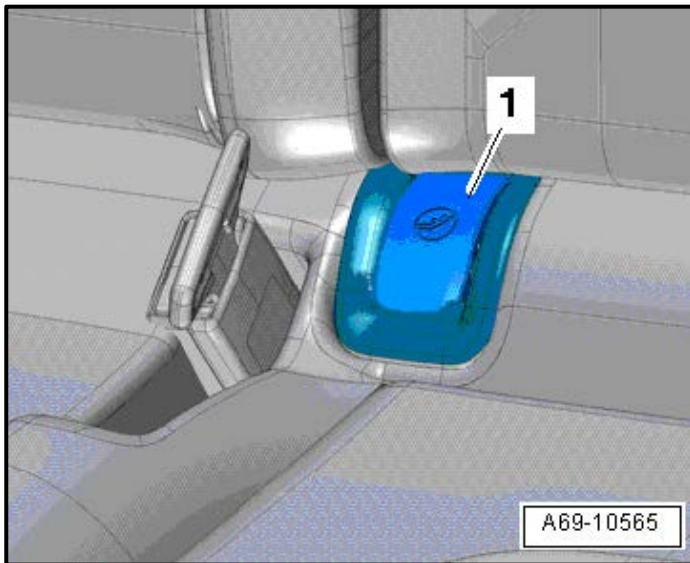
- Reinstall the covers <1> to the LATCH child seat anchors.

**CAUTION**  
Edges on the child seat anchor cover may be sharp.

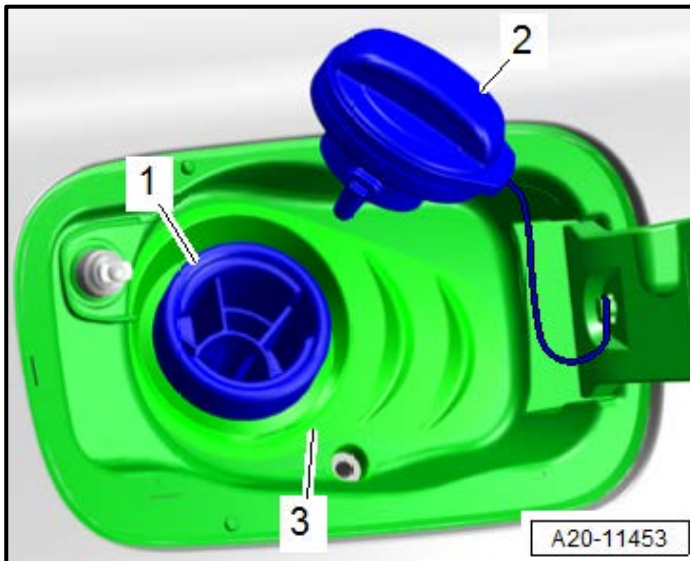
- Open the fuel door and remove the fuel cap <2>.
- Refill the fuel tank with the same amount of fuel removed prior with the -VAS 5190- Fuel Extraction Unit.
- Verify using the sightglass on the side of the -VAS 5190- Fuel Extraction Unit that the fuel tank was filled with the same amount of fuel that was extracted before reconnecting the battery.

**NOTE**  
**Risk for repeat repair!**  
Failing to fill the fuel tank with the same amount of fuel that was extracted can result in fuel level sending unit faults, or fuel gauge inaccuracies. Additional diagnostic time required to perform a capacitive discharge or remove fused power to the instrument cluster to clear these faults or inaccuracies are NOT covered under this campaign.

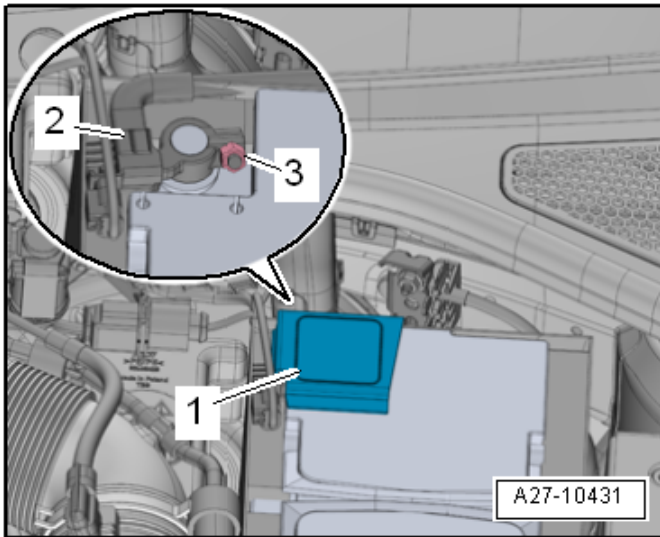
- Deisolate and then reconnect the negative battery terminal <2> to the battery post.
- Tighten the nut <3> to 6 Nm.

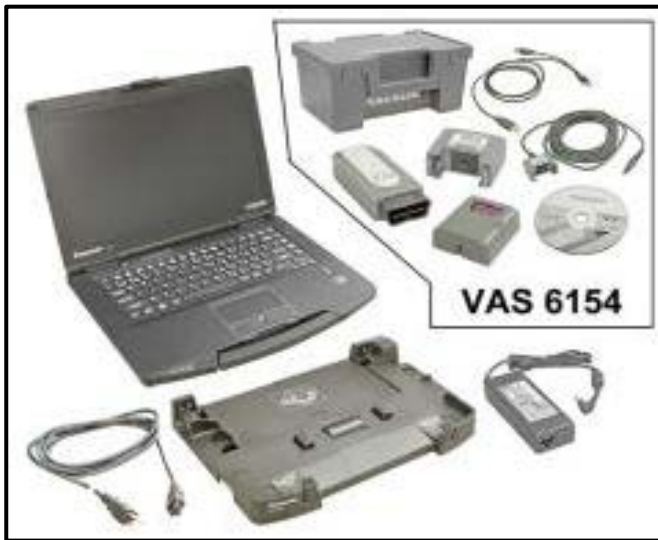
- Switch the ignition ON.
- Attach an appropriate VAS tester to the vehicle.
- Clear all DTCs.
- Cycle the ignition multiple times and check for fuel leaks.
- Reset customer convenience basic settings (i.e. one touch windows, instrument cluster clock, etc.).
