May 2, 2018

09021 Version 3

## MID Displays ACC, CMBS, LKAS, RDM, Brake Warnings and Other Listed Symptoms

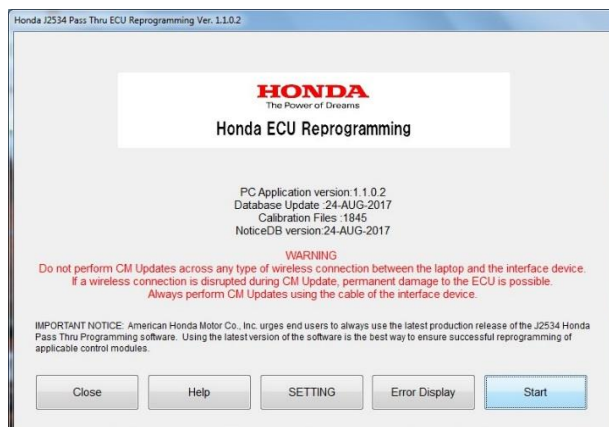
5. Confirm the software is the same or later as listed in SOFTWARE INFORMATION.
