**SUBJECT: NEW VEHICLE RECOMMENDED DELIVERY HOLD**

**Customer Satisfaction Program 22P08 – Supplement #2**

Certain 2022 Model Year Expedition/Navigator, 2021-2022 Model Year F-150 and Mach-E Vehicles Equipped with Ford/Lincoln Co-Pilot and BlueCruise/ActiveGlide BlueCruise/ActiveGlide Maps Expiration

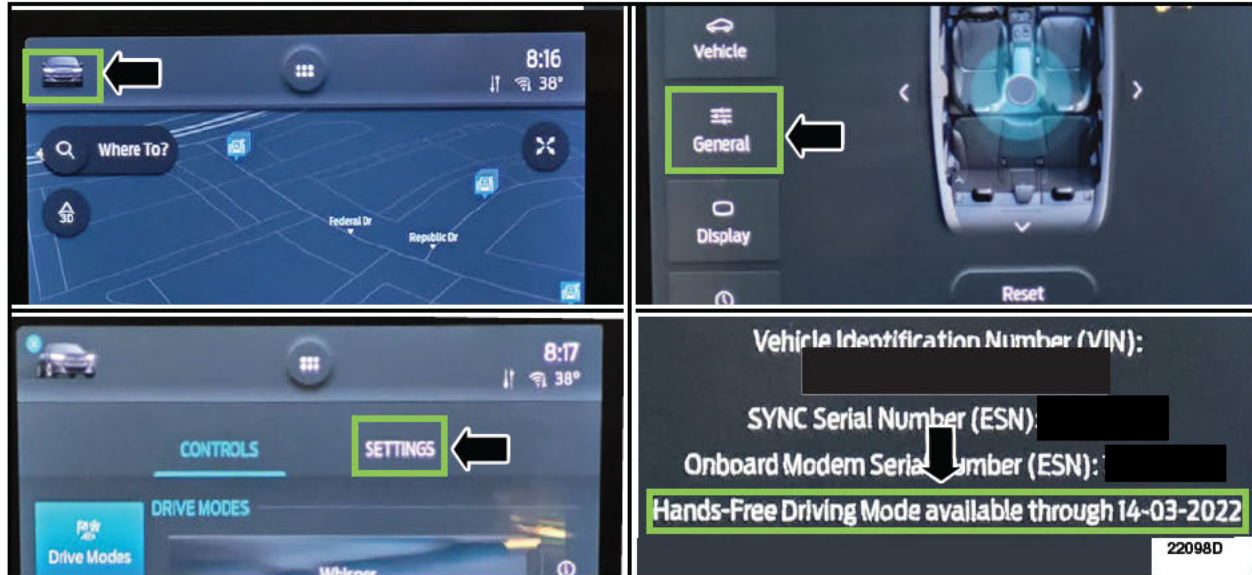
FIGURE 1

- On the center display screen, navigate to Settings > About SYNC > Hands-Free Driving Mode available through DD-MM-YYYY. Record the expiration date. See Figure 1.

**NEW ! NOTE:** Mach-E shown Expedition, Navigator and F-150 vehicles similar.

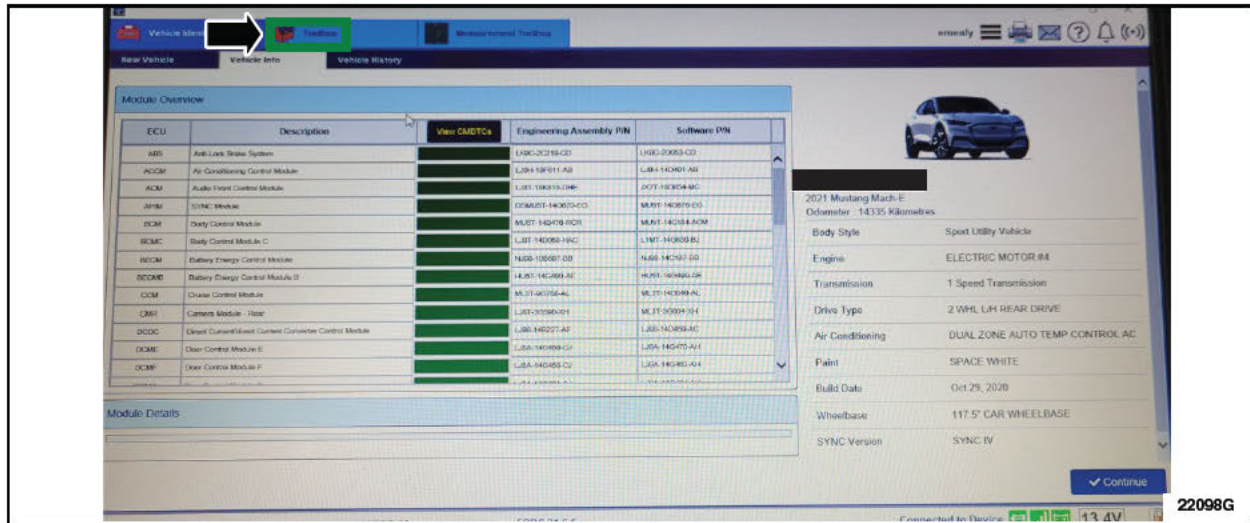
FIGURE 2

6. Select Toolbox tab. See Figure 2.

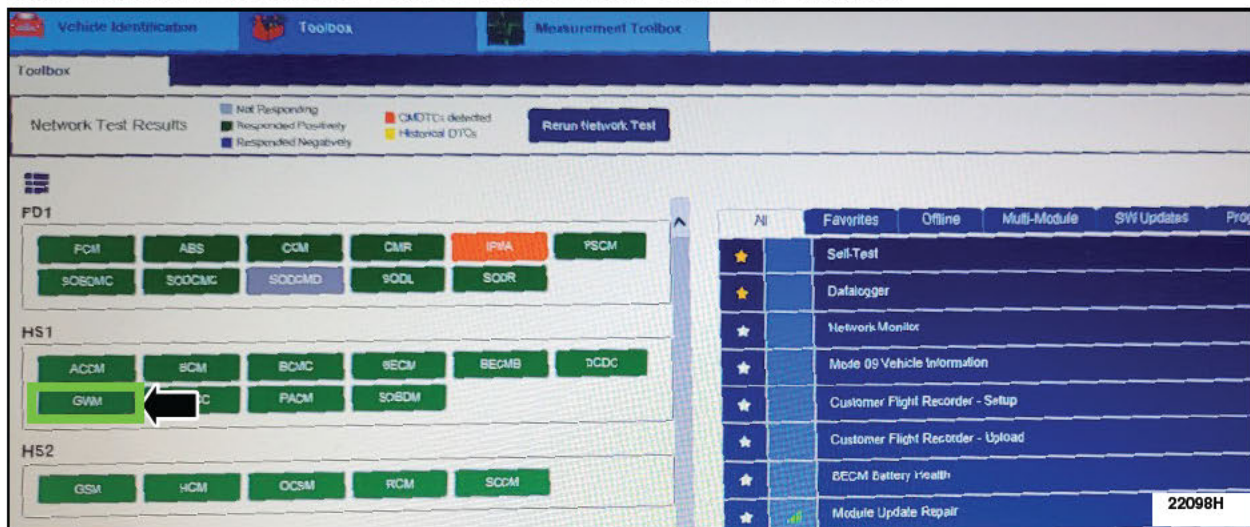
FIGURE 3

7. From the list on the LH side of the screen, select the GWM. See Figure 3.

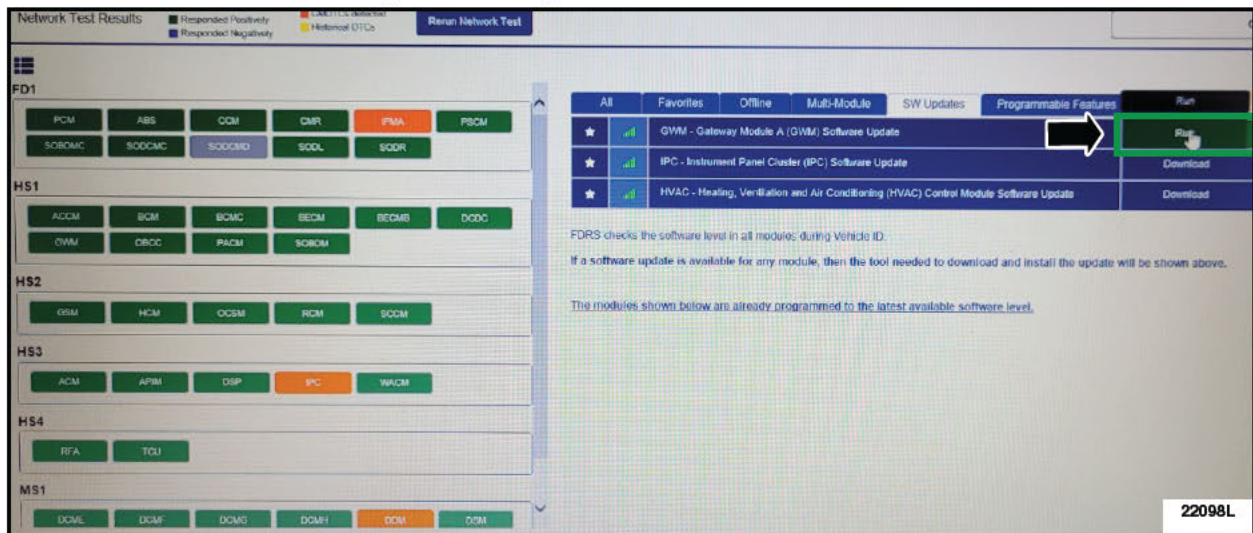
FIGURE 7

9. Click RUN to start the GWM update. See Figure 7.

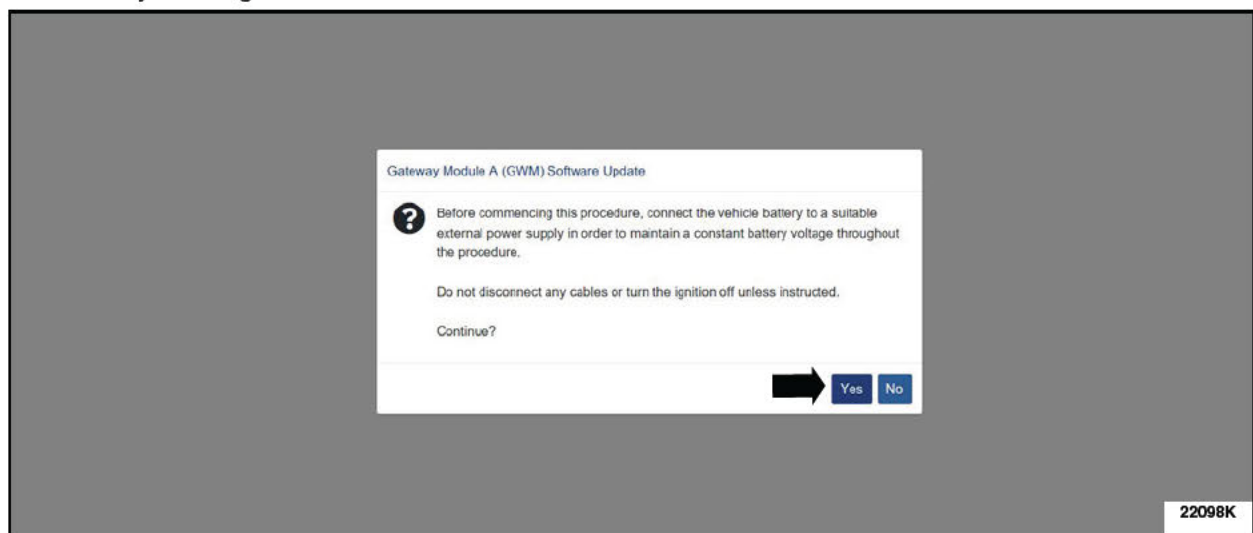
FIGURE 8

10. Verify that the vehicle is connected to a battery charger. Click yes and follow all on-screen instructions carefully. See Figure 8.

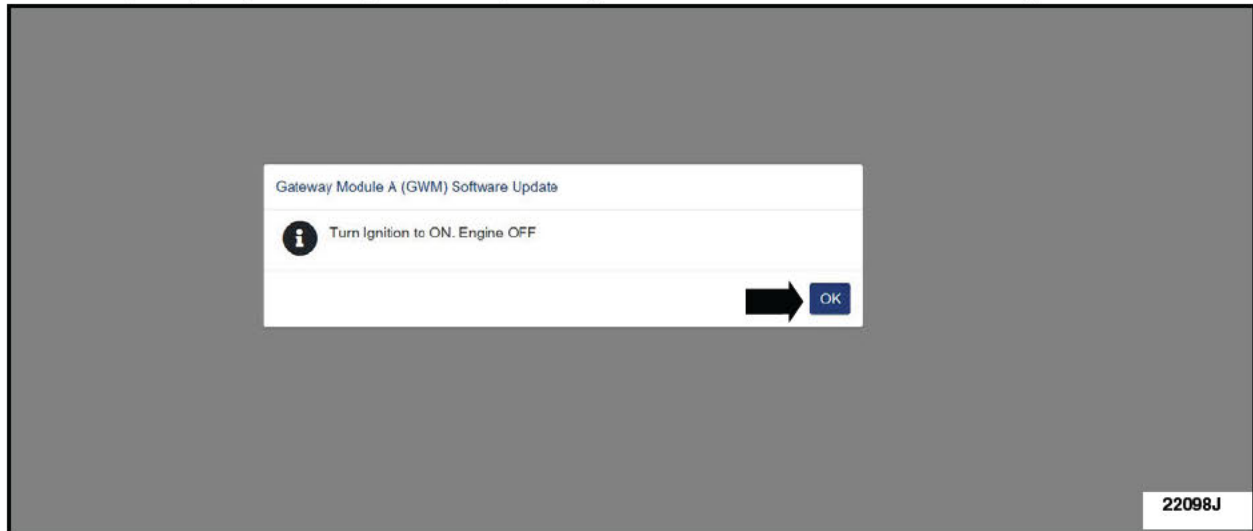
FIGURE 9

11. When prompted, turn the ignition to key on engine off and click the OK icon. See Figure 9.

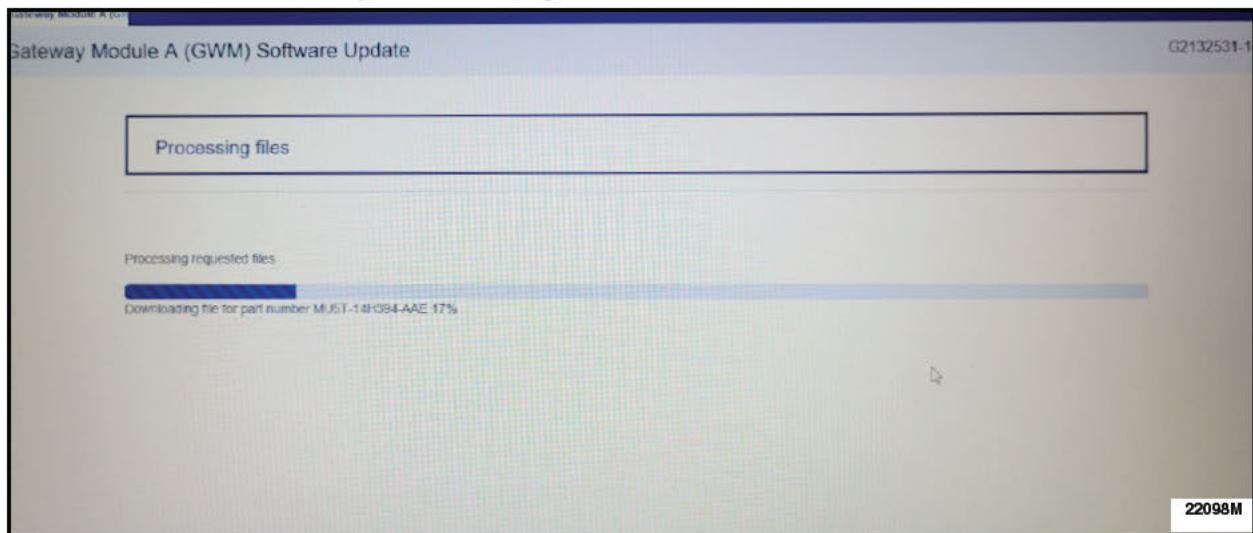
FIGURE 10

12. Allow the software files to process. See Figure 10.

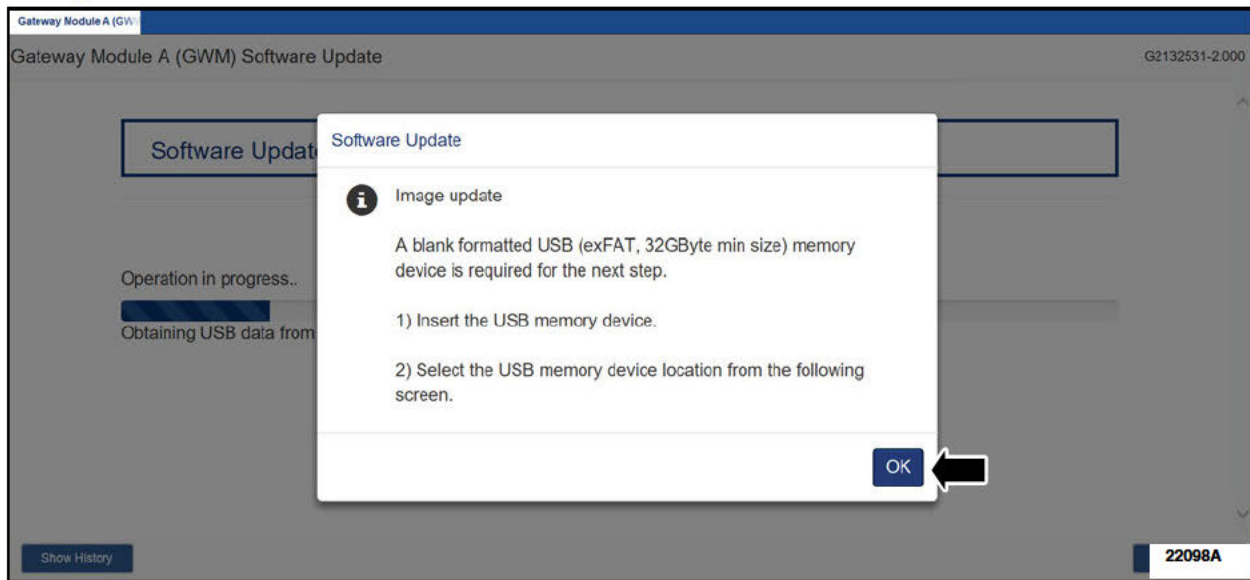
FIGURE 11

13. When prompted, connect the USB flash drive to the diagnostic scan tool and click the OK icon. See Figure 11.

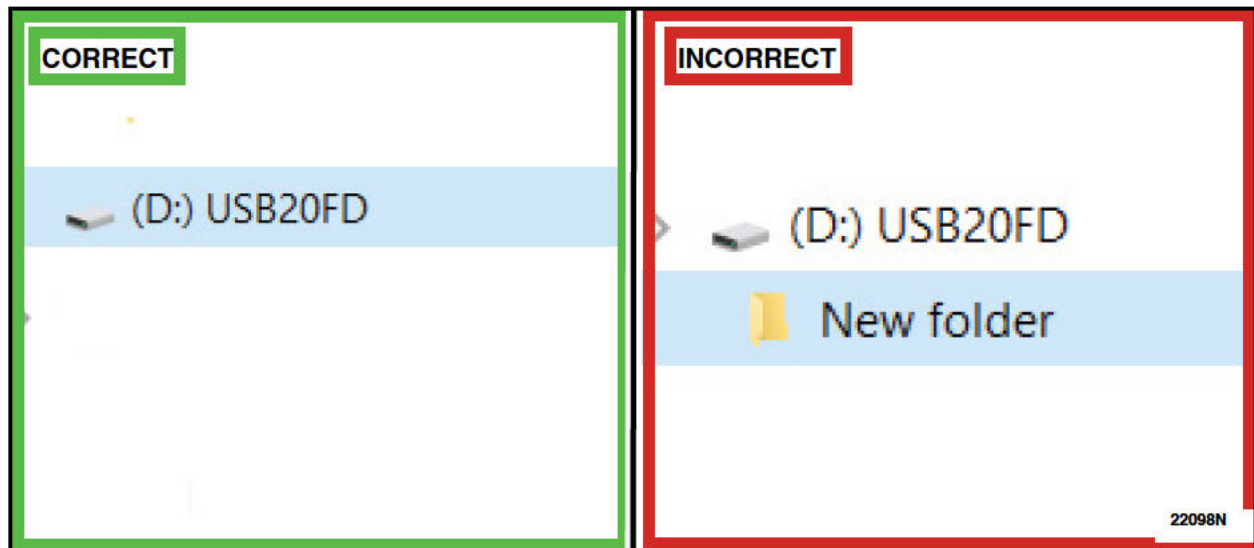
FIGURE 12

**NOTE:** Do not install the software update on a sub folder on the USB drive. See Figure 12.

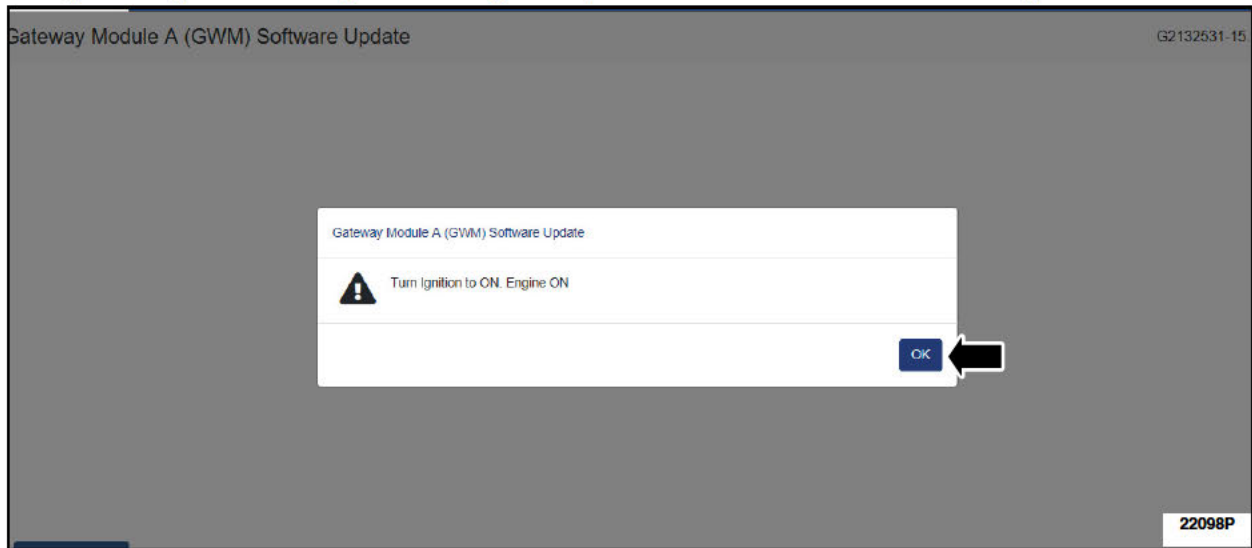
FIGURE 13

14. Cycle the ignition to the ignition on engine on position and click the OK icon. See Figure 13.

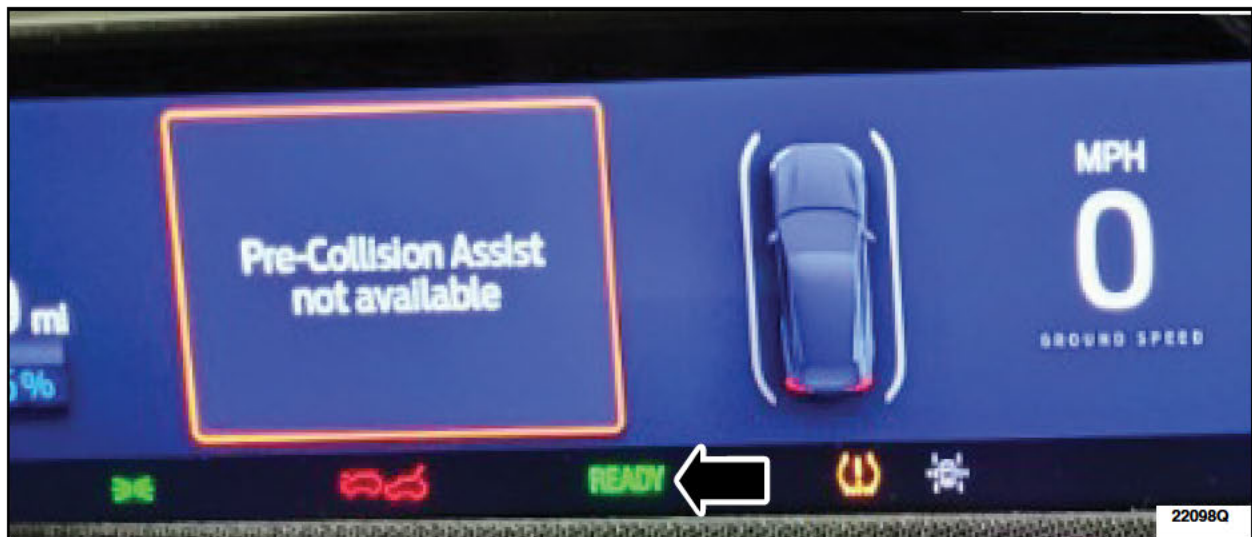
FIGURE 14

15. Verify that the green ready light is on on the instrument cluster. See Figure 14.

**NEW ! NOTE:** Mach-E shown Expedition, Navigator and F-150 vehicles similar.

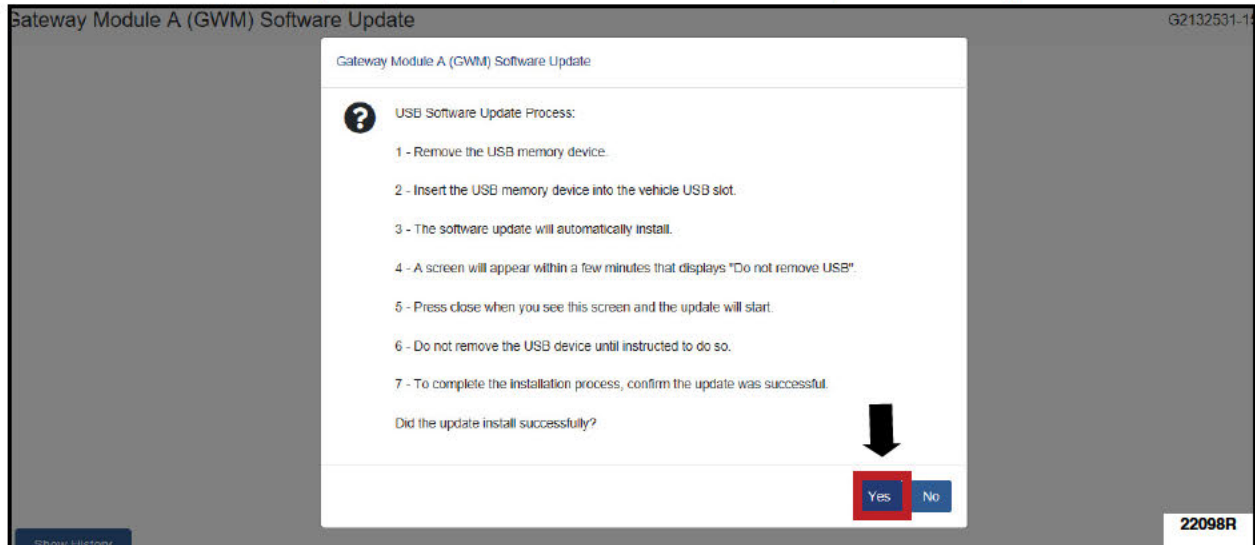
FIGURE 15

**IMPORTANT:** Do not select the Yes button in FDRS until the software update on the USB drive has been completed. See Figure 15.

**NOTE:** If the yes or no icon in FDRS is pressed by accident the software update will not be successful. **DO NOT PROCEED WITH THE CAN FLASH.** You may receive an inaccurate message stating that the software update was successful but the bluecruise maps will not be updated.

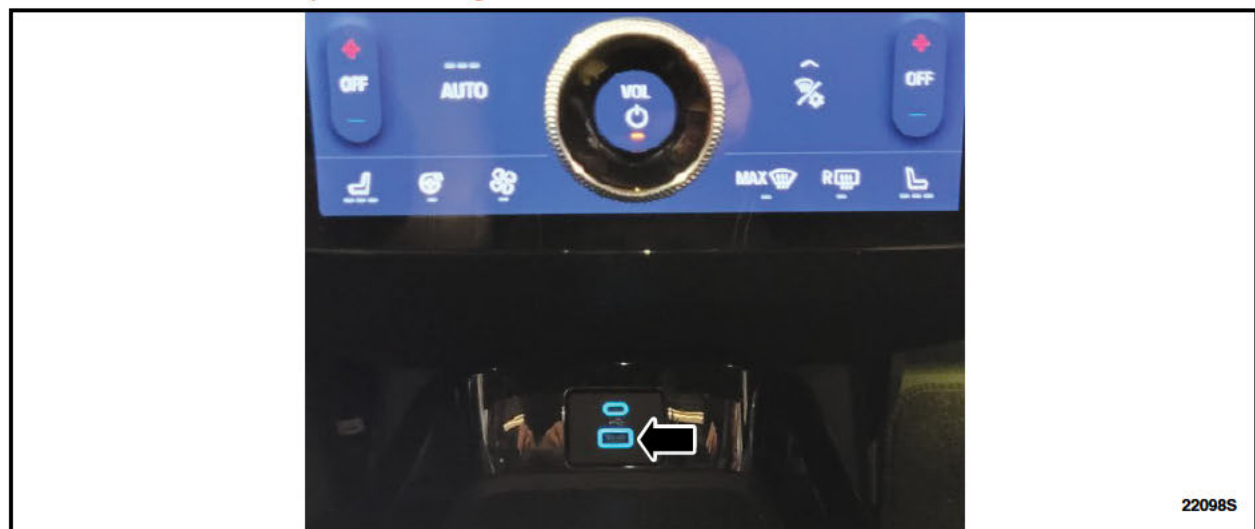
FIGURE 16

16. When prompted by the diagnostic scan tool, safely remove/eject the USB flash drive from the diagnostic scan tool and connect it to the USB hub in the vehicle to install the software into the GWM. See Figure 16.

**NEW ! NOTE:** Mach-E shown Expedition, Navigator and F-150 vehicles similar.

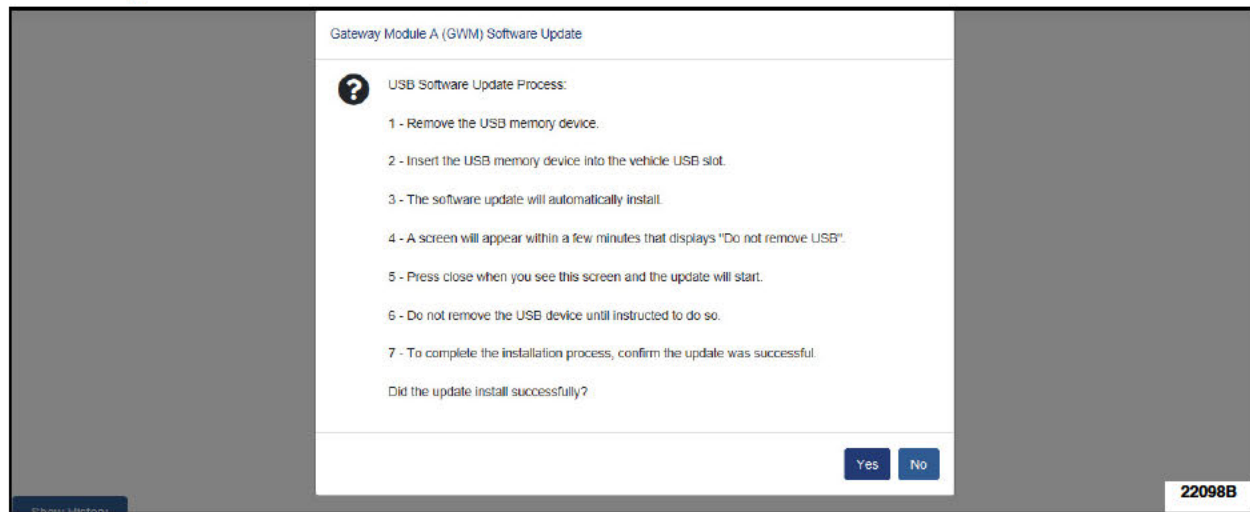
FIGURE 17

17. The update should start automatically. It is normal for the GWM to reset during this step.  
See Figure 17.

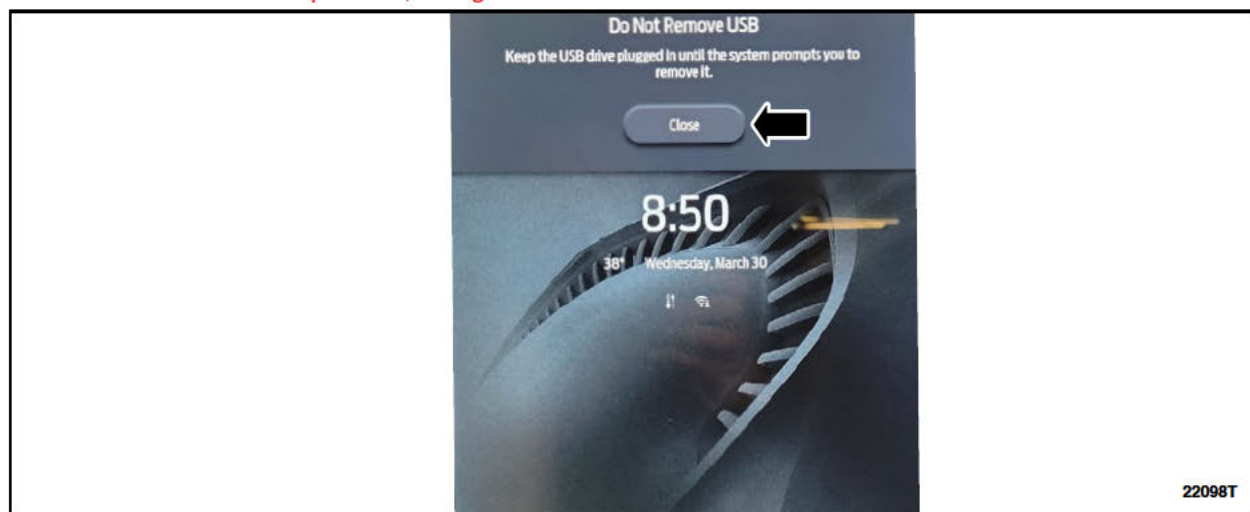
FIGURE 18

18. Press the close icon on navigation screen. The GWM software update will start automatically.  
See Figure 18.
19. Set a timer for 10 minutes to ensure enough time passes to allow the update to complete before removing the USB drive.

**NEW ! NOTE:** Mach-E shown Expedition, Navigator and F-150 vehicles similar.

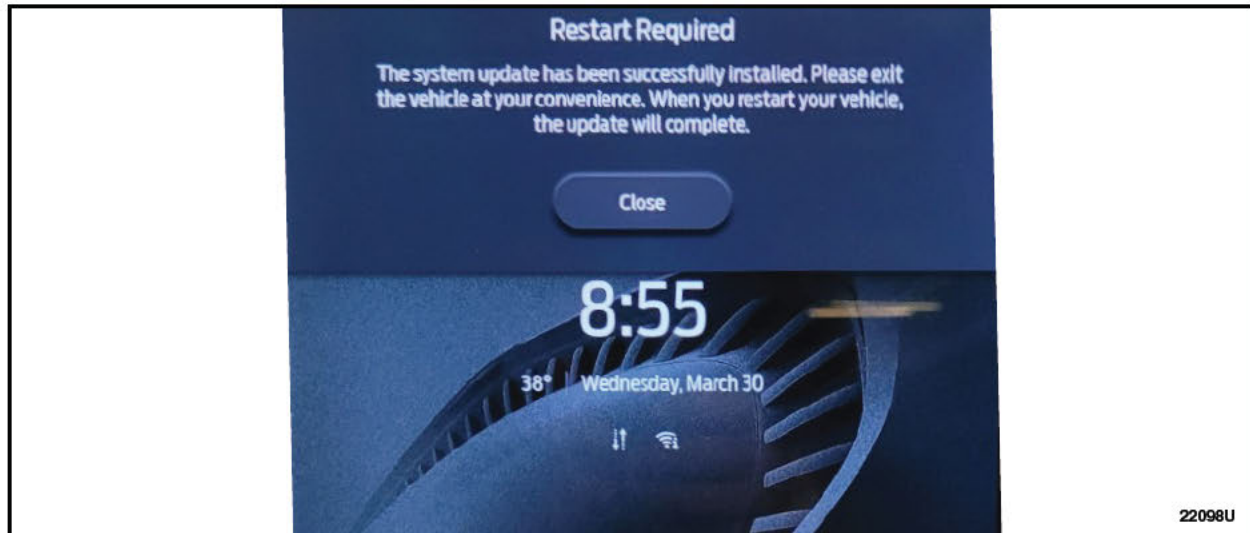
**FIGURE 19**

**NEW !** 20. Turn off the vehicle and open and close the driver's door. See Figure 19.

**NOTE:** You may receive a question regarding the alarm system. Click yes or no as appropriate.

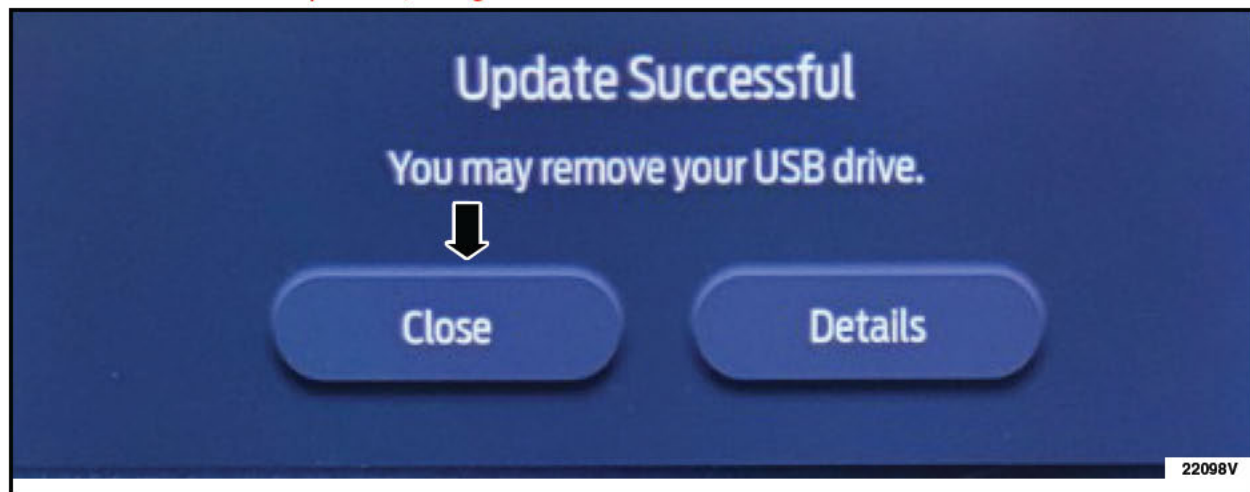
**FIGURE 20**

21. Restart the vehicle. **Only remove the USB stick from the vehicle when the update successful message appears.** See Figure 20.
22. If there is not an immediate message stating that the update was successful set a timer for 5 minutes. It may take up to 5 minutes before SYNC touchscreen displays Update Successful pop up. After 5 minutes if "Successful" pop up is not shown on SYNC touchscreen.
  - Select the close icon on the SYNC touchscreen.
  - Remove the USB stick
  - Click yes on the FDRS screen "Was the USB Update Successful" prompt (FDRS verifies if the module software update was successfully installed on the module).

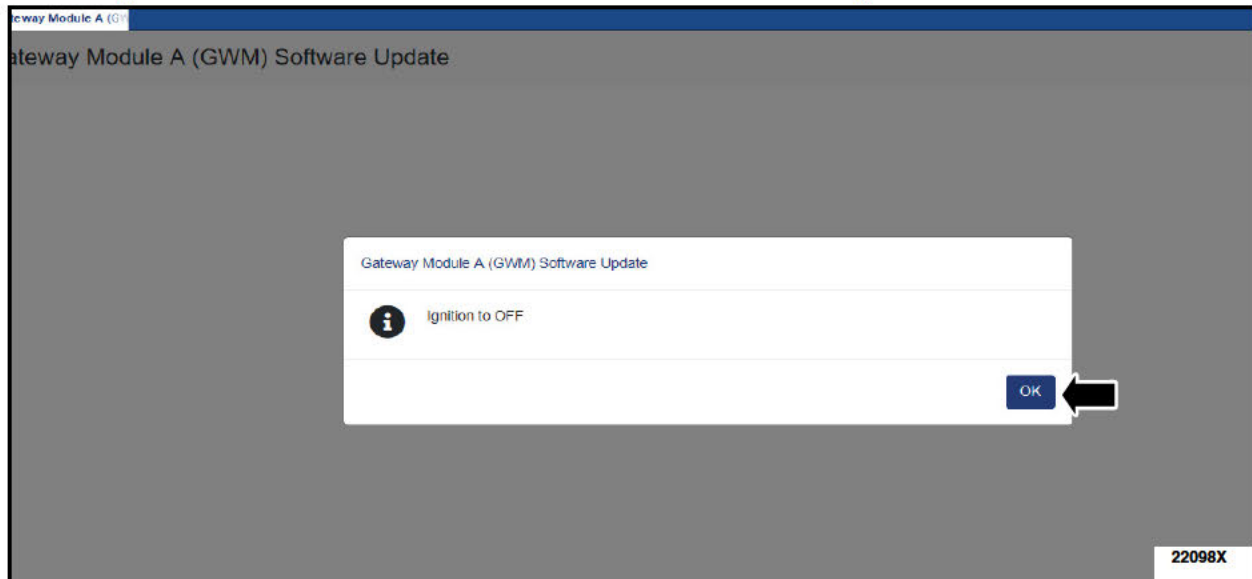
**FIGURE 21**

23. Turn ignition to off and click the OK icon on the FDRS screen. See Figure 21.

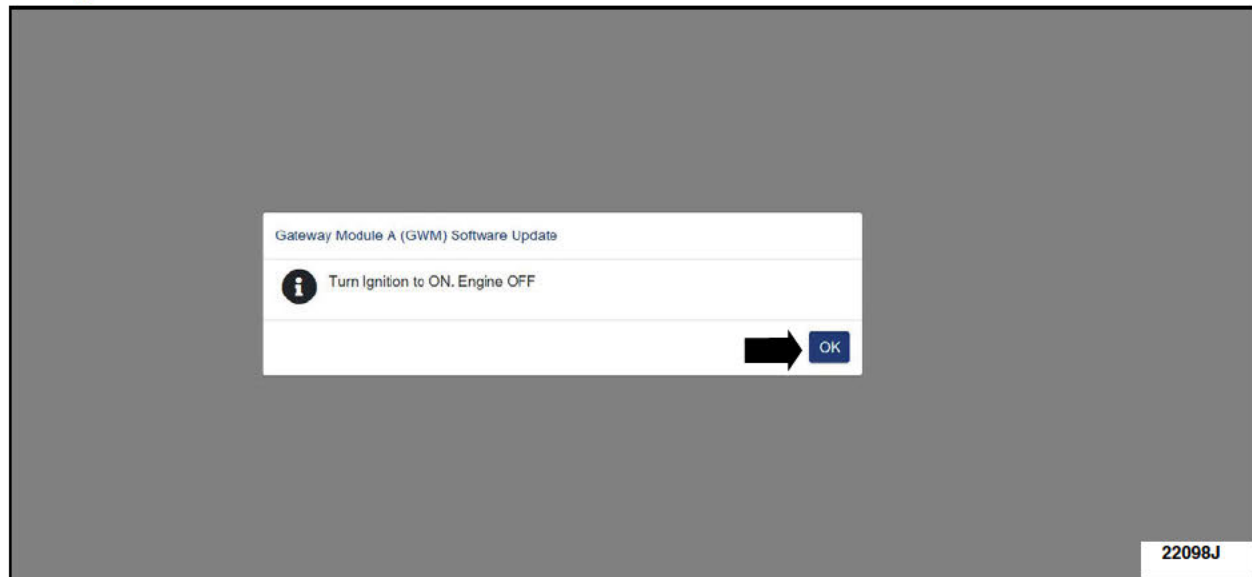
**FIGURE 22**

24. Turn ignition to the ignition on engine off position and click the OK icon on the FDRS screen. See Figure 22.

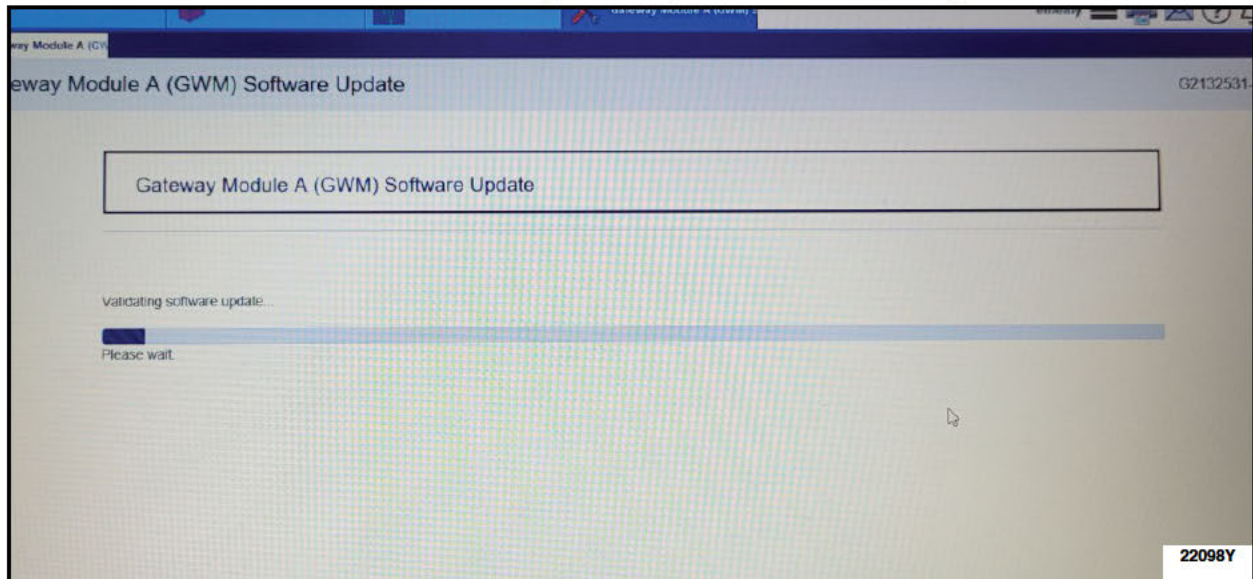
**FIGURE 23**

25. On the FDRS screen wait for the validating software process to finish. See Figure 23.

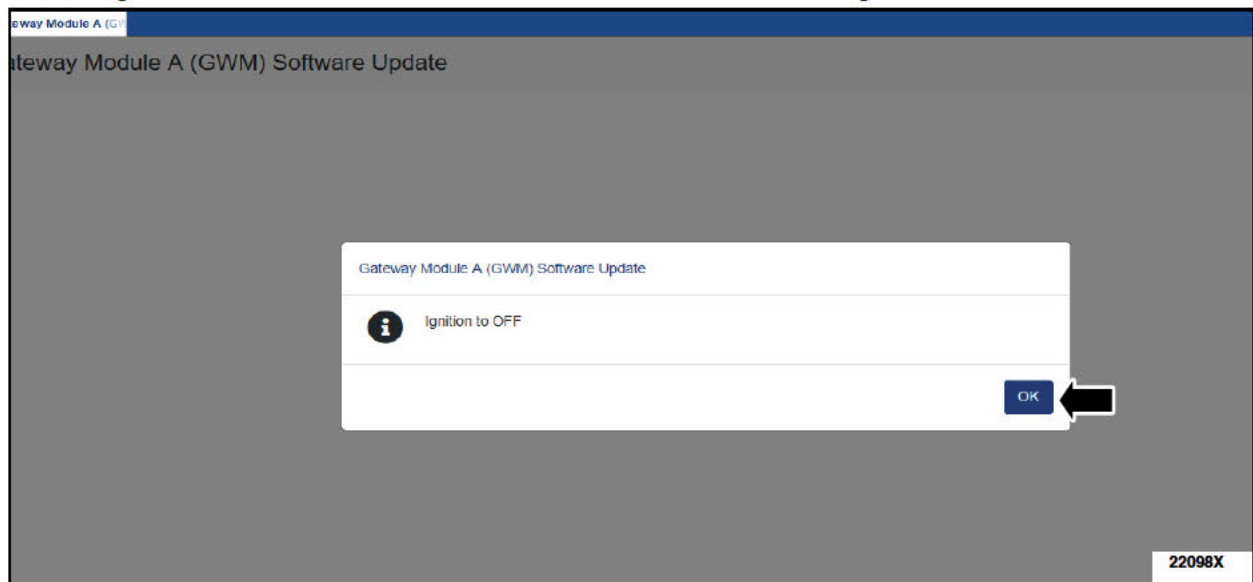
**FIGURE 24**

26. Turn ignition to off and click the OK icon on the FDRS screen. See Figure 24.

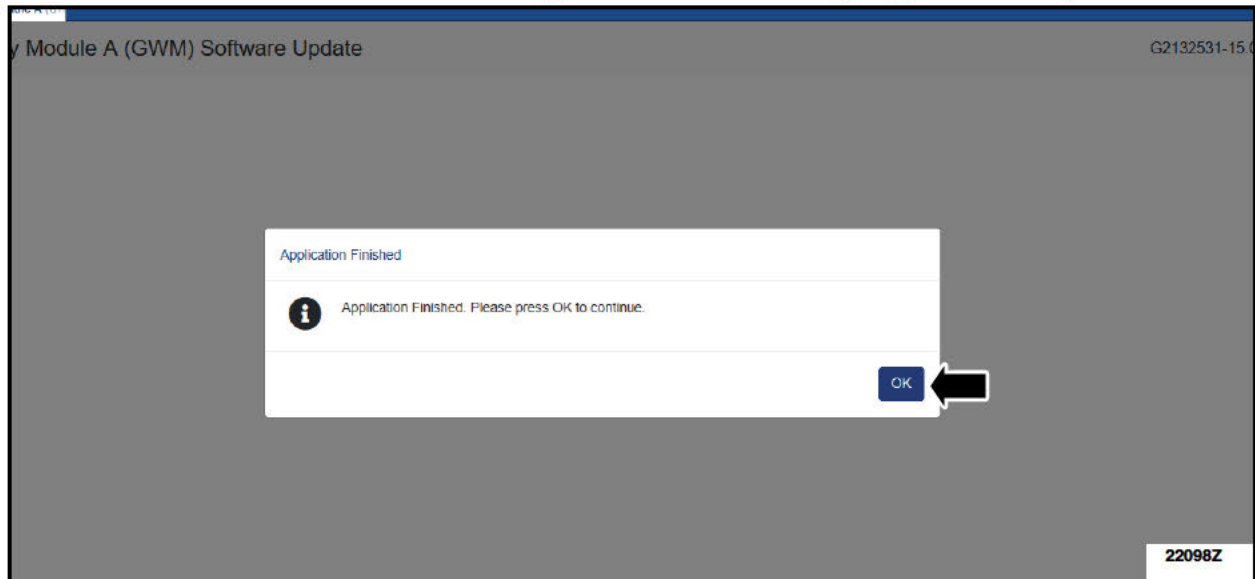
**FIGURE 25**

27. Click OK on the FDRS screen when the application finished message appears. See Figure 25.

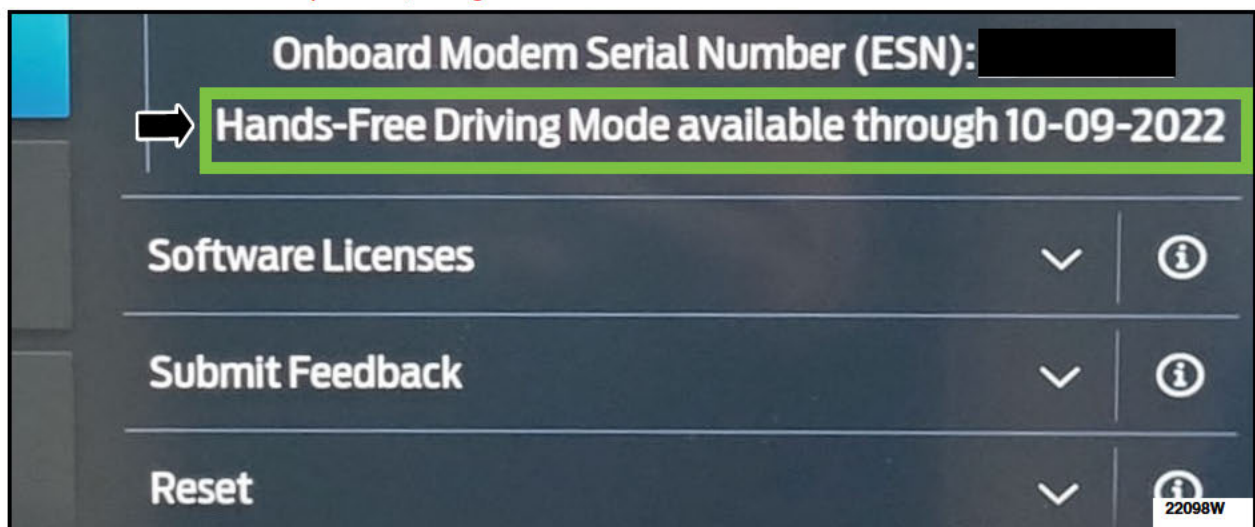
**FIGURE 26**

32. On the center display screen, navigate to Settings > About SYNC > Hands-Free Driving Mode available through DD-MM-YYYY. Verify that expiration date is in the future. See Figure 26.

**NEW ! NOTE:** Mach-E shown Expedition, Navigator and F-150 vehicles similar.

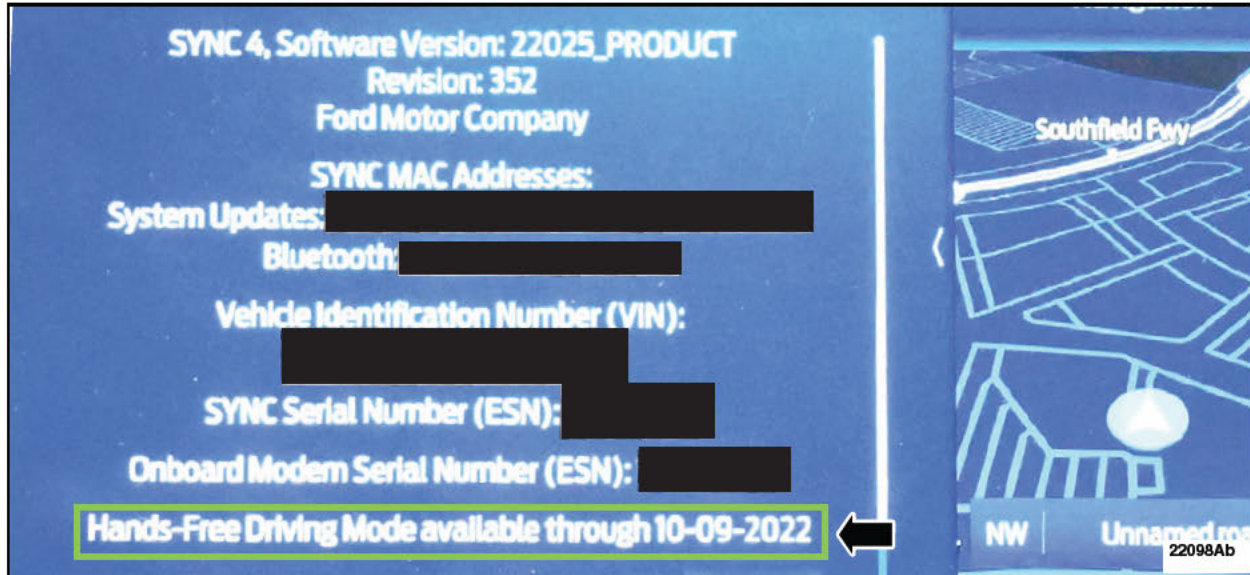
**FIGURE 1**

3. On the center display screen, navigate to Settings > About SYNC > Hands-Free Driving Mode available through DD-MM-YYYY. Record the expiration date. See Figure 1.

**NEW !** *NOTE: F-150 shown Expedition, Navigator and Mach-E vehicles similar.*

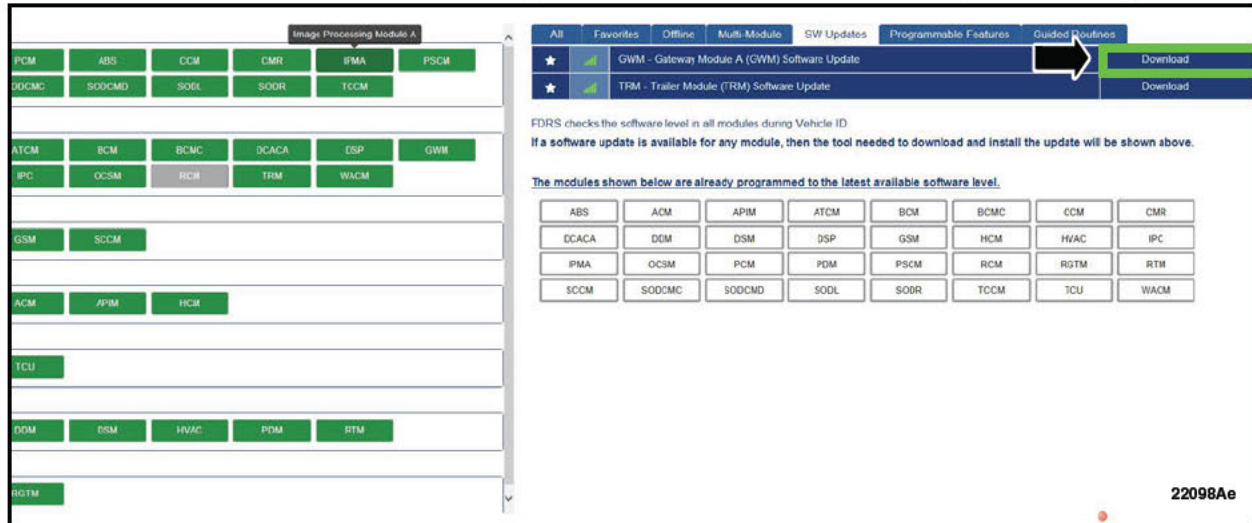
FIGURE 4

8. From the list on the RH side of the screen, download GWM - GWM Software Update. See Figure 4.

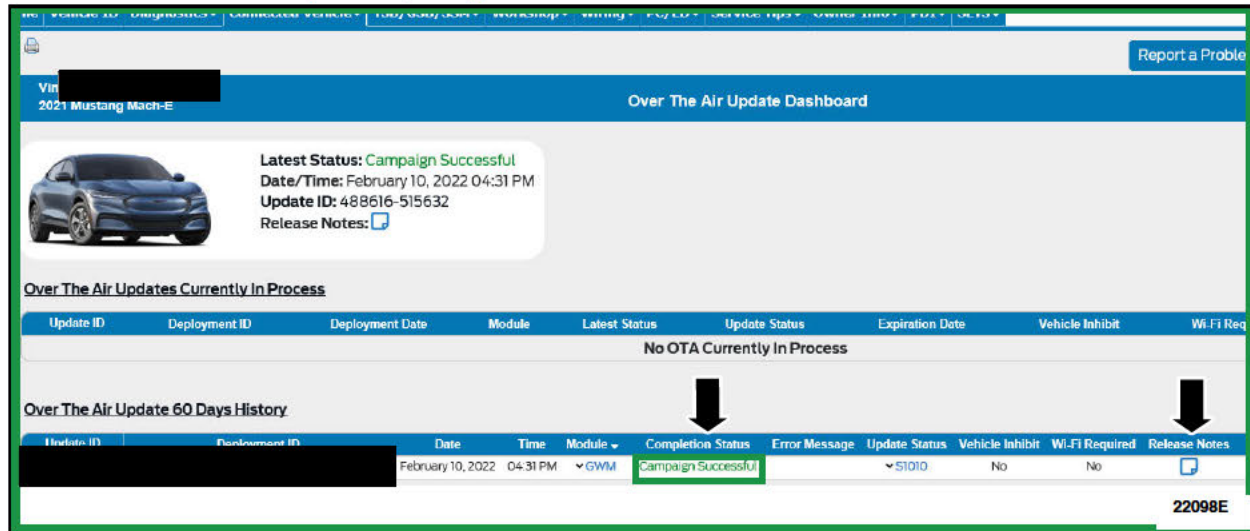
FIGURE 5

**NOTE:** If software is already at the latest level, this selection will not be available. Verify that an Over The Air (OTA) update was previously installed. Log into Professional Technician System (PTS) > Connected Vehicle tab > OTA Dashboard. Click on release notes to confirm what was included in the OTA update. See Figures 5 and 6.

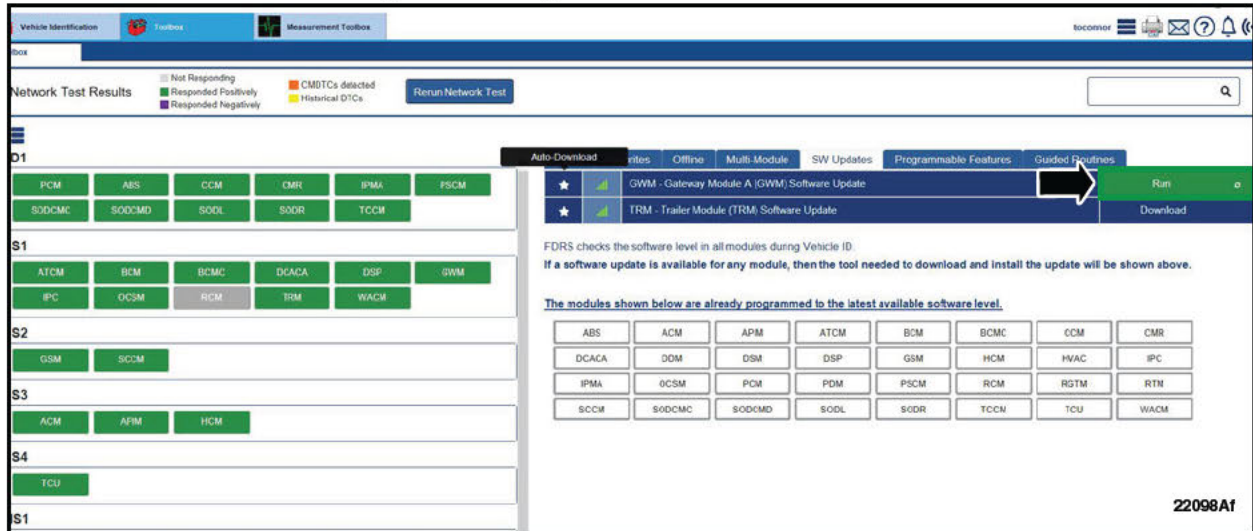
FIGURE 7

9. Click RUN to start the GWM update. See Figure 7.

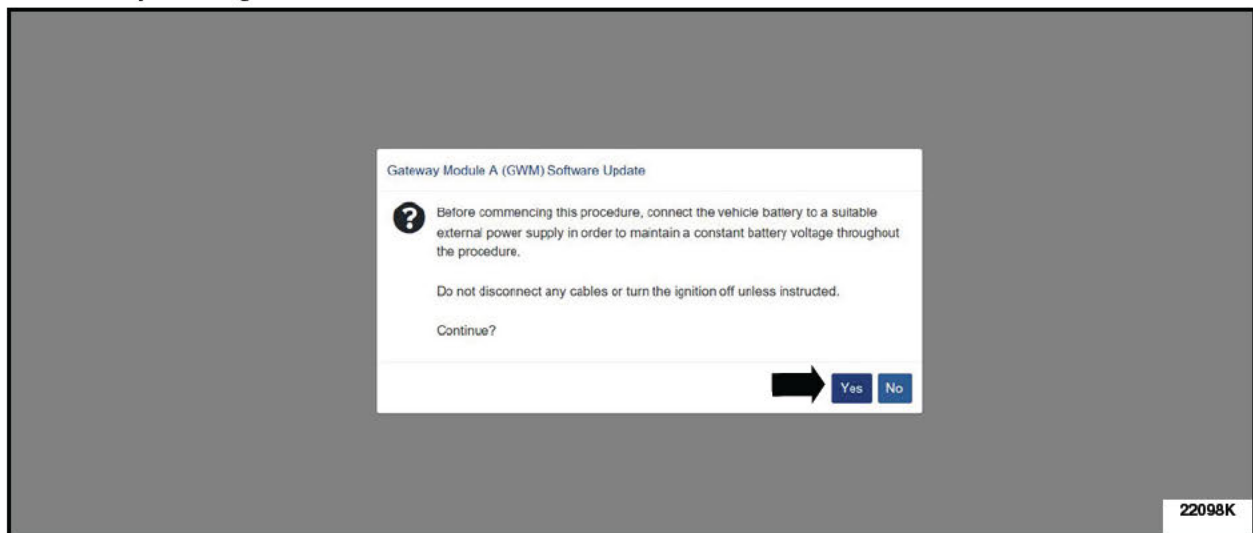
FIGURE 8

10. Verify that the vehicle is connected to a battery charger. Click yes and follow all on-screen instructions carefully. See Figure 8.

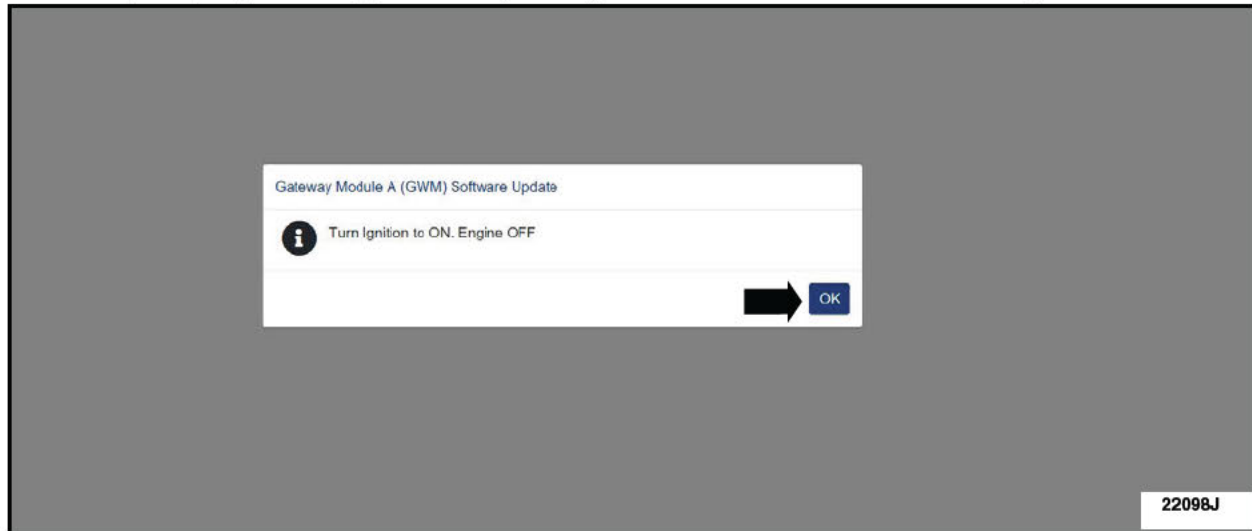
FIGURE 9

11. When prompted, turn the ignition to key on engine off and click the OK icon. See Figure 9.

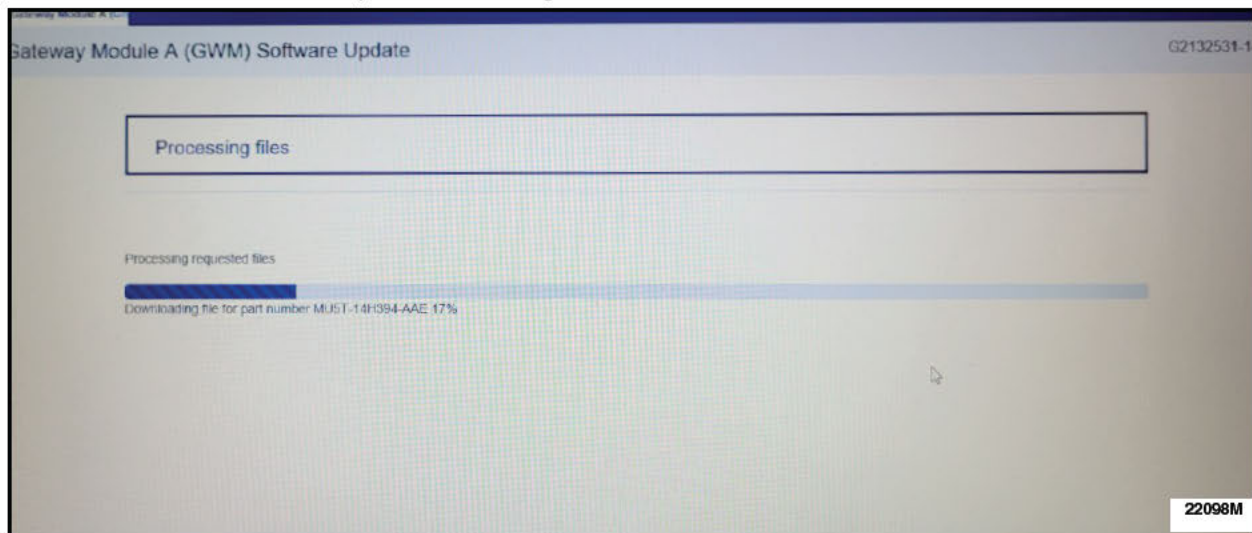
FIGURE 10

12. Allow the software files to process. See Figure 10.

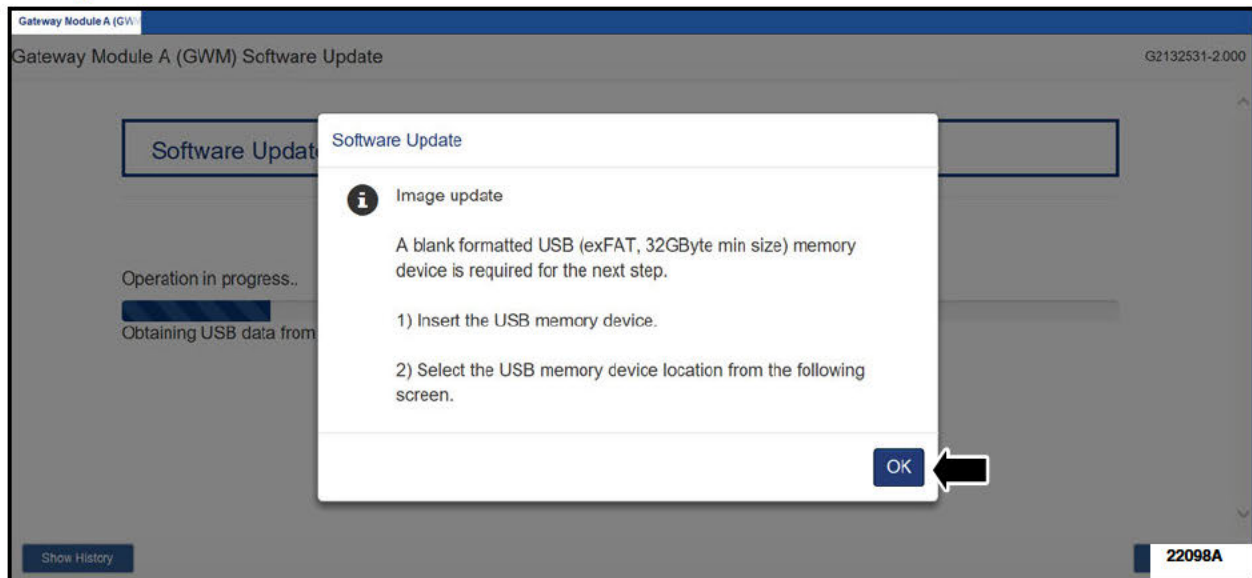
FIGURE 11

13. When prompted, connect the USB flash drive to the diagnostic scan tool and click the OK icon. See Figure 11.
