**SUBJECT: NEW VEHICLE RECOMMENDED DELIVERY HOLD**

**Customer Satisfaction Program 22P08 – Supplement #2**

Certain 2022 Model Year Expedition/Navigator, 2021-2022 Model Year F-150 and Mach-E Vehicles Equipped with Ford/Lincoln Co-Pilot and BlueCruise/ActiveGlide BlueCruise/ActiveGlide Maps Expiration

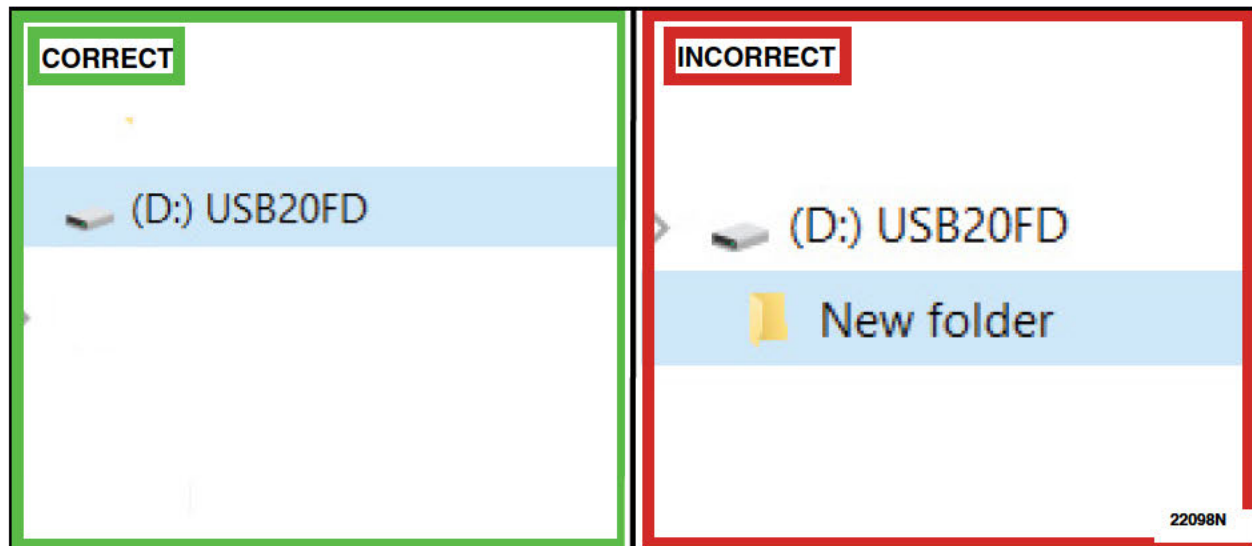
FIGURE 12

**NOTE:** Do not install the software update on a sub folder on the USB drive. See Figure 12.

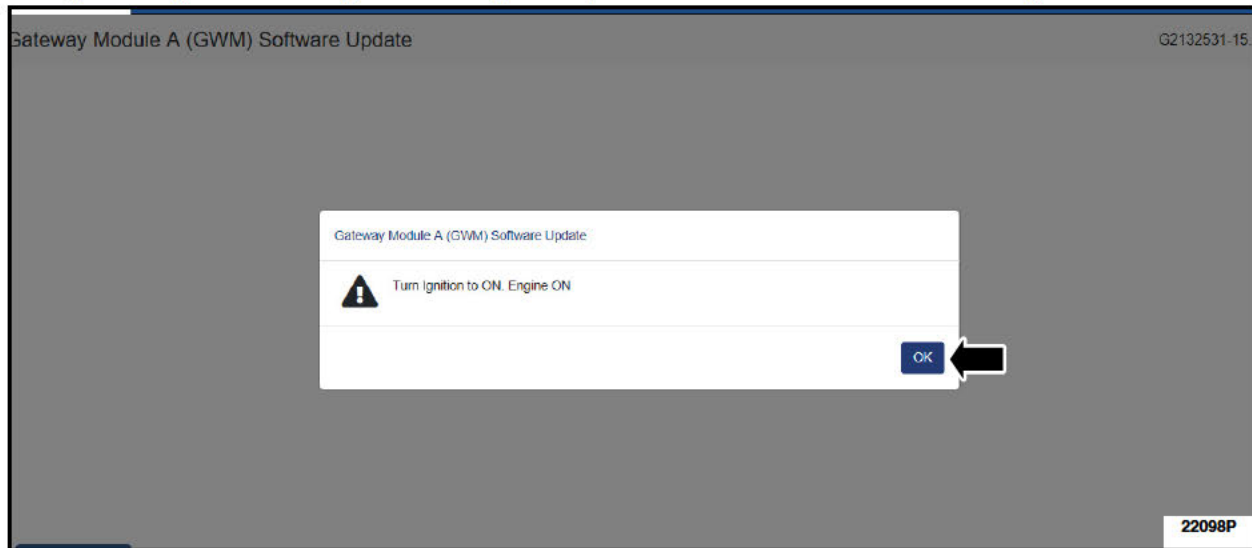
FIGURE 13

14. Cycle the ignition to the ignition on engine on position and click the OK icon. See Figure 13.

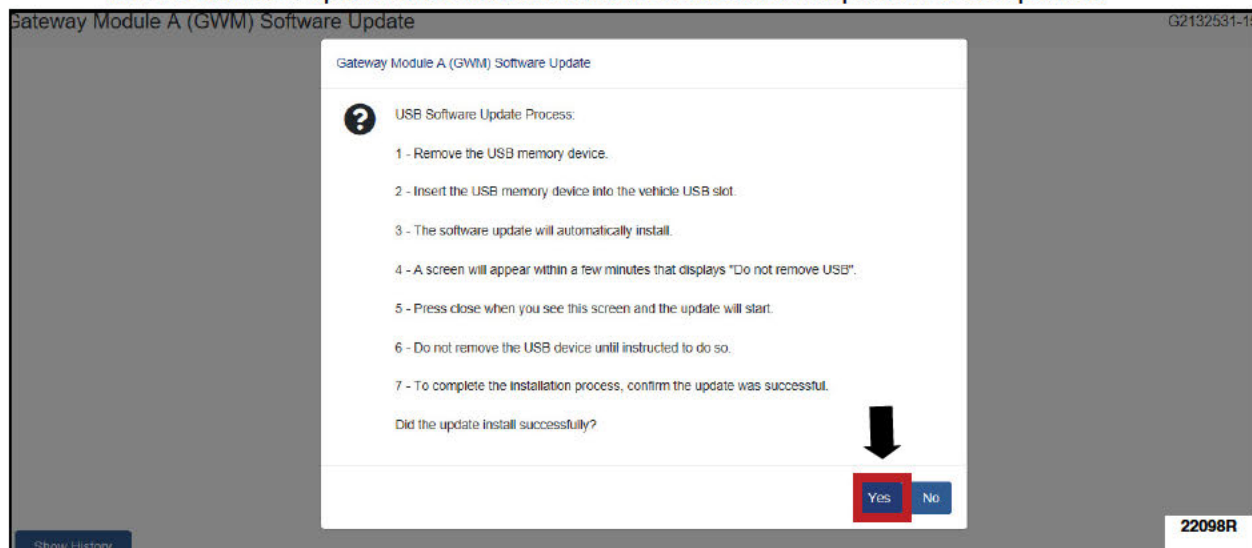
FIGURE 14

**IMPORTANT:** Do not select the Yes button in FDRS until the software update on the USB drive has been completed. See Figure 14.

**NOTE:** If the yes or no icon in FDRS is pressed by accident the software update will not be successful. **DO NOT PROCEED WITH THE CAN FLASH.** You may receive an inaccurate message stating that the software update was successful but the Bluecruise maps will not be updated.

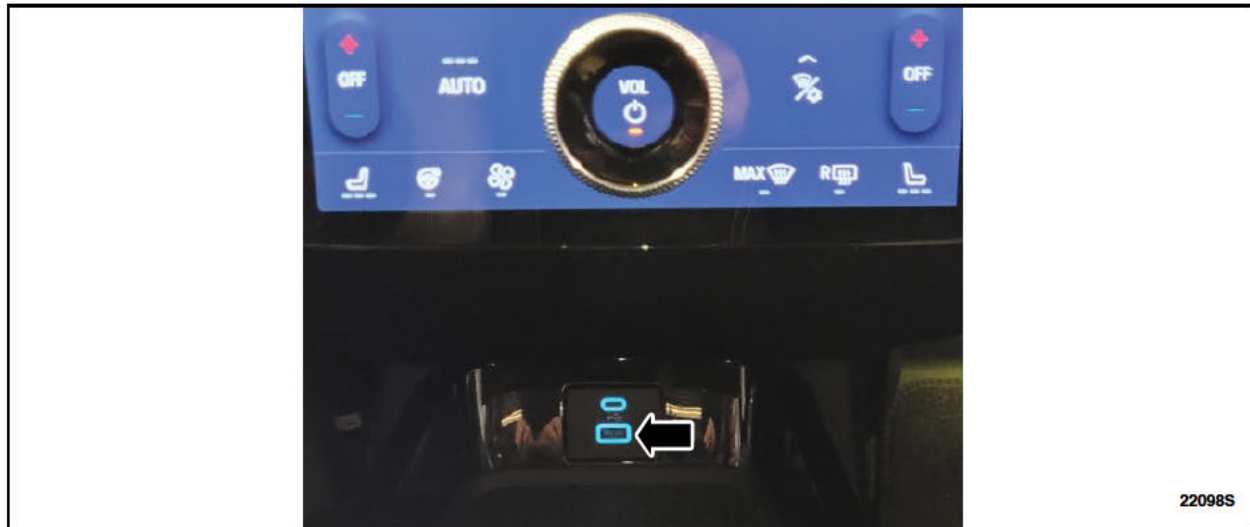
FIGURE 15

15. When prompted by the diagnostic scan tool, safely remove/eject the USB flash drive from the diagnostic scan tool and connect it to the USB hub in the vehicle to install the software into the GWM. See Figure 15.

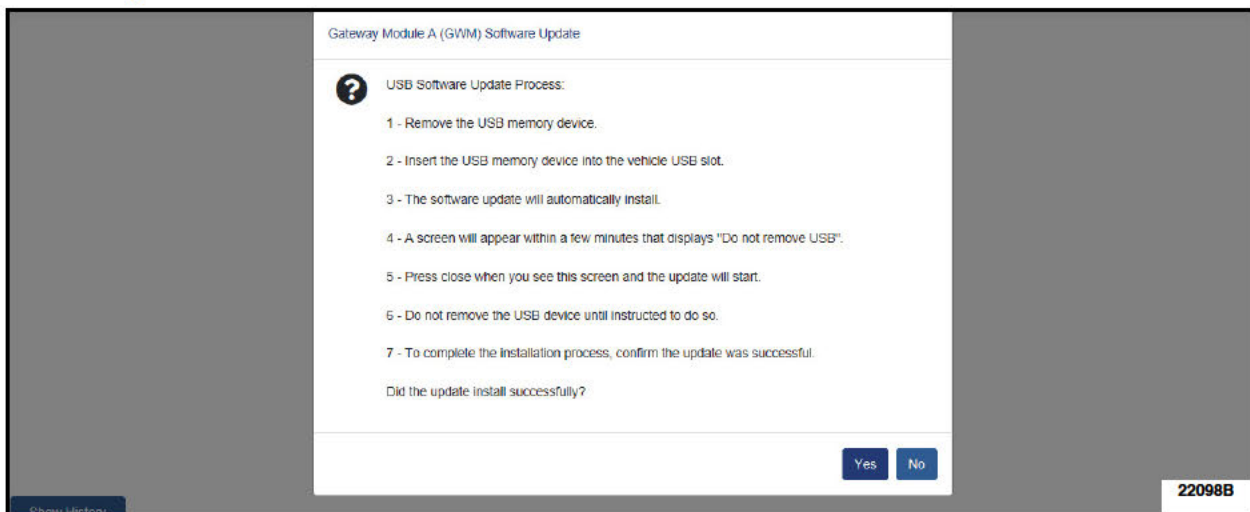
FIGURE 16

16. The update should start automatically. It is normal for the GWM to reset during this step. See Figure 16.

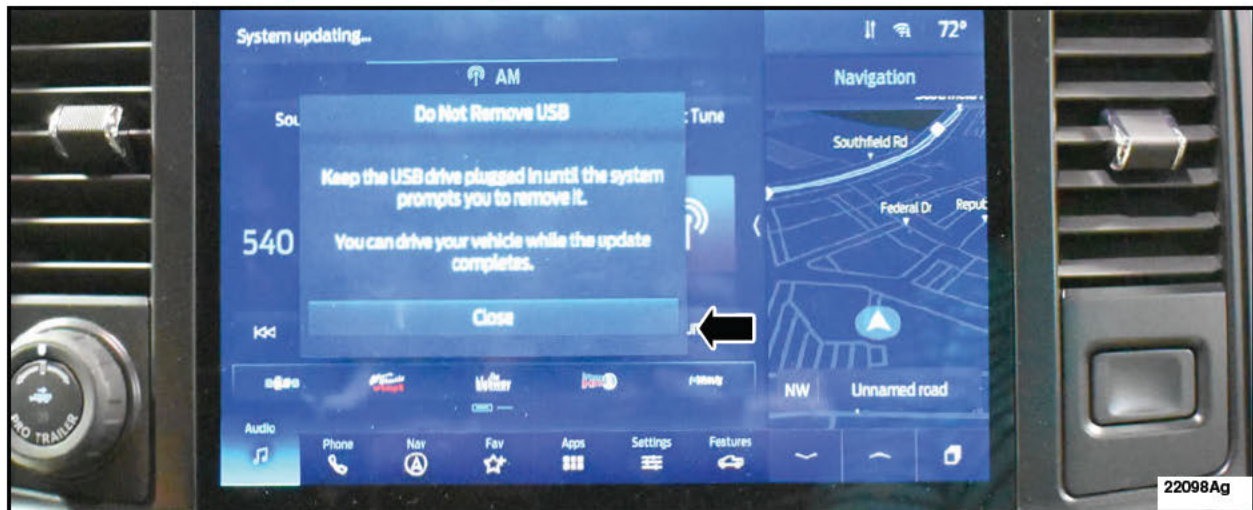
FIGURE 17

17. Press the close icon on navigation screen. The GWM software update will start automatically.  
See Figure 17.
18. Set a timer for 10 minutes to ensure enough time passes to allow the update to complete before removing the USB drive.

**NEW !** NOTE: F-150 shown Expedition and Navigator vehicles similar.

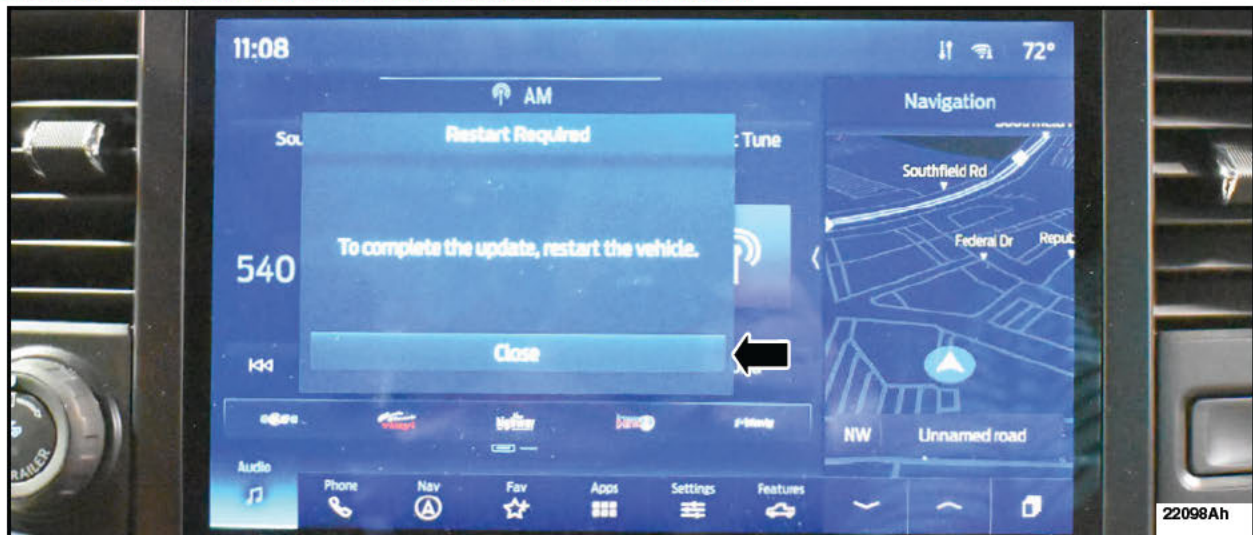
FIGURE 18

19. Turn off the vehicle and open and close the driver's door. See Figure 18.

**NEW !** NOTE: F-150 shown Expedition and Navigator vehicles similar.

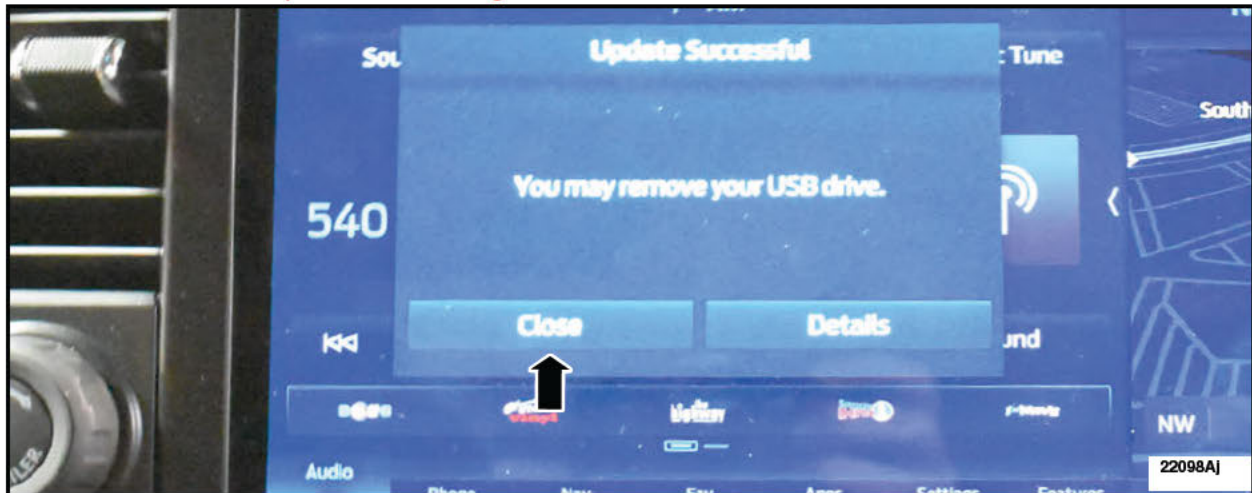
FIGURE 19

20. Restart the vehicle. **Only remove the USB stick from the vehicle when the update successful message appears.** See Figure 19.
21. If there is not an immediate message stating that the update was successful set a timer for 5 minutes. It may take up to 5 minutes before SYNC touchscreen displays Update Successful pop up. After 5 minutes if "Successful" pop up is not shown on SYNC touchscreen.
- Select the close icon on the SYNC touchscreen.
  - Remove the USB stick
  - Click yes on the FDRS screen "Was the USB Update Successful" prompt (FDRS verifies if the module software update was successfully installed on the module).

**NEW ! NOTE:** F-150 shown Expedition and Navigator vehicles similar.

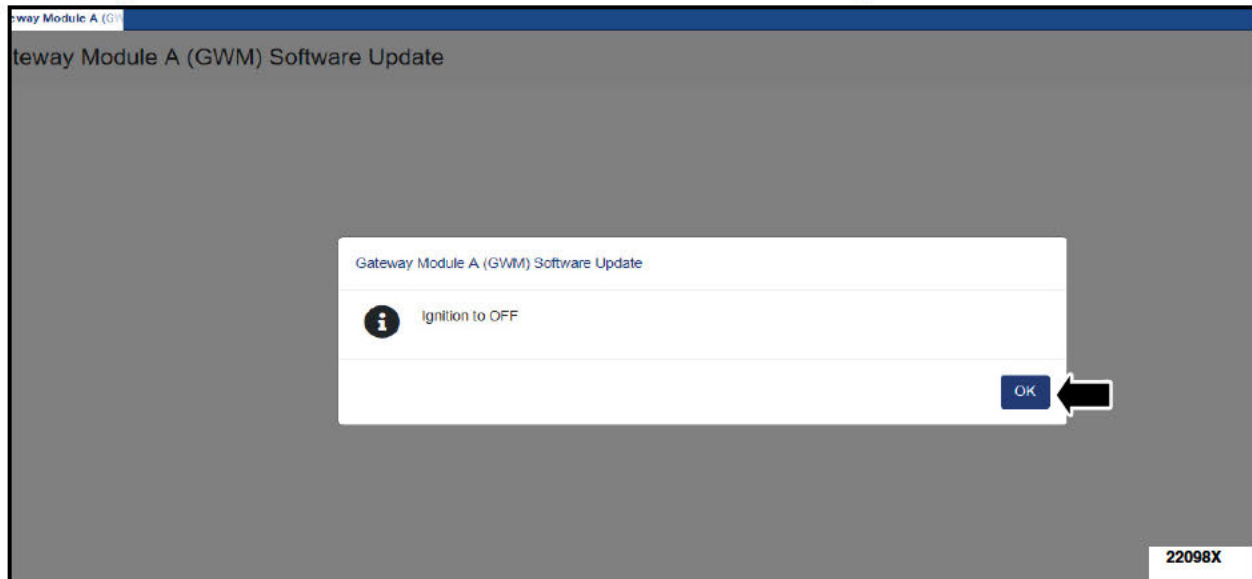
**FIGURE 20**

22. Turn ignition to off and click the OK icon on the FDRS screen. See Figure 20.

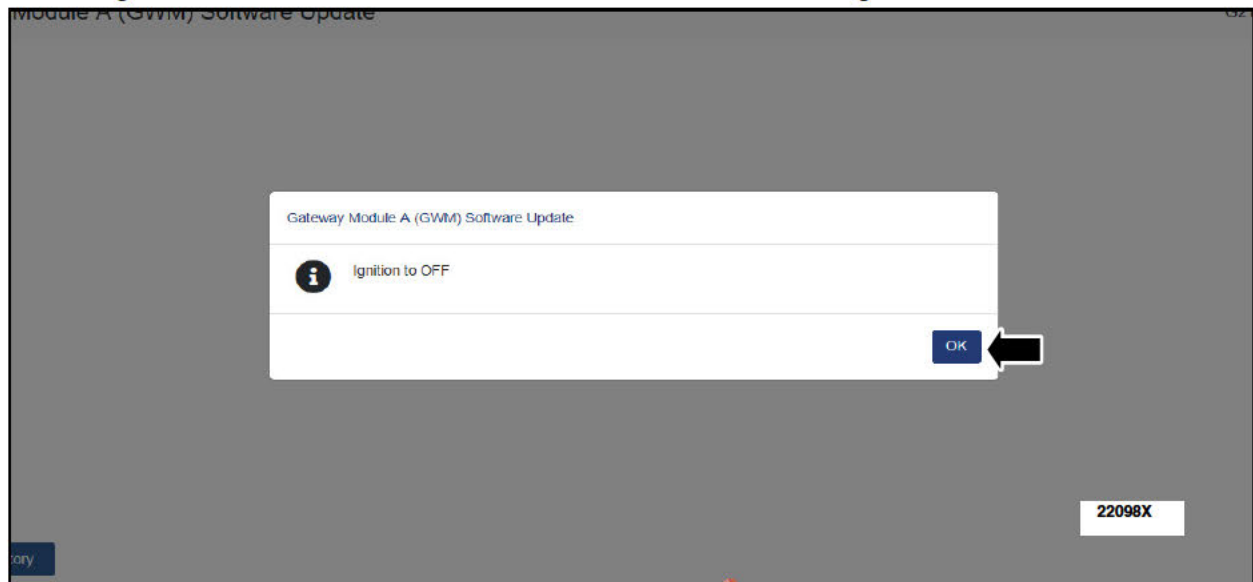
**FIGURE 23**

25. Turn ignition to off and click the OK icon on the FDRS screen. See Figure 23.

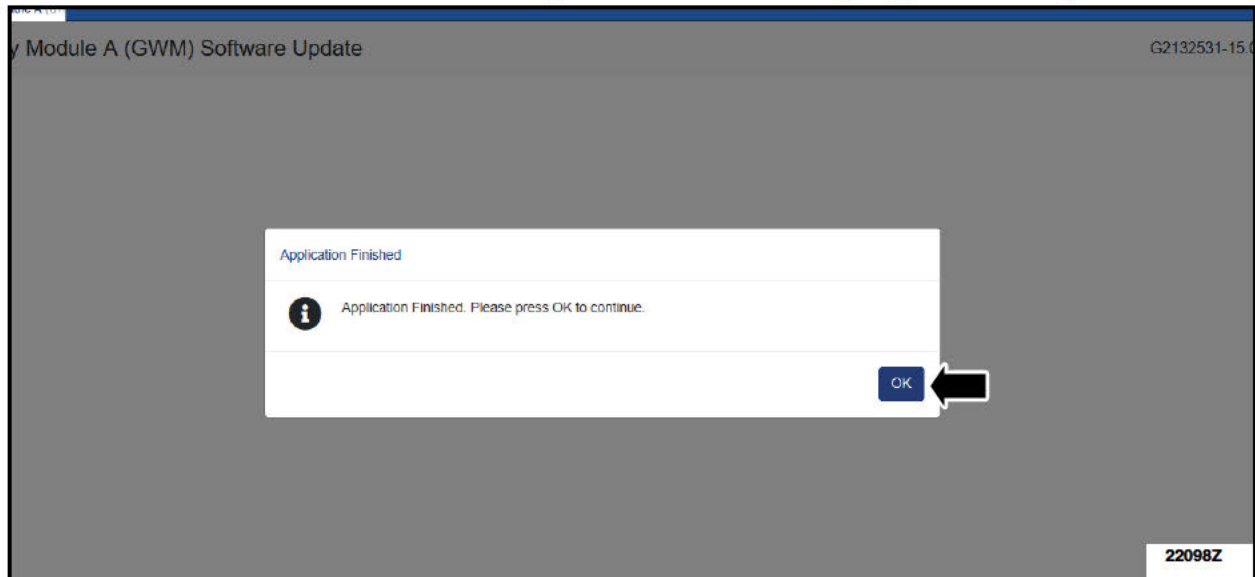
**FIGURE 24**

26. Click OK on the FDRS screen when the application finished message appears. See Figure 24.

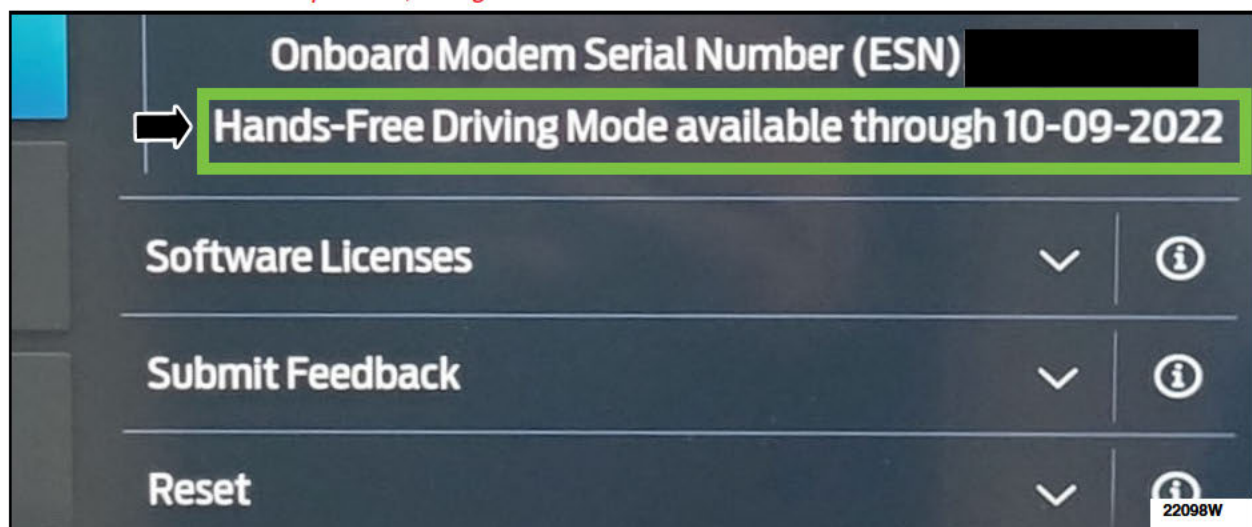
**FIGURE 25**

31. On the center display screen, navigate to Settings > About SYNC > Hands-Free Driving Mode available through DD-MM-YYYY. Verify that expiration date is in the future. See Figure 25.

**NEW !** NOTE: Mach-E shown Expedition, Navigator and F-150 vehicles similar.
