## Product Update: 2015–20 TLX PGM-FI Idle Stop Software Update

Update the PGM-FI Software.

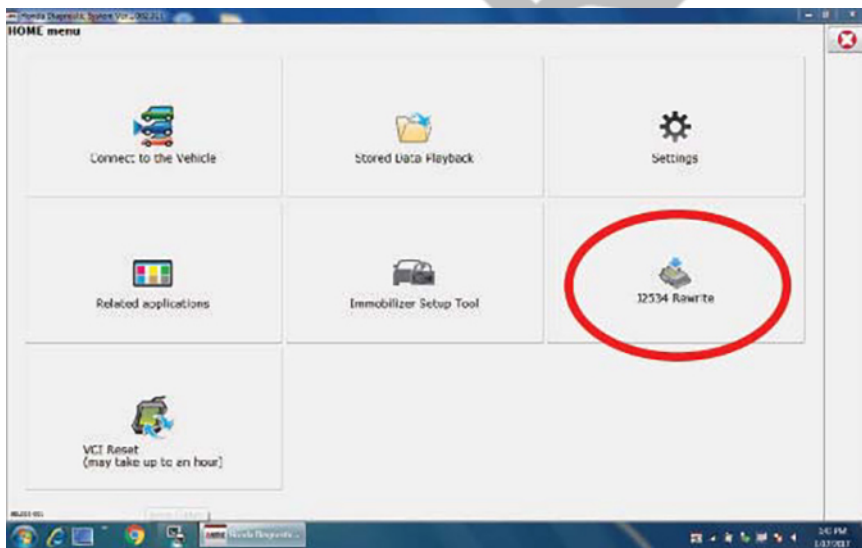
2. From the HOME menu, select the **J2534 Rewrite**.

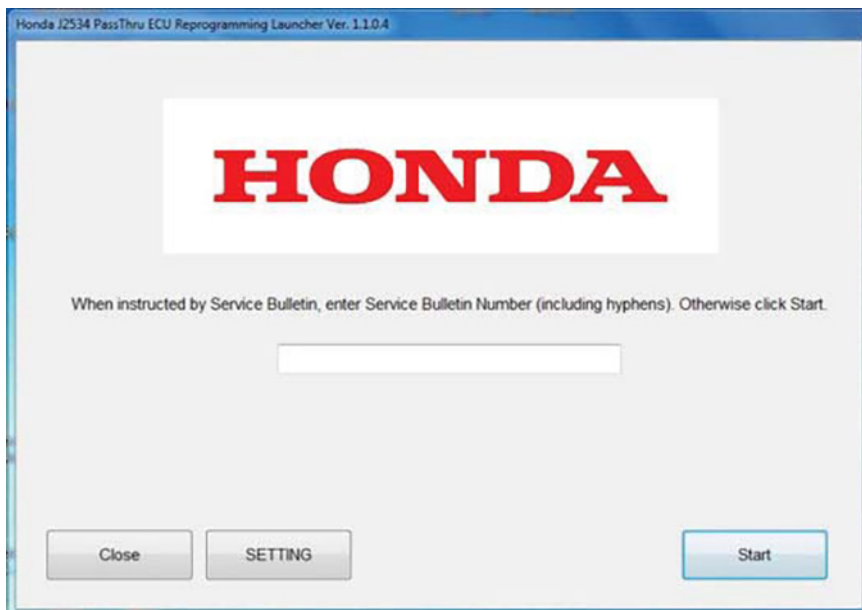
- When prompted select **Start**, do not enter a service bulletin number.

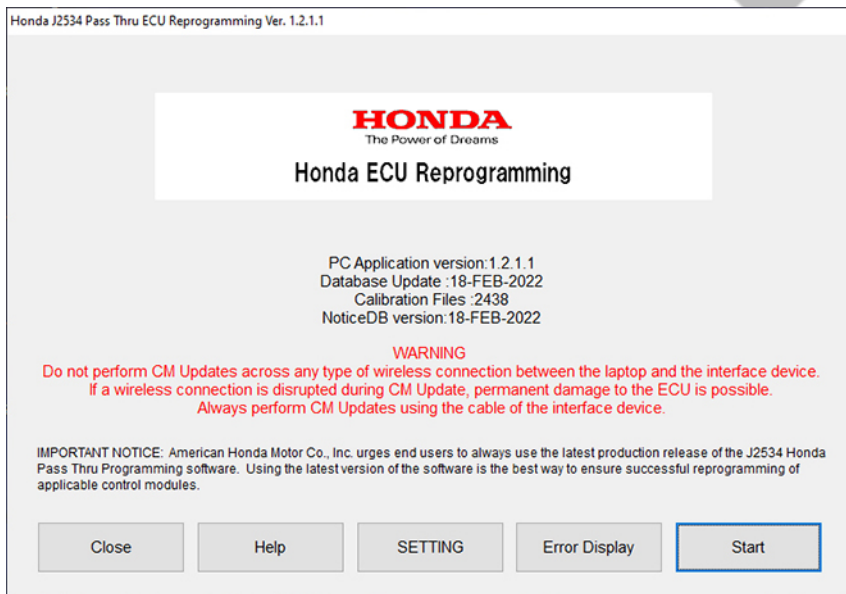
NOTE: Under certain conditions the **HOME** menu screen may come up. If it does, just minimize it to show the screen under it.

- Connect the i-HDS to the vehicle and select **Start** to begin reprogramming.

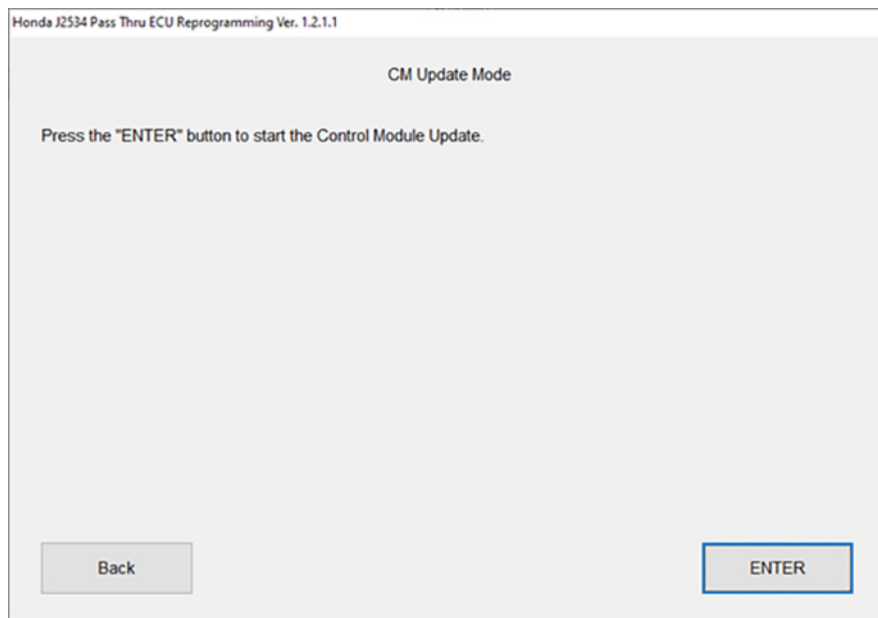
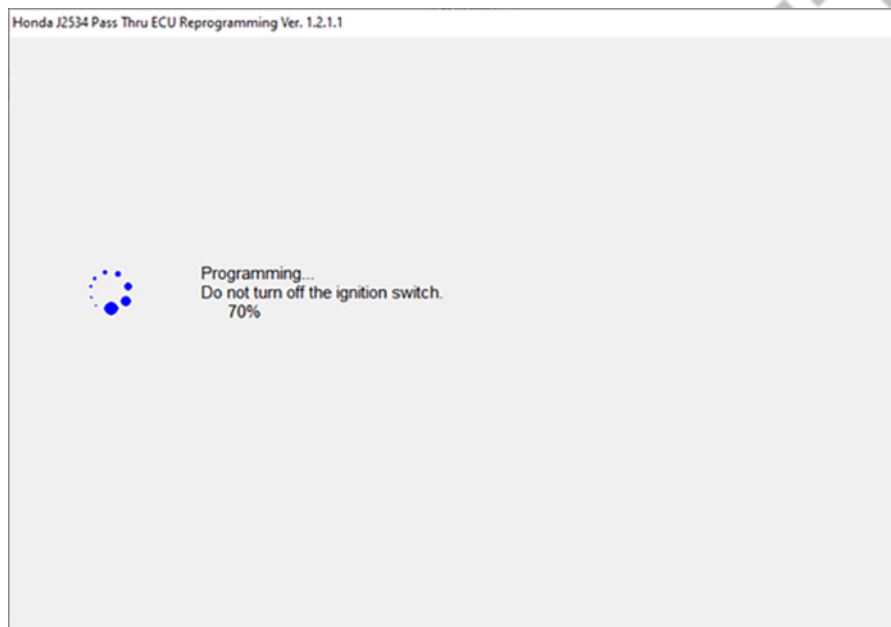
9. Select **ENTER** to begin reprogramming, and follow the screen prompts.

PGM-FI  
Completed.  
Turn the ignition switch OFF.
