**RECALL**

<b>ORIGINAL CREATION DATE:</b>	08/30/2023
<b>REVISION DATE:</b>	09/11/2023
<b>SUBJECT:</b>	400V E2Ver2 Body and ESM Software Update
<b>RATIONALE:</b>	Updates to vehicle response when certain fault codes associated with battery pack liquid accumulation and/or a thermal event are detected.
<b>VINs or MODELS AFFECTED:</b>	Service Specified Buses
<b>COMPLETE BY:</b>	Earliest Service Opportunity
<b>SERVICE CAMPAIGN #:</b>	SC-23-127
<b>NHTSA RECALL NUMBER:</b>	22V887
<b>REMEDY KIT NAME / NUMBER:</b>	065661
<b>ESTIMATED LABOR TIME:</b>	.75
<b>LABOR OP CODE:</b>	HB50V

**400V E2Ver2 Body and ESM Software Update**

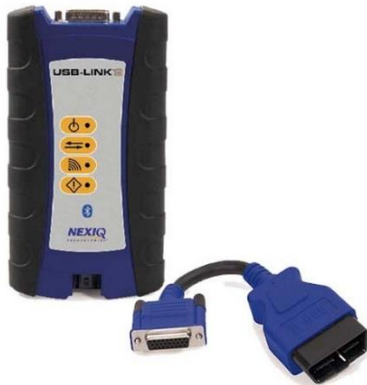
6. For example, here is the Nexiq USB Link connected to the Diagnostic Port located on the street side wheel well electronics cabinet (eCab).

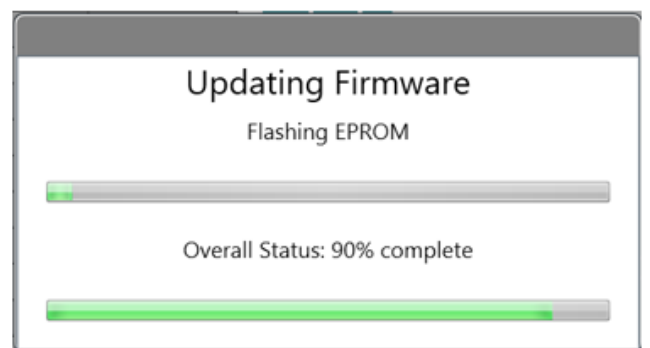
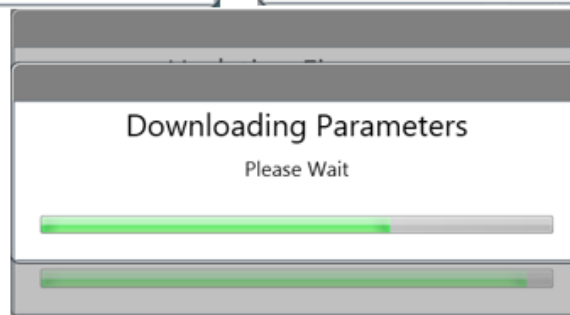
19. The Proterra Diagnostic Tool will connect to the device, and the following screens are displayed.
