**SUBJECT: RECALL CAMPAIGN SD
1985-1991 VOLKSWAGEN GOLF, GTI, JETTA
REPLACE HEAT EXCHANGER**

**Subject: Recall Campaign SD
1985-91 Volkswagen Golf, GTI, Jetta
Replace Heat Exchanger**

SD RECALL CAMPAIGN

Replace Heat Exchanger
on
**1985-1991 Golf,
GTI and Jetta**
VEHICLES

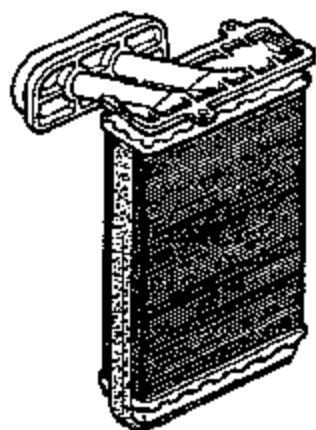
1 Heat Exchanger

Part Number: 1H1 819 030
includes gasket and
protective foam strip

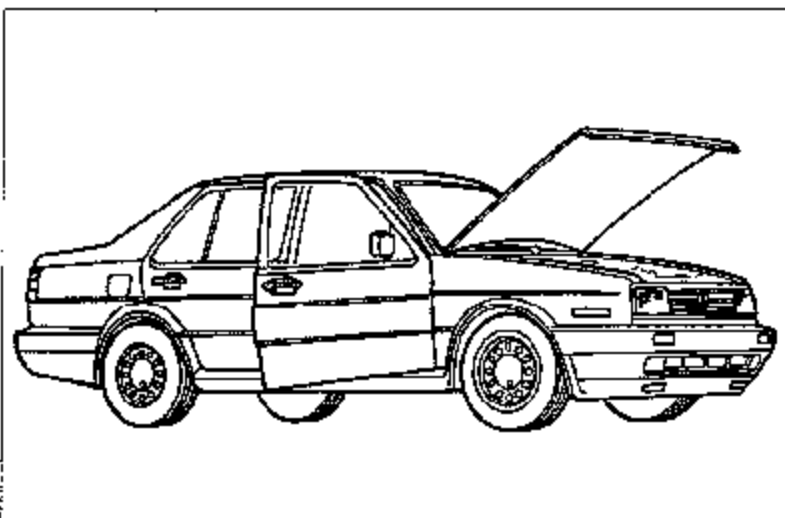
- Bring vehicle into shop
- Open hood and both front doors
- Install power saver
- Disconnect battery

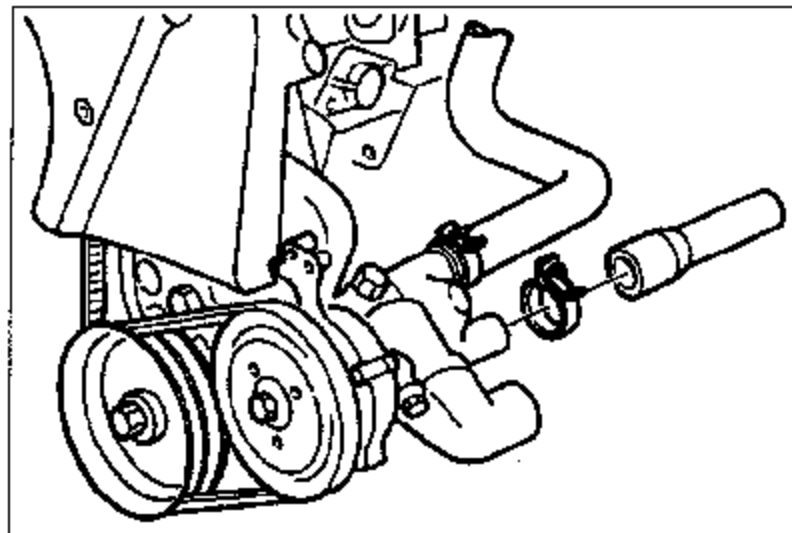
- Cut tie wraps holding wire harness to heater hoses.

- Disconnect both heat exchanger hoses at firewall, use special VW pliers KL3385

- Plug heat exchanger inlet and outlet pipes to avoid spilling coolant (see arrows)

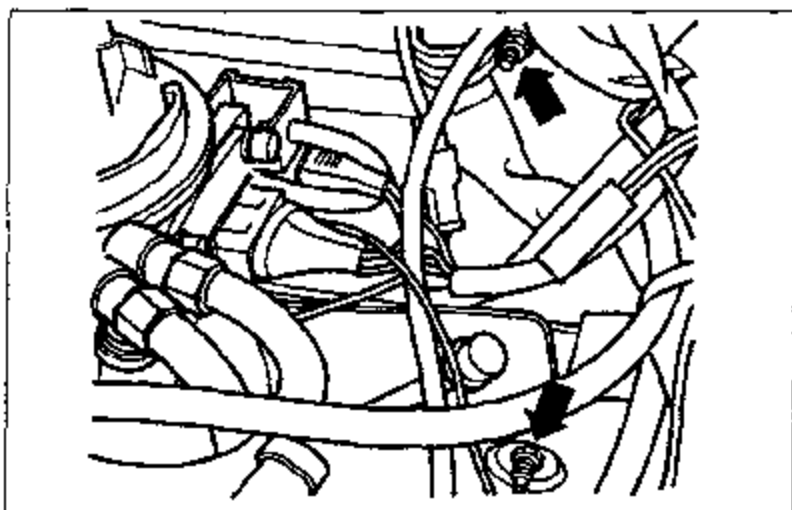
Remove two 6mm heater box retaining nuts near ignition coil (see arrows)

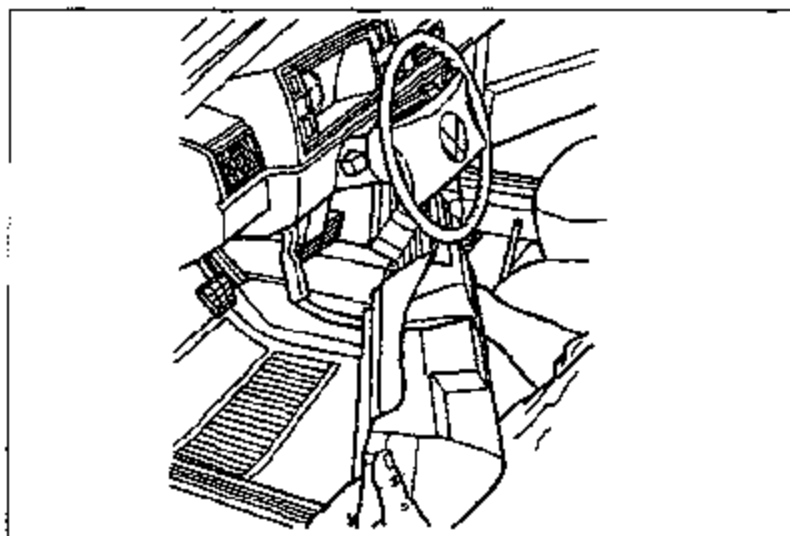
Remove left and right lower dashboard panels

Remove shift lever handle and cover

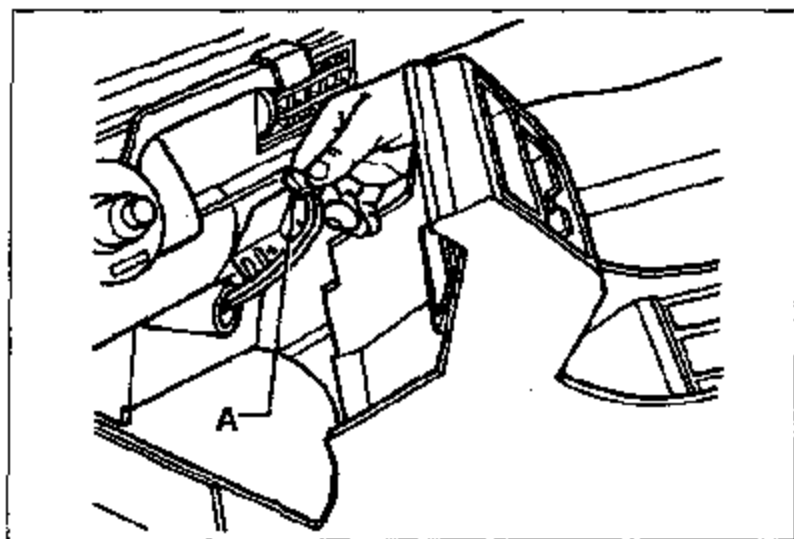
Remove center console fasteners and disconnect electrical connection(s) "A"

Note:
Steering wheel does not have to be removed. This and the following pictures do not show steering wheel for better clarity.

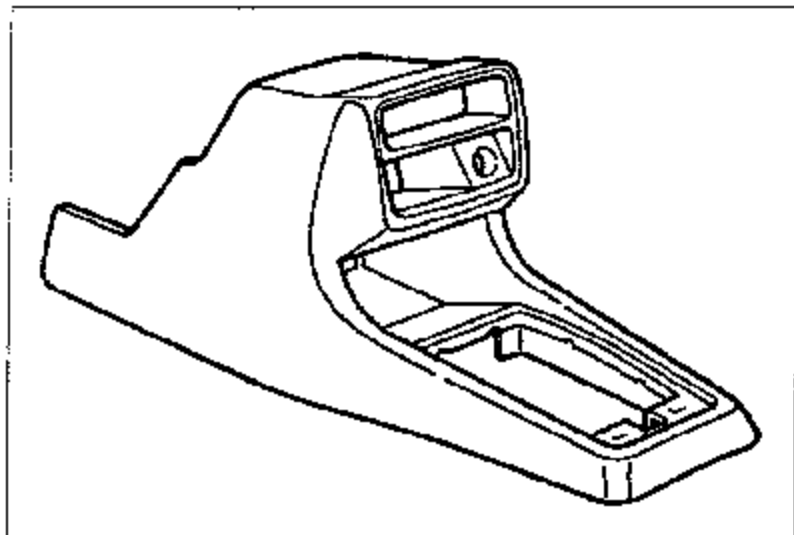
Remove center console from vehicle

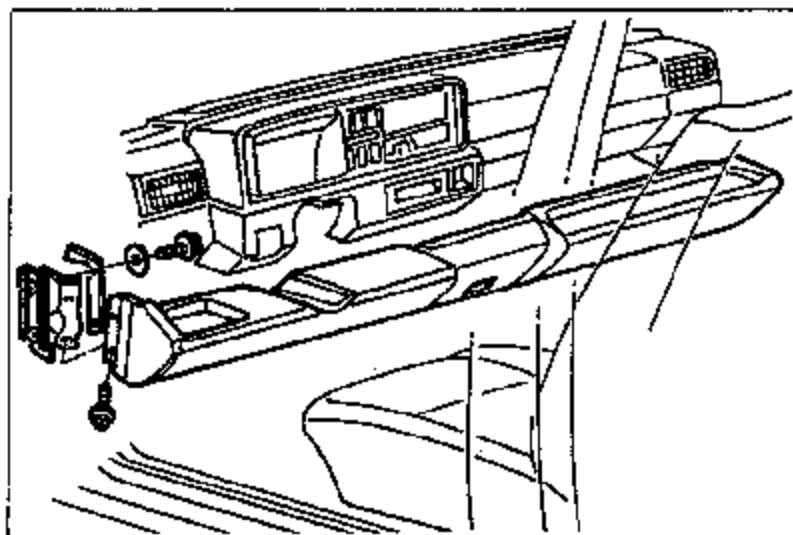
If vehicle is equipped with kneebar, disconnect fuse box from kneebar

Remove kneebar

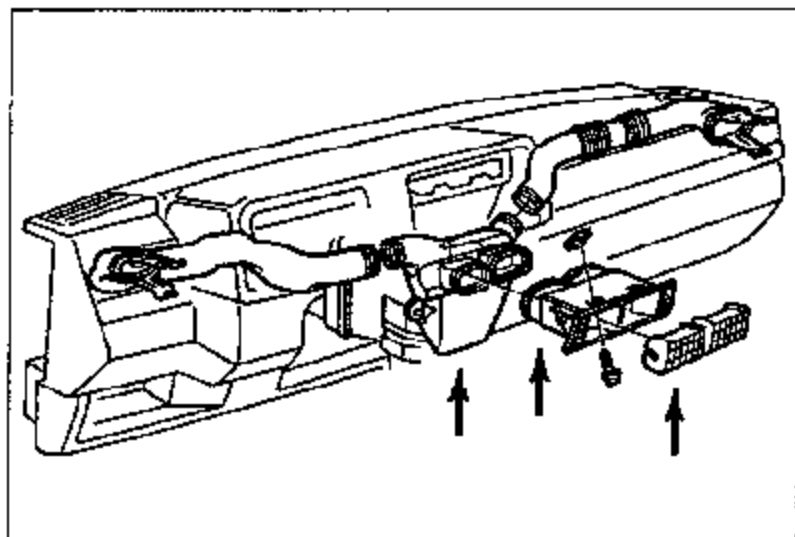
Remove center vent inserts, vent housing and defroster duct (see arrows)

2 screws secure center defroster duct to firewall

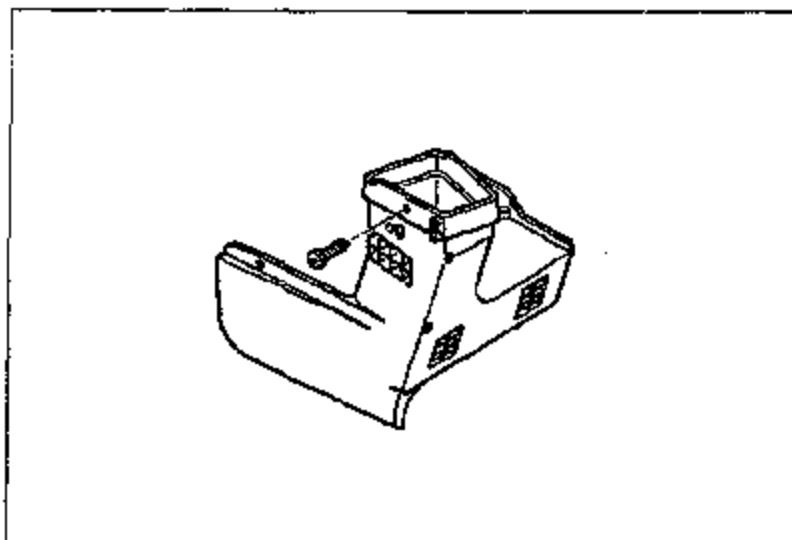
Remove/pull back felt covering on passenger side of heater box for easier access

Remove left footwell vent

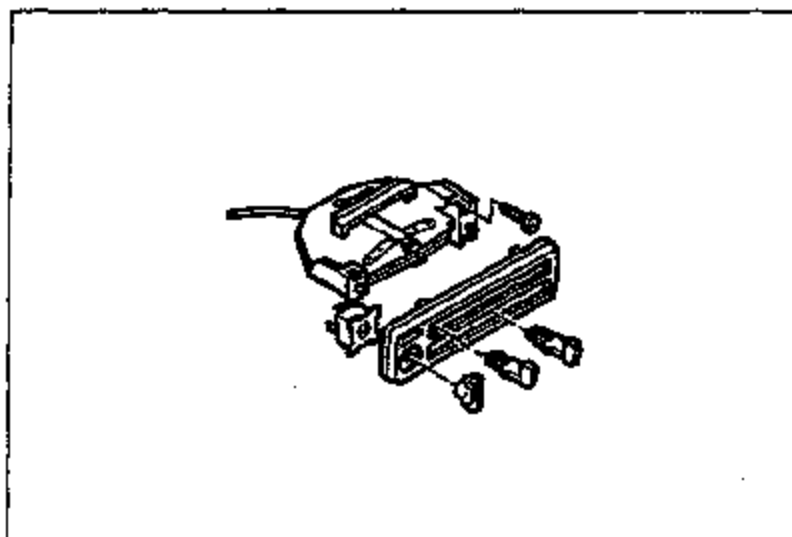
Remove knobs and trim plate for air/heater control unit and screws holding fresh air, A/C and heater control unit

Disconnect temperature control cable from control unit

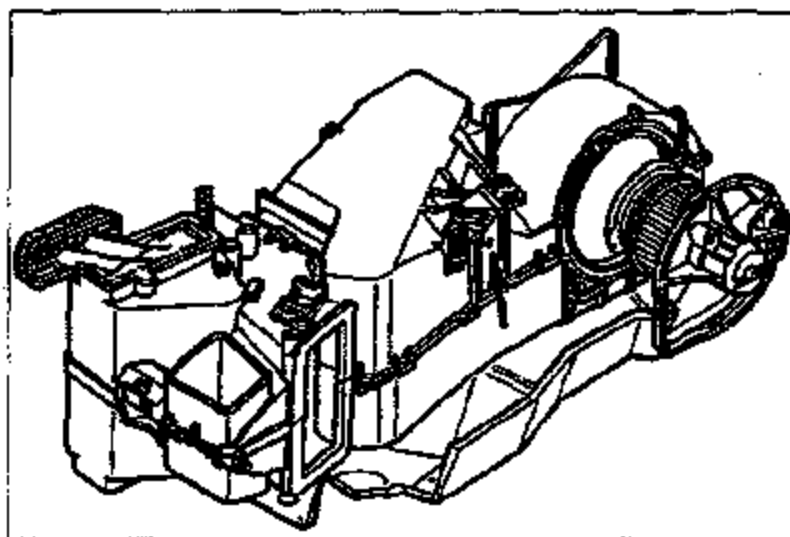
Loosen but do not remove evaporator/blower housing mounting bracket nut under dashboard next to glove box – see arrow – to gain sufficient access between box and firewall for the removal of the heater box securing clips

Caution:
Do not bend A/C lines

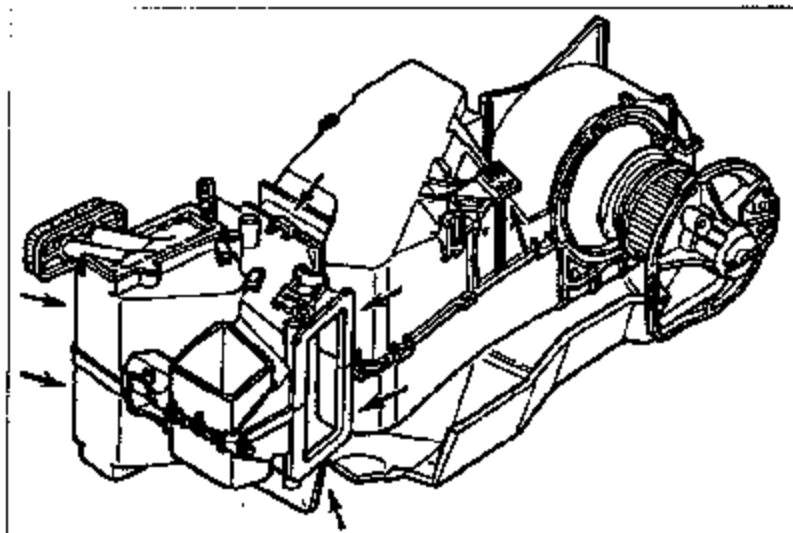
On drivers side, carefully pull heater box away from firewall for access

Remove all six securing clips – see arrows – holding heater box to evaporator/blower housing

• To remove the two clips on the firewall side use a thin screwdriver

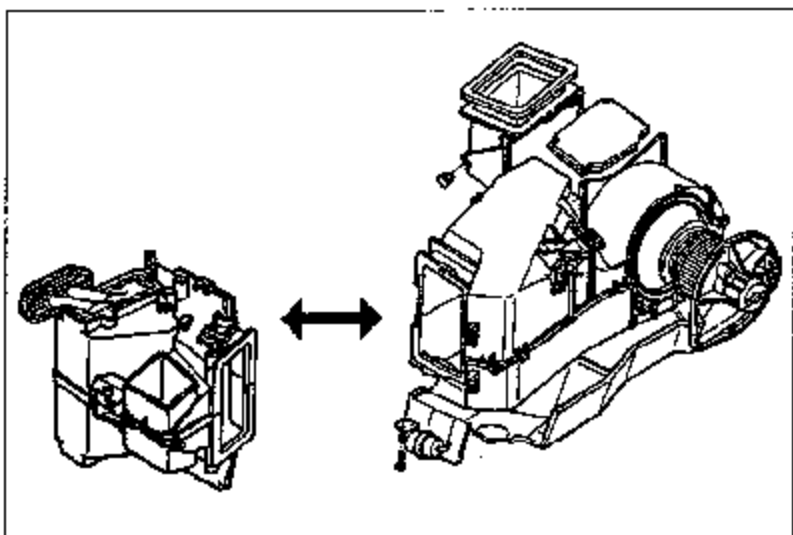
Separate heater box from evaporator/blower housing

Remove clip holding vacuum line

Do not break flap control lever

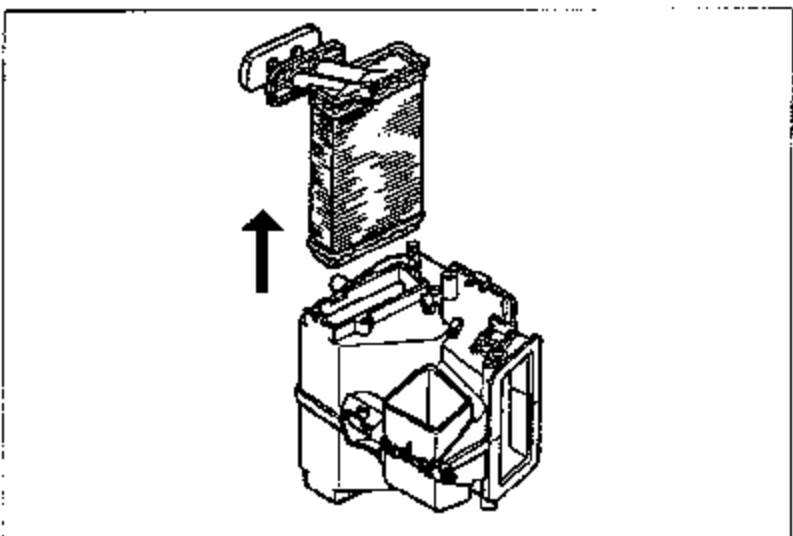
Carefully remove heater box from vehicle

Remove heat exchanger from heater housing – drain cooling fluid and discard heat exchanger

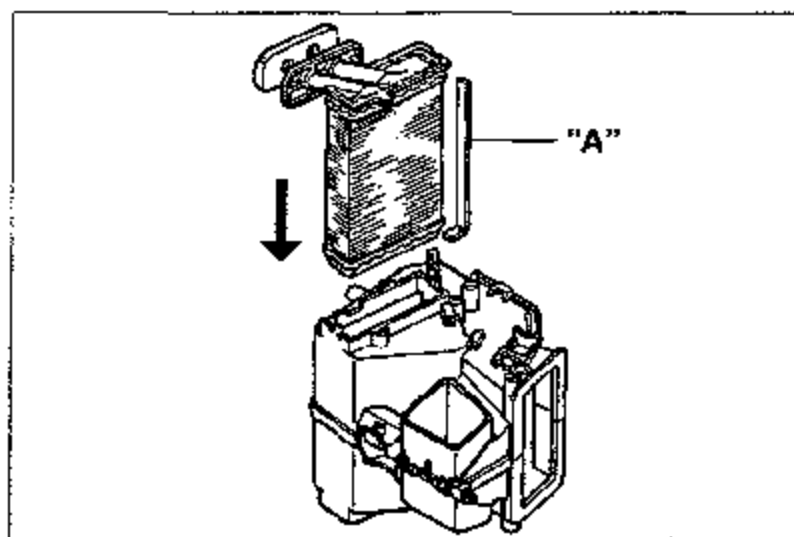
Install new heat exchanger, part number 1 H1 819 030 into heater housing; seat properly

Ensure that foam strips "A" are properly in place

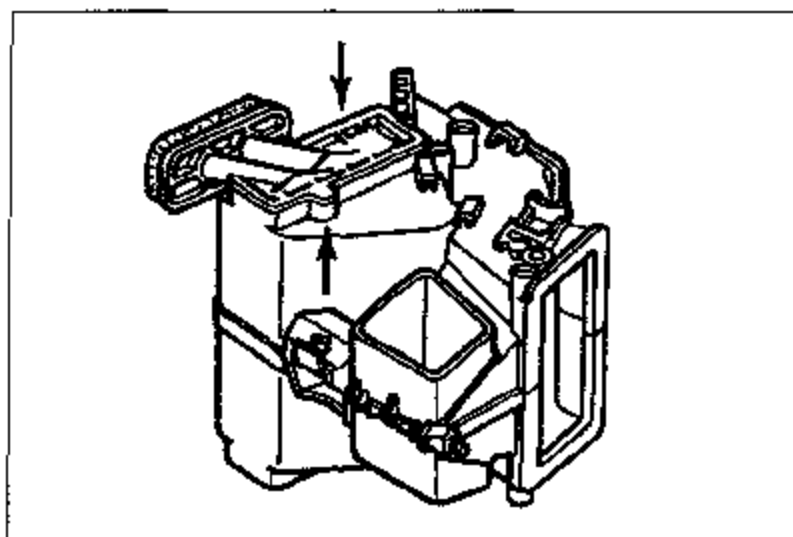
If retaining clips holding the heat exchanger in place are broken, secure with two metal screws, part number N 013 966 12 (see arrows)

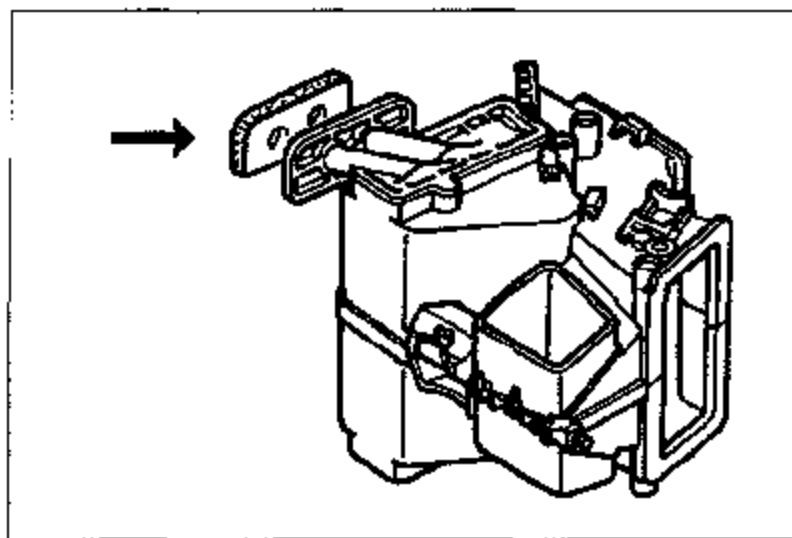
Attach supplied new gasket, part number 191 819 019 to heat exchanger inlet/outlet pipes

Ensure that gasket (see arrow) is in place

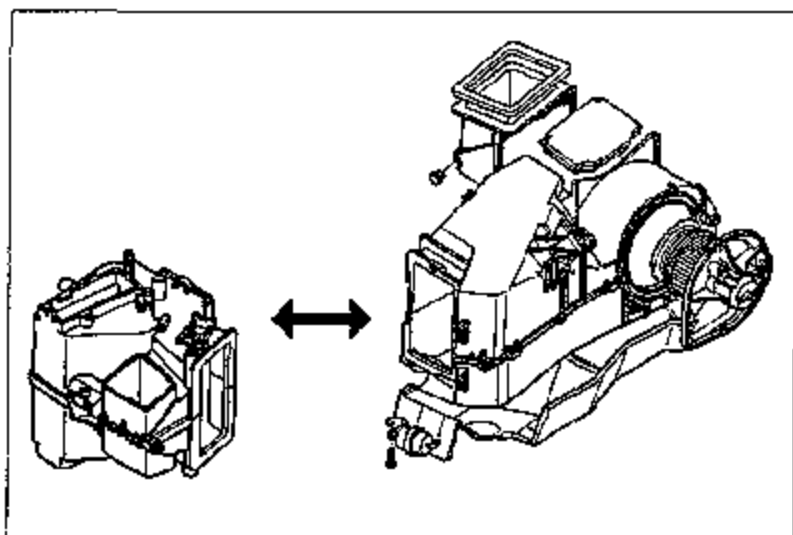
Align heater box to evaporator/
blower housing and slide
together

Secure heater box with all six
retaining clips starting with front,
top and bottom

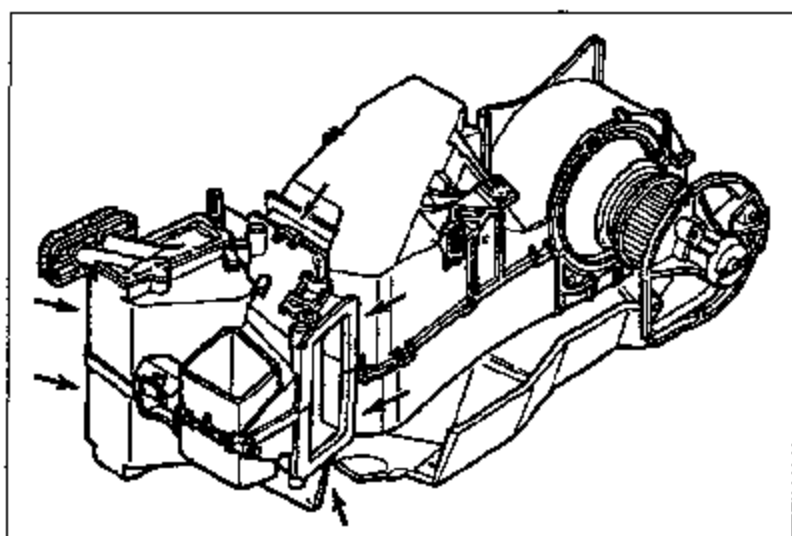
• Between firewall and heater box
carefully push up the two clips from
lower corner of edge or use caulking
strip to hold clip to right hand middle
finger and guide clip into position.
Either way, use middle finger to
secure clip

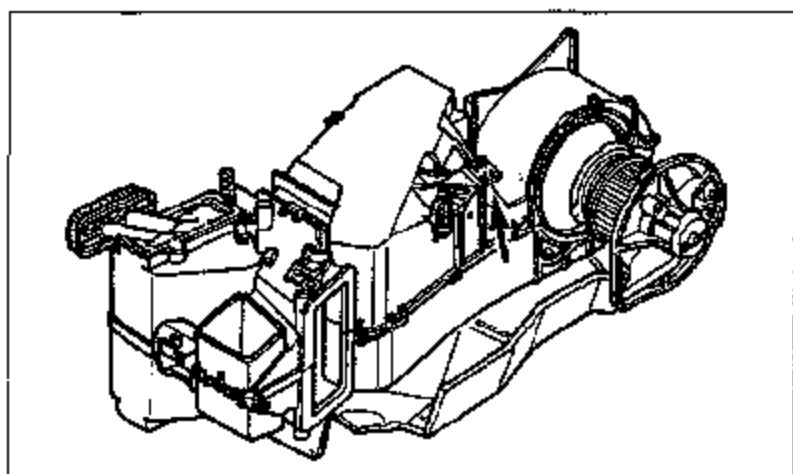
Retighten evaporator/blower housing
mounting bracket nut next to glove box
(see arrow)

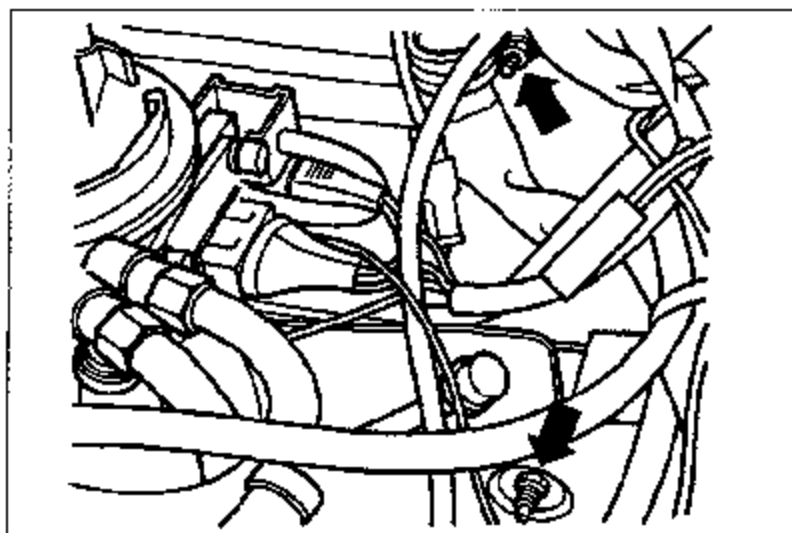
Reinstall and tighten two 6mm nuts holding heater box to firewall (see arrows)

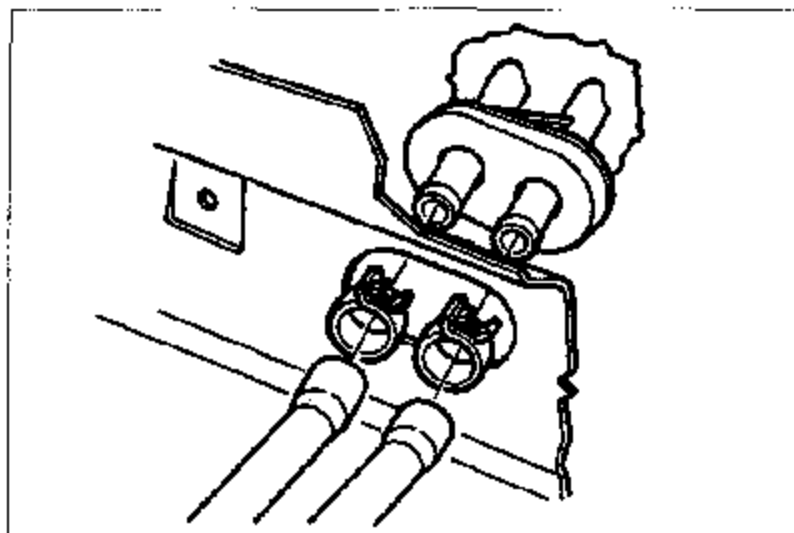
Reconnect both heater hoses to new heat exchanger; using special VW pliers KL3385

Loosely attach wire harness to heater hose using new tie wraps, part number N 020 902 1

Reconnect thermostat housing using new gasket, part number 059 121119

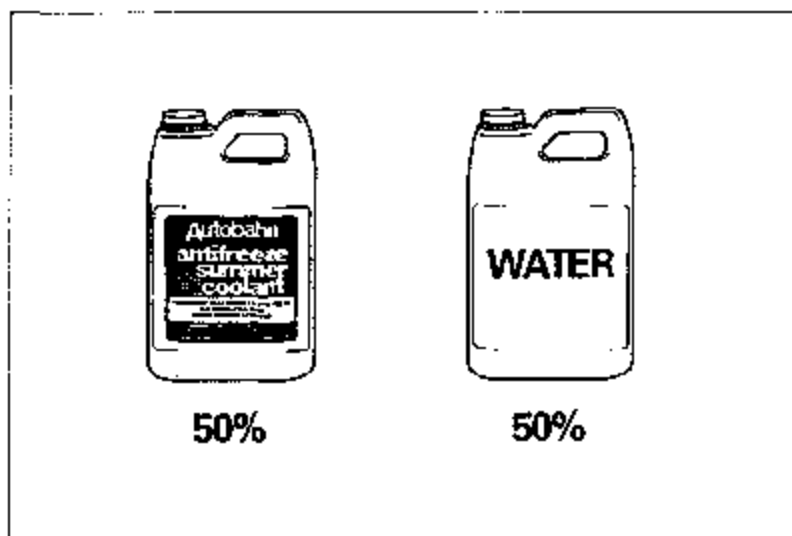
Refill cooling system with new mixture; use antifreeze, part number ZVW 237 104 and mix 50/50 with water prior to filling

Note:
It is imperative that system is filled with VW supplied phosphate-free antifreeze coolant mixture

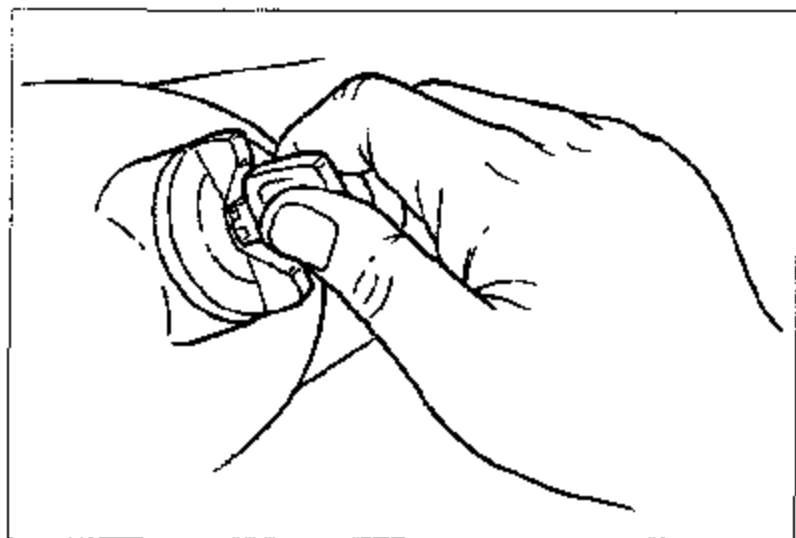
Reconnect battery

Start engine and warm up to a point where the cooling fan cycles **at least once**

Check cooling system for leaks

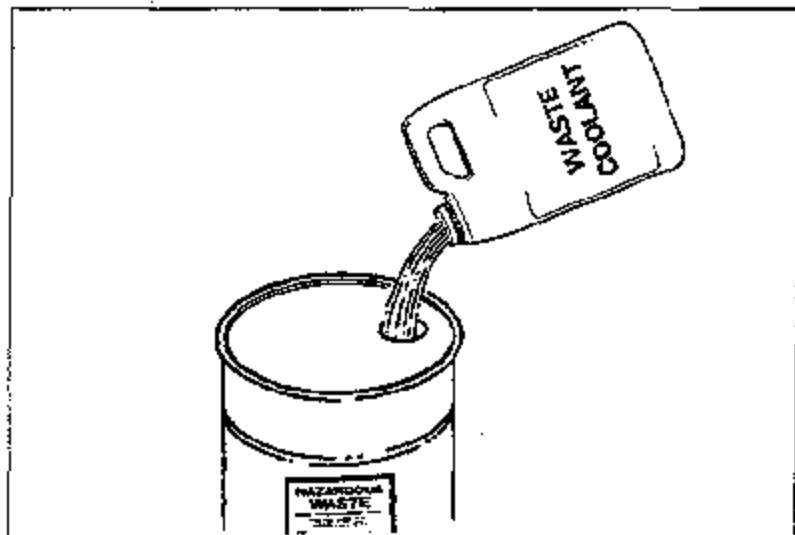
- Do not spill drained coolant fluid

- Store drained coolant fluid in appropriate container in accordance with your state or local requirements
