**IMPORTANT RECALL INFORMATION #40521  
JULY 2004**

**SUBJECT: PRODUCT RECALL #40521 ALUMINUM WHEEL LUG NUT TORQUE  
2002 & 2003 Pride & Triumph Conventional & Fifth Wheel Travel Trailers  
and 2004 Pride, Triumph, Prowler, Wilderness, Terry, Mallard and Pioneer  
Conventional & Fifth Wheel Travel Trailers**

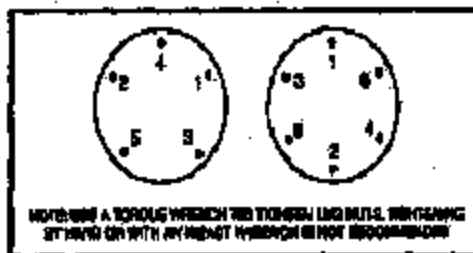
### Wheel Lug Nut Tightening Sequence

Place the wheel on the wheel mounting surface. Replace the wheel lug nuts with the rounded end of the lug nut toward the wheel. Tighten each lug nut by hand until the wheel is held against the wheel mounting surface. Lower the tire to the ground. Tighten the lug nuts to an initial 60 ft.-lbs., and then to the final torque specification.

Before each trip be sure to check and tighten the wheel lug nuts if necessary to the torque specification. If a wheel has been removed or replaced check the torque again at 10, 25, and 50 miles of initial road use.
