This Service Information bulletin supersedes S.I. B12 04 04 dated July 2004.

**Safety Recall Campaign 04V-344: DME Replacement on N62/N73 Engines**

2004 MY 545i and 545iA produced from May 2004 through July 2004.

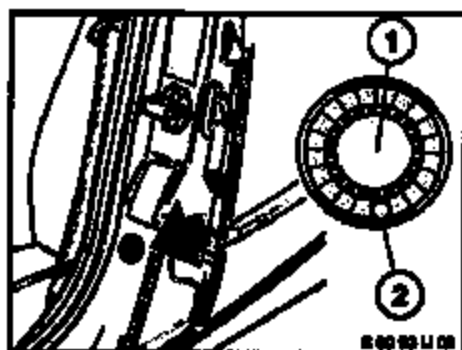
**LABEL INSTRUCTIONS**

This Recall Campaign has been assigned code number 416. After the vehicle has been checked, and corrected if necessary, obtain a label (SD 92-253) and:

- a. emboss your BMW dealer warranty number in the middle of the label (1);
- b. punch out code number 416 printed on the label and,
- c. affix the label to the B pillar as shown.
