Recall Campaign 04V-409: Increased Engine Speed with Slight Clutch Pedal Pressure

E53 X5 with the 3.0 liter engine and manual transmission produced from 8/25/2003 through April 15, 2004.

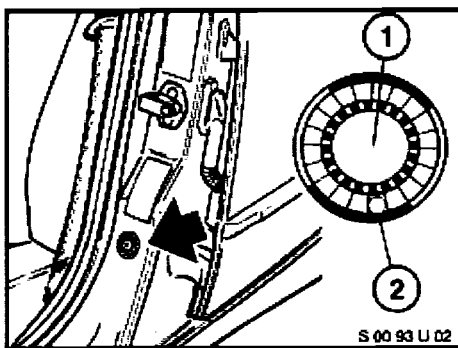
LABEL INSTRUCTIONS

This Recall Campaign has been assigned code number **421**. After the vehicle has been checked, and corrected if necessary, obtain a label (SD 92-267) and:

- a. emboss your BMW dealer warranty number in the middle of the label (1);
- b. punch out code number **421** printed on the label and,
- c. affix the label to the **B** pillar as shown.
