HYUNDAI DE PUERTO RICO  
C/O MMSC  
Road 2 Km. 20.1 Candelaria Ward, Toa Baja, PR 00949  
P.O. Box 192216, San Juan, PR 00919-2216  
Tel. (787) 999-4310 Fax (787) 251-3024 / 8700  
www.hyundaipr.com

**RE: Defect Information Report**

Certain model year 2005 Hyundai Tucson vehicles produced beginning July 30, 2004 through February 27, 2005.

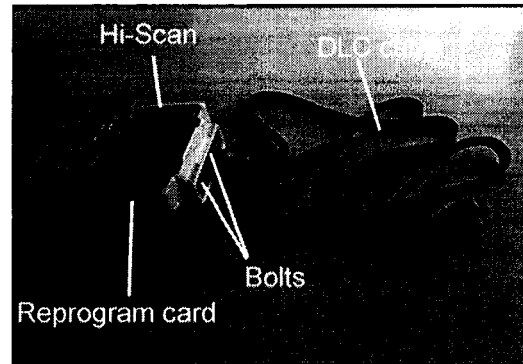
DCP03217

- 1) Attach the Data Link Connector (DLC) cable to the Hi-Scan Pro main body and securely tighten the two bolts.
- 2) Remove the system software card from the Hi-Scan Pro and insert the reprogramming software card, with the new ECM program, into the Hi-Scan top slot.

The only card in the Hi-Scan should be the reprogramming card.

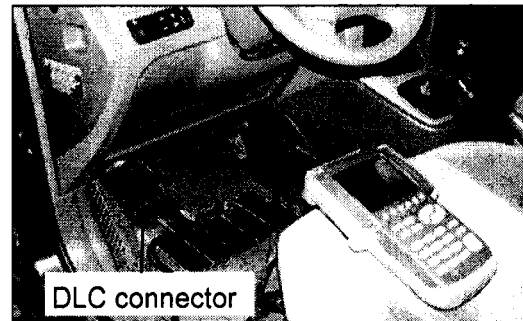
DSC06262

- 3) Plug the DLC cable from the Hi-Scan Pro into the data link connector (16 Pin connector) under the instrument panel on the driver's side.

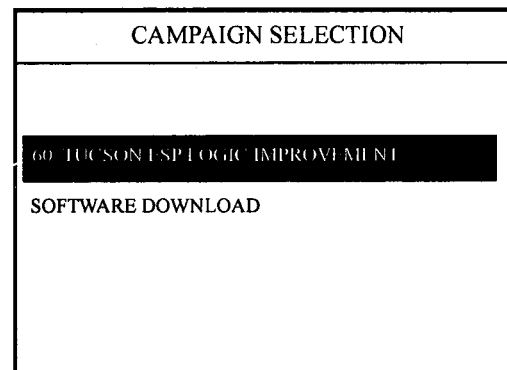
- 4) Turn the ignition switch to the ON position (Do not start the engine).
- 5) Turn the Hi-Scan Pro ON and press ENTER.
- 6) Select option "60. TUCSON ESP LOGIC IMPROVEMENT" and press ENTER.
