**Subject: Recall Campaign JH (05V-0⁹36)
2003-2004 Audi A4 Cabriolet and 2004 Audi S4 Cabriolet
Replace Xenon Headlight Reflectors**

**Subject: Safety Recall JH
2003-2004 Audi A4 Cabriolet and 2004 Audi S4 Cabriolet
Replace Xenon Headlight Reflectors**

Subject: 2003-2004 Audi A4 Cabriolet and 2004 Audi S4 Cabriolet Vehicles Equipped with Xenon Headlights Replace Left and Right Xenon Headlight Reflectors

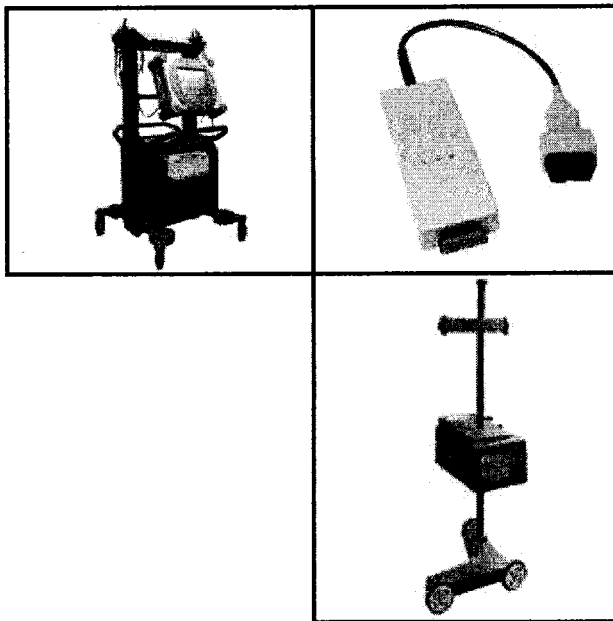
Special Tools and Equipment:

⇐ VAS 5051 or VAS 5052

⇐ VAS 6017B K-wire adapter

⇐ Hella Universal Beamsetter IV VAS 5107

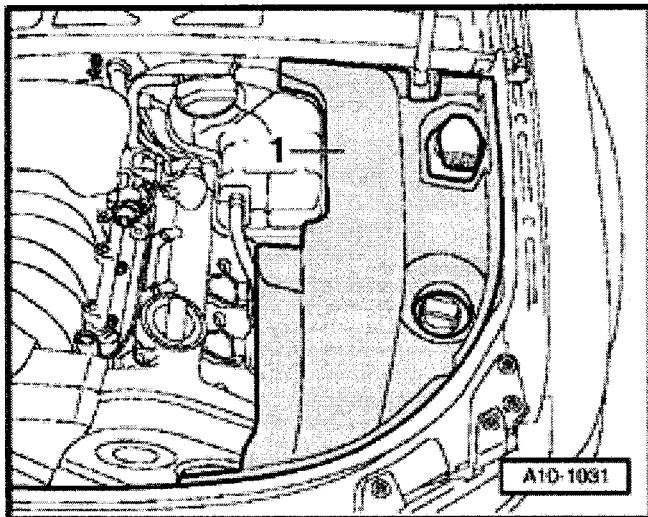
Left headlight

- ← Remove cover -1- in engine compartment (left side), if present

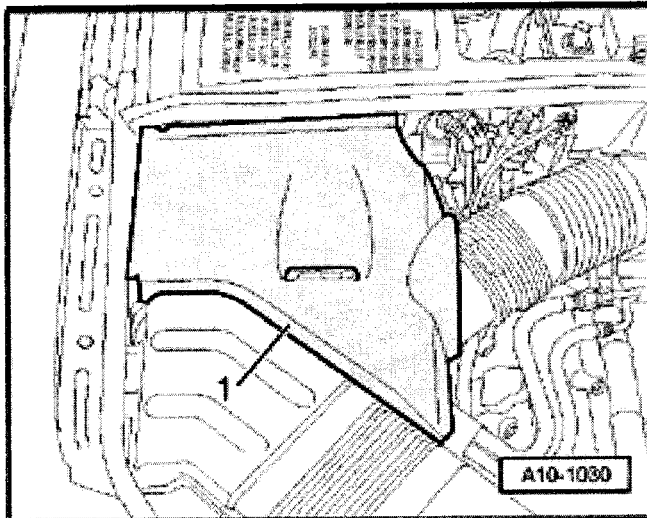
Right headlight

⇐ Remove cover -1- in engine compartment (right side), if present

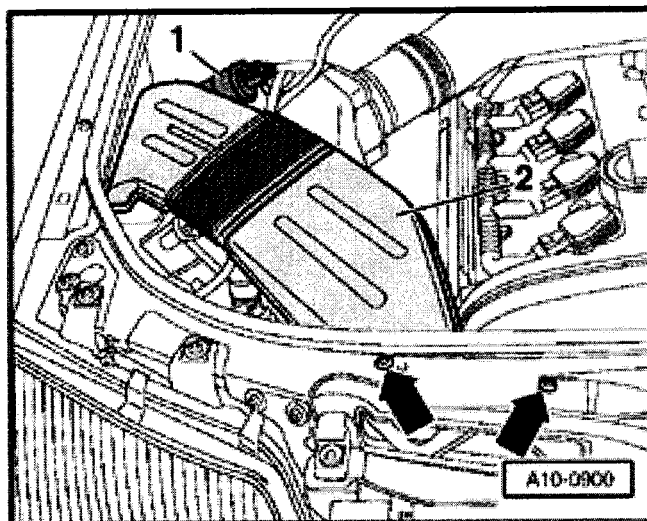
⇐ Remove bolts -arrows-

⇐ Detach Evaporative Emission (EVAP) Canister Purge Regulator Valve -N80- -1- at air guide

⇐ Remove air guide -2-

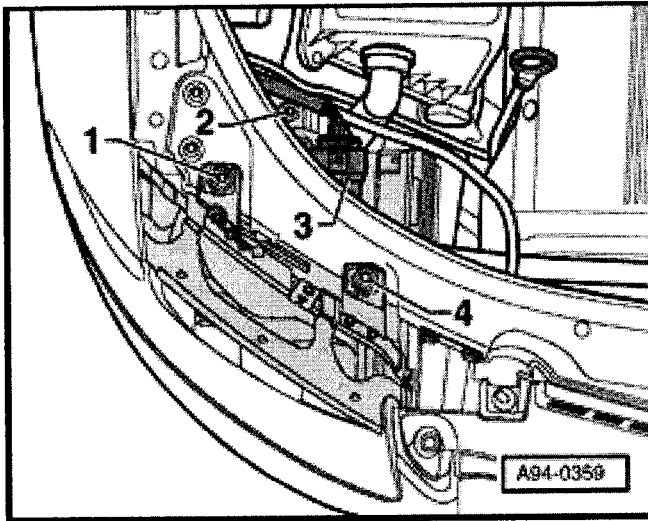
Both sides

- Apply adhesive tape below headlights to protect paint
- ⇐ Remove bolts -1- and -4-
- ⇐ Loosen bolt -2- several turns but do not remove
- Cut cable tie, if present
- ⇐ Disconnect electrical harness connector -3-

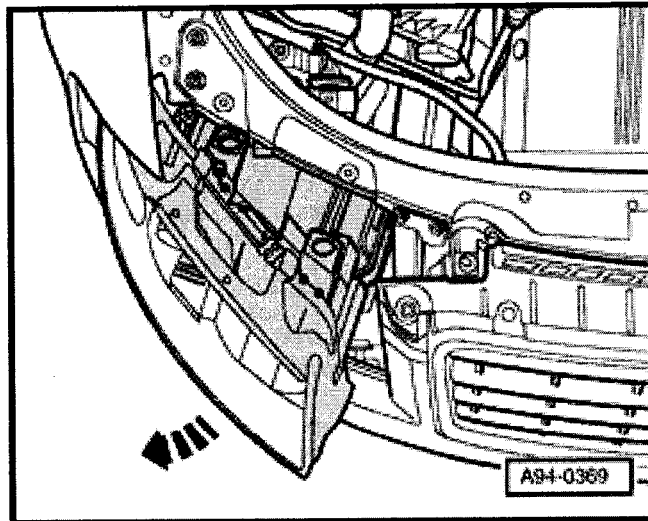
- ⇐ Swing headlight in direction of fender
- Remove headlight from body by pulling outward

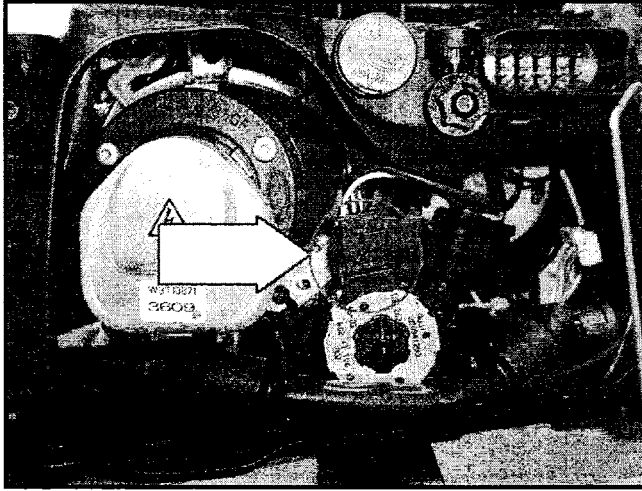
- Remove housing cover from headlight housing
- ⇐ Disconnect connector -arrow- from headlight adjusting motor

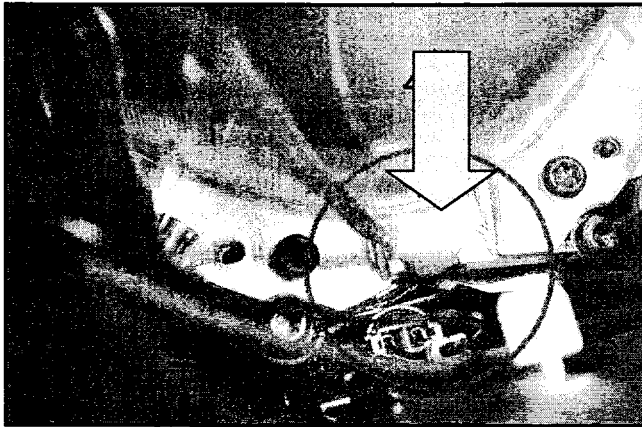
- ⇐ Disconnect ground cable -arrow- for gas discharge bulb from headlight beam screen

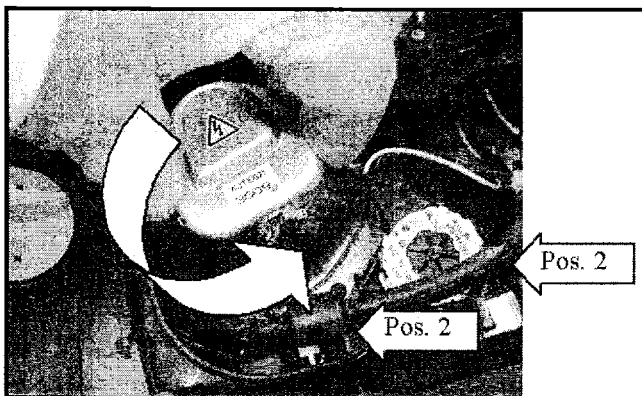
- ⇐ Push harness connector for gas discharge bulb down slightly while turning counterclockwise -curved arrow-, then pull connector from gas discharge bulb
- ⇐ Pull harness for gas discharge bulb from both mounting tabs -Pos. 2-

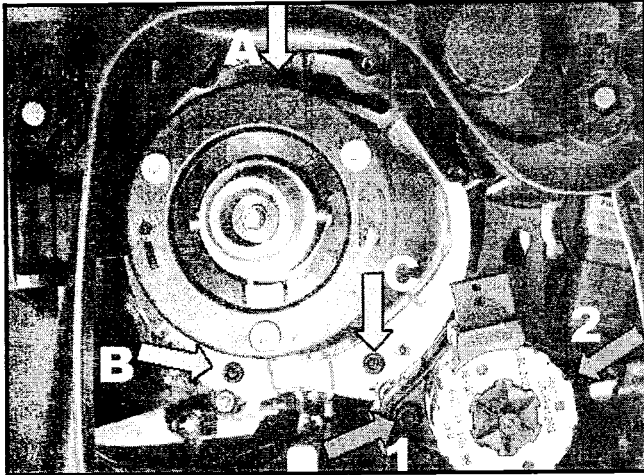
- ⇐ Use Torx T20 to remove screws -arrows A, B and C-, holding gas discharge reflector in place
- ⇐ Loosen screws -arrows 1 and 2- for headlight adjusting motor, but do not remove them
- Tilt headlight adjusting motor slightly, making sure connecting rod does not become disengaged from reflector assembly

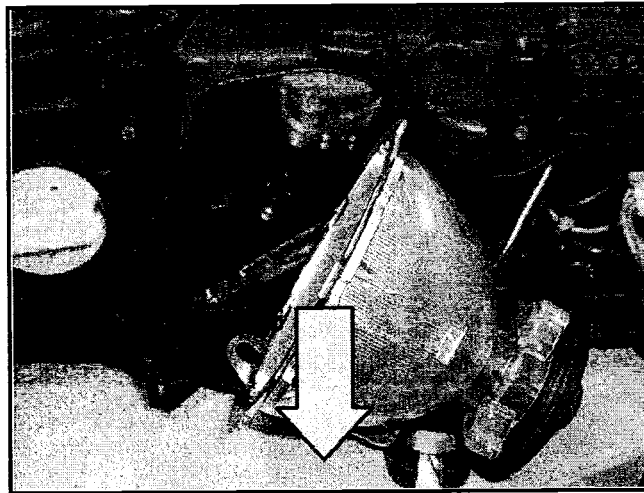
- Put on gloves supplied in reflector kit to avoid damaging bulb and reflector
- ⇐ Remove reflector
 - If necessary, push cable to side and pull reflector out diagonally -arrow-

Note: Glass portion of bulb must not be handled without gloves under any circumstances

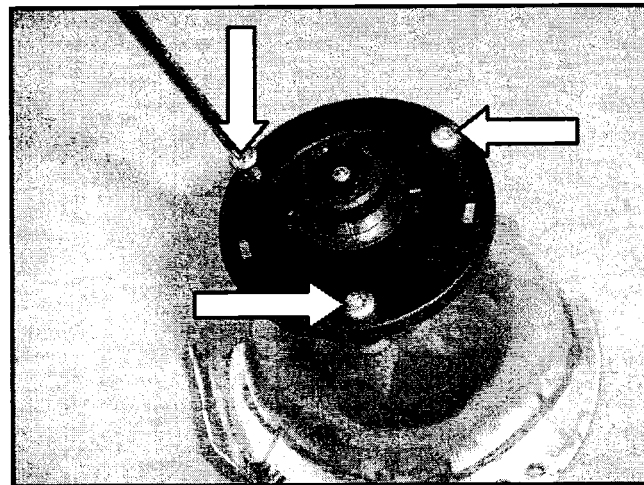
- ⇐ Remove Torx T10 screws -arrows- then remove retaining ring
- Pull gas discharge bulb out by base and lay carefully to the side

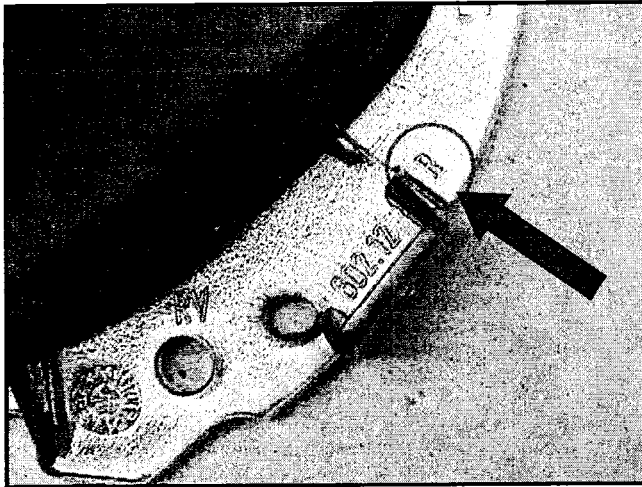
⇐ Locate mark on new reflector -arrow- that indicates on which side of vehicle to install reflector (mark is next to tab sticking out on edge of reflector)

- R - right headlight reflector
- L - left headlight reflector

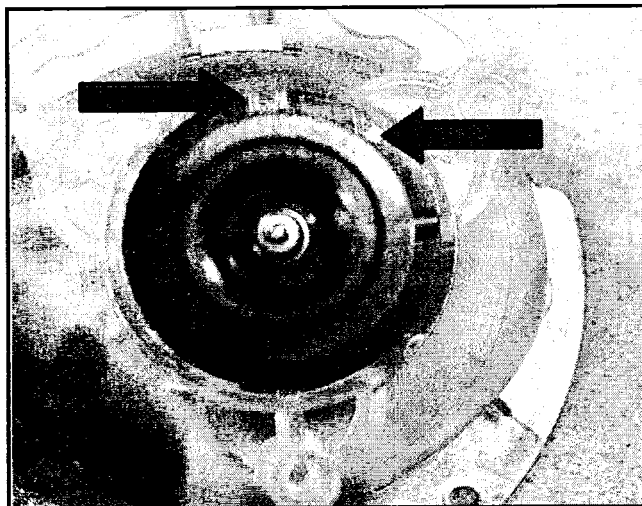
• Install gas discharge bulb in new reflector, careful to only touch bulb base

⇐ Pay attention to locating tabs -arrows-

- Set retaining ring on and install Torx T10 screws

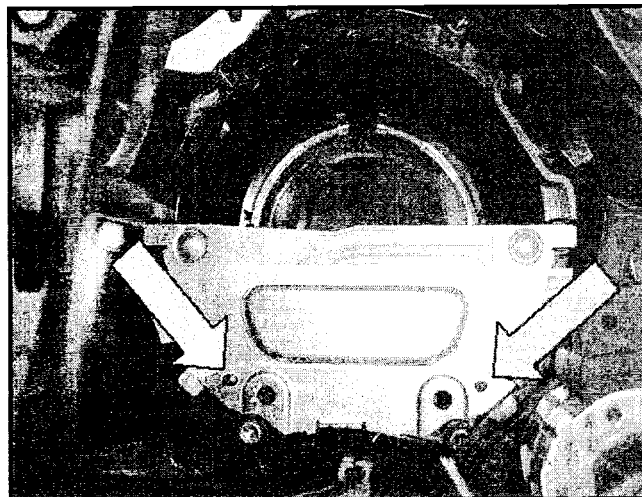
⇐ Examine position of headlight beam screen in headlight. Make sure it is properly located on guide pins -arrows-

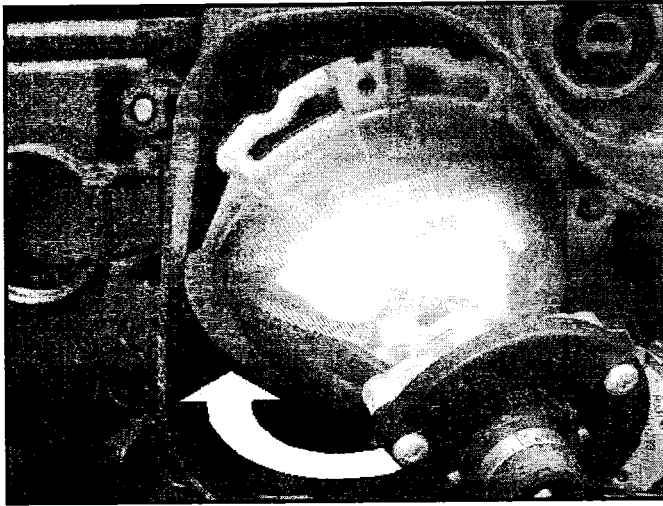
Note: Left and right side reflectors are different, pay attention to location

⇐ Install new reflector in headlight housing

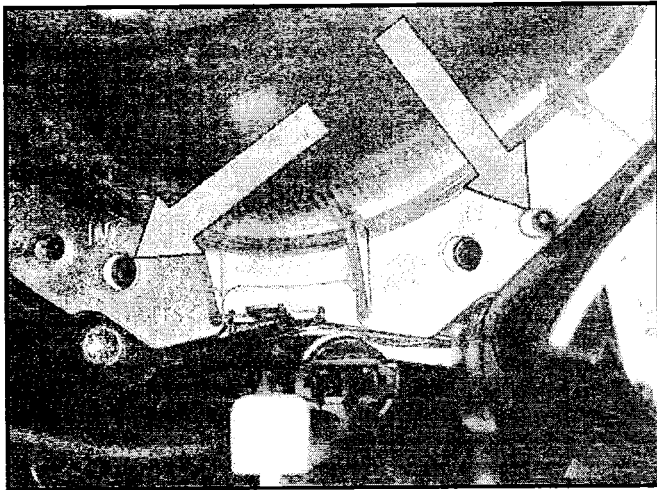
⇐ Align reflector with headlight beam screen over guide pins -arrows-

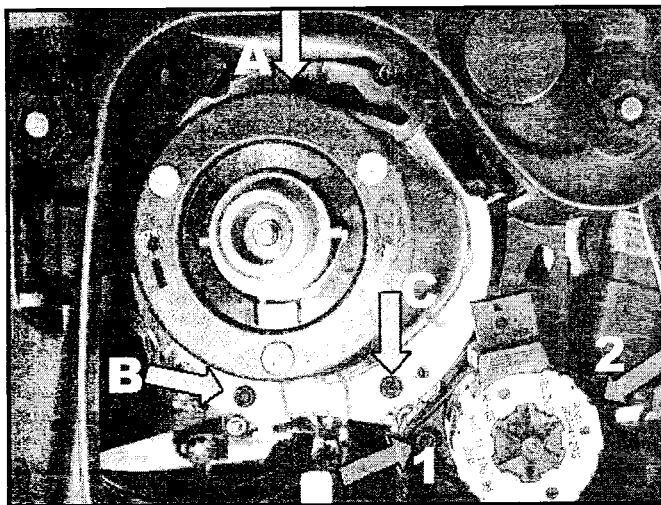
⇐ Using Torx T20 install screws -arrows A, B and C- for reflector

⇐ Tighten two screws -arrows 1 and 2- for adjusting motor

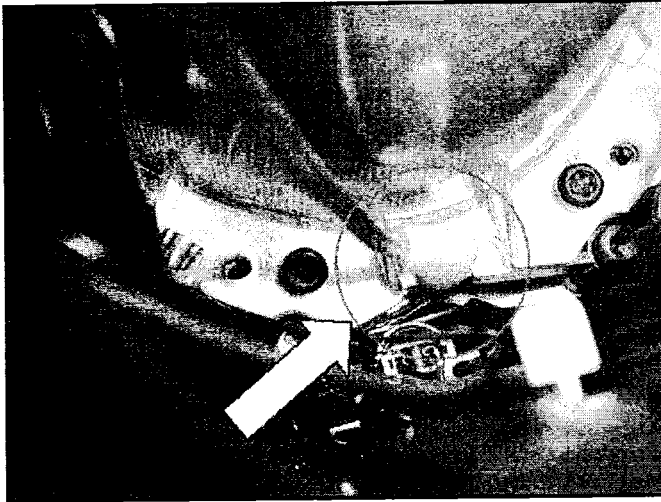
- ⇐ Connect ground cable on terminal at bottom of headlight beam screen

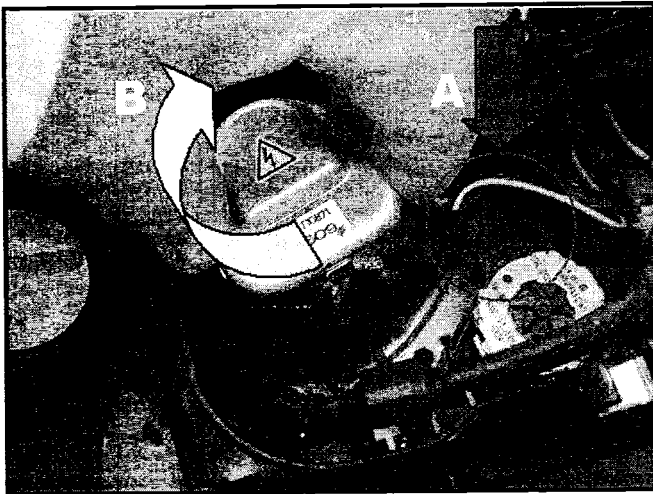
- ⇐ Connect connector to headlight adjusting motor -arrow A-
- ⇐ Install harness connector for gas discharge bulb -arrow B- by pushing it down slightly while turning clockwise

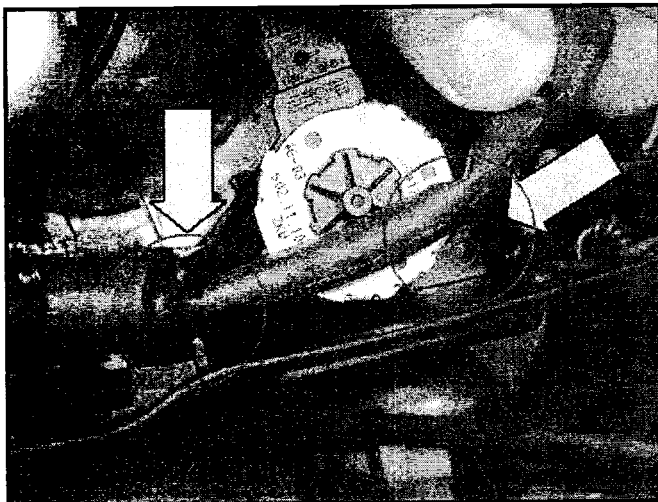
- ⇐ Clip harness connector for gas discharge bulb in both places -arrows-
- Install headlight cover
- Repeat procedure for opposite headlight

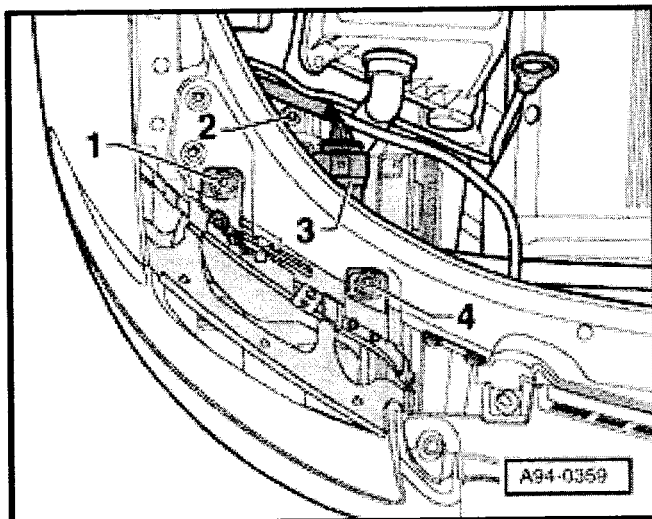
- ← Install bolts -1-, -2- and -4- and torque to 6 Nm (53 in. lbs.)
- ← Connect electrical harness connector -3-
- Reconnect battery ground (GND) cable and tighten to 6 Nm (53 in. lbs.)
- Reinstall battery cover
- Set anti-theft radio code and check operation
- Set clock and power window pinch protection
- Set power seat memory initialization, if present
- Adjust headlights using VAS 5051 or VAS 5052 with VAS 6017B and VAS 5107 Hella Universal Beamsetter IV
- Replace air guide and engine covers
- Close hood
- Destroy and properly dispose of removed part(s)

- Install headlights in reverse of removal, making sure to:
 - Push headlight horizontally up to stop on bottom headlight mount
 - Align headlight to contours of body (gap widths)
