**HYUNDAI AMERICA TECHNICAL CENTER, INC.**

RE: Recall Number 05V-119 Defect Information Report (additional information)  
(Hyundai Campaign 068)

**Subject: Campaign 068 – 2005 MY Tucson - Electronic Stability Program (ESP) Hydraulic Electronic Control Unit (HECU) Reprogramming Procedure**

Group	CAMPAIGN
Number	05-01-003

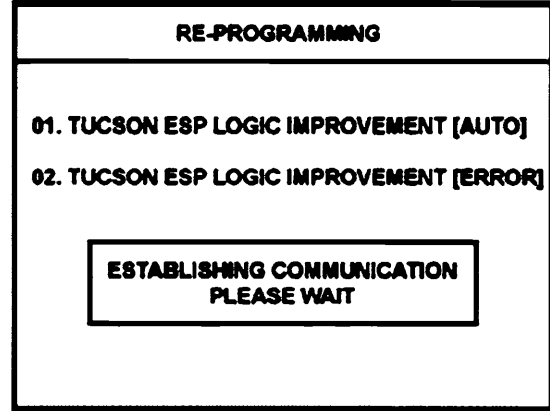
9. The Hi-Scan Pro will establish communication, check the HECU ID, and reprogram the HECU automatically. Wait until the reprogramming is complete.

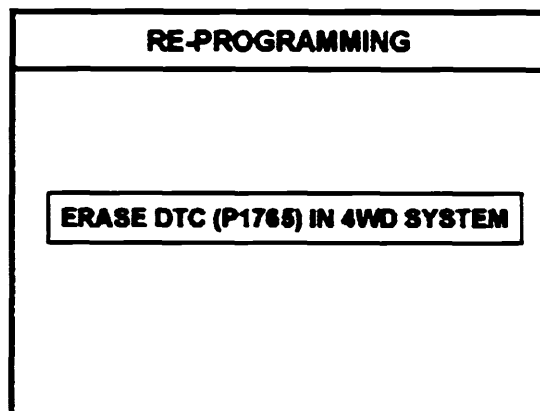
12. Turn the ignition key to the “**OFF**” position for 20 seconds and then start the engine to check for proper operation.
13. For 4WD vehicles only, the diagnostic code information “**ERASE DTC (P1765) in 4WD SYSTEM**” is displayed when the reprogramming has been completed. This does not indicate a problem, and the DTC P1765 diagnostic code may be cleared by following the procedure on page 10 of this TSB.

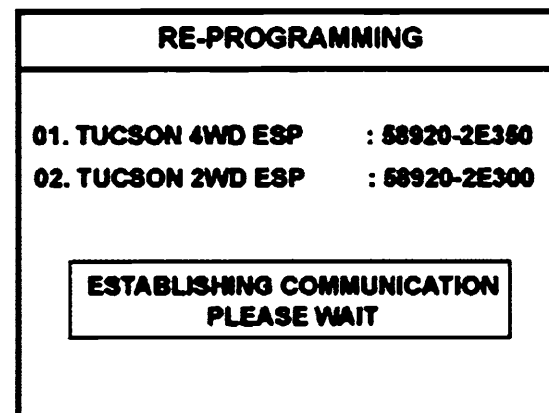
8. Wait until the reprogramming is completed.

- Do not interrupt the reprogramming at any time.
- The ESP HECU will be rendered inoperative if the program does not download completely.

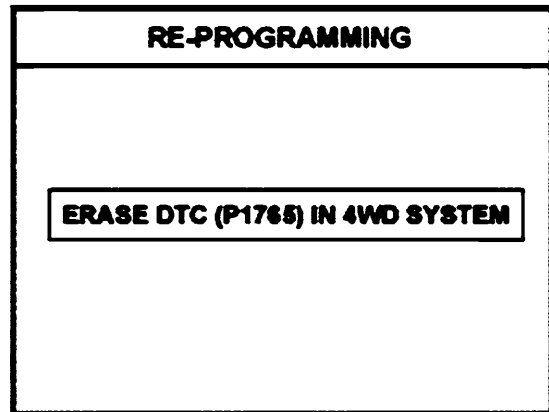
- The Hi-Scan Pro displays the new ESP HECU ID on the Hi-Scan Pro screen.
- Check the ESP HECU ID displayed on the Hi-Scan Pro screen to verify that the correct ESP HECU software is being downloaded, as shown in the “ESP HECU SPECIFICATION TABLE” on page 2 of this TSB.

9. When the “**REPROGRAMMING COMPLETED**” message is displayed, turn the Hi-Scan Pro off and the software loading process is complete.

11. For 4WD vehicles only, the diagnostic code information “**ERASE DTC (P1765) IN 4WD SYSTEM**” is displayed when the reprogramming has been completed. This does not indicate a problem, and the DTC P1765 diagnostic code may be cleared by following the procedure on page 10 of this TSB.
