GM SERVICE AND PARTS OPERATIONS
DCS1467
URGENT DISTRIBUTE IMMEDIATELY

Subject: 05027 Product Safety Recall
 Fuel Module Reservoir Assembly

Models: 2000-2001 Chevrolet 1500 Series Suburban
 2000-2001 GMC 1500 Series Yukon XL

PRODUCT FIELD ACTION ANNOUNCEMENT

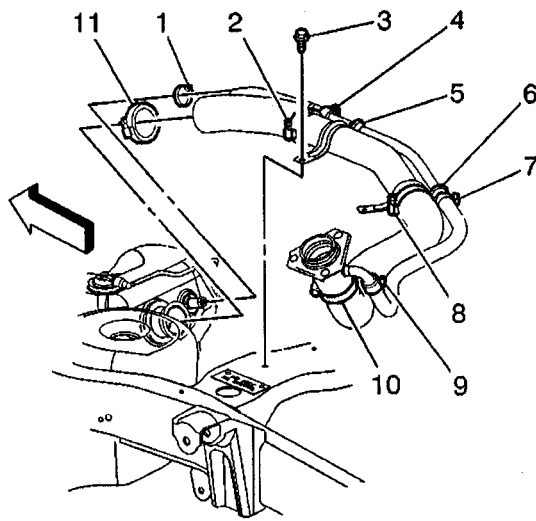
570590

9. Loosen the fuel fill hose clamp (2).
10. Disconnect the fuel fill hose from the fuel fill pipe.
11. Loosen the vent hose clamp (4).
12. Disconnect the vent hose from the vent pipe.
13. Use a hand or air operated pump device in order to drain as much fuel through the fuel fill pipe as possible.
14. Remove the left and right evaporative emission (EVAP) canister mount bolts.

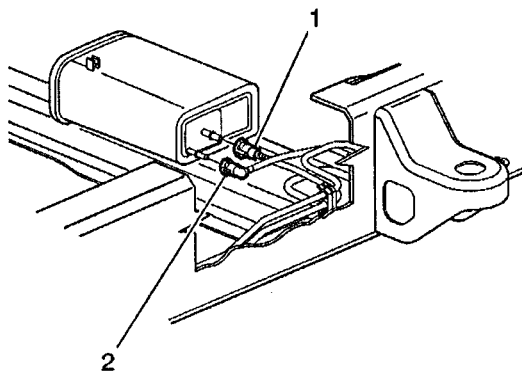
627194

15. Disconnect the pipes (1) (2) at the EVAP canister.

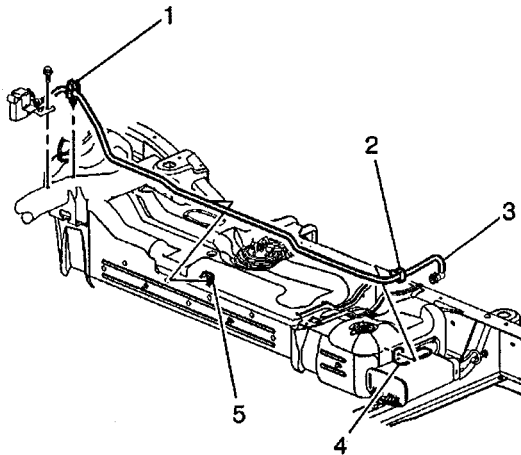
625803

16. Disconnect the vent valve pipe (2) at the EVAP canister bracket.
17. Remove the EVAP canister from the vehicle.

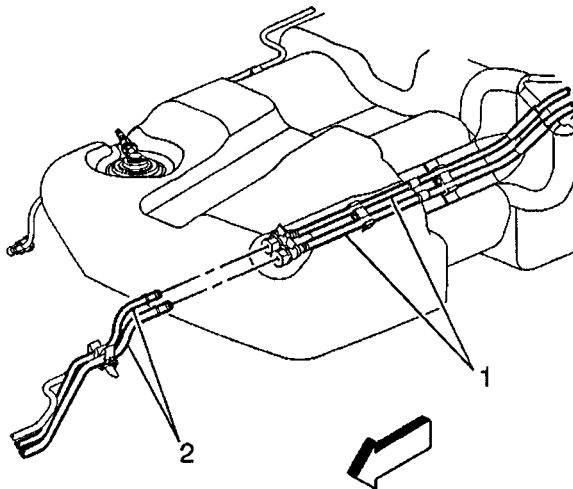
569639

18. Disconnect the chassis fuel pipes (2) at the fuel tank pipes (1). Refer to Quick Connect Fitting(s) Service (Plastic Collar) SI Document #546475, if necessary.
19. Cap the fuel and EVAP pipes in order to prevent possible fuel system contamination.
20. Disconnect the EVAP vent pipe at the fuel tank clip.
21. With the aid of an assistant, support the fuel tank.

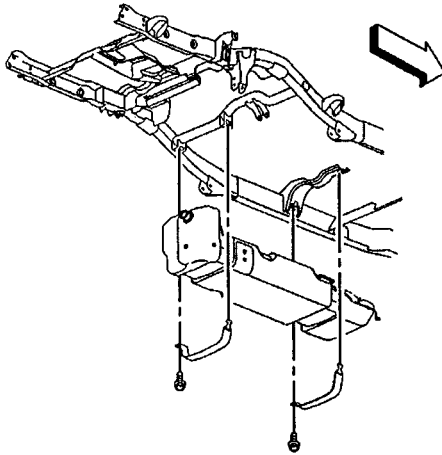
570588

Notice: Do not bend the fuel tank straps. Bending the fuel tank straps may damage the straps.

22. Remove the fuel tank strap attaching bolts.
23. Remove the fuel tank straps.
24. Carefully lower the rear of the fuel tank slightly.
25. Remove the fuel sender cover on the Suburban only.
26. Disconnect the fuel sender and the fuel pressure sensor electrical connectors.
27. Remove the fuel tank.
28. Place the fuel tank in a suitable work area.

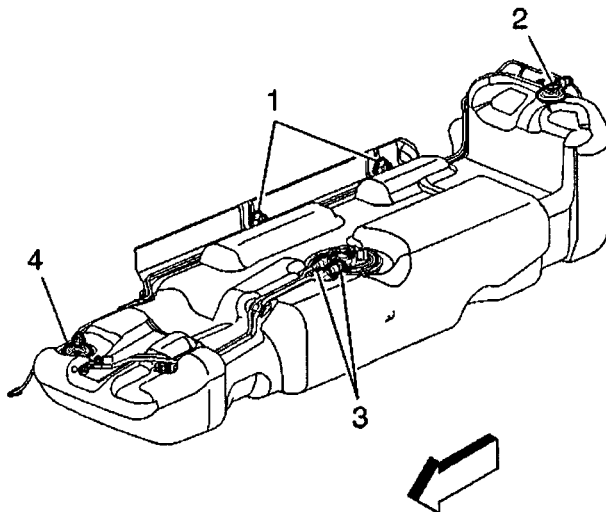
570582

29. Remove the fuel feed and return pipes (3) from the fuel sender and the retaining clips.

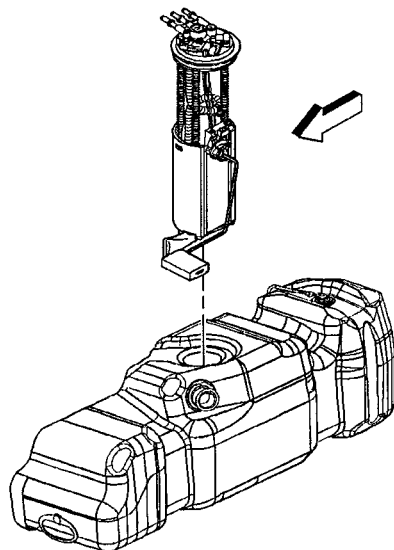
386369

Notice: Do not handle the fuel sender assembly by the fuel pipes. The amount of leverage generated by handling the fuel pipes could damage the joints.

30. Remove the fuel sender assembly retaining ring using the J 44402 fuel tank sending unit wrench.
31. Remove the fuel sender assembly and the seal. Discard the seal. In the extremely rare and unlikely event that the fuel sender assembly must be replaced, be sure that the new assembly contains the recall kit parts. Comparison of the electrical connector that goes through the cover with the electrical connector in the recall kit is the easiest method. If they are the same, the recall kit is not required.

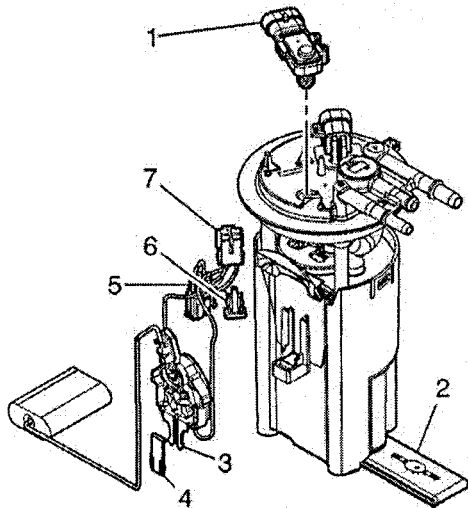
1702863

33. Disconnect the fuel pump electrical connector (5).
34. Remove the fuel level sensor electrical connector retaining clip (6).
35. Disconnect the fuel level sensor electrical connector (7).
