06V-432
(18 pages)

DCC will conduct a voluntary safety recall to reprogram the powertrain control module and replace the fuel pump module on all affected vehicles.

**DEFECT INFORMATION REPORT FOR DAIMLERCHRYSLER CORPORATION
RECALL F44**

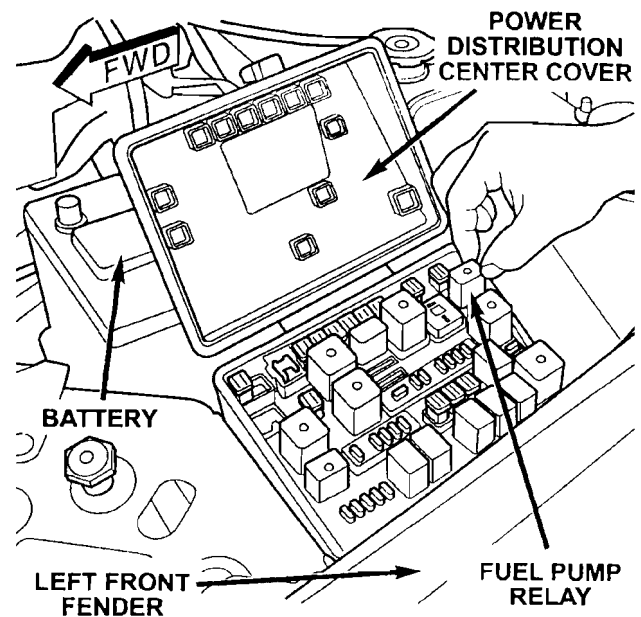
Figure 2

1. Release the fuel pressure from the fuel system using the following procedure:
 - a. Open the Power Distribution Center (PDC) cover located next to the battery (Figure 2).
 - b. Remove the fuel pump relay (Figure 2).

NOTE: Refer to the PDC cover for fuel pump relay location.

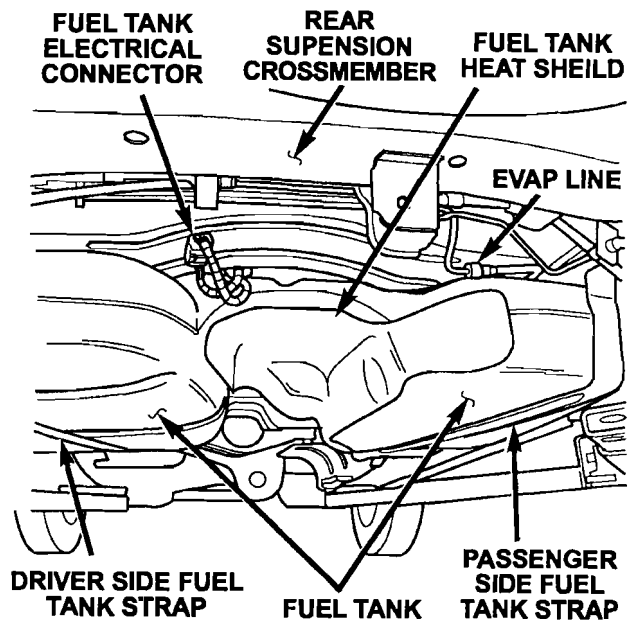
Figure 3

h. Disconnect the fuel tank electrical connector located at the rear of the tank (Figure 3).

28. Connect the fuel line, EVAP line and vapor recirculation tube located at the right front corner of the fuel tank (Figure 4).
29. Connect the fuel tank electrical connector located at the rear of the tank (Figure 3).
30. With the help of an assistant, place the rear portion of the exhaust system into position and support the exhaust system with jack stands.

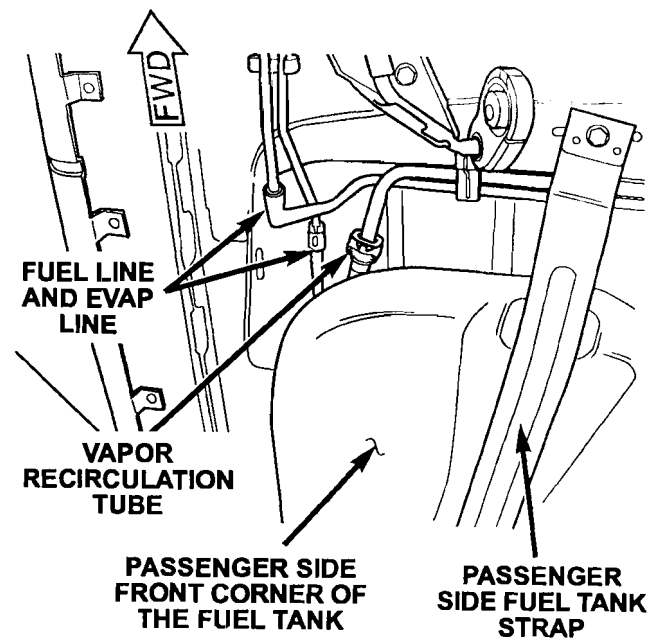
Figure 4

i. Disconnect the fuel line, EVAP line, and vapor recirculation tube located at the right front corner of the fuel tank (Figure 4).

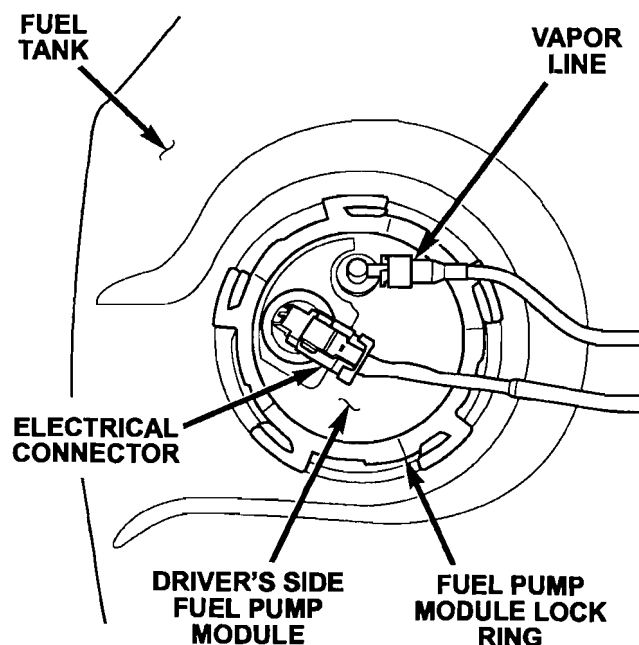
Figure 5

4. Place the fuel tank on the floor.
5. Using a vacuum cleaner, remove any debris from the area around the driver's side fuel pump module lock ring (Figure 5).
6. Disconnect the vapor line and the electrical connector on the driver's side fuel pump module (Figure 5).

18. Connect the vapor line and the electrical connector onto the driver's side fuel module (Figure 5).

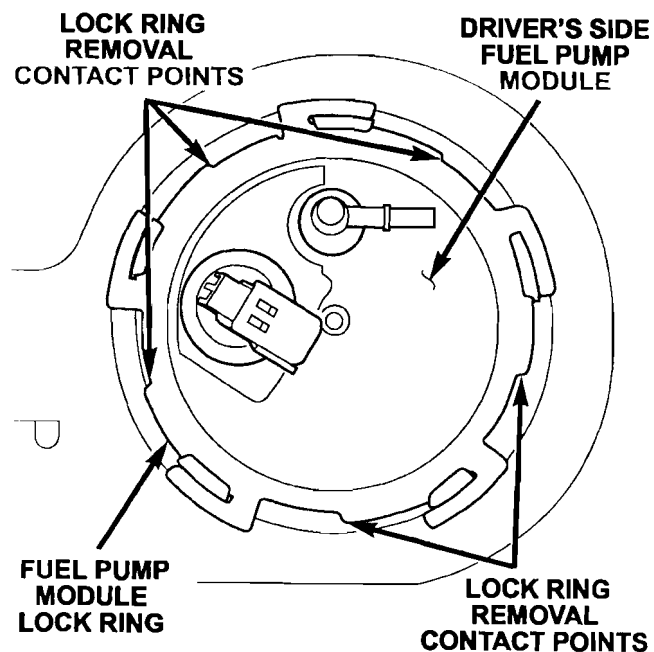
Figure 6

7. Using a brass punch and hammer, remove the driver's side fuel pump module lock ring (Figure 6).

NOTE: Use a brass punch to rotate the lock ring 1/4 turn. Make contact only at the points shown in Figure 6.

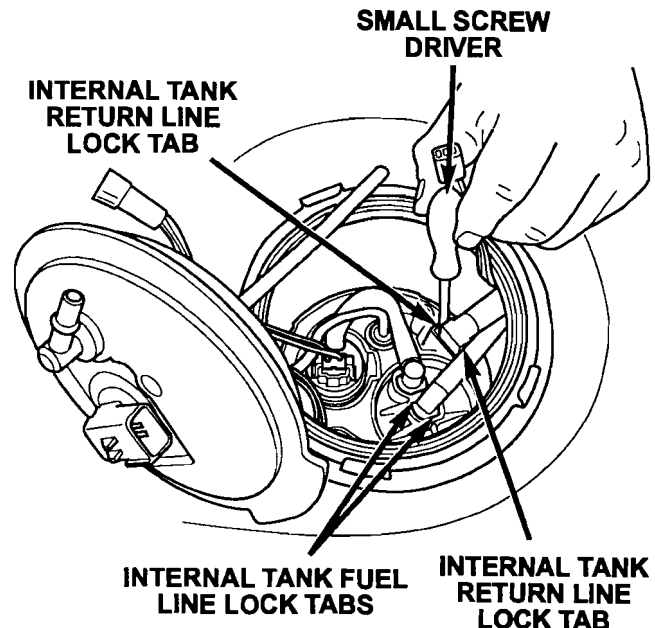
Figure 7

- Remove the internal tank return fuel line from pump module. Use a small screwdriver to pry the lock tab back and tilt the hose to one side. Pry the lock tab back on other side to release the hose (Figure 7).

CAUTION: Care should be taken to not crack/break the locking tabs or supply line fitting.

- Connect the return fuel line first and then connect the supply fuel line to the new fuel pump module (Figure 7).
- Connect the wires from the passenger side level sensor to the new pump module.

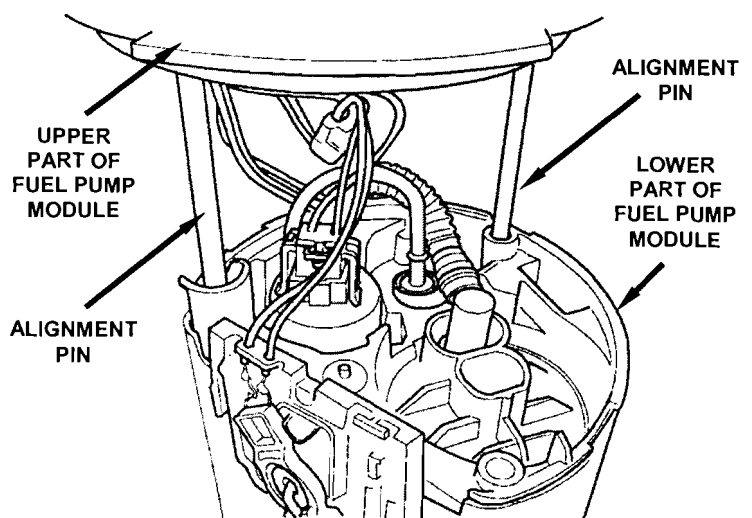
Figure 8

- Remove the internal tank supply fuel line from top of the pump module. Use a small screwdriver to pry the lock tab back and tilt the hose to one side. Pry the lock tab back on other side to release the hose (Figure 8).

NOTE: The lower part of the fuel pump module is off-set from the upper part when correctly installed into the tank (Figure 8).

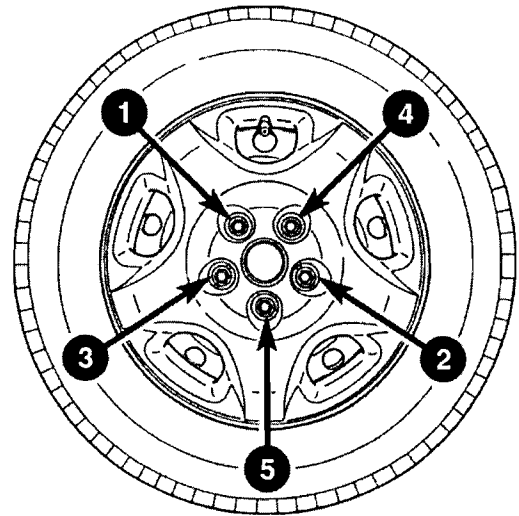
Figure 9

23. Install the tire/wheel assembly. Tighten the lug nuts to 100 ft. lbs. (135 N·m) and in the sequence shown in Figure 9.

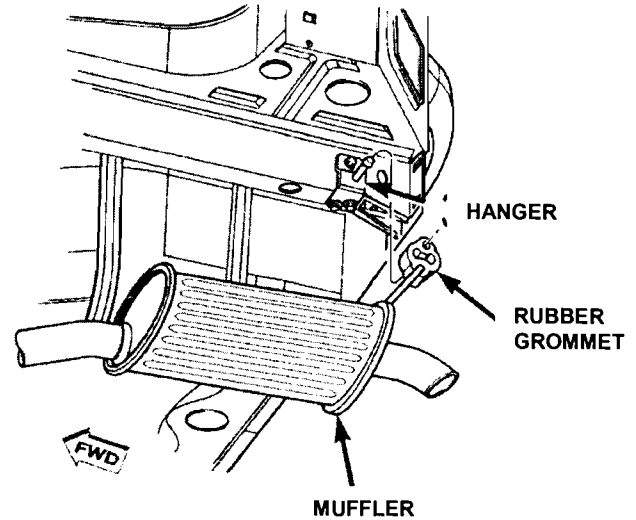
**Figure 10**

31. Connect the inlet pipe of the front muffler to the outlet pipe of the catalytic converter. Tighten the exhaust pipe clamp to 40 ft. lbs. (54 N·m)
32. Install the center exhaust hanger rubber grommets.
33. Install the rear muffler rubber grommets onto the hangers (Figure 10).
34. Lower the vehicle from the hoist.
36. Fill the fuel tank with the fuel removed in Step 3a.
37. Install the fuel pump relay into the PDC and then close and latch the PDC cover.
38. Connect the negative battery cable.
39. Using the DRBIII scan tool to pressurize the fuel system, check for any fuel leaks.
40. Disconnect and remove the DRBIII from the vehicle.
