Subject: Recall Campaigns M7 and JL (06V-017)
2003 MY Volkswagen Passat with 1.8L Turbo or 2.8L V6 Engine
2003 MY Audi A4 quattro with 1.8L Turbo or 3.0L Engine
2003 MY Audi A6 with 3.0L Engine
Replace Fuel Pump

**Subject: Safety Recall M7
2003 Model Year Volkswagen Passat with 1.8L Turbo or 2.8L V6 Engine
Replace Fuel Pump**

Subject: Safety Recall JL
2003 Model Year Audi A4 quattro with 1.8L Turbo or 3.0L Engine and
2003 Model Year Audi A6 with 3.0L Engine
Replace Fuel Pump

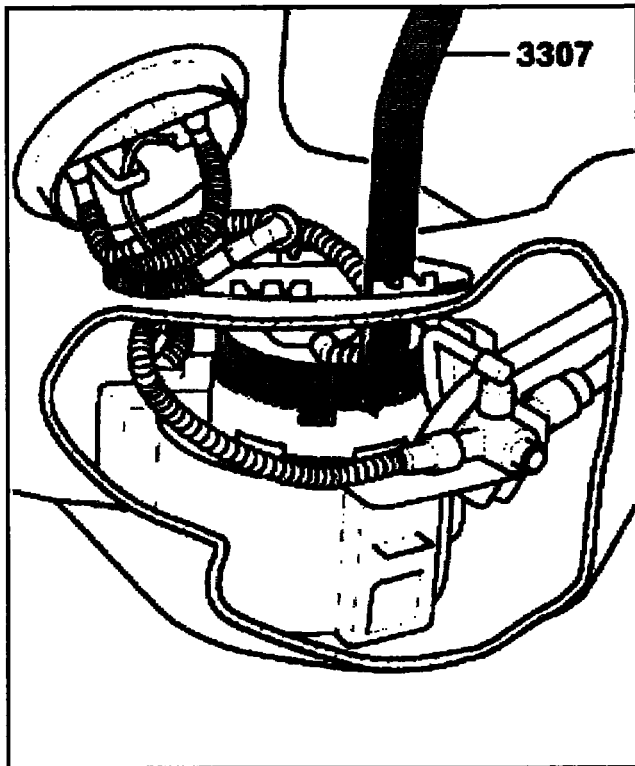
⇐ Insert 3307 fuel pump wrench into fuel tank opening and position on fuel delivery unit

⇐ Release fuel delivery unit by turning approximately 15° counterclockwise until it stops (bayonet connection)

● Note: For illustrative purposes, a cross-sectional view of fuel tank is shown
