RECALL CAMPAIGN BULLETIN

VOLUNTARY RECALL CAMPAIGN VOLUNTARY SERVICE CAMPAIGN ALTIMA AND SENTRA QR25DE ENGINE OIL CONSUMPTION

CAMPAIGN I.D. # PB023
NHTSA #: 06V-223
APPLIED VEHICLES: 2006 Altima (L31), with QR25DE Engine
2006 Sentra (B15), with QR25DE Engine
APPLIED VINs: Altima 1N4AL11**6C 159667 – 234874, or
1N4AL11**6N 344352 – 415475
Sentra 3N1AB51**6L 526889 - 597232

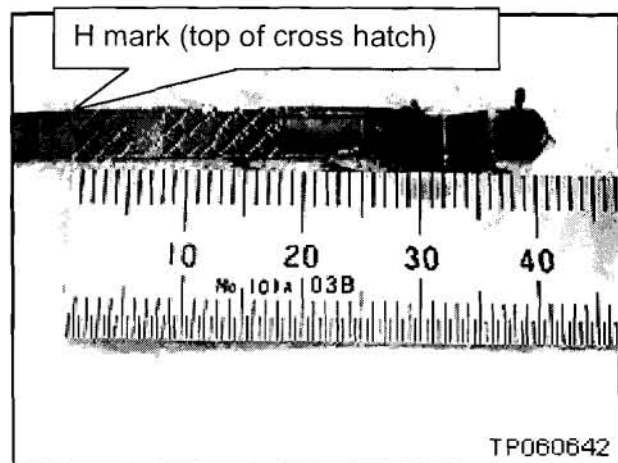
2. Write down the exact oil level reading using the engine dipstick and ruler (see Figure B1).

- Use the ruler included in the Special Tool Kit.
- To measure; line up the 0 mm edge of the ruler with the H mark on the dipstick.
- The example in Figure B1 shows the oil level is 8mm below the H mark.

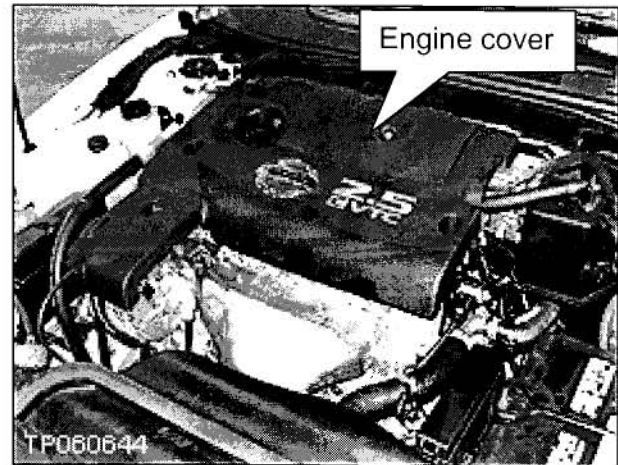
Figure C1

1. Remove the plastic engine cover.

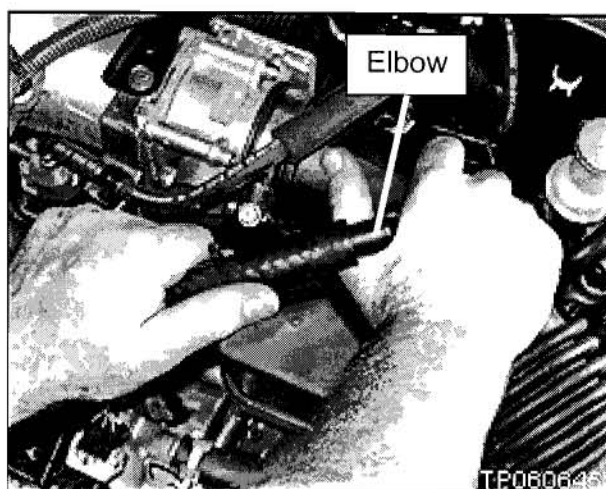
Figure C2

9. Remove clamp and disconnect the valve cover PCV breather hose.

CAUTION: Hold the air duct elbow as shown in this picture to prevent breaking it.

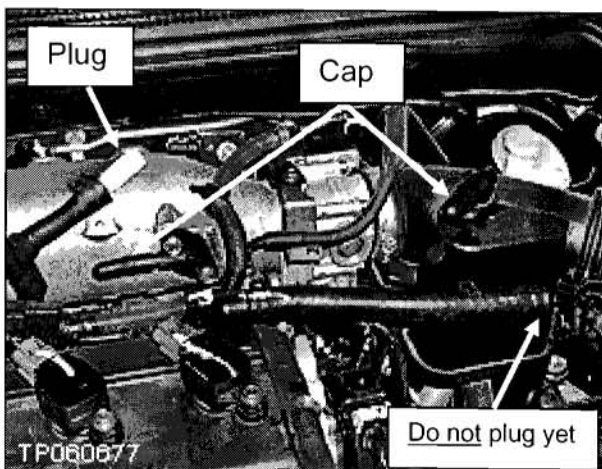
Figure C3

10. Disconnect the PCV hose at the intake manifold.
11. Cap the ports, plug and clamp the hose as shown in Figure C3.

DO NOT PLUG the valve cover PCV breather hose yet.

IMPORTANT: You MUST use the caps and plugs from the Special Tool Kit. Make sure the Caps and Plugs are fully installed/seated. DO NOT use “pinch-off” pliers, they will not seal well enough.

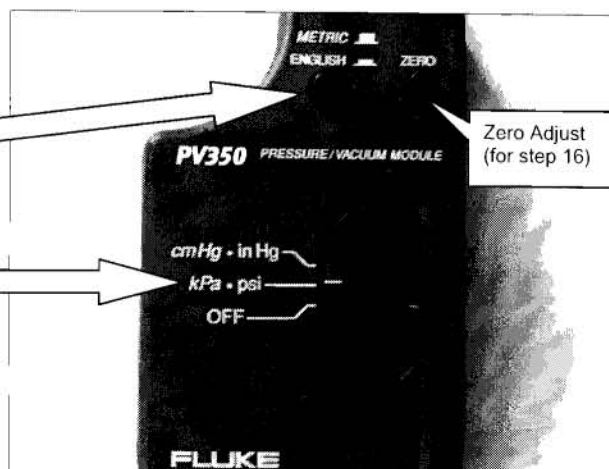
Figure C4

kPa•psi (slide switch in center position)

NOTE: The PV350 and Fluke meter are included in the Special Tool Kit.

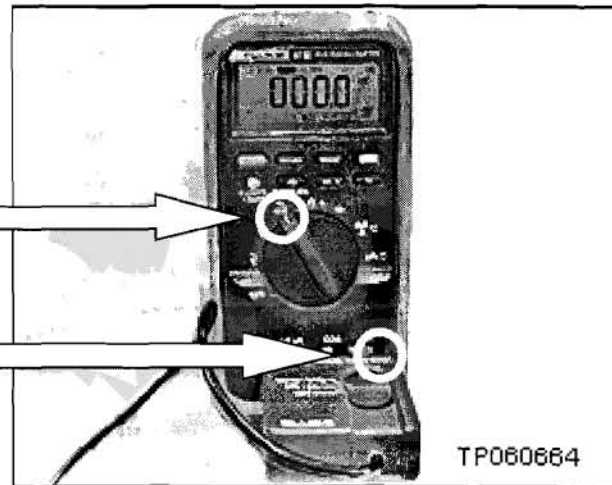
Figure C5

14. Install the PV350 into the Fluke meter (COM & Volt/Ohm holes).

15. Set the Fluke meter dial to mV (Millivolts).

16. Zero the meter using the Zero Adjust on the PV350 module.

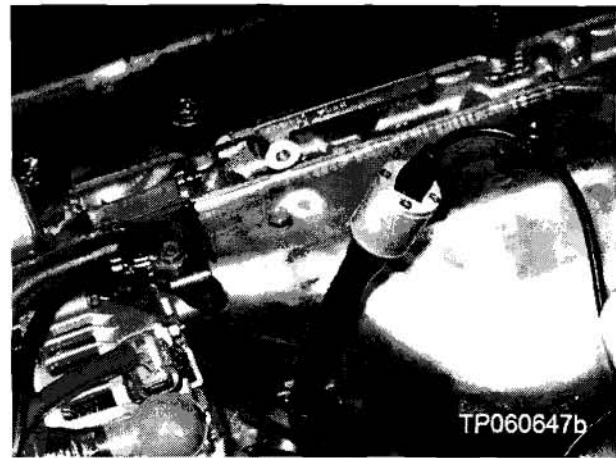
Figure C6

17. Install the sensing end of the PV350 onto the oil dipstick tube and tighten the clamps.

IMPORTANT: Make sure the rubber tube is securely clamped at each end.

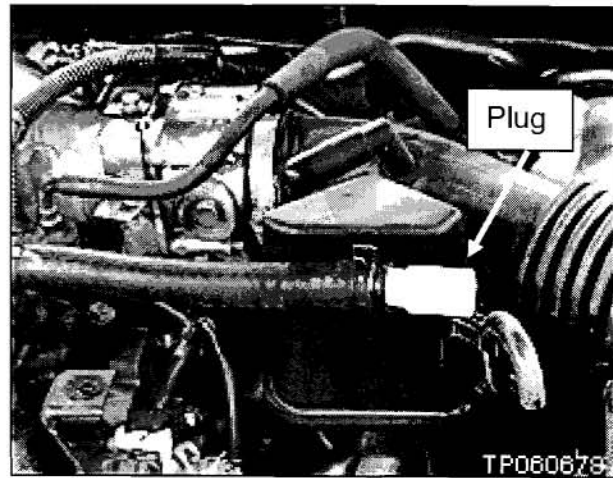
Figure C7

- Make sure the plug is completely installed / seated.

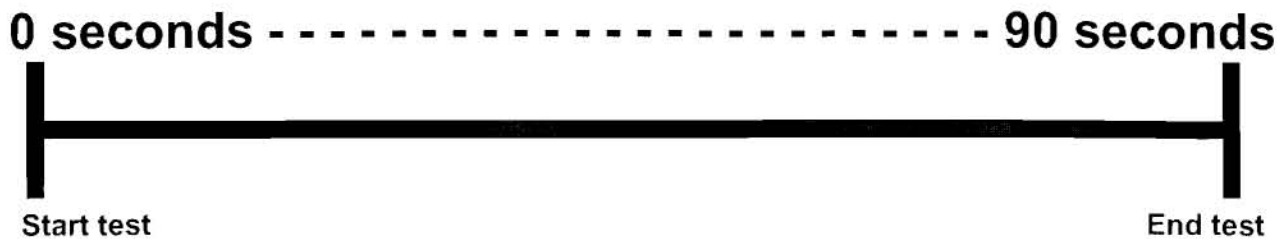
- D. Immediately after plugging the PCV breather hose, begin the 90 second time:

NOTE: Keep the engine at idle during this 90 second test.

Test length: 90 seconds only

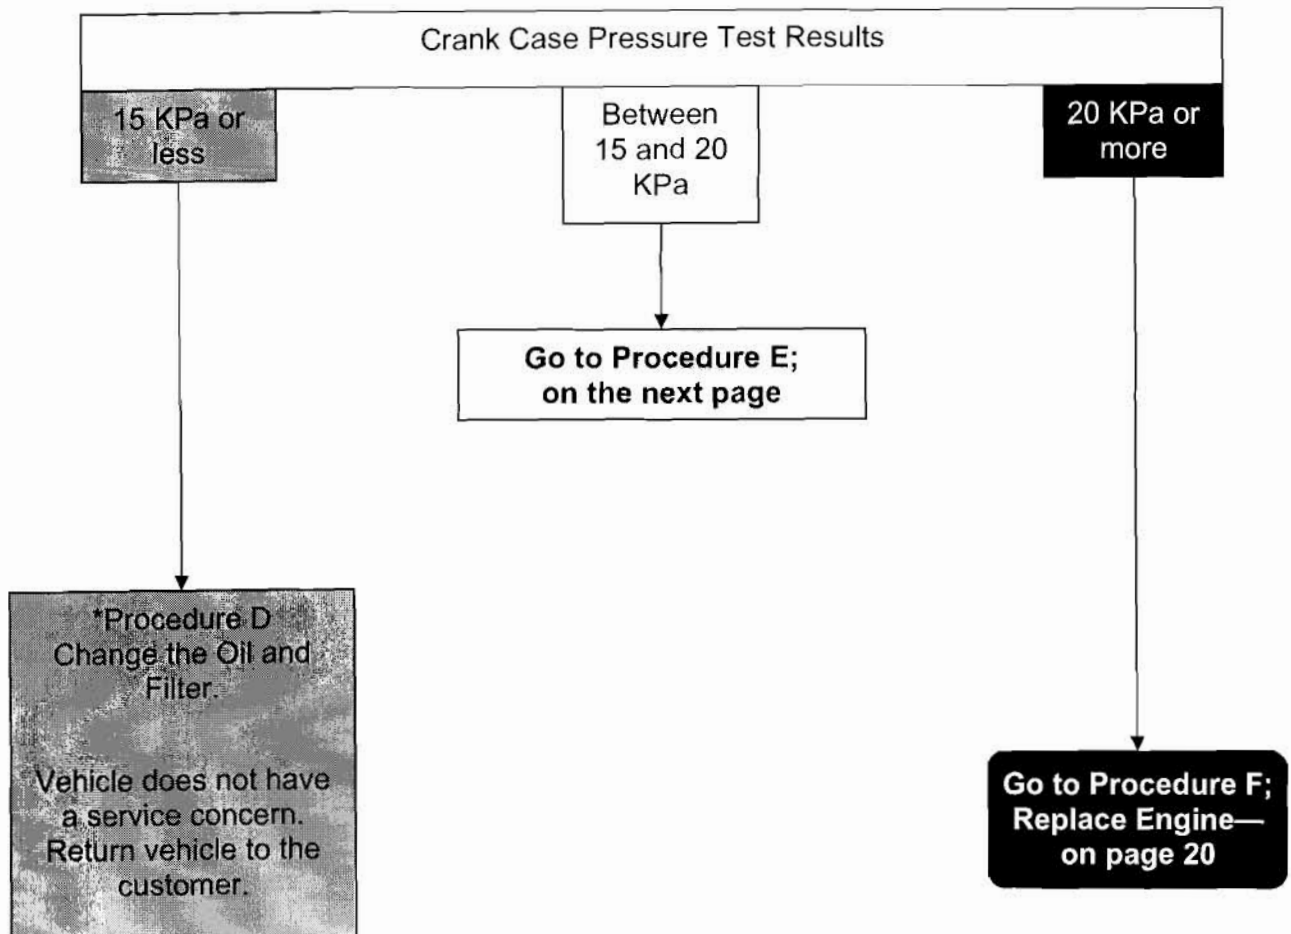
* Procedure D is only an oil and filter change. This bulletin does not have instructions for Procedure D. If needed, refer to the Service Manual for Instructions on changing the oil and filter.

23. See Test Results Flow Chart on the next page.

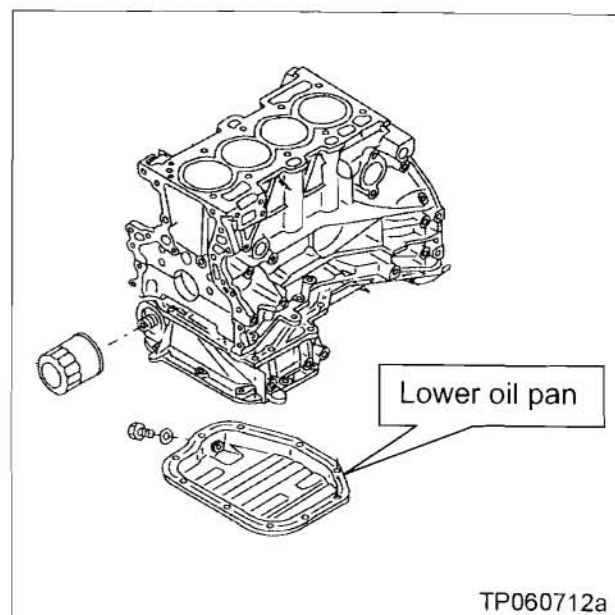
Figure E1

17. Remove the bolts from the lower engine oil pan.

NOTE: Pan bolts will be reused.

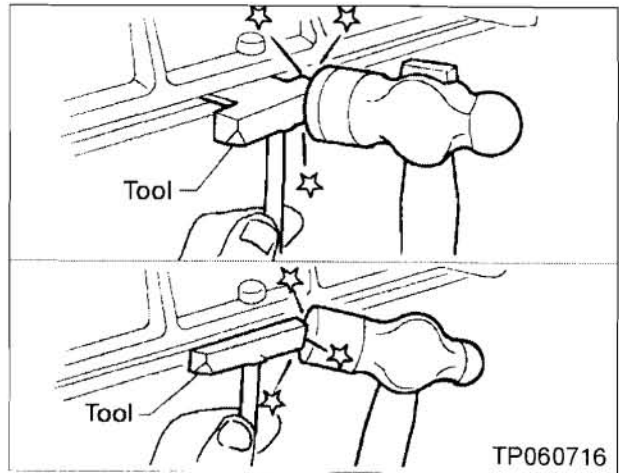
Figure E2

18. Use special tool to cut pan sealant.

- Special tool J-37228 is available from TECH-MATE at 1-800-662-2001.

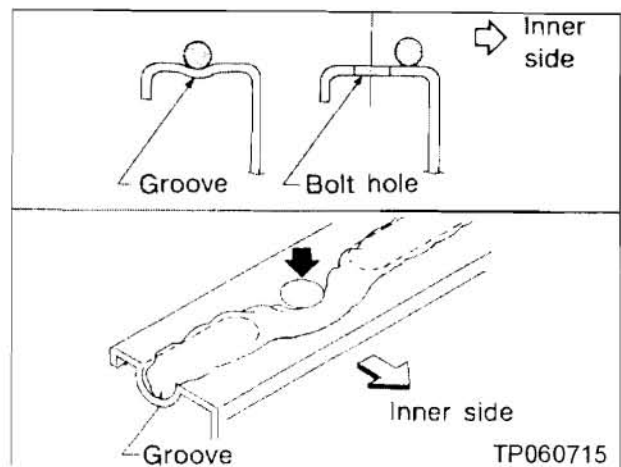
Figure E3

20. Apply sealant to the new lower oil pan as shown.

- Use RTV Silicone (Ultra Gray)—Nissan P/N 999MP-AM003P or equivalent.

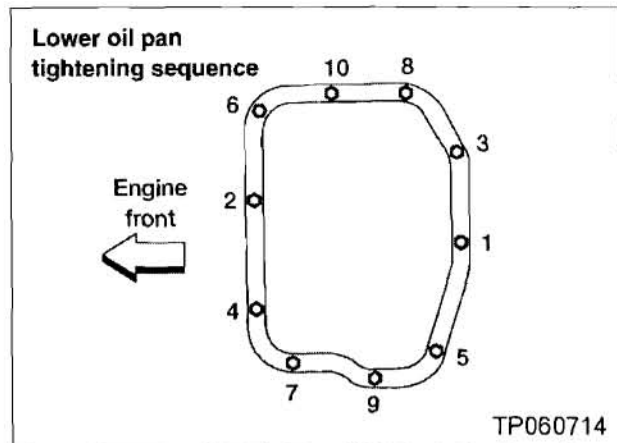
Figure E5

21. Install the new lower oil pan; tighten the bolts in the order shown.

Torque spec:
6.4 – 7.5 N.m (0.65 – 0.76 kg-m,
57 – 66 in-lb)

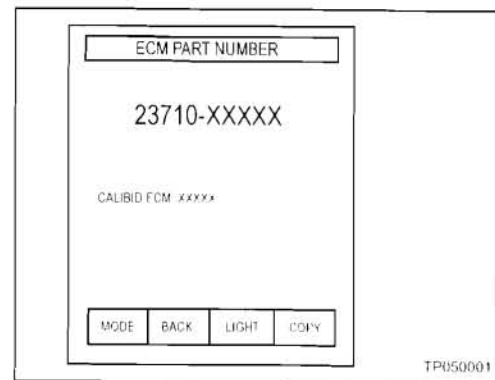
- Figure A1 is an example of the ECM Part Number printout.

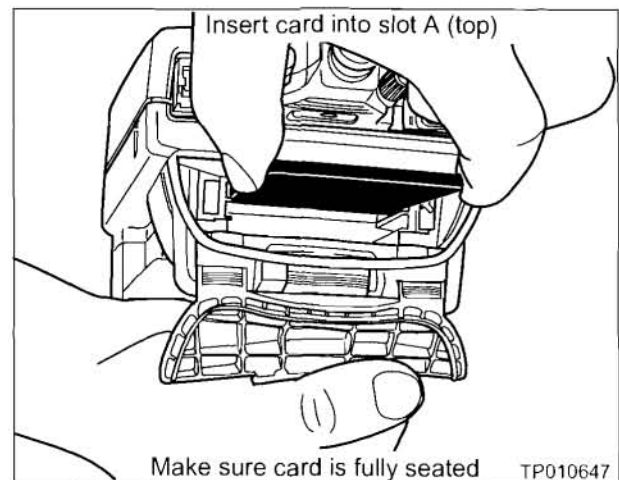
Figure A2

1. Install the Reprogramming Card into CONSULT-II.
 - Make sure CONSULT-II is disconnected from the vehicle and turned OFF.
 - The Reprogramming Software Card is the "orange" Card.
 - Use slot A—top slot (see Figure A2).

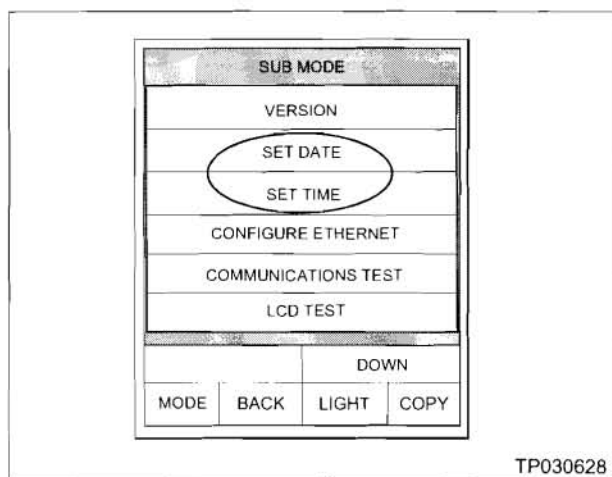
Figure A3

C. Touch **SET DATE** (see Figure A3).

- 1) If the date is not correct, touch the **MONTH**, **DAY** or **YEAR** as needed. Then adjust it by using arrow keys. Once done, press **SAVE**, press **BACK**, and go to step D.
- 2) If the date is OK, press **BACK** and go to step D.

D. Touch **SET TIME** (see Figure A3).

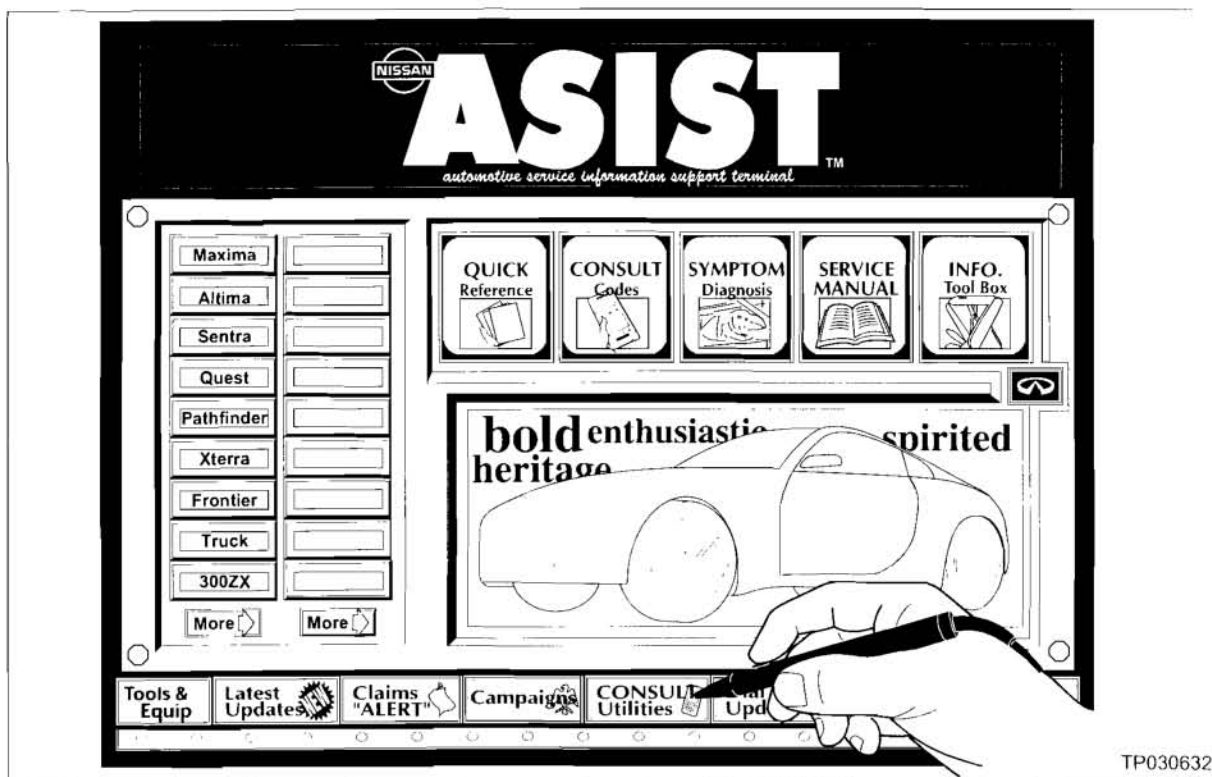
Figure A4

5. From the ASIST PC main menu screen, select **"CONSULT UTILITIES"** (see Figure A4).

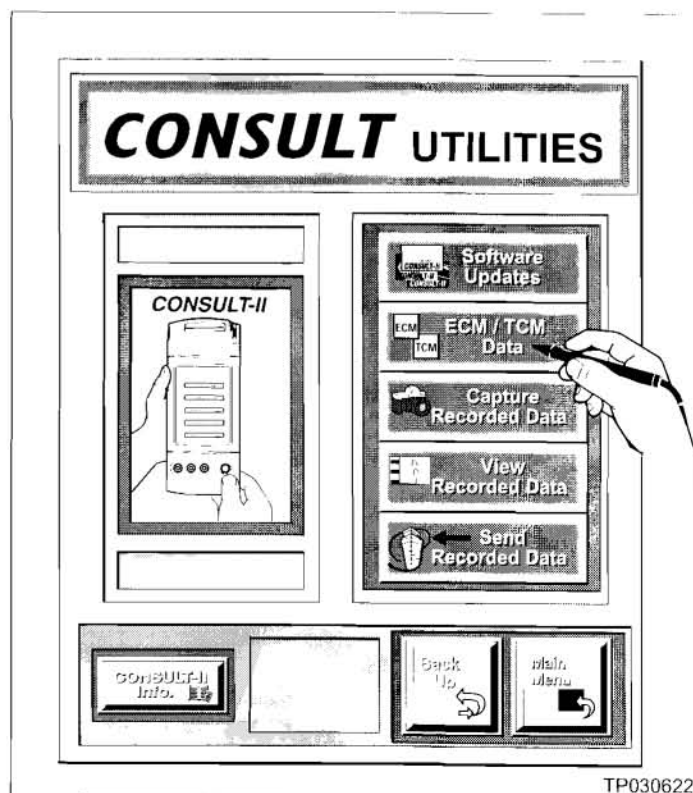
Figure A5

6. From the **"CONSULT UTILITIES"** screen, select **"ECM / TCM DATA"** (see Figure A5).

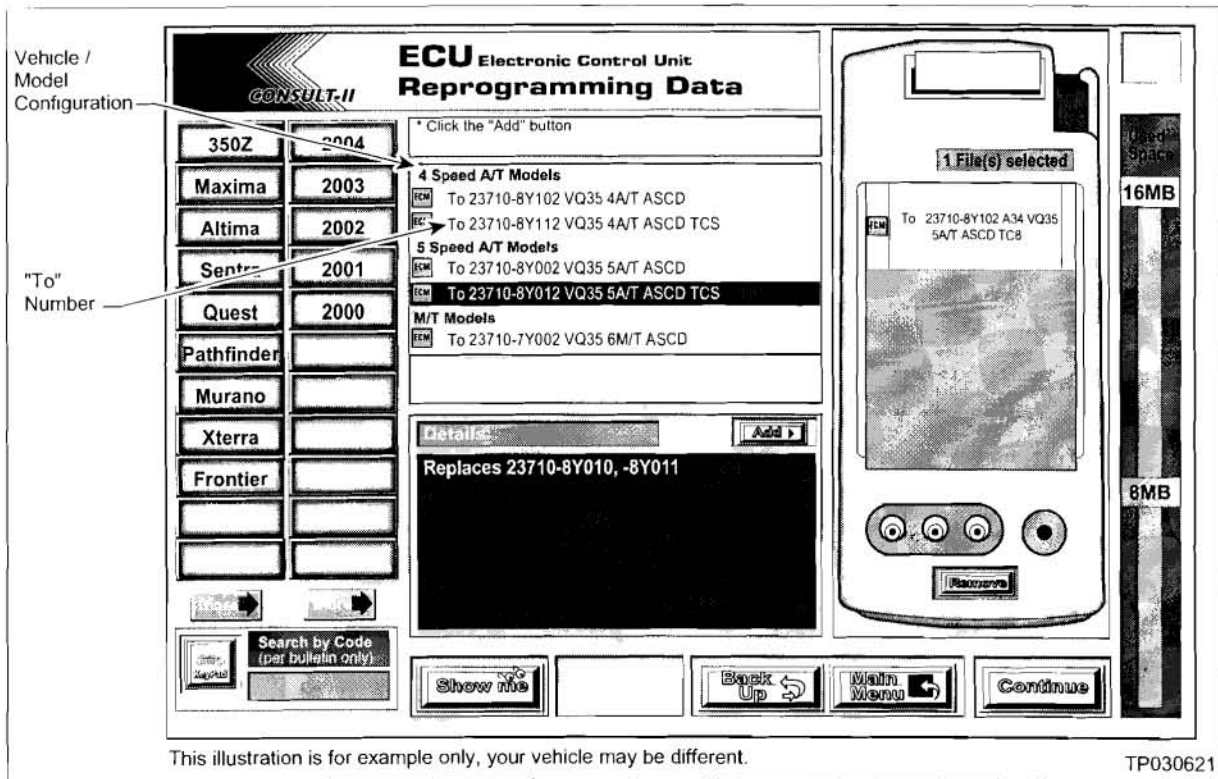
Figure A6

7. Select the **"ECU REPROGRAMMING DATA"** (see Figure A6) as follows:

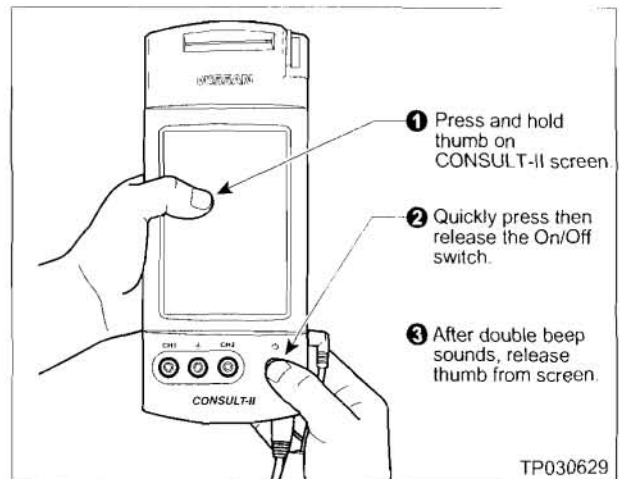
8. Turn ON CONSULT-II as shown in Figure A7.

NOTE: If you accidentally choose a menu option other than "Transfer Files via LAN"; turn CONSULT-II OFF, and then back ON as shown in Figure A7 above.

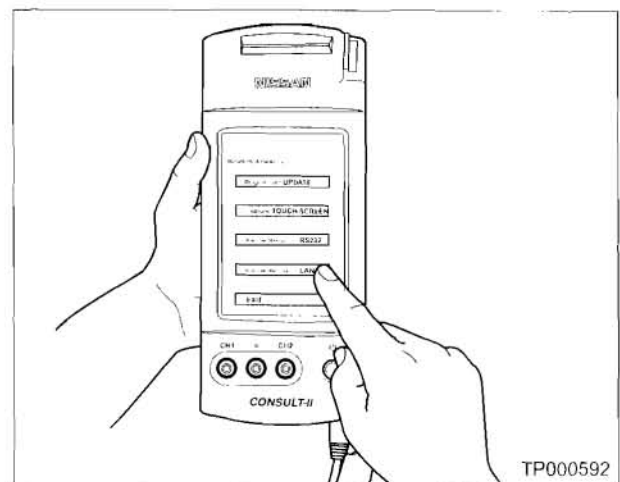
Figure A8

9. Select **Transfer files via LAN** (see Figure A8).

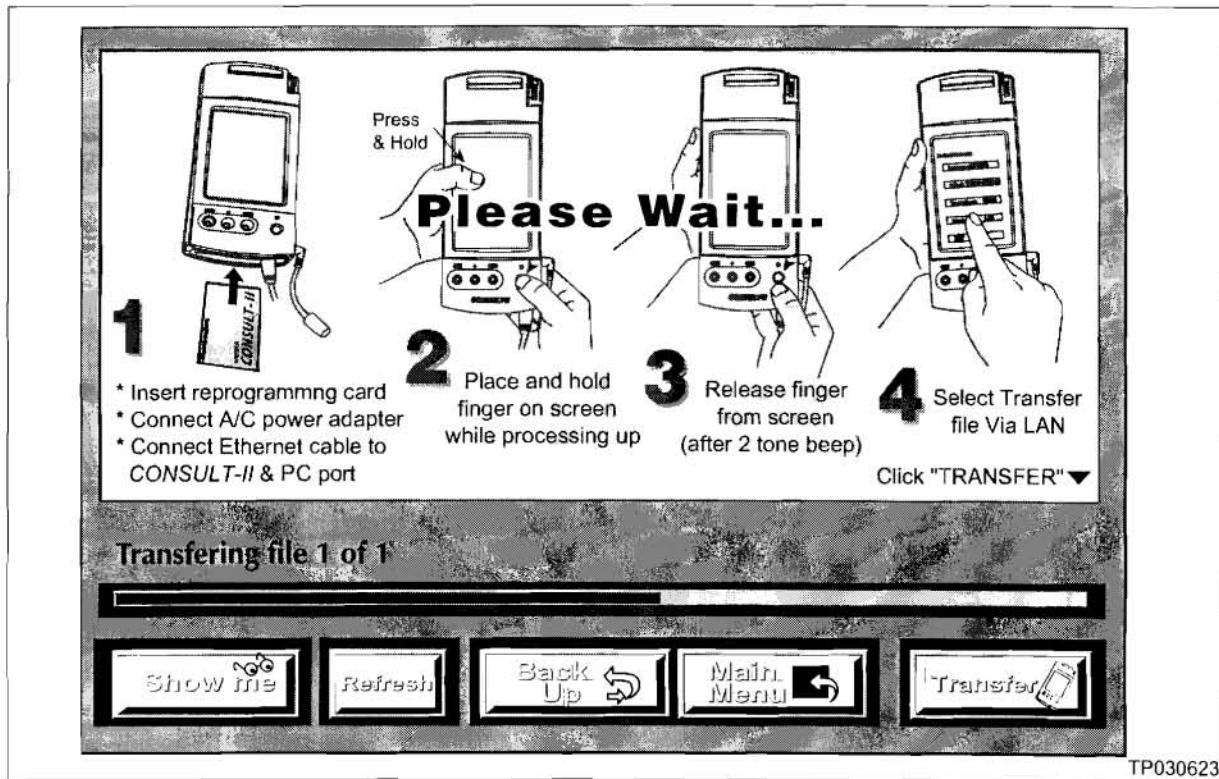
Figure A9

A. On the ASIST screen, click on **"Transfer"** (see Figure A9).

- Data transfer will take about 15 seconds.
- Transfer progress is displayed on the ASIST screen.

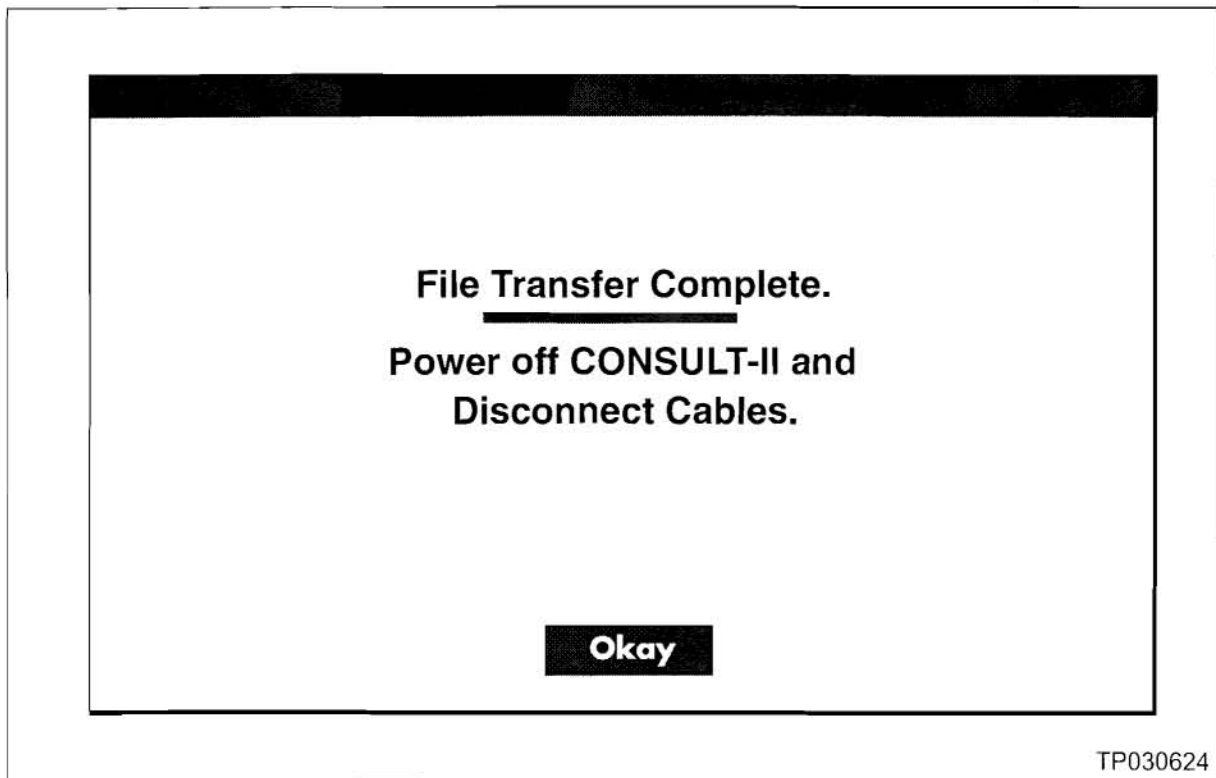
Figure A10

CAUTION: DO NOT DISCONNECT THE ETHERNET CABLE UNTIL COMPLETE IS DISPLAYED AS SHOWN IN FIGURE A10 ON THE NEXT PAGE.

11. When transfer is complete as shown in Figure A10.

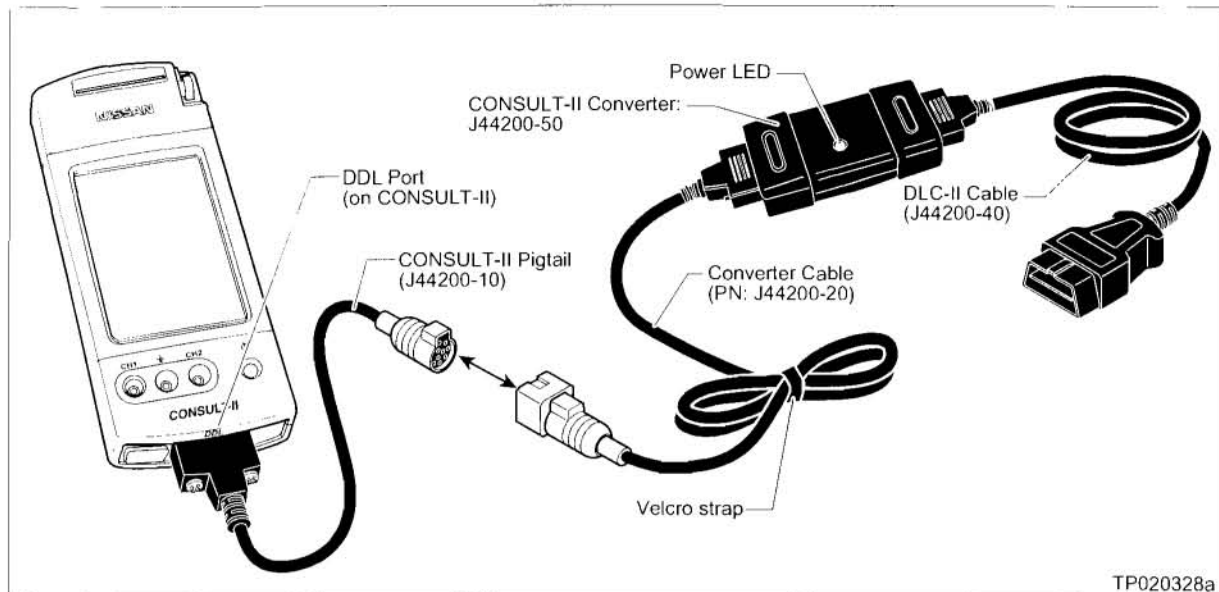
- Make sure the DLC-II is straight and fully plugged in to the vehicle.
- Make sure all other DLC-II cable connections shown in Figure A11 are connected properly.

- Nissan requires the use of essential tools shown in Figure A11 when performing ECM reprogramming.
- J44200-10 "Pigtail" should not be removed from the CONSULT-II DDL Port. This "Pigtail" allows use of the stronger "quick disconnect" cable set.
- If cables are very often changed at the DDL Port (base) of the CONSULT-II unit, cable connector pin damage may result.
- If there is connector pin damage, ECM reprogramming may fail. Permanent ECU damage can occur.

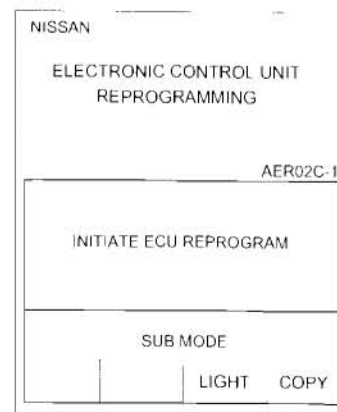
Figure A12

- CONSULT-II will turn ON automatically (see Figure A12).
- Confirm that all electrical loads* (except for the ignition) are OFF.

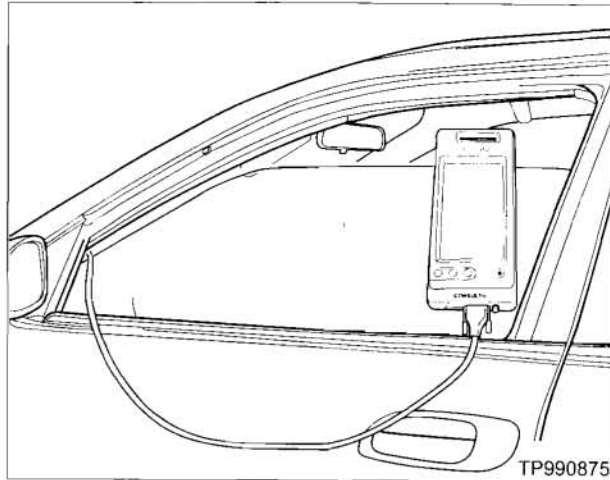
Figure A13

- This step is necessary to ensure the CONSULT-II and DLC-II cable will not be disturbed during reprogramming.

CAUTION: DO NOT connect the CONSULT-II AC power supply for Steps 17, 18 and 19.

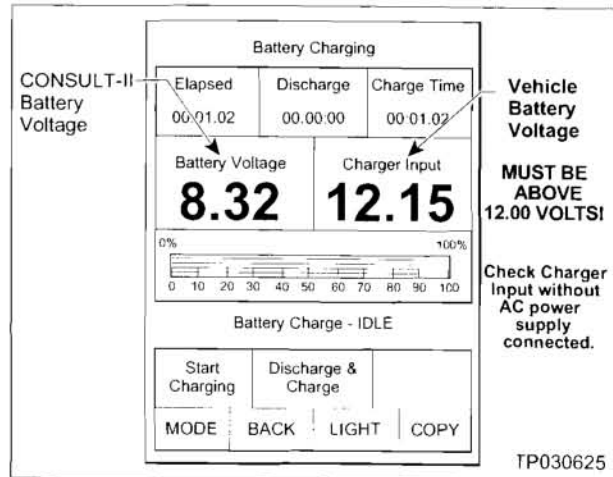
Figure A14

18. Check the CONSULT-II's "Charger Input" reading (see Figure A14).

- A reading above 12 volts confirms;
 - a. The DLC-II is properly connected to the vehicle,
 - b. The vehicle battery voltage is sufficient for ECM reprogramming, and
 - c. CONSULT-II has a sufficient power supply to perform ECM reprogramming.
- If the vehicles battery voltage ("Charger Input") is below 12 volts, one or more of the following may be the cause:
 - a. The battery charger you hooked up in section 1 is not charging the battery (poor connection or it is not working).
 - b. The DLC-II does not have a good connection to the vehicle (not straight).
 - c. The DLC-II cable may have a malfunction (damaged wire or pins).
 - d. The CONSULT-II Converter (J44200-50 / black box) is not working correctly

- Do not attempt ECU Reprogramming if the vehicle's battery voltage is below 12 volts.
- Permanent ECU damage can occur if the vehicle battery does not maintain the minimum voltage during ECU Reprogramming.
- If "Charger Input" is above 12 volts, power from the vehicle battery will keep CONSULT-II's power supply at the correct level during reprogramming. (see Figure A14).

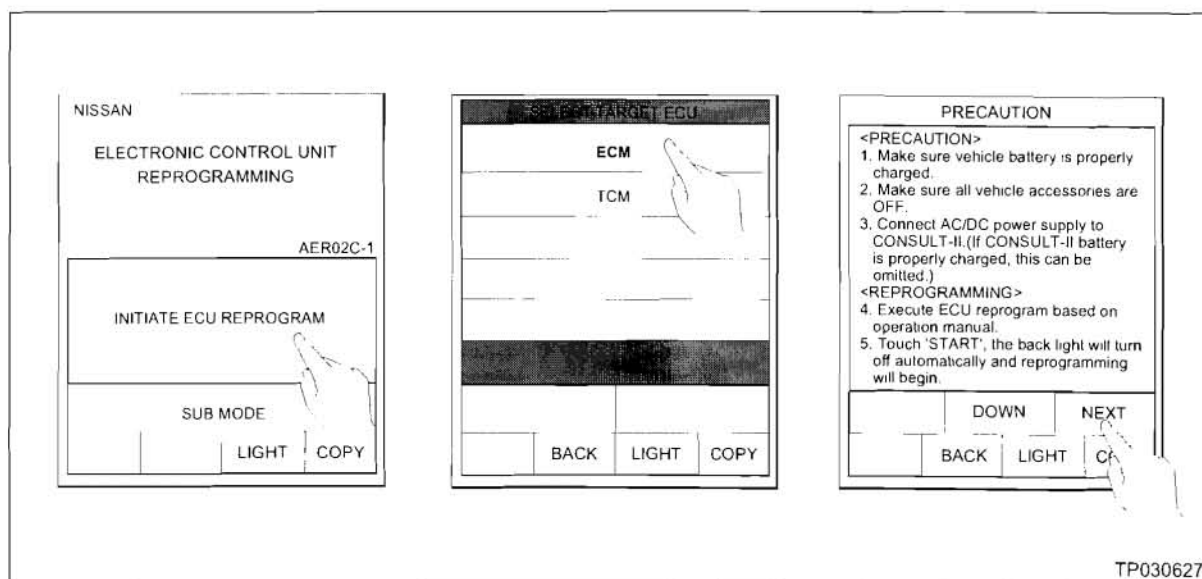
Figure A15

20. Press **INITIATE ECU REPROGRAM** (see Figure A15), then

- A. Press **ECM**
- B. Review the precaution
- C. Press **NEXT**

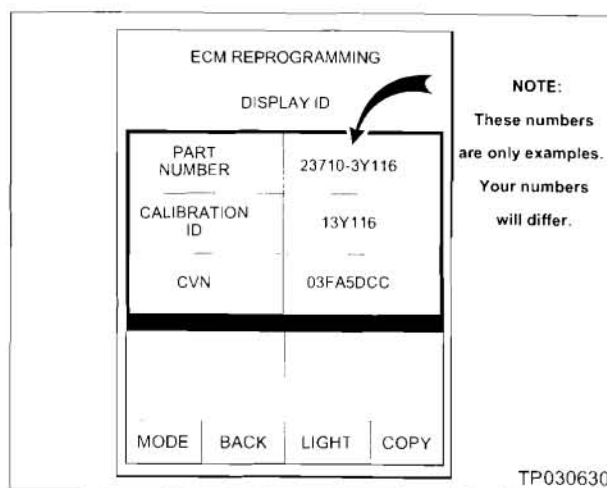
Figure A16

21. Press **CHECK ECM P/N** to "confirm" (take note of) the current ECM part number (see Figure A16).

NOTE: This is the vehicle's ECM part number BEFORE Reprogramming.

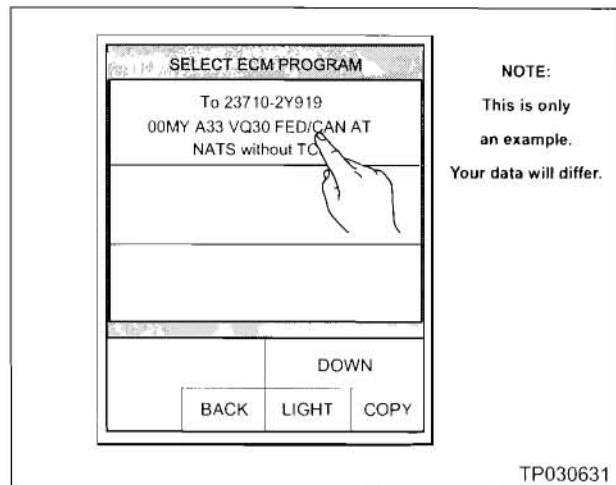
Figure A17

24. Select the ECM program to install (see Figure A17).

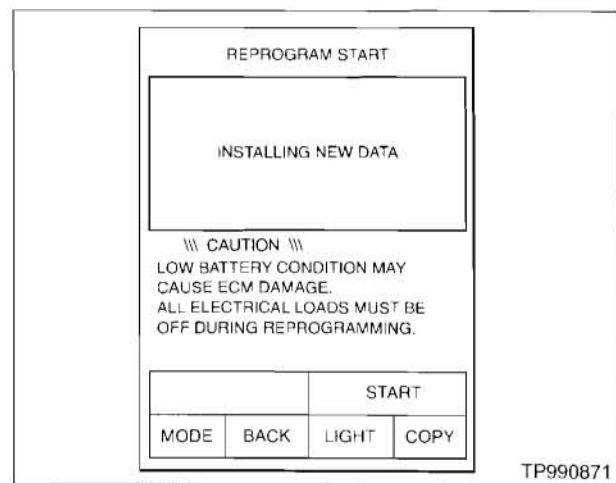
Figure A18

25. The "**REPROGRAM START**" window should appear (see Figure A18).

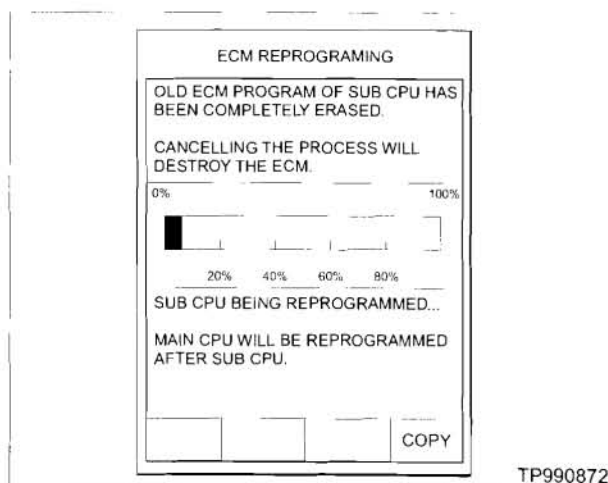
- After a few seconds, the window shown in Figure A19 will appear.
- CONSULT-II will now turn OFF its screen backlight.
- When the screen backlight goes OFF, ECM reprogramming has started.

NOTE: This process will take from 10 to 20 minutes.

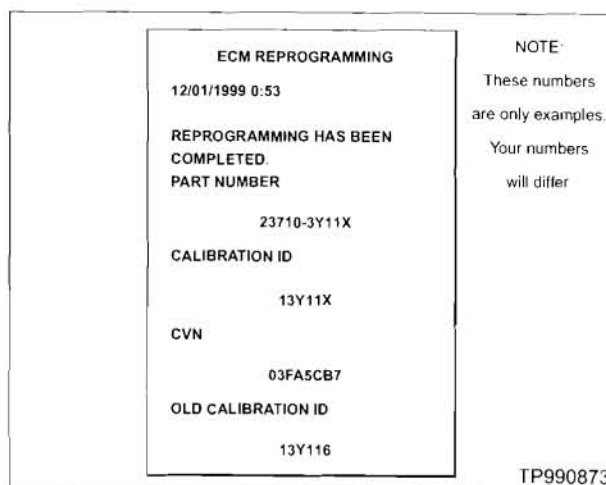
Figure A20

27. When the Reprogramming is complete, CONSULT-II will "beep", turn the screen backlight back ON and automatically print out a report (see Figure A20).

- Remember it may take up to 20 minutes.
- Attach the print-out to the repair order for future reference.

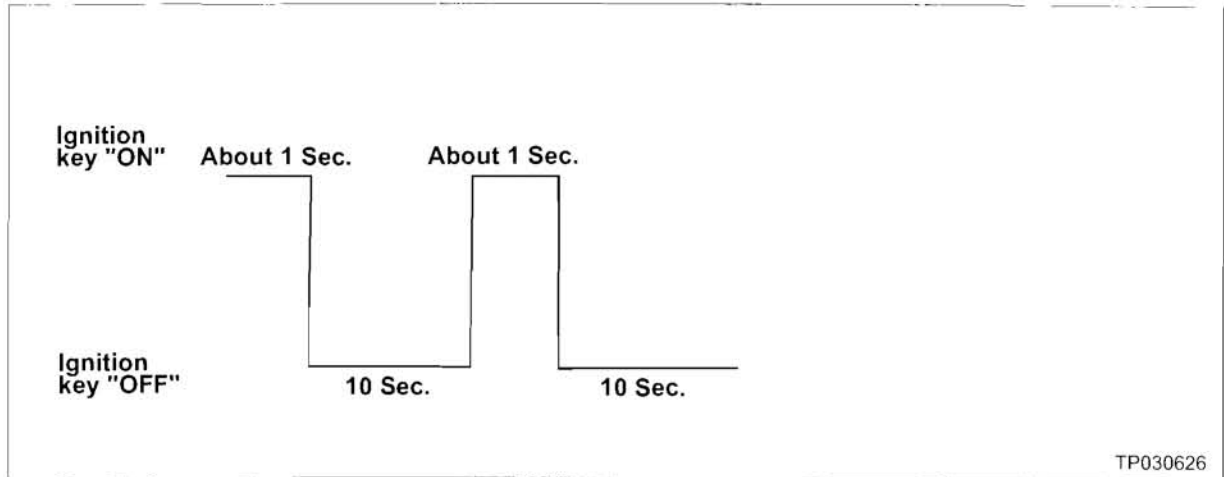
Figure A21

30. **Wait more than 10 seconds, then turn the ignition switch ON for 1 second. Then, turn the ignition switch OFF again for 10 seconds (see Figure A21).**

- This will reset ECM self learned Data.

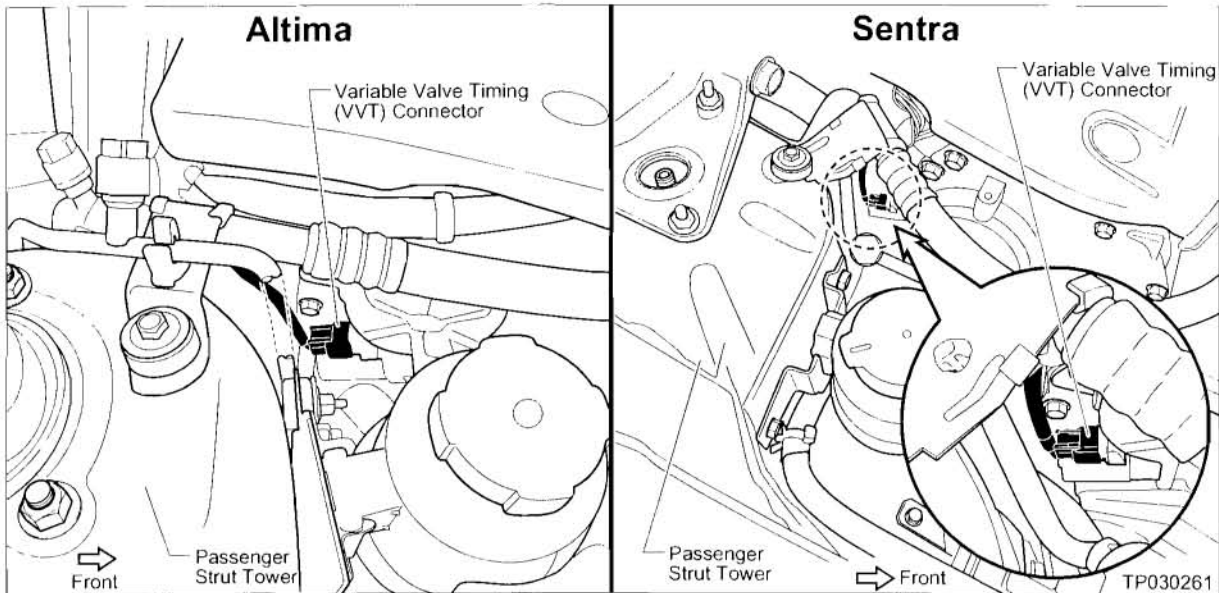
Figure F1

Variable Valve Timing (VVT) Wire Harness Connector (Altima and Sentra)

- Make sure the VVT Wire Harness Connector is disconnected before removing the engine (see Figure F1).

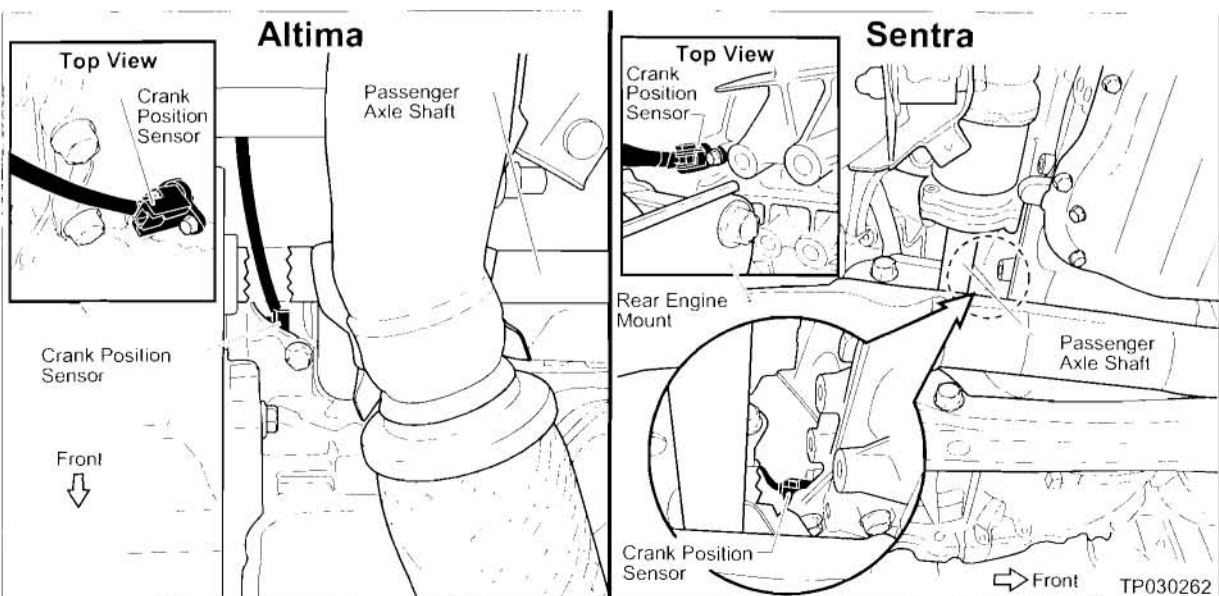
Figure F2

Crankshaft Position Sensor (Altima and Sentra)

- Remove the Crankshaft Position Sensor before separating the engine and transmission. Do NOT damage the edge of the Crankshaft Position Sensor or the ring gear teeth. Pull the sensor straight out to help avoid damage (see Figure F2).
- To release the wire harness connector, push IN on the release tab, then PULL the connector OFF.

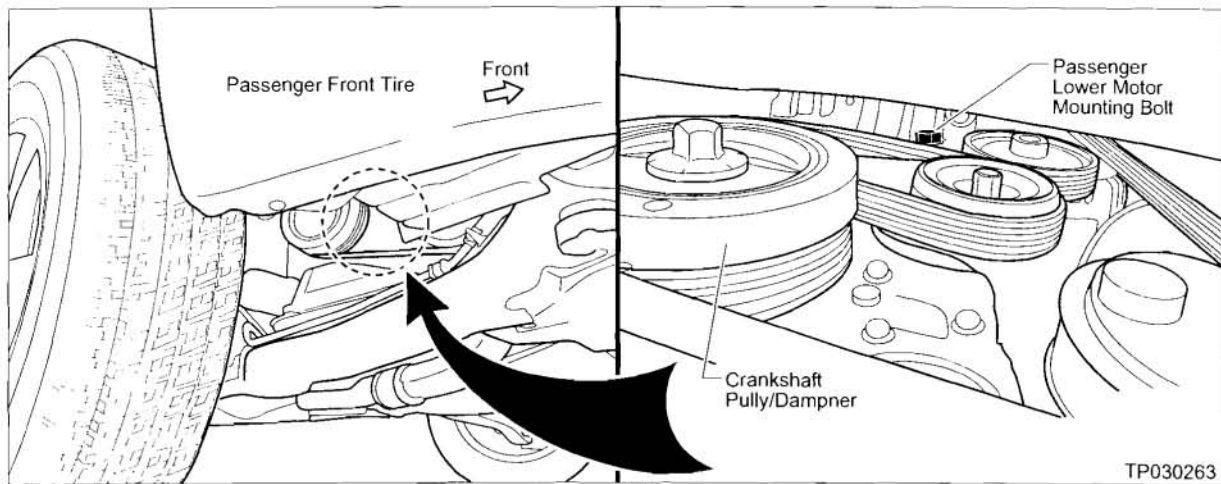
Figure F3

Passenger Side Lower Motor Mount Bolt (Altima ONLY)

- The Passenger Side Lower Motor Mount Bolt can be difficult to see. Before you remove the engine, remember to remove this bolt (see Figure F3).

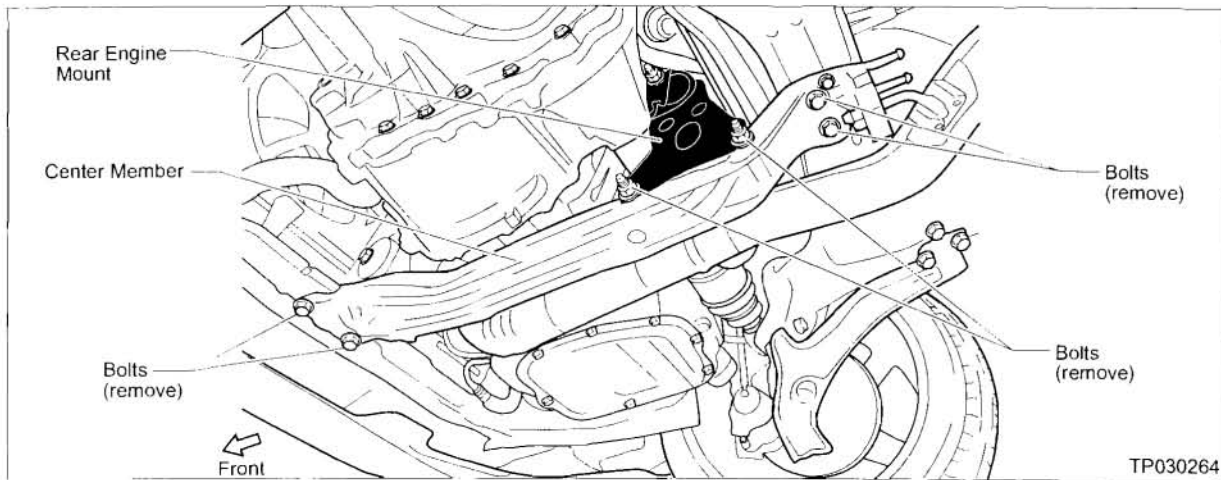
Figure F4

Center Member (Sentra ONLY)

- Remove the Center Member, but leave the Rear Engine Mount on the engine (see Figure F4).

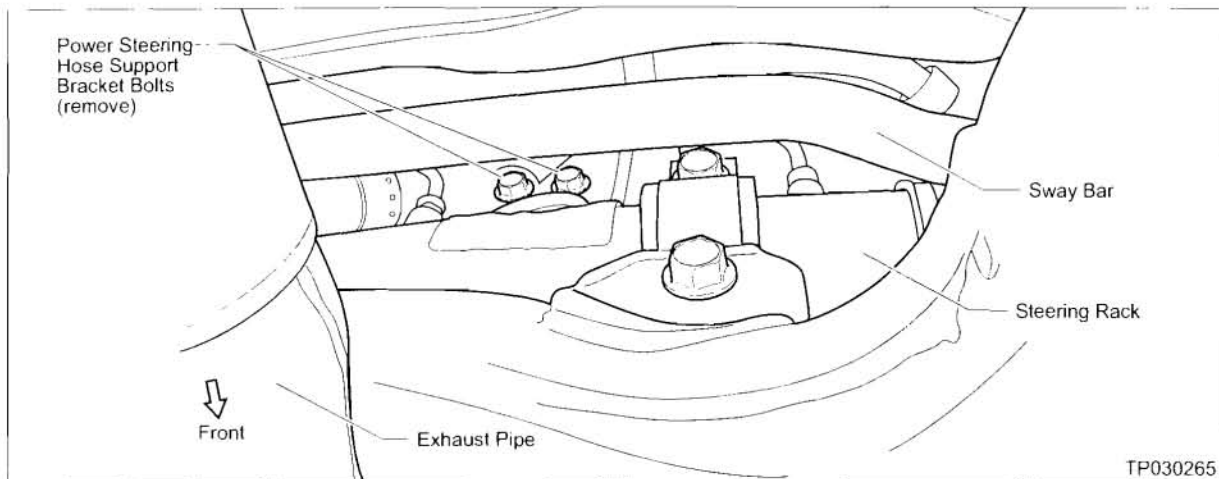
Figure F5

Power Steering Hose Support Bracket Bolts (Altima ONLY)

- Make sure to remove the Power Steering Hose Support Bracket Bolts before engine removal (see Figure F5).

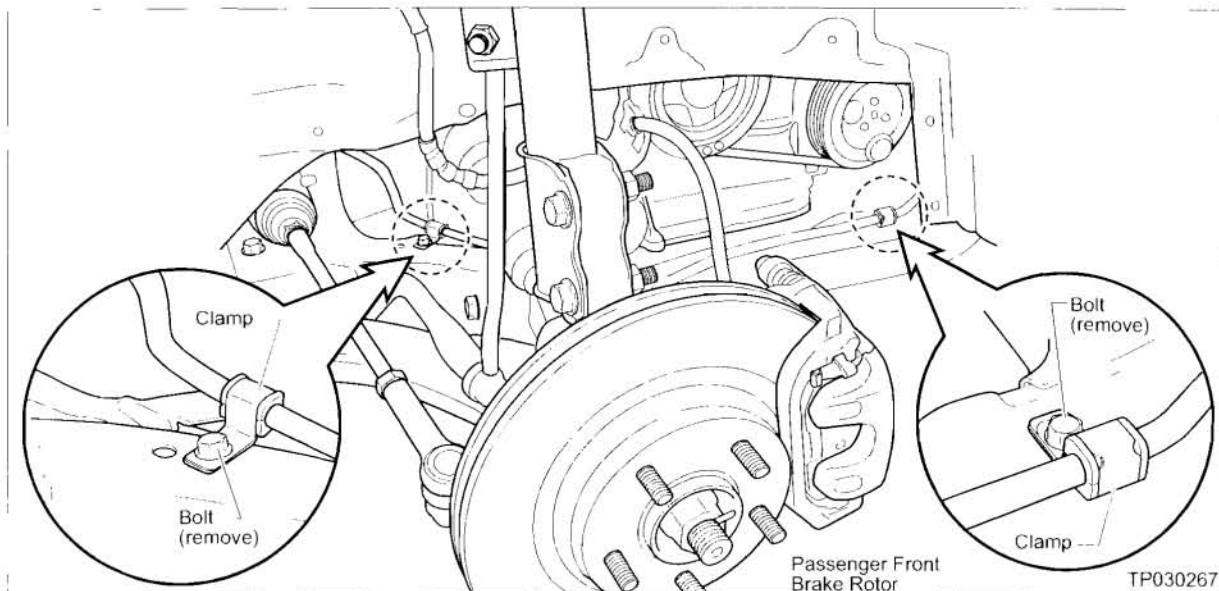
Figure F6

Power Steering Pipe Clamps (Altima ONLY)

- Remove the Power Steering Pipe Clamps on the engine cradle before removing the engine (see Figure F6).

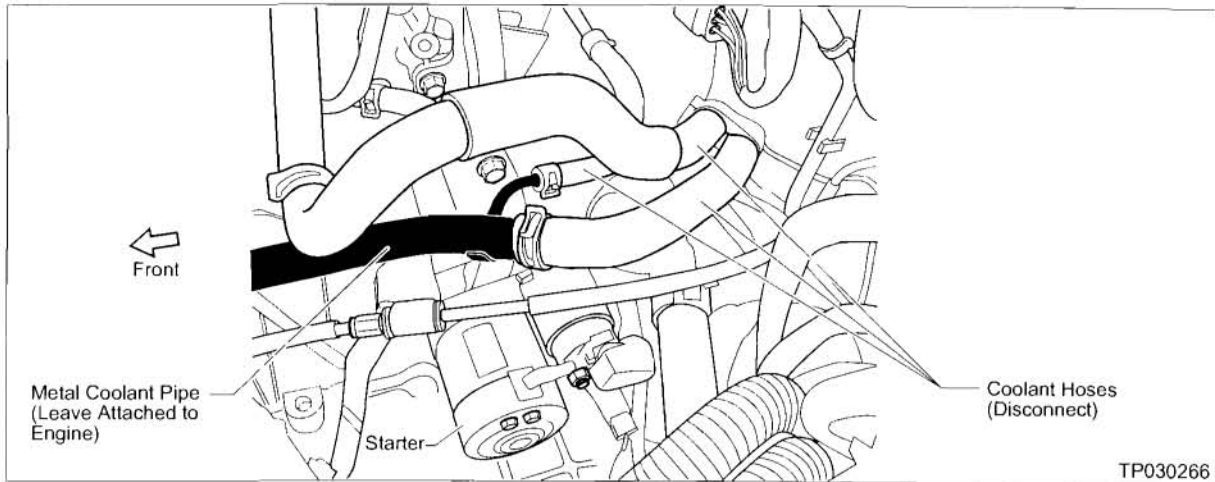
Figure F7

Coolant Pipe (Alitma ONLY)

- Disconnect the Coolant Hoses from the Metal Coolant Pipe, but leave the metal pipe on the engine (see Figure F7).

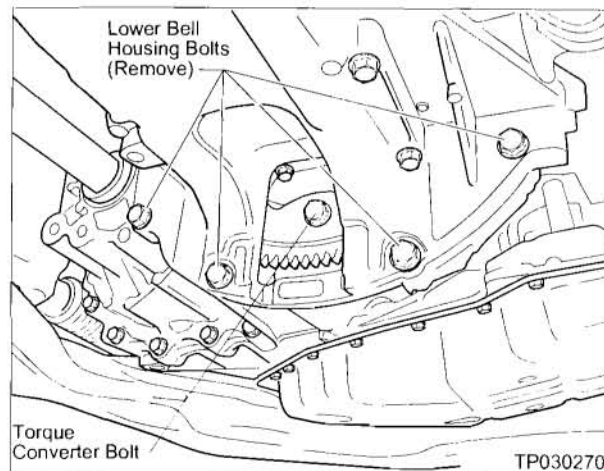
Figure F8

Torque Converter/Lower Bell Housing Bolts (Altima and Sentra)

- Remove the Torque Converter and **Lower Bell Housing Bolts** before removing the engine. It's easier to do this before the engine is out of the vehicle (see Figure F8).

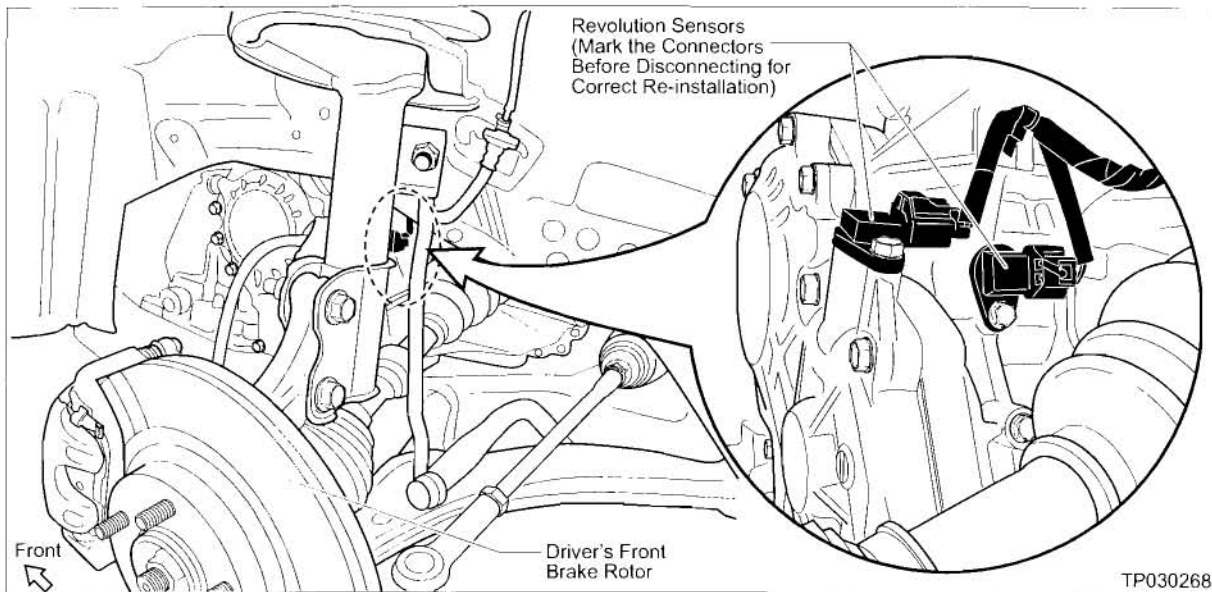
Figure F9

A/T Revolution Sensor Wire Harness Connectors (Altima and Sentra)

- Make sure you mark the A/T Revolution Sensor Wire Harness Connectors for proper re-installation (see Figure F9). If these connectors are “mixed up”, improper transmission shifting can occur.
