RECALL CAMPAIGN BULLETIN

VOLUNTARY RECALL CAMPAIGN VOLUNTARY SERVICE CAMPAIGN ALTIMA AND SENTRA QR25DE ENGINE OIL CONSUMPTION

CAMPAIGN I.D. # PB023
NHTSA #: 06V-223
APPLIED VEHICLES: 2006 Altima (L31), with QR25DE Engine
2006 Sentra (B15), with QR25DE Engine
APPLIED VINs: Altima 1N4AL11**6C 159667 – 234874, or
1N4AL11**6N 344352 – 415475
Sentra 3N1AB51**6L 526889 - 597232

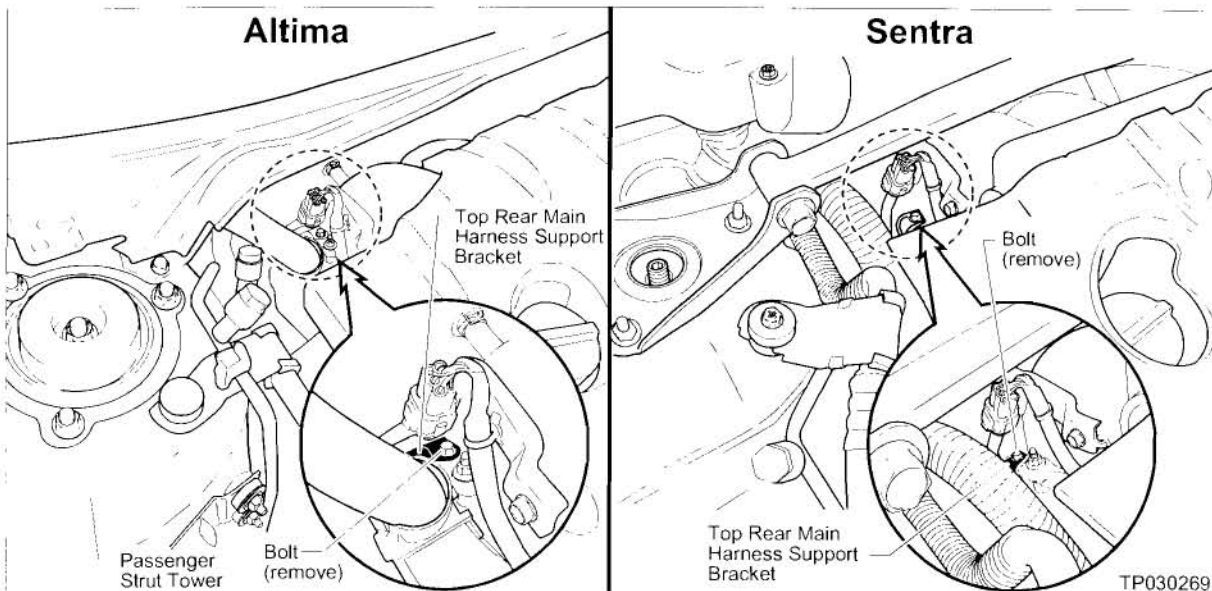
Figure F10

Top Rear Main Harness Support Bracket (Altima and Sentra)

- Remove the bolt that secures the Top Rear Main Harness Support Bracket to the engine before engine removal (see Figure F10).

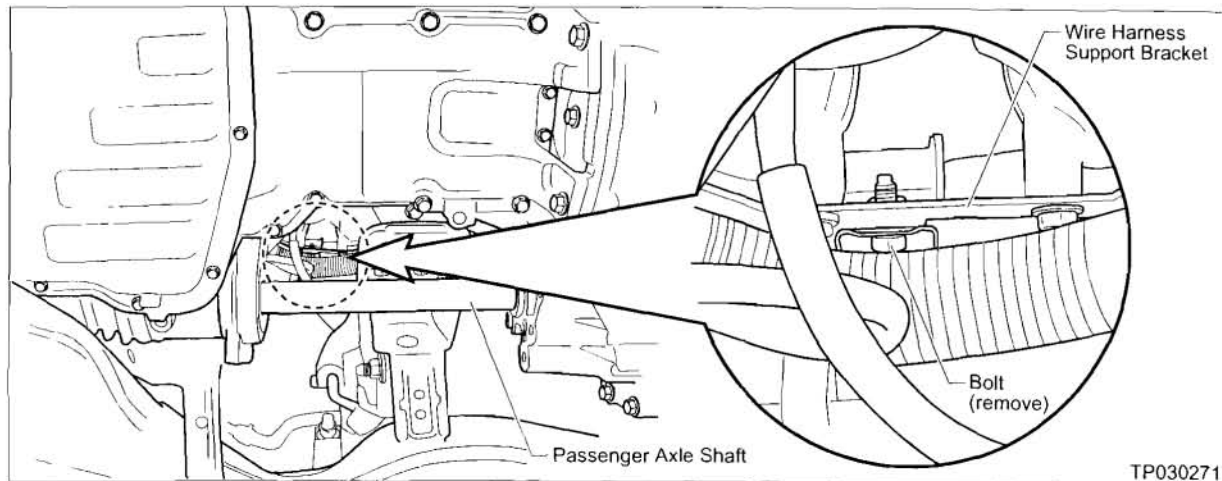
Figure F11

Wire Harness Support Bracket (Altima ONLY)

- Remove one bolt to release the Wire Harness Support Bracket (see Figure F11).

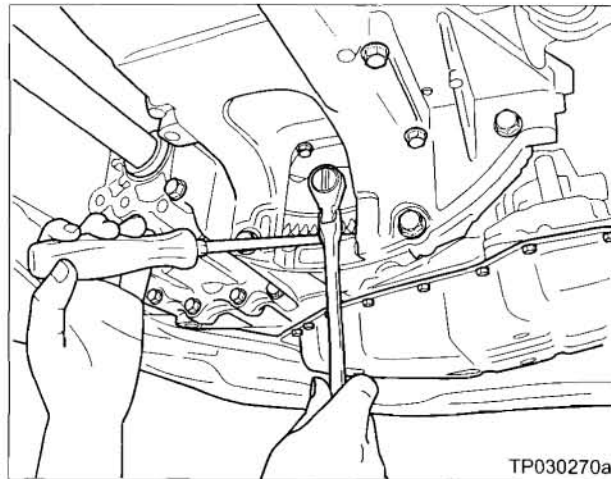
Figure F12

Torque Converter to Flex Plate Securing (Altima and Sentra)

- Use a screwdriver to move the Torque Converter up or down to align the Torque Converter bolt holes with the Flex Plate bolt holes (see Figure F12).
- Make sure the bolt "shoulder" is fully seated in the mounting hole.

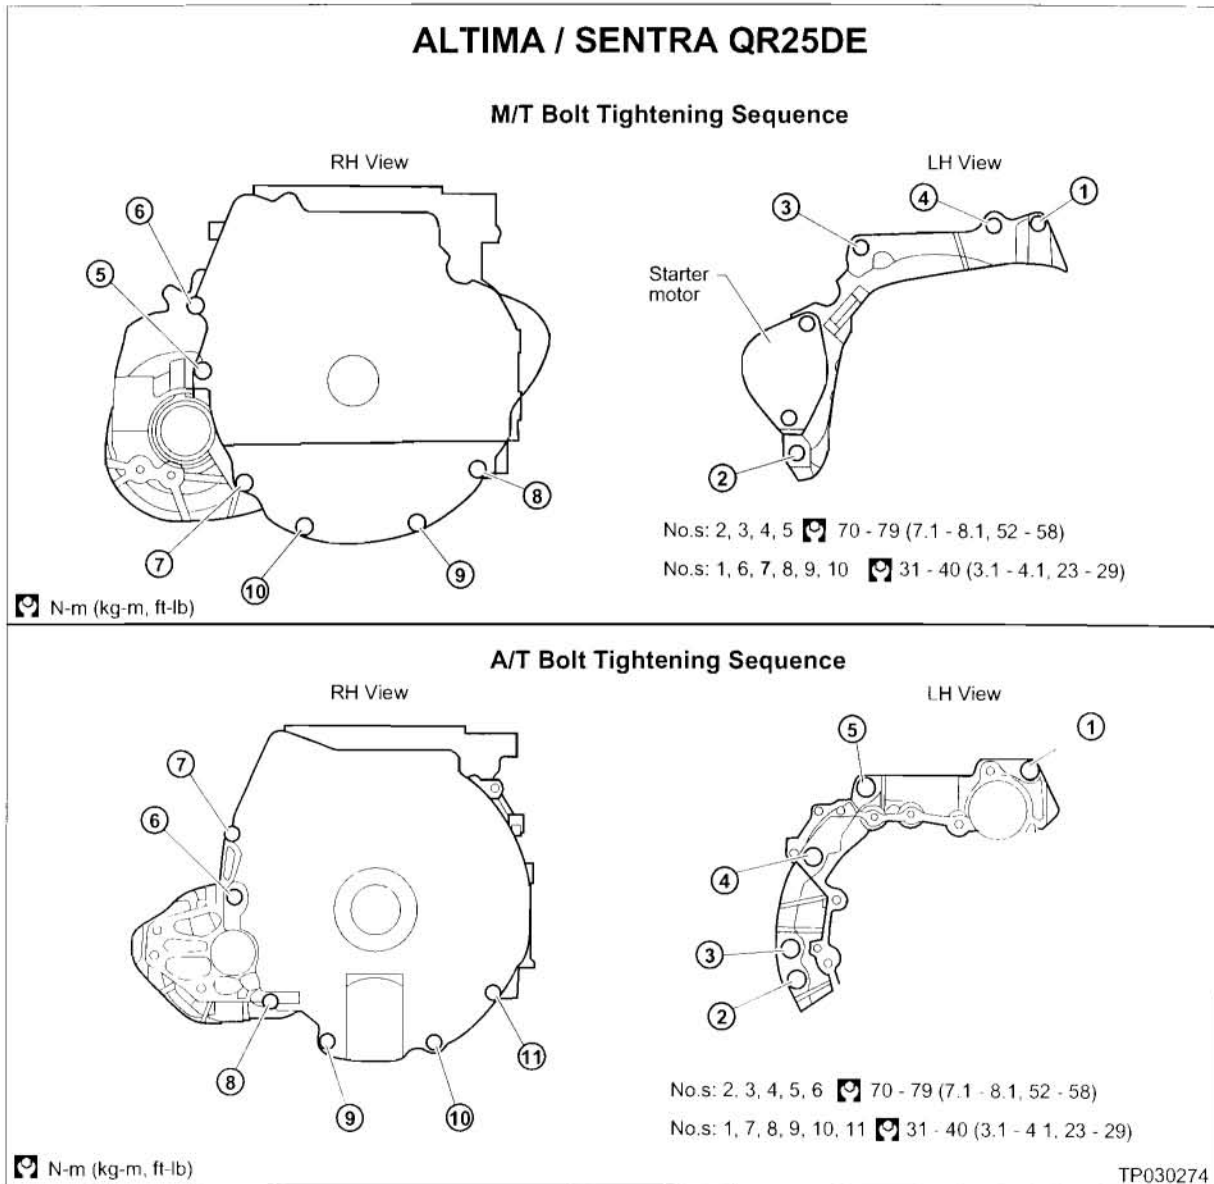
Figure F13

CAUTION:

- The engine and transmission must be fully mated together before tightening the bolts.
- Do NOT use the bolts to pull the engine and transmission together.

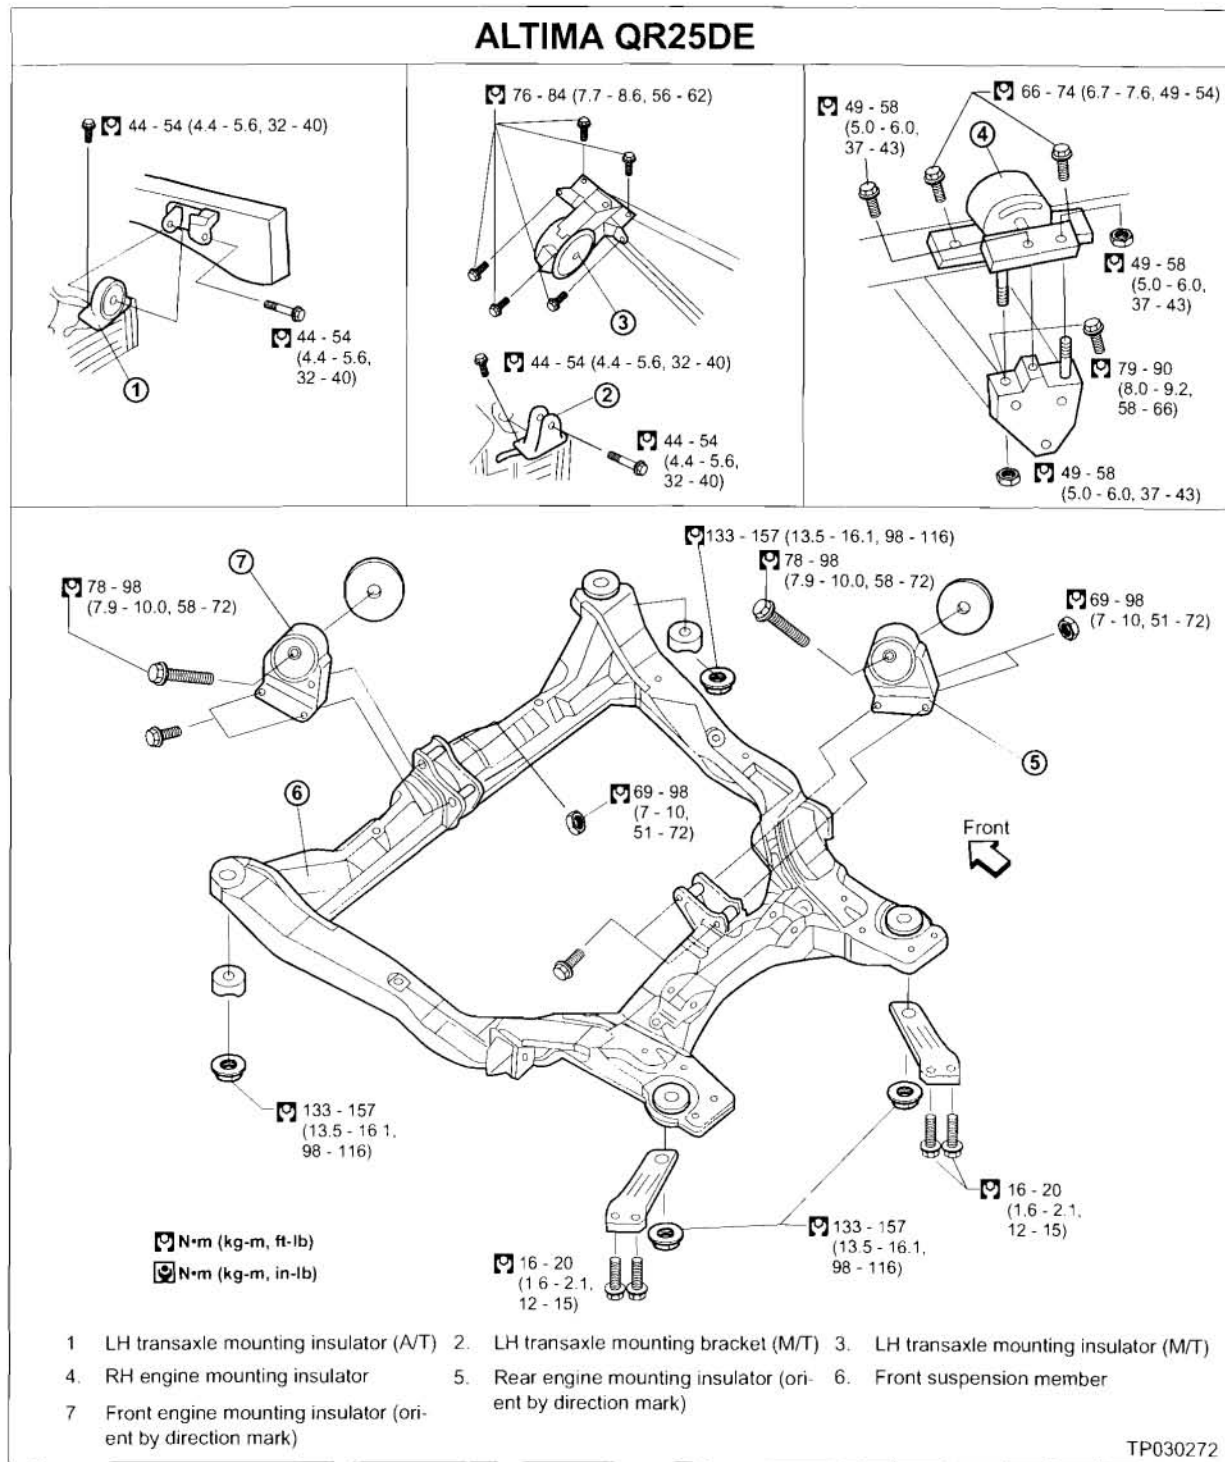
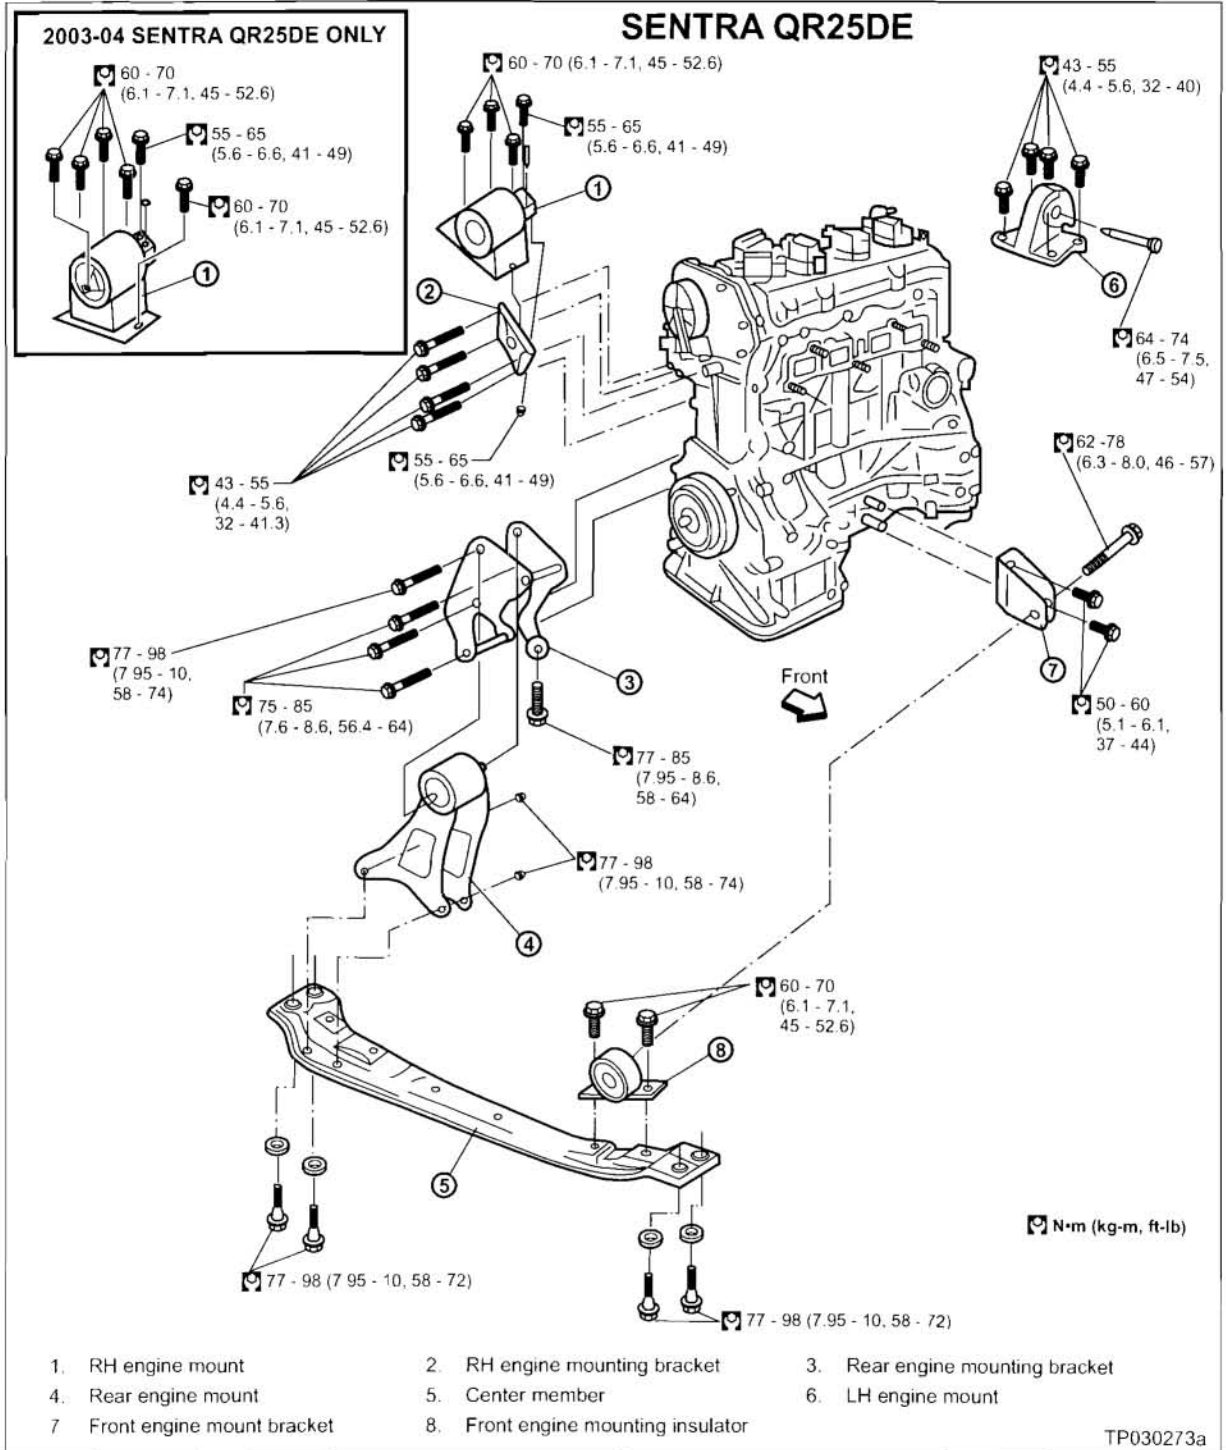
Torque Specifications (Altima and Sentra)

- Refer to the below Illustrations for torque specifications. As needed; refer to the applicable Electronic Service Manual for other torque specifications.

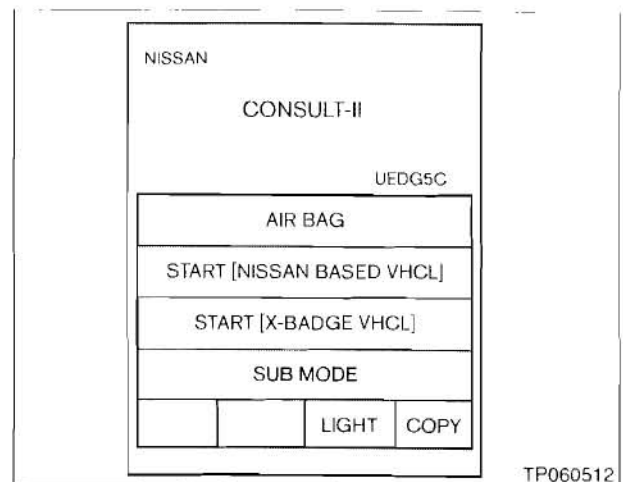
Figure G1

3. Attach CONSULT-II to the vehicles OBD-II connector port.

- Turn the ignition ON.
 - CONSULT-II will turn on automatically.
- Select START (NISSAN BASED VEHICLES).

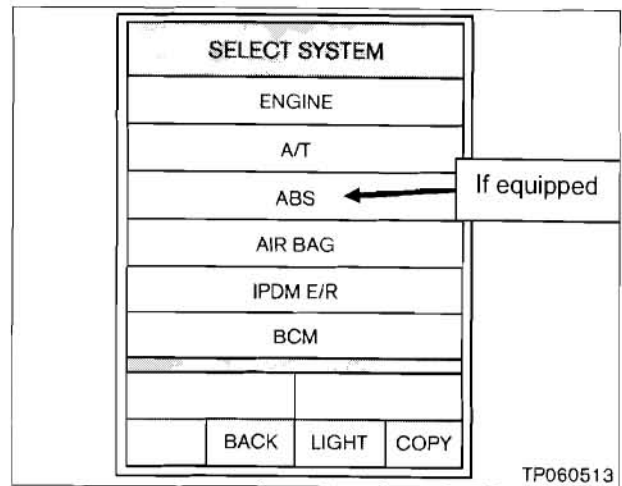
Figure G2

- c. CONSULT will display the systems shown in Figure G2.

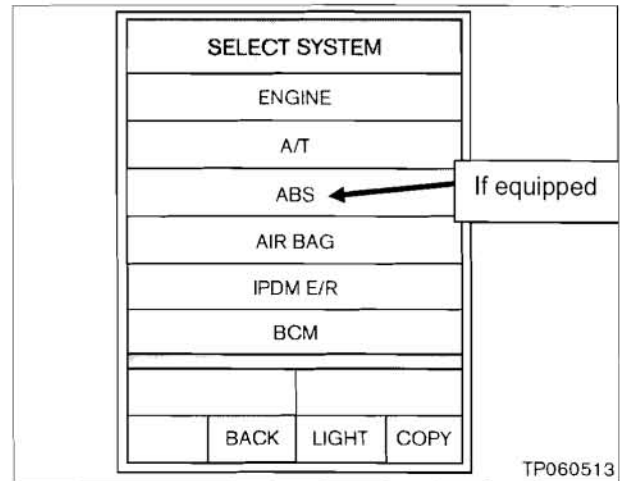
Figure G9

If DTC is stored:

- PRINT the data.
- Repair the DTC as needed.
See Service Manual for DTC repair information.

- c. Press **ERASE** and **OK**
- d. Press **BACK** two times.
- e. Repeat a through d for each system.

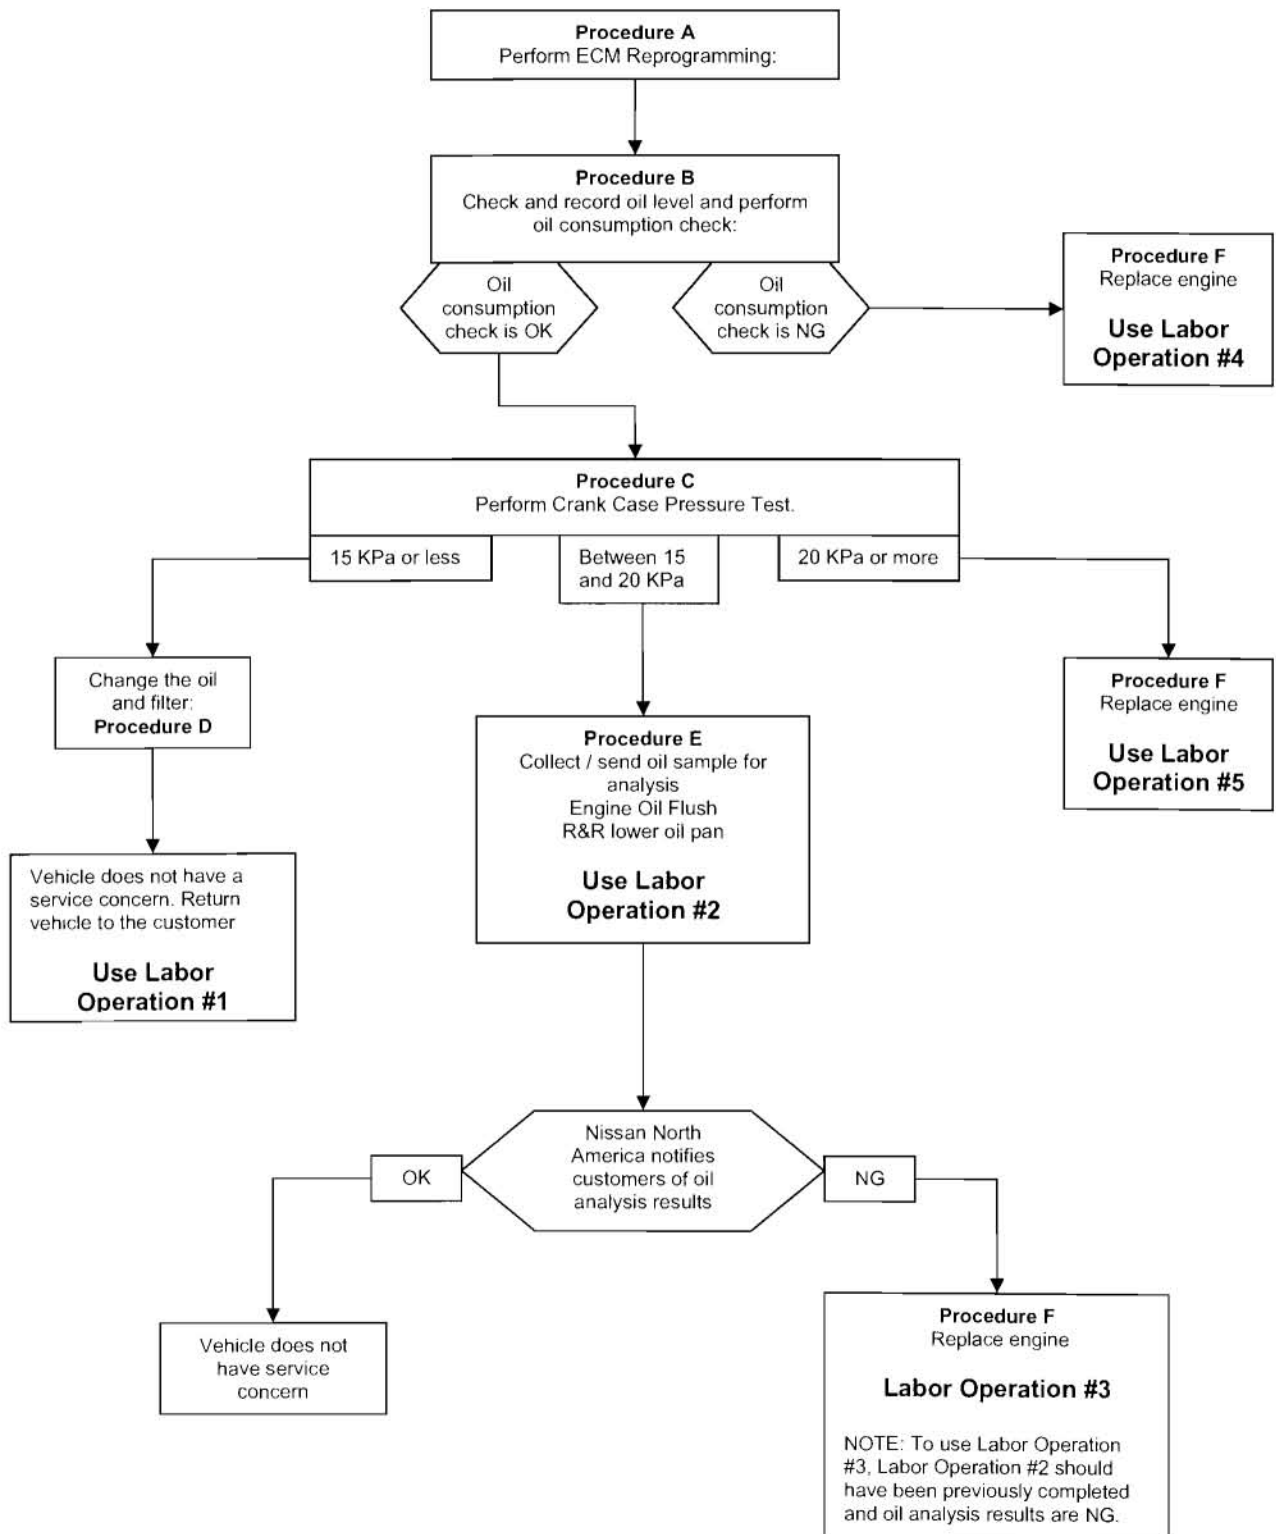
Labor Operation Flow Chart

Key to Procedures:

Procedure E: Send Oil for Analysis, Engine Oil Flush, Replace Lower Oil Pan

Procedure F: Replace Engine
