NTB06-051

VOLUNTARY RECALL CAMPAIGN 2003 ALTIMA AND SENTRA WITH QR25DE ENGINE CRANK ANGLE SENSOR / ECM REPROGRAMMING

CAMPAIGN I.D. # R0606
NHTSA #: 06V-242
APPLIED VEHICLES: 2003 Altima (L31) with QR25DE Engine
2003 Sentra (B15) with QR25DE Engine
APPLIED VINS: Altima: 1N4AL11**3C 100000 - 355207
Sentra: 3N1AB51**3L 716572 - 736783

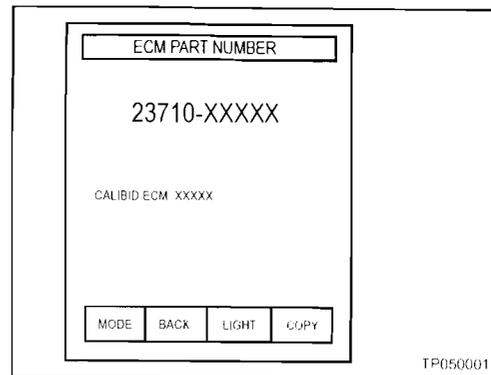
2. Attach this printout to the Repair Order.
 - Figure A is an example of the ECM Part Number printout.

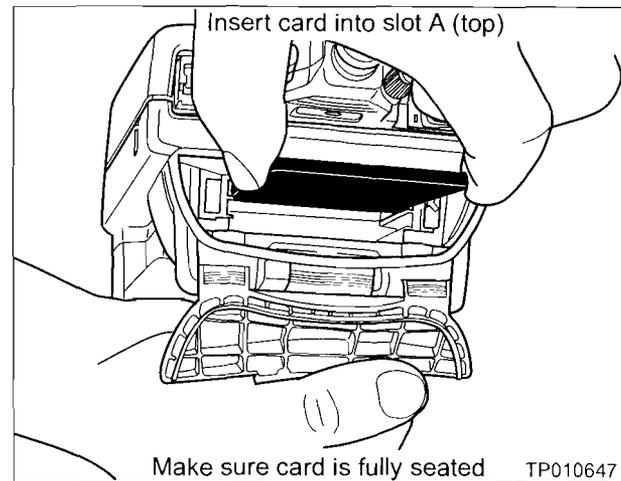
Figure 1

1. Install the Reprogramming Card into CONSULT-II.
 - Make sure CONSULT-II is disconnected from the vehicle and turned OFF.
 - The Reprogramming Software Card is the “orange” Card.
 - Use slot A—top slot (see Figure 1).

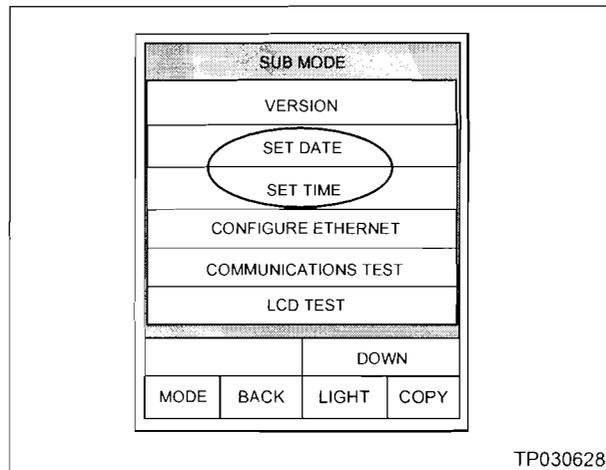
Figure 2

C. Touch **SET DATE** (see Figure 2).

D. Touch **SET TIME** (see Figure 2).

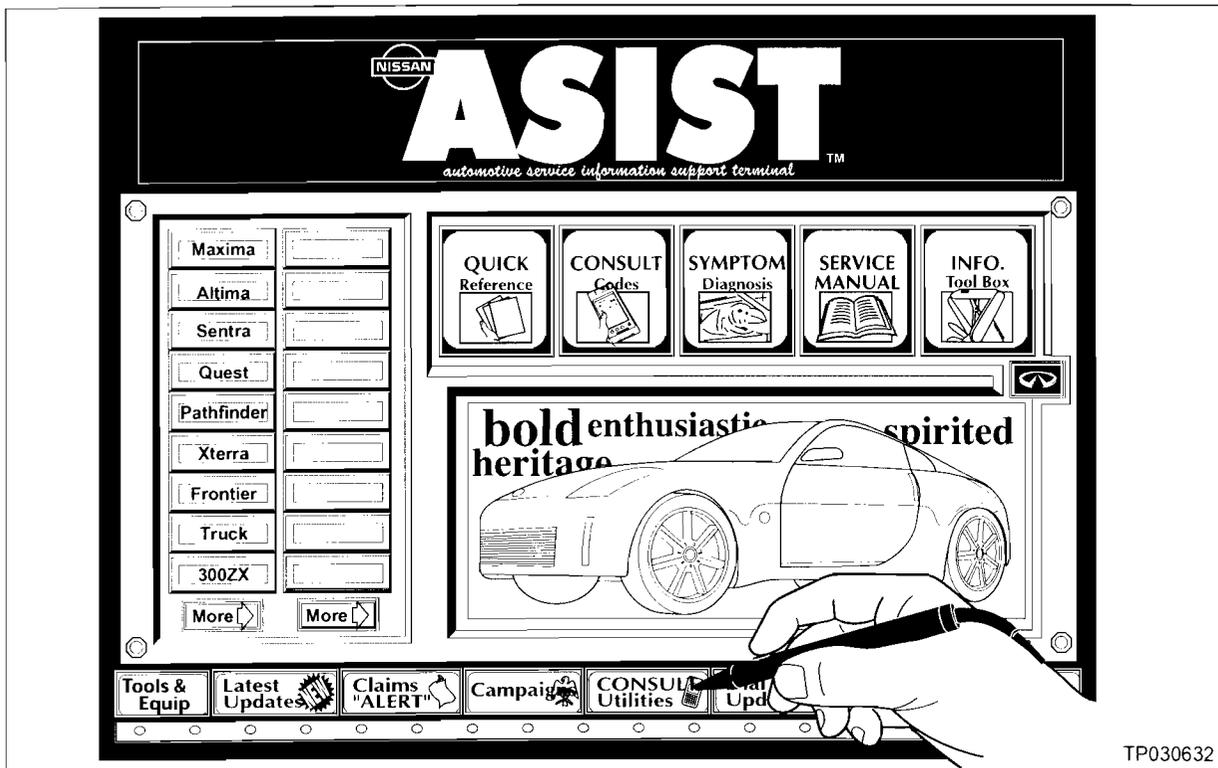
Figure 3

- From the ASIST PC main menu screen, select **"CONSULT UTILITIES"** (see Figure 3).

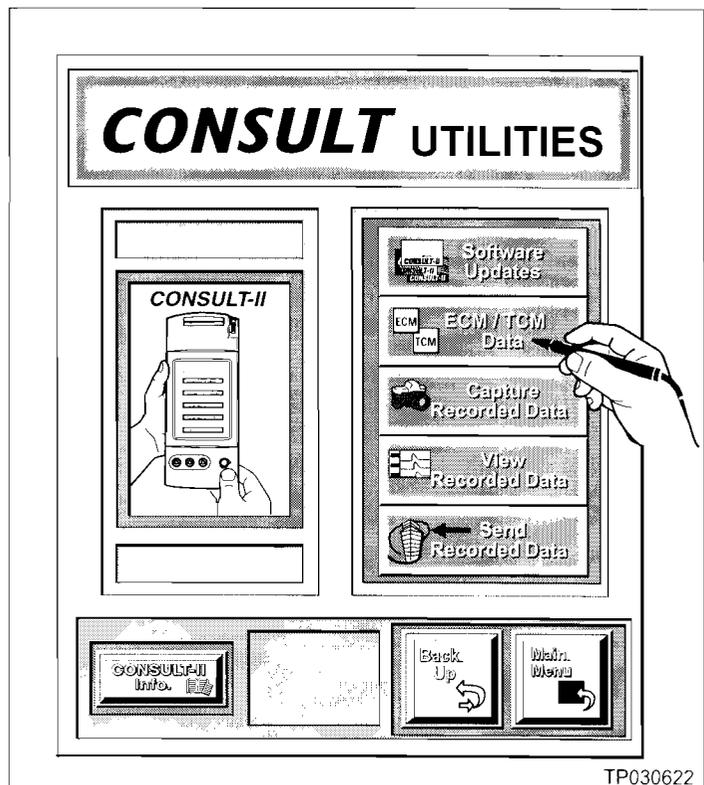
Figure 4

- From the **"CONSULT UTILITIES"** screen, select **"ECM / TCM DATA"** (see Figure 4).

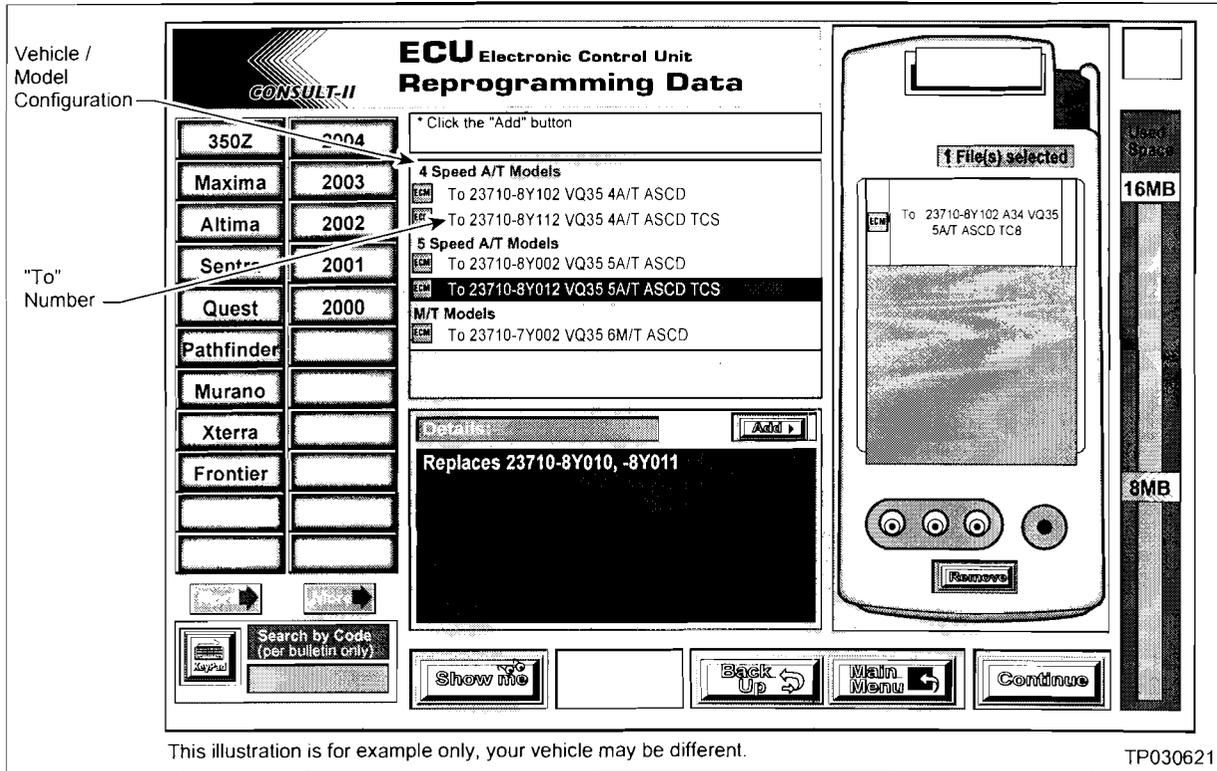
Figure 5

7. Select the "ECU REPROGRAMMING DATA" (see Figure 5) as follows:

- A. Select vehicle model and model year.
- B. Select the correct reprogramming data:
 - 1) Locate the specific "Model Configuration" (Example: QR25 A/T ASCD).

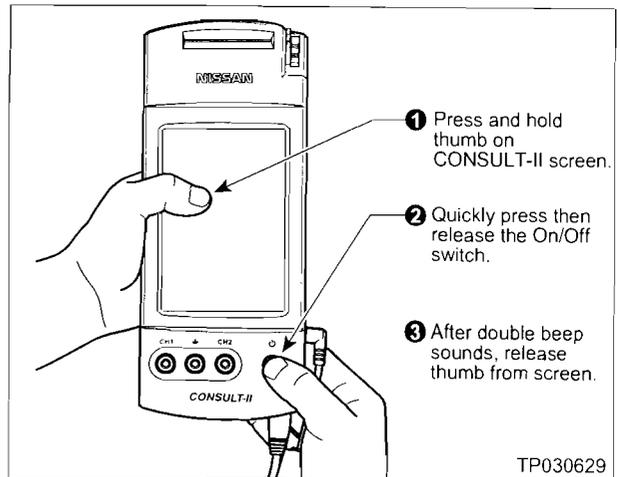
8. Turn "ON" CONSULT-II as shown in Figure 6.

NOTE: If you accidentally choose a menu option other than "Transfer Files via LAN"; turn CONSULT-II "OFF", and then back "ON" as shown in Figure 6 above.

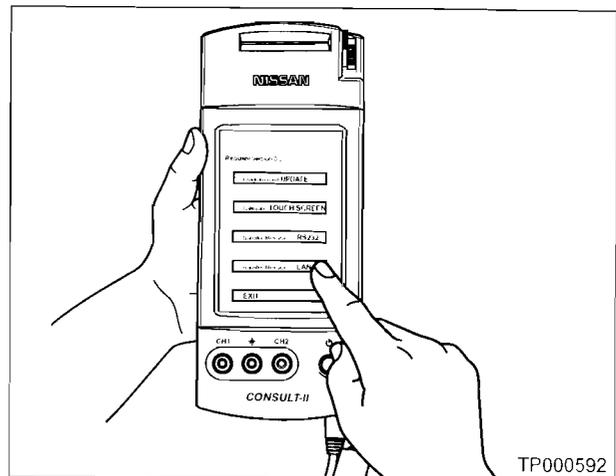
Figure 7

9. Select **Transfer files via LAN** (see Figure 7).

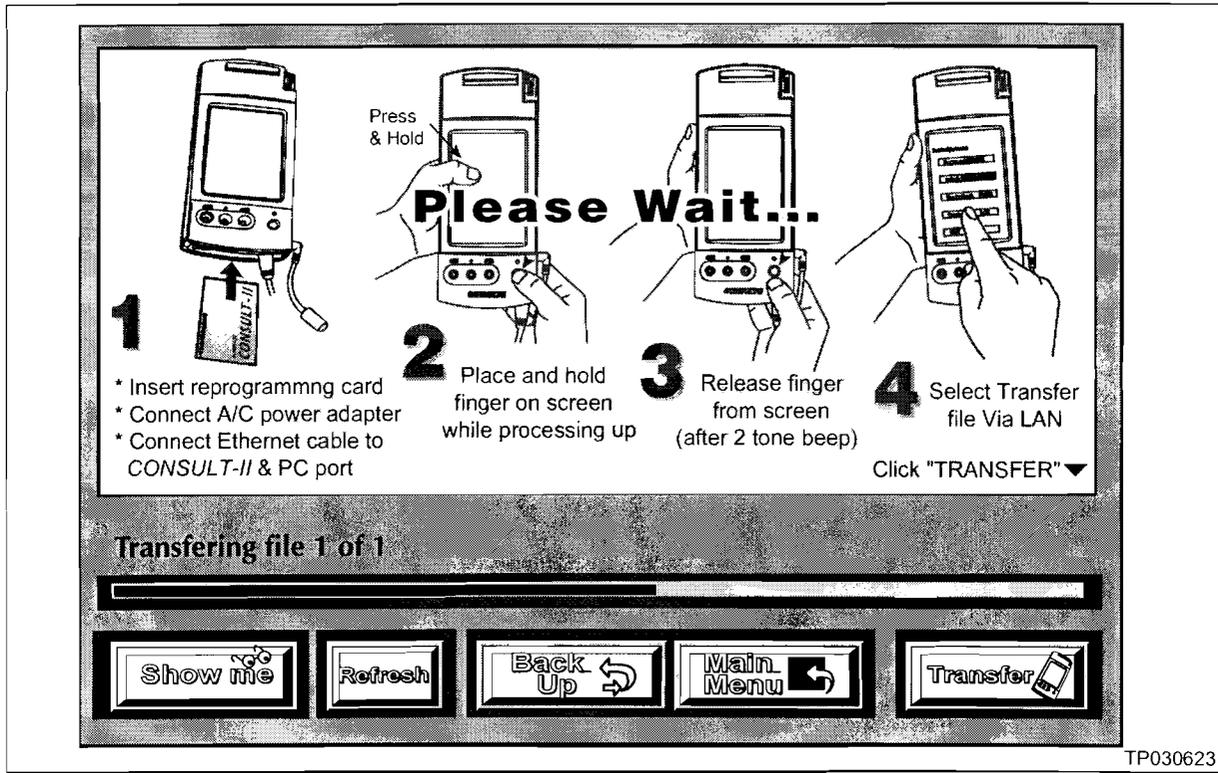
Figure 8

A. On the ASIST screen, click on "Transfer" (see Figure 8).

- Data transfer will take about 15 seconds.
- Transfer progress is displayed on the ASIST screen (see Figure 8).

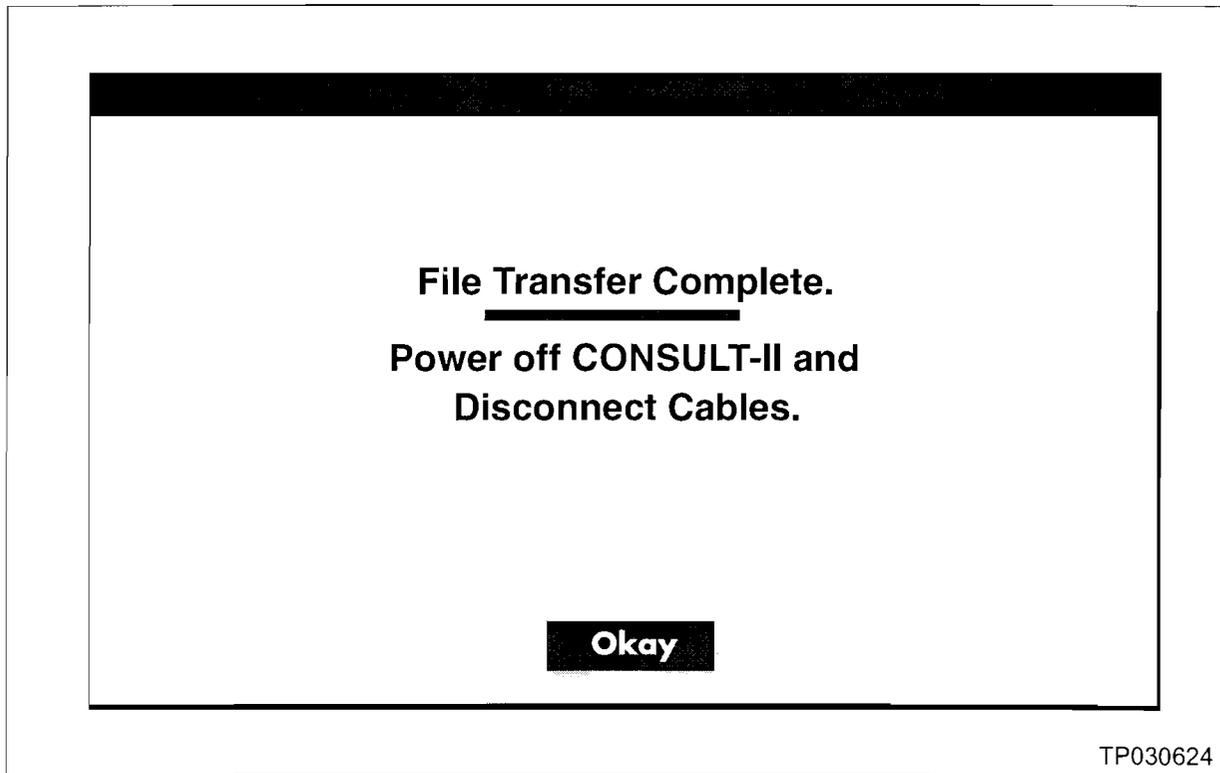
Figure 9

CAUTION: DO NOT DISCONNECT THE ETHERNET CABLE UNTIL "COMPLETE" IS DISPLAYED AS SHOWN IN FIGURE 9 ON THE NEXT PAGE.

11. When transfer is complete (see Figure 9):

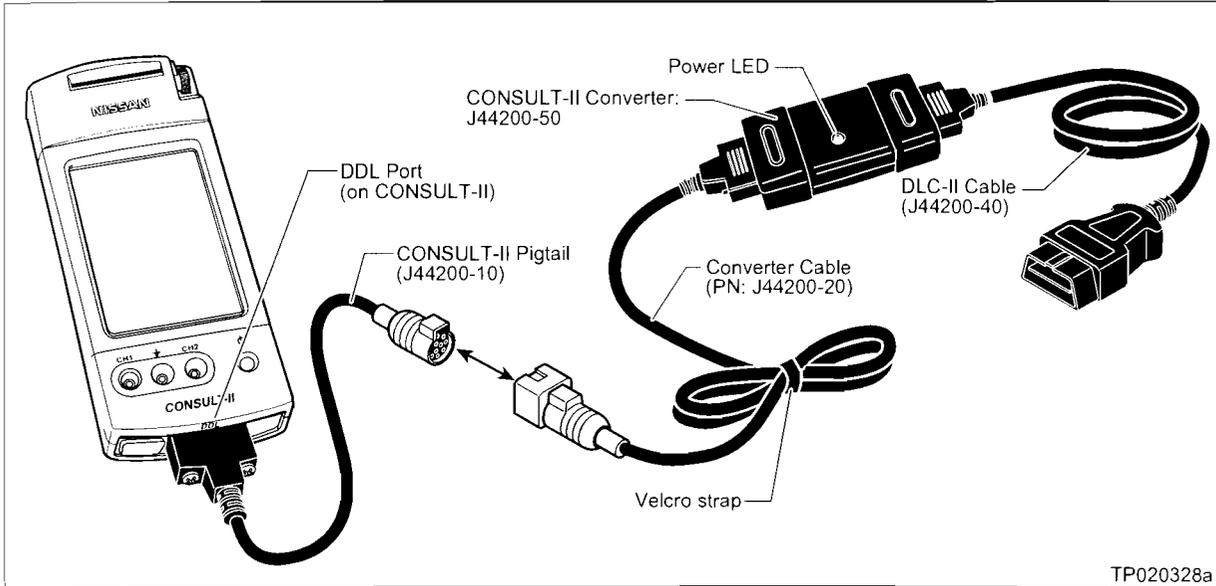
14. Connect CONSULT-II to the vehicle using the DLC-II cable with black Converter Box (see Figure 10 on next page).

- Make sure the DLC-II is straight and fully plugged in to the vehicle.
- Make sure all other DLC-II cable connections shown in Figure 10 are connected properly.

- Nissan requires the use of essential tools shown in Figure 10 when performing ECM reprogramming.
- J44200-10 "Pigtail" should not be removed from the CONSULT-II DDL Port. This "Pigtail" allows use of the stronger "quick disconnect" cable set.
- If cables are very often changed at the DDL Port (base) of the CONSULT-II unit, cable connector pin damage may result.
- If there is connector pin damage, ECM reprogramming may fail. Permanent ECU damage can occur.

- If the vehicles battery voltage (“Charger Input”) is below 12 volts, one or more of the following may be the cause:
 - a. The battery charger you hooked up in section 1 is not charging the battery (poor connection or it is not working).
 - b. The DLC-II does not have a good connection to the vehicle (not straight).
 - c. The DLC-II cable may have a malfunction (damaged wire or pins).
 - d. The CONSULT-II Converter (J44200-50 / black box) is not working correctly (see Figure 10 on page 14).

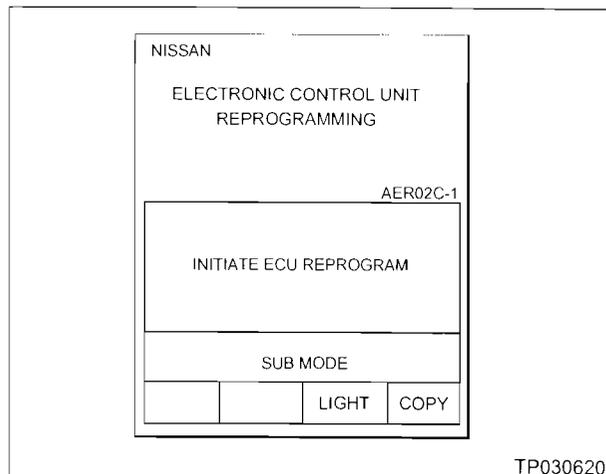
Figure 11

- CONSULT-II will turn "ON" automatically (see Figure 11).
- Confirm that all electrical loads* (except for the ignition) are "OFF".

17. Press **SUB MODE** (see Figure 11) then:

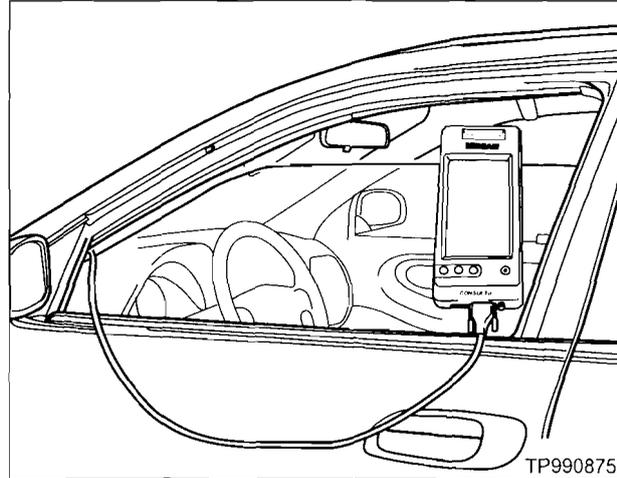
Figure 12

16. Roll down the driver's window part way, exit the vehicle, close the door, and hang the CONSULT II unit on the outside of the window (see Figure 12).

- This step is necessary to ensure the CONSULT-II and DLC-II cable will not be disturbed during reprogramming.

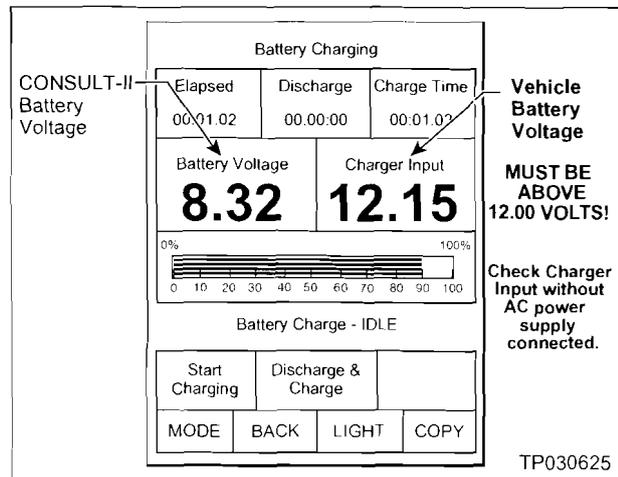
18. Check the CONSULT-II's "Charger Input" reading (see Figure 13).

19. The “Charger Input” reading **MUST** be above 12 volts (see Figure 13 on page 15).

- Do not attempt ECU Reprogramming if the vehicle's battery voltage is below 12 volts.
- Permanent ECU damage can occur if the vehicle battery does not maintain the minimum voltage during ECU Reprogramming.
- If “Charger Input” is above 12 volts, power from the vehicle battery will keep CONSULT-II's power supply at the correct level during reprogramming. (see Figure 13).

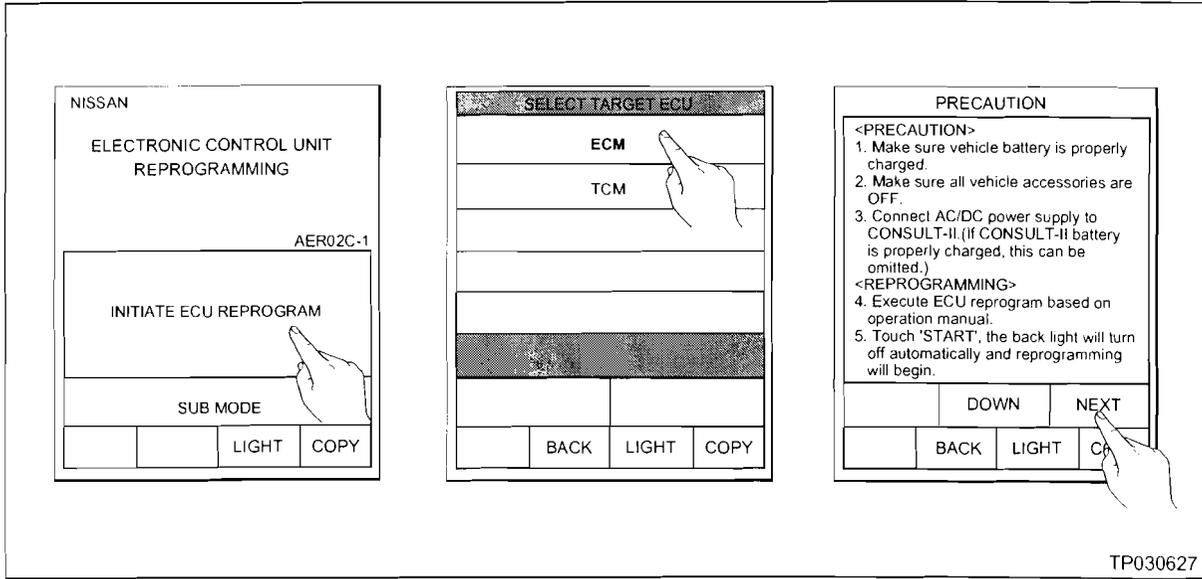
Figure 14

20. Press **INITIATE ECU REPROGRAM** (see Figure 14), then

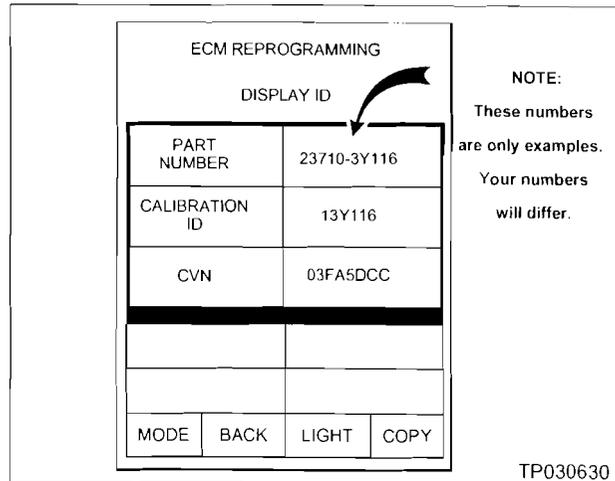
Figure 15

21. Press **CHECK ECM P/N** to “confirm” (take note of) the current ECM part number (see Figure 15).

NOTE: This is the vehicle’s ECM part number BEFORE Reprogramming.

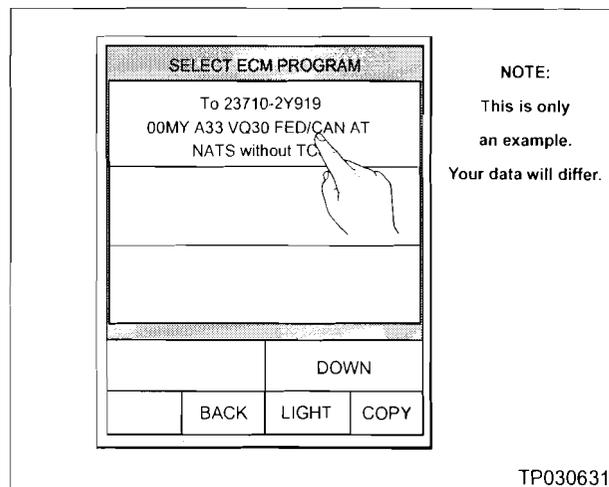
Figure 16

24. Select the ECM program to install (see Figure 16).

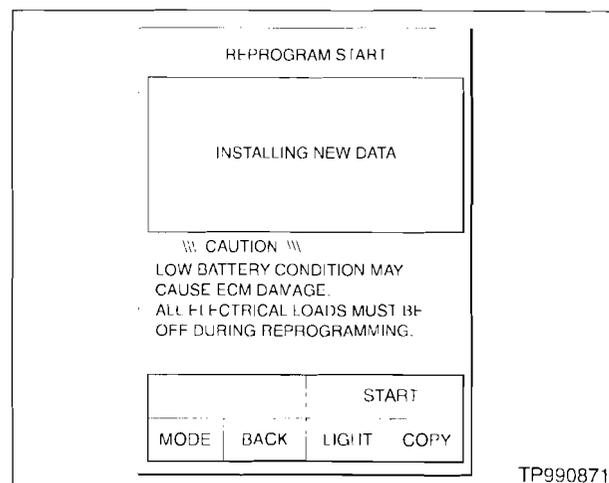
Figure 17

25. The "REPROGRAM START" window should appear (see Figure 17).

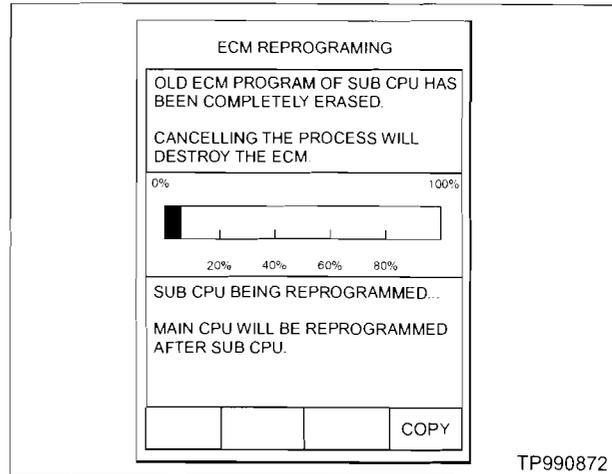
- After a few seconds, the window shown in Figure 18 will appear.
- CONSULT-II will now turn "OFF" its screen backlight.
- When the screen backlight goes "OFF", ECM reprogramming has started.

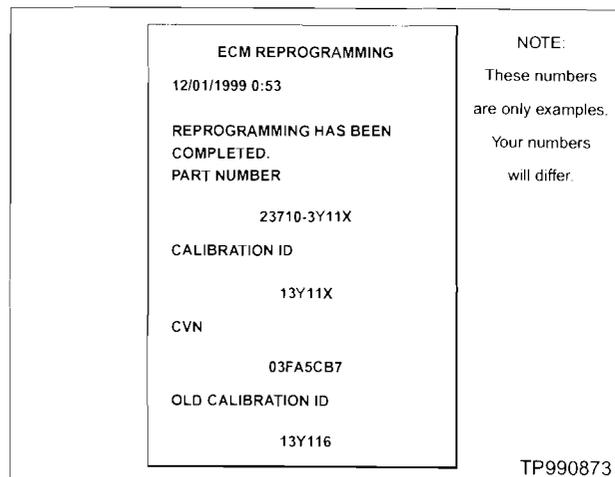
Figure 19

27. When the Reprogramming is complete, CONSULT-II will "beep", turn the screen backlight back ON and automatically print out a report (see Figure 19).

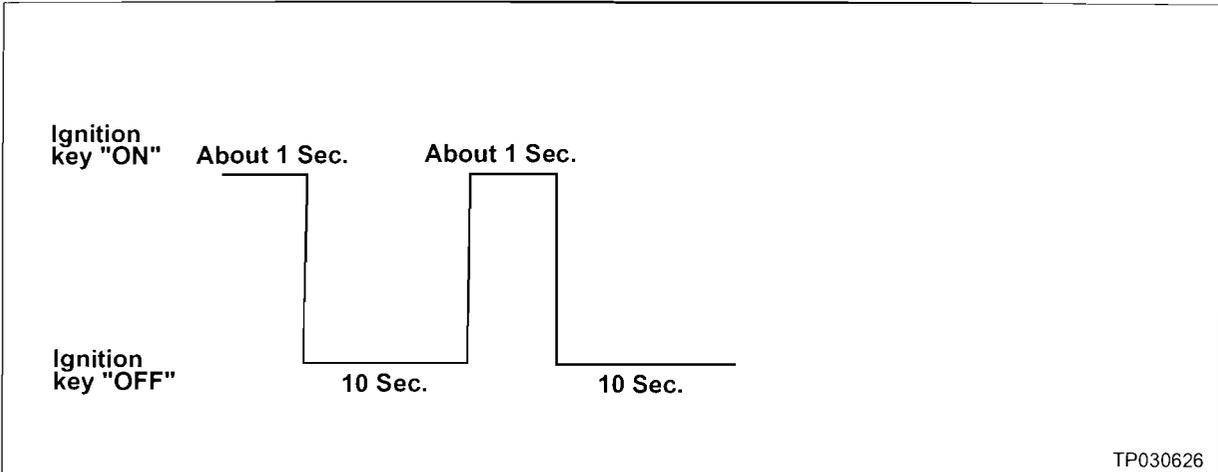
Figure 20

30. Wait more than 10 seconds, then turn the ignition switch "ON" for 1 second. Then, turn the ignition switch "OFF" again for 10 seconds (see Figure 20).

- This will reset ECM self learned Data.
