Subject: Recall Campaign JP (06V-293)
2006 Audi A3 – Replace Side Curtain Airbag

Subject: Safety Recall JP
2006 Model Year Audi A3
Replace Side Curtain Airbag

**Subject: 2006 Model Year Audi A3 Vehicles
Replace Side Curtain Airbag**

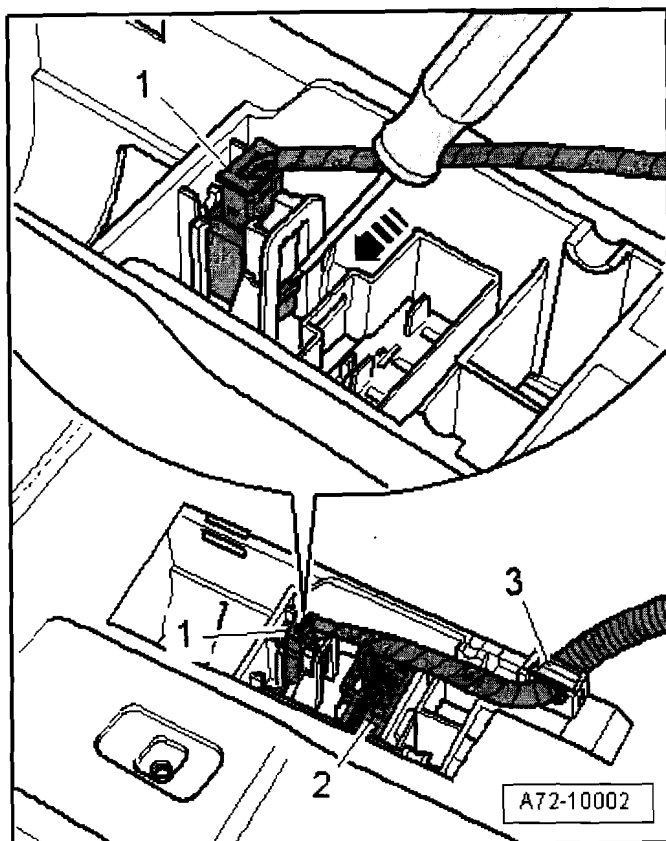
- ⇐ Disengage cover cap -1- in direction of arrow

- ⇐ Use small screwdriver to push in locking tabs on side of wire holder -3- and lift out
- ⇐ Disconnect electrical harness connector -2- for seat operation
- ⇐ Disengage retaining clips using a flat-head screwdriver in direction of arrow and disconnect electrical harness connector -1- for side airbag
- Connect VAS 6235 airbag adapter to harness connector
- Lift front seat out of vehicle with help of second technician

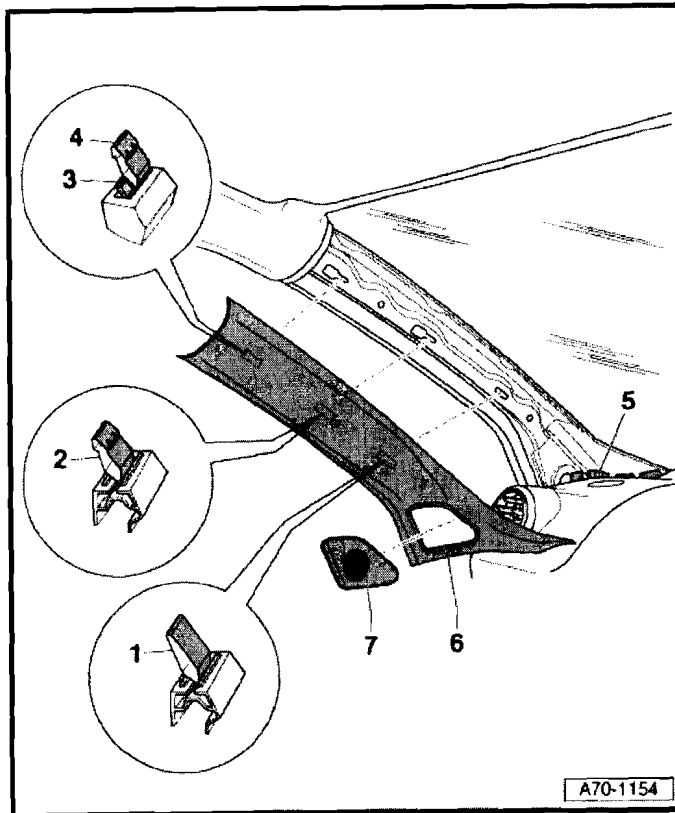
(Drivers side shown for illustrative purposes)

- A-pillar trim has special clips requiring careful removal to prevent damage
- Clips -2- and -4- have a catch at bottom of clip that can not be pulled out
- The top clip position has a guide pin -3- to locate trim properly on A-pillar when installing
- The bottom clip -1- must be pulled out completely before disengaging clips -2- and -4-

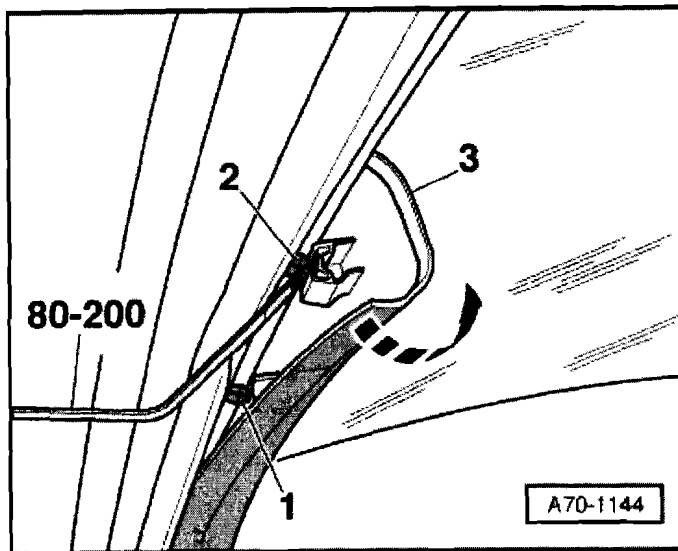
- ⇐ Pull out A-pillar trim -3- in area of sealing rubber by hand far enough from A-pillar until 80-200 pry lever can be positioned at top retainer -2-
- ⇐ Push out retainers -1- and -2- in succession to catch using 80-200 pry lever
- Pull bottom retaining clip completely out

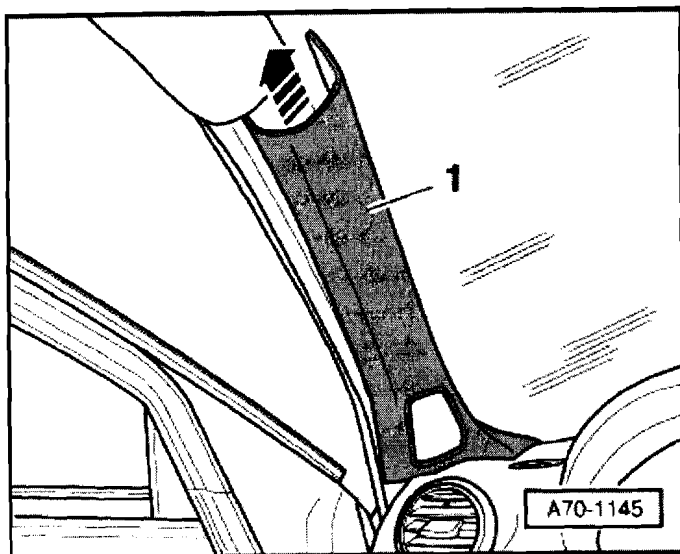
- ⇐ Pull A-pillar trim -1- upward -arrow- to release upper retainers completely
- ⇐ Disconnect loud speaker electrical harness connector
- Remove right side A-pillar trim using information from left side

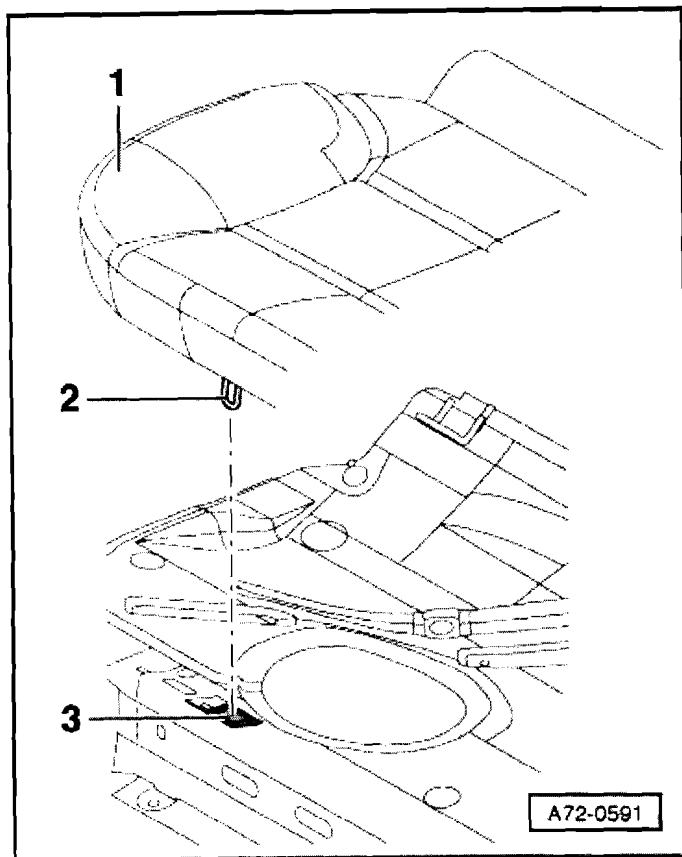
- ⇐ Raise rear seat bench -1- at front being careful not to damage plastic sleeve -3- when pulling tab -2- out
- Push seat bottom back slightly and lift over retainer in rear
- Pull rear seat bench toward front of vehicle
- Remove seat bench from vehicle
- Lay clean cover over floor pan to prevent seat back from getting dirty
- Release latch on rear seat back and fold down

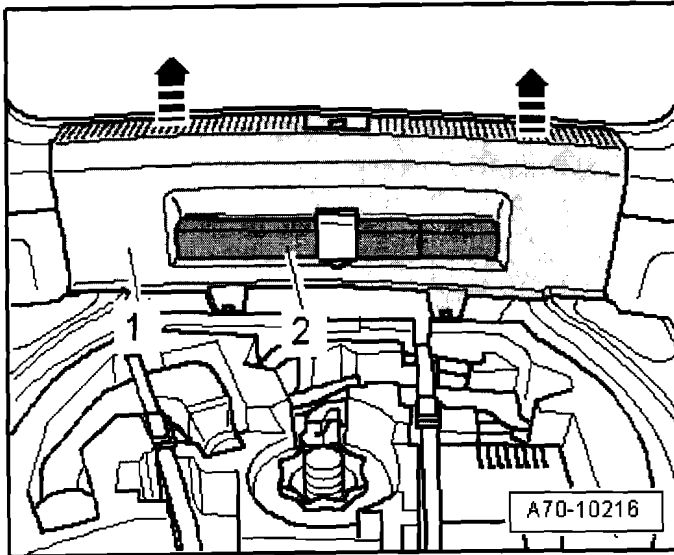
Note: Steps must be followed in sequence; otherwise, parts may break

- Remove luggage compartment floor mat
 - Remove rear hatch seal and cover corner edges with tape to protect headliner
- ⇐ Lift rear cross panel trim -1- until retaining clips disengage

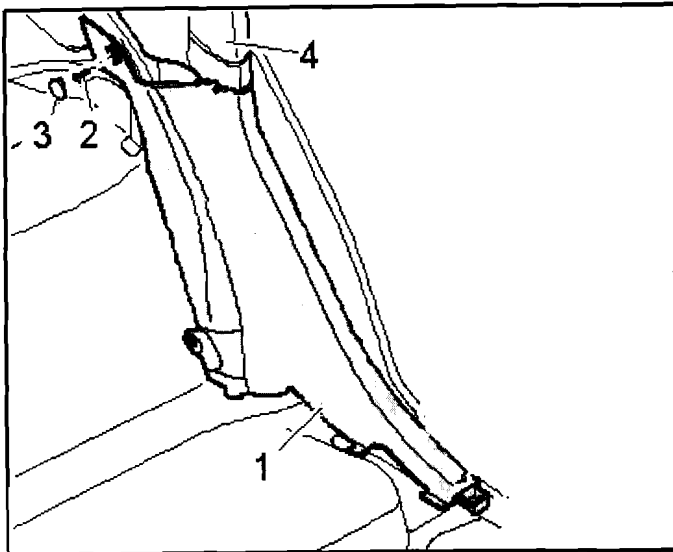
(Left side shown for illustrative purposes)

- ⇐ Unclip cover plug -3- from trim -1-
- ⇐ Remove bolt -2-
- ⇐ Pry lower C-pillar trim away from upper C-pillar trim -4-
- ⇐ Carefully pull lower C-pillar trim -1- away from wheel well until three retaining clips release
- Remove right side lower C-pillar using information from left side

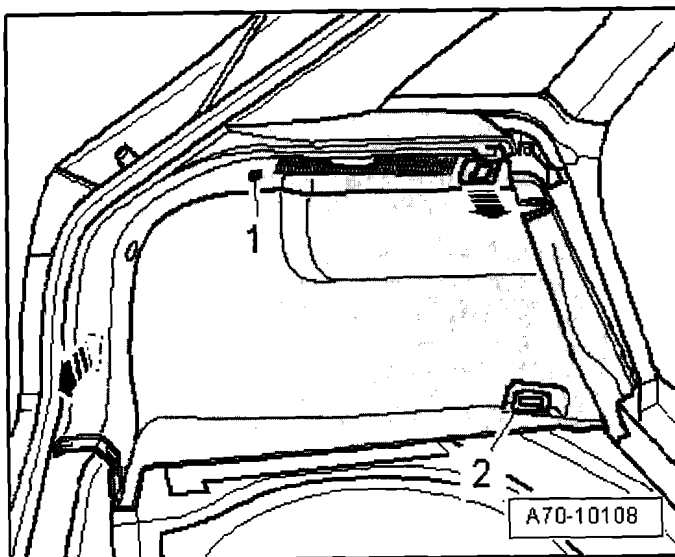
- ⇐ Use small screwdriver to remove luggage compartment light from left luggage compartment trim and disconnect electrical harness connector
- ⇐ Remove bolt -1- and bolt -3- located behind lower C-pillar trim
- Carefully separate upper portion of luggage compartment side trim from C-pillar and D-pillar trim panels
- ⇐ Pry out spring clips from body -arrows-
- ⇐ Lift side luggage compartment trim upward and over tie-down -2- and remove

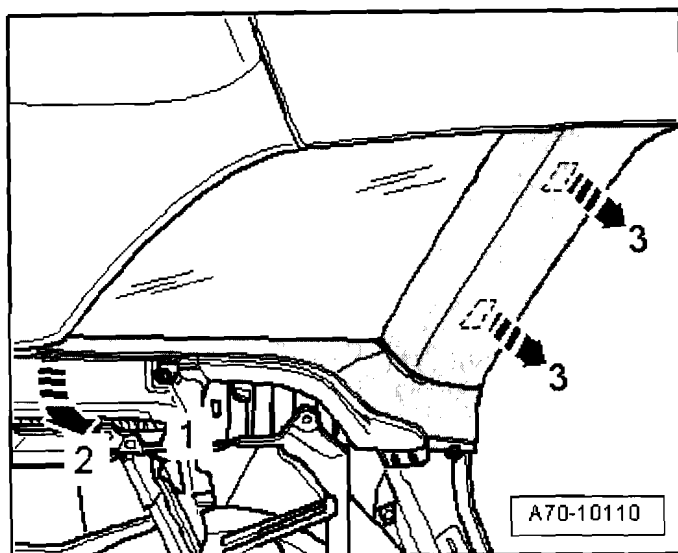
- ⇐ Remove bolt -1-
- ⇐ Disengage C-pillar trim from D-pillar trim -arrow 2-
- ⇐ Pull C-pillar trim from bottom to release retaining clips -arrows 3-
- Remove C-pillar trim downward out of upper engaging tab
- Remove right side using information from left side

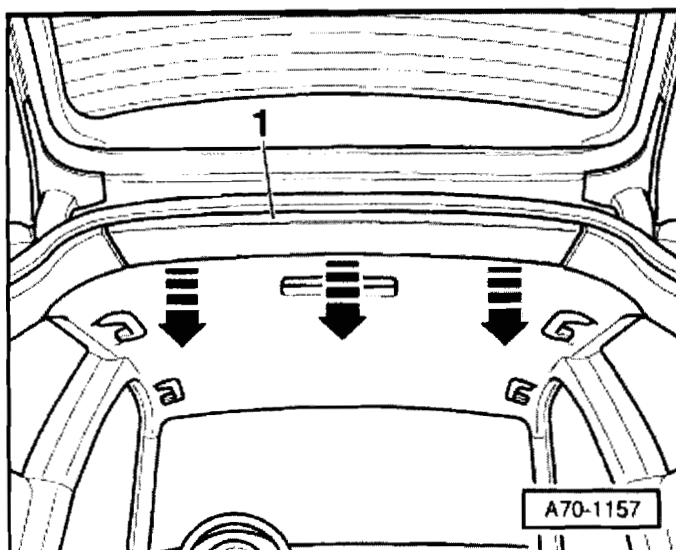
- ⇐ Pull roof end trim -1- from roof frame
-arrows-

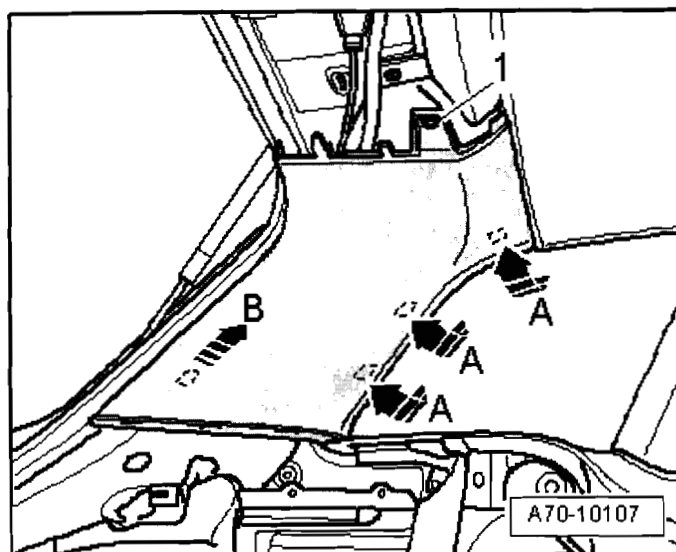
- ⇐ Remove bolt -1-
- ⇐ Pull D-pillar trim from top -arrows A- until three retaining clips release
- ⇐ Slide D-pillar trim upward at rear edge -arrow B- until engaging tab releases
- Remove right side using information from left side

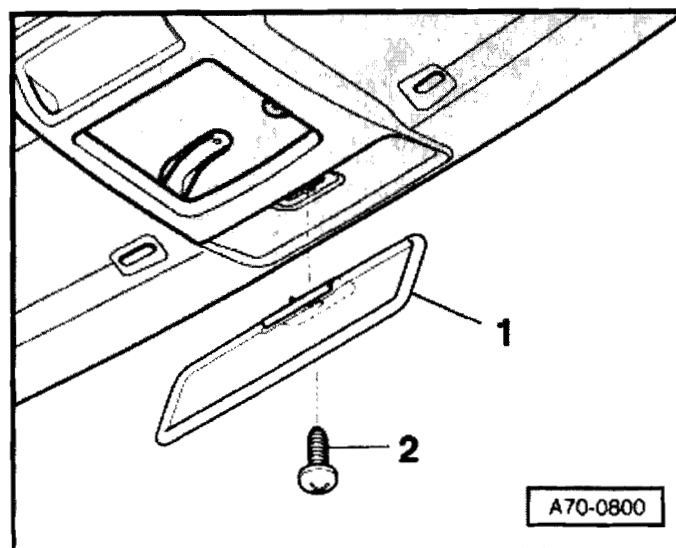
- ⇐ Remove screw -2- and remove center sun visor -1-

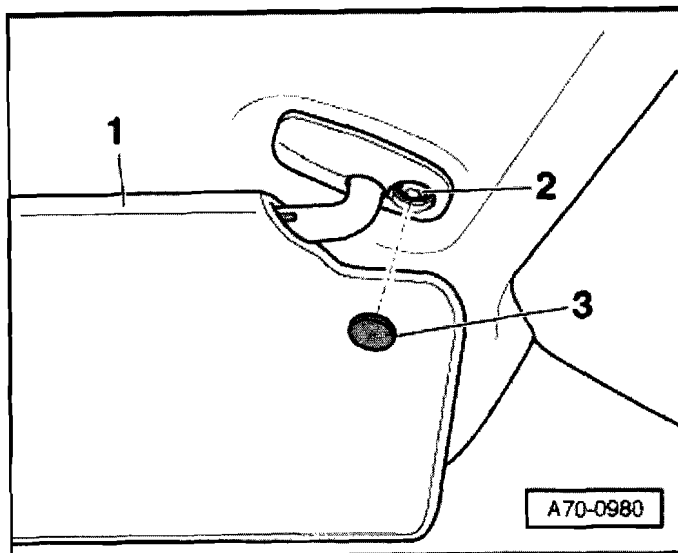
- Disengage sun visor -1- from sun visor pivot
- ⇐ Pry off cover cap -3-
- ⇐ Remove bolt -2-
- Pivot sun visor downward to remove
- Disconnect vanity mirror light switch harness connector

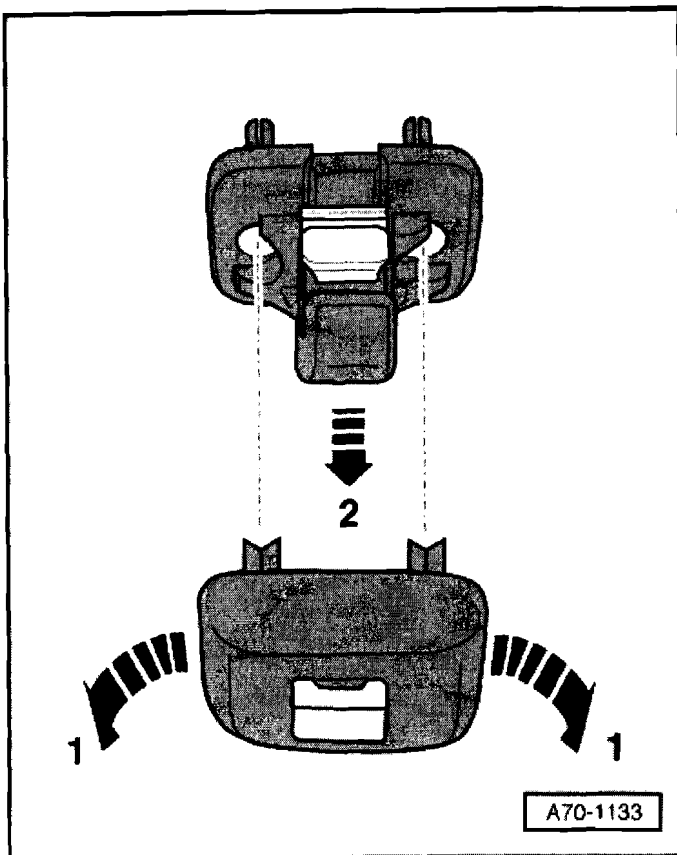
- ⇐ Use 3409 trim removal wedge to pry loose sun visor pivot cover -arrows 1- and pull downward
- ⇐ Pull out sun visor pivot -arrow 2-

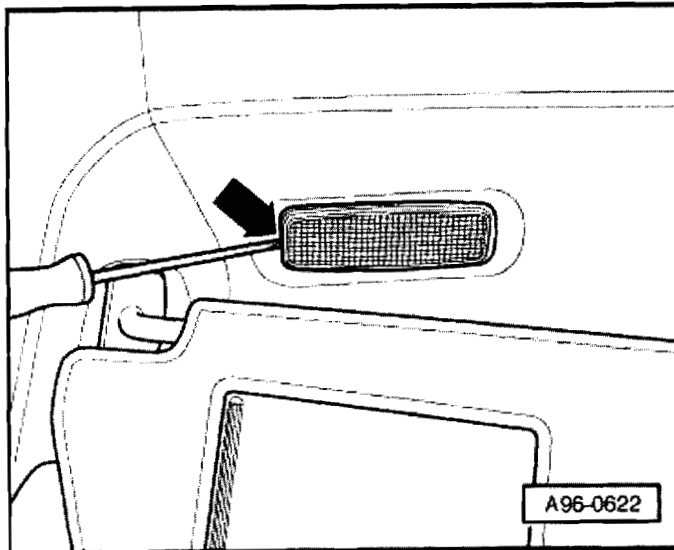
⇐ Carefully pry out vanity mirror light using a flat screwdriver at recess -arrow-

- Disconnect vanity mirror light connector

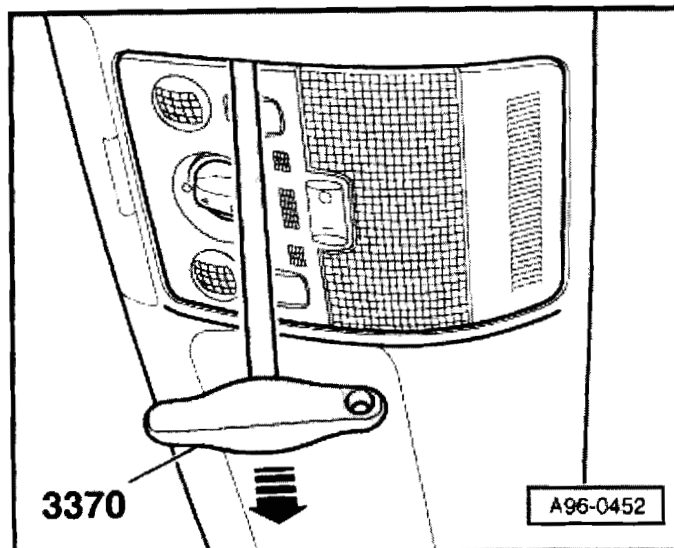
⇐ Carefully remove cover for map/reading light using 3370 special hook

- Disconnect electrical harness connector, if present

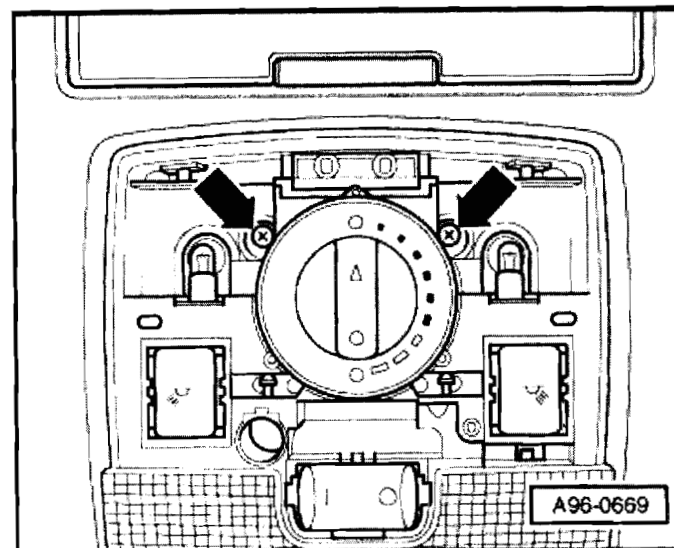
⇐ Remove bolts -arrows-

- Swing front interior map/reading light downward and remove it from opening of roof liner
- Disconnect all electrical harness connectors

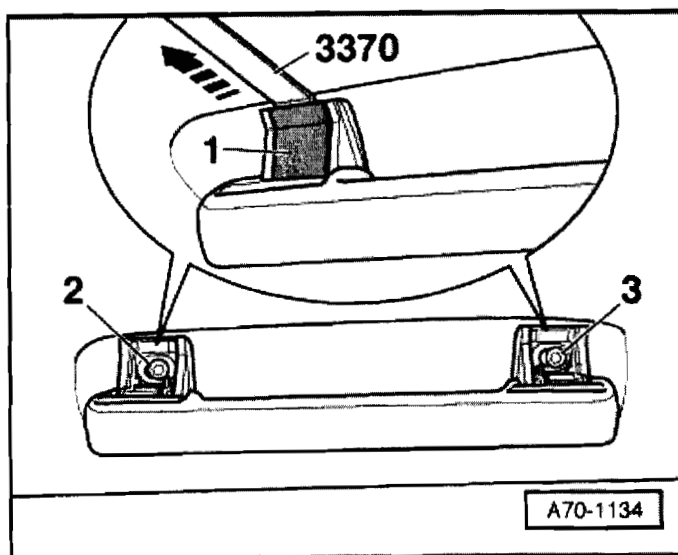
- ⇐ Open cover caps -1- on roof grab handle using 3370 special hook
- ⇐ Remove bolts -2- and -3-
- Remove all roof grab handles in similar manner

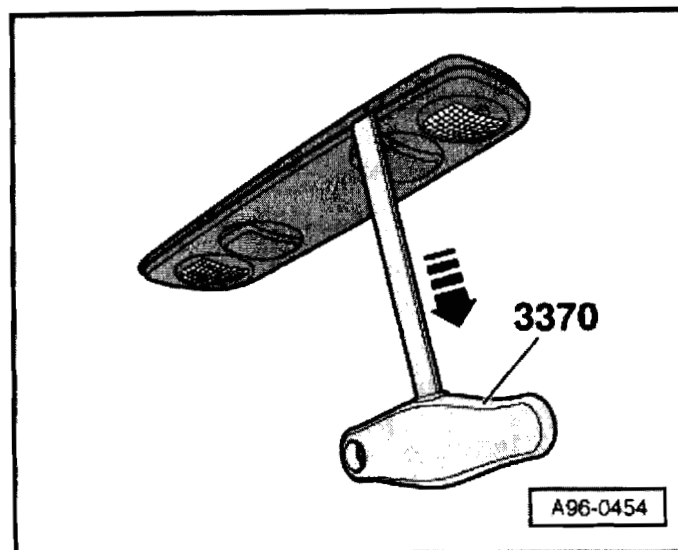
- ⇐ Carefully pull rear interior reading light out of opening in vehicle headliner using 3370 special hook
- Disconnect rear interior reading light connector

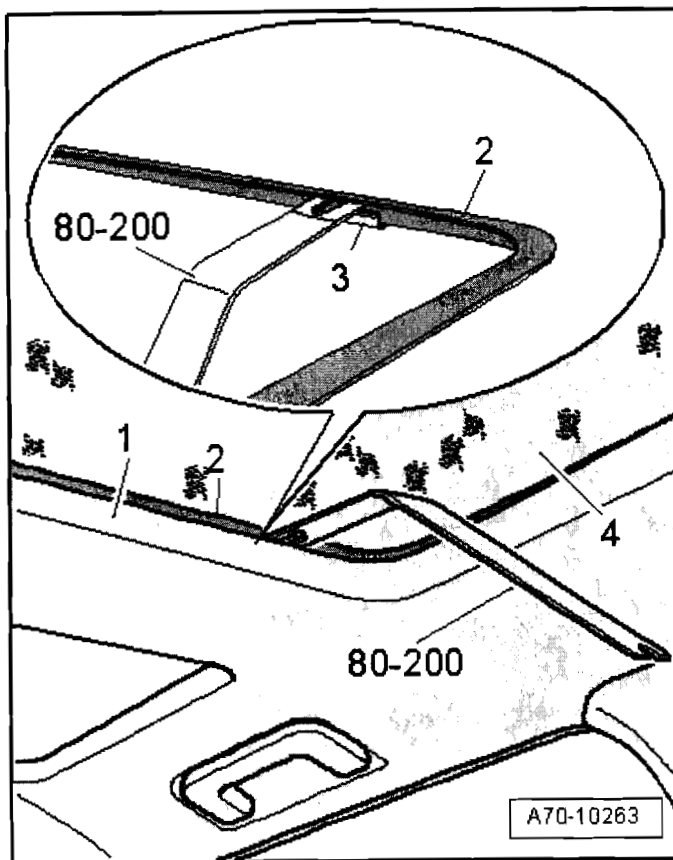
Note: Only for vehicles with Open Sky System

- Clean the 80-200 pry lever to prevent soiling of the molded headliner
- ⇐ Let 80-200 pry lever glide along between retaining frame -2- for sunroof cutout and molded headliner -1- until one of the retainers is touched
- ⇐ Disengage all retainers -3- in succession using 80-200 pry lever as shown in the illustration

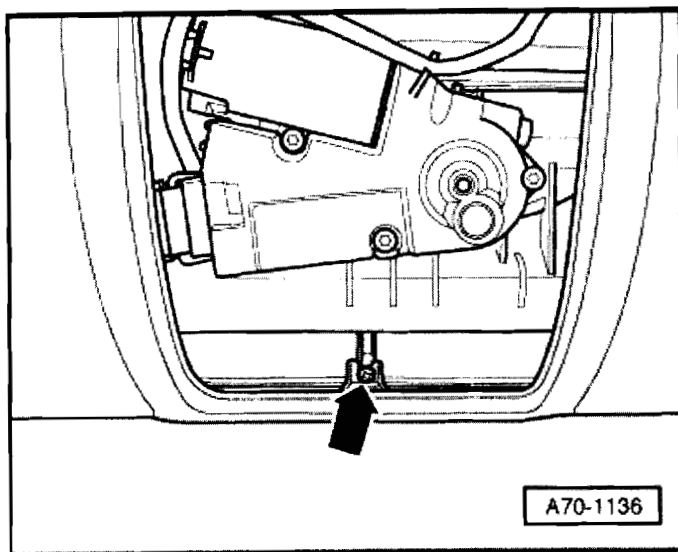
- ⇐ If present, remove bolt -arrow- in roof opening of front interior reading light

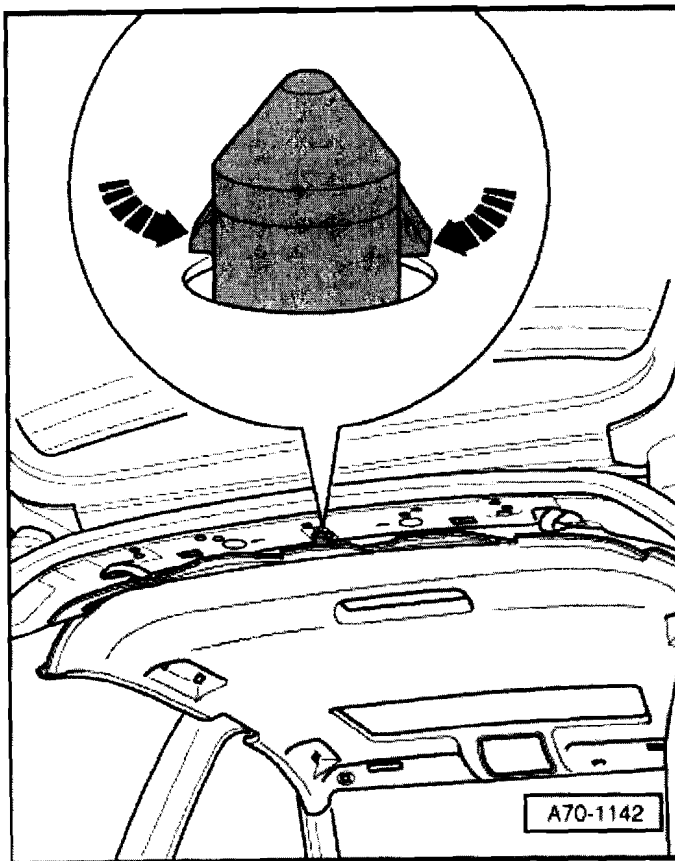
- ⇐ Disengage retainer at rear retaining clip
-arrows- using small hook tool

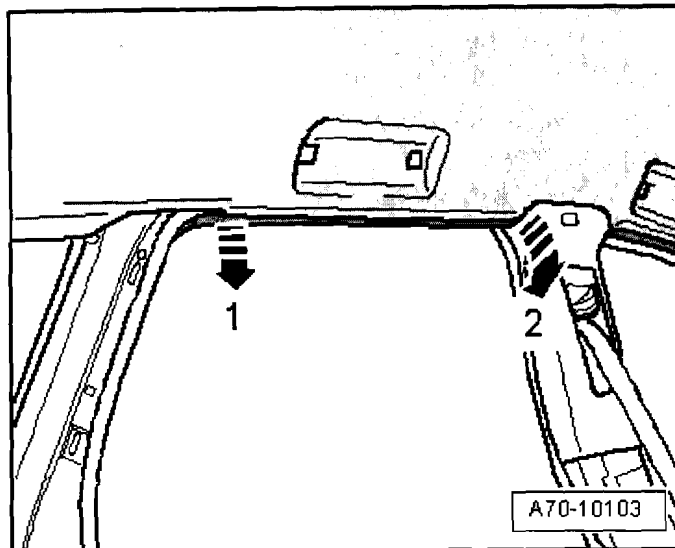
- ⇐ Pull molded headliner out of rubber lip of
door seal -arrow 1- starting at C-pillar
- ⇐ Carefully lift molded headliner over edge
of upper B-pillar trim -arrow 2-

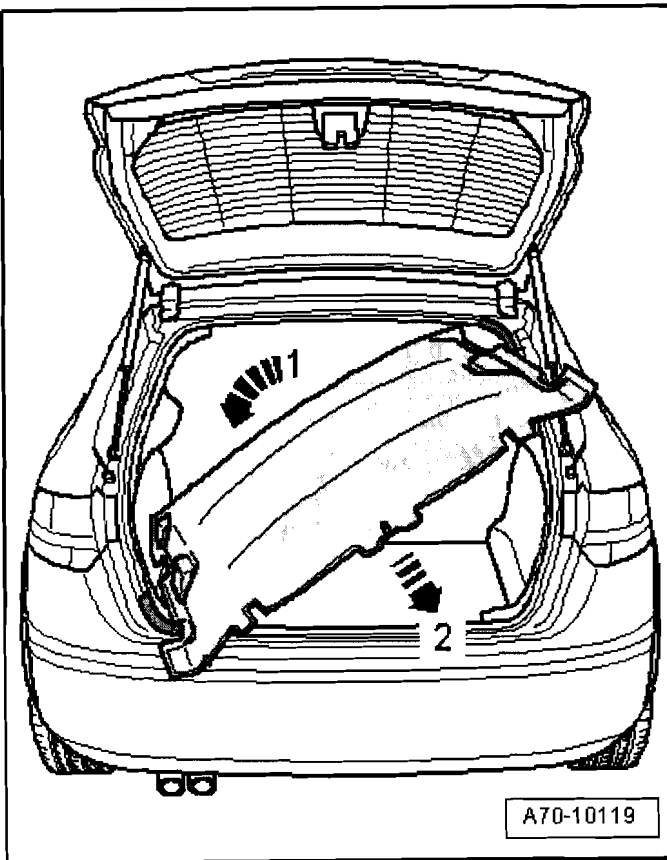
⇐ Lower molded headliner at left side of vehicle -arrow 1-

⇐ Remove molded headliner through rear lid opening -arrow 2-, with help from second technician

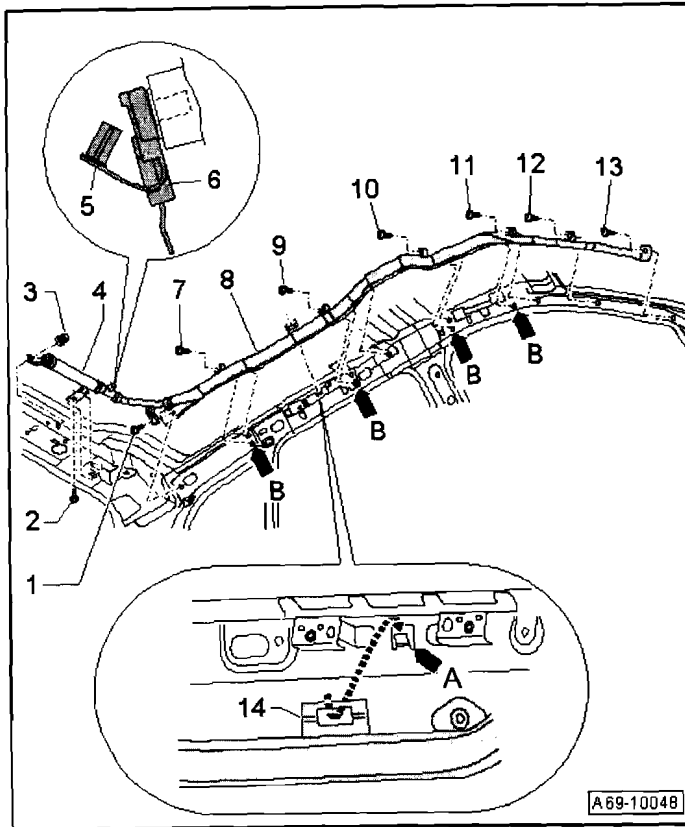
- ⇐ Disconnect electrical harness connector -6- by opening securing clip -5- using a screwdriver
- ⇐ Remove cap nut -3- at Ground (GND) pin
- ⇐ Remove bolts -1-, -2-, -7- and -9- through -13-
- ⇐ Disengage side curtain airbag -8- at retaining hook -arrow A- and remove

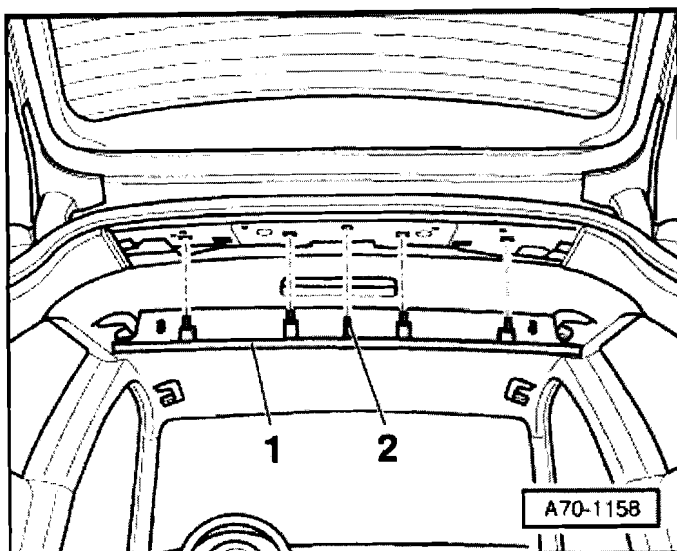
- ⇐ Press spring clips of roof end trim -1- into mounts on roof frame
- ⇐ Make sure that guide pin -2- engages in mounting hole

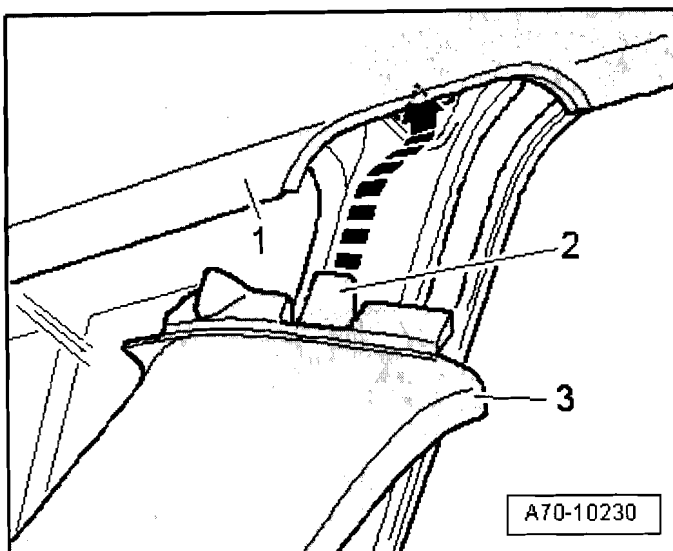
- ⇐ Insert upper C-pillar trim -3-, ensuring retaining tab -2- engages in body cut-out -arrow- and molded headliner -1-

- ⇐ Apply locking compound to bolt and reinstall; tighten to 3.5 Nm (31 in. lbs.)

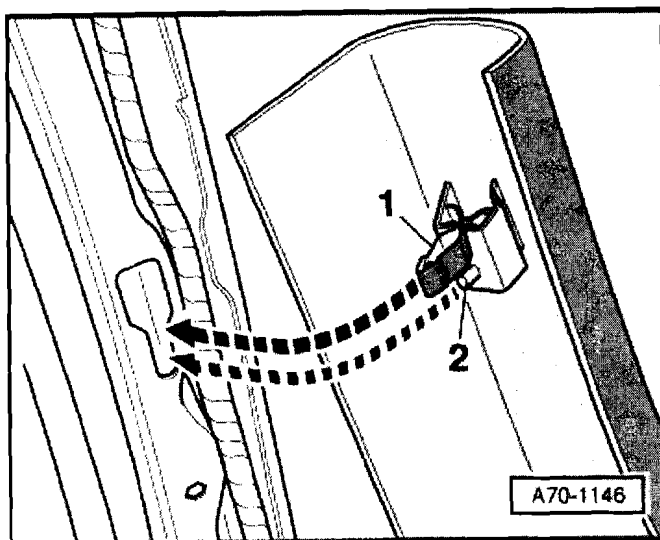
- Slide A-pillar trim into guide on instrument panel
- ⇐ When positioning A-pillar trim, make sure that guide pin -2- below the top retainer -1- can also be inserted into groove on A-pillar
- Pull rubber lip of door seal over edge of upper A-pillar trim
- Reinstall driver's seat being sure to remove VAS 6235 adapter and reconnect wiring harness
- Tighten seat rail bolts 40 Nm (30 ft. lbs.)
- Switch ignition on
