Safety Defect and Noncompliance Report Guide for Vehicles

PART 573 Defect and Noncompliance Report

Make(s): Orion Model Years Involved: 1987 – 1998 Model(s): I & V

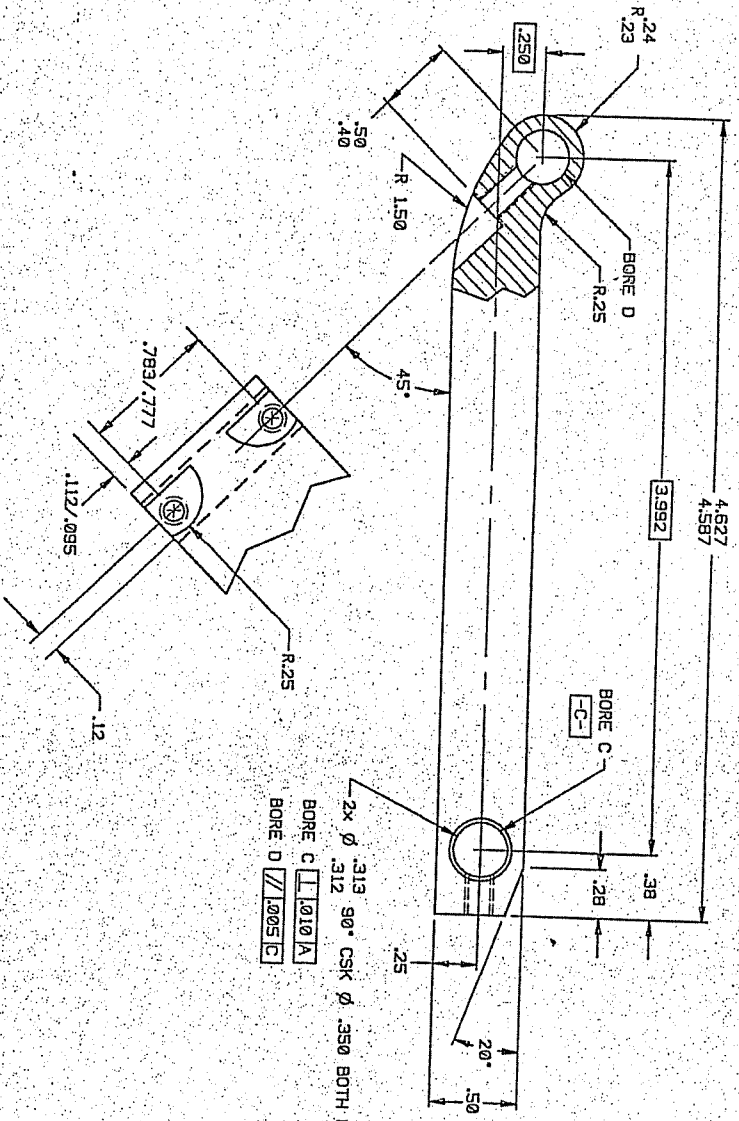
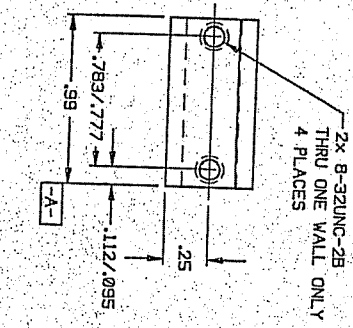
2X 8-32UNC-2B THRU ONE WALL ONLY 4 PLACES
