Recall Campaign 07V-178: Replace the Seat Occupancy Detection Mat

E63, E64 (6 Series)

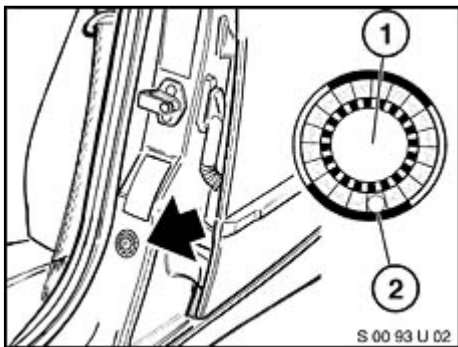
LABEL INSTRUCTIONS

This Recall Campaign has been assigned code number **491**. After the vehicle has been checked, and corrected if necessary, obtain a label (SD 92-320) and:

- emboss your BMW dealer warranty number in the middle of the label (1);
- punch out code number **491** (2) printed on the label and,
- affix the label to the **B** pillar as shown.
