Safety Recall Campaign Circular

Code: **JV**

**Subject: 2006 MY Audi A6 Avant Vehicles
Automatic Rear Lid Software**

September 2007

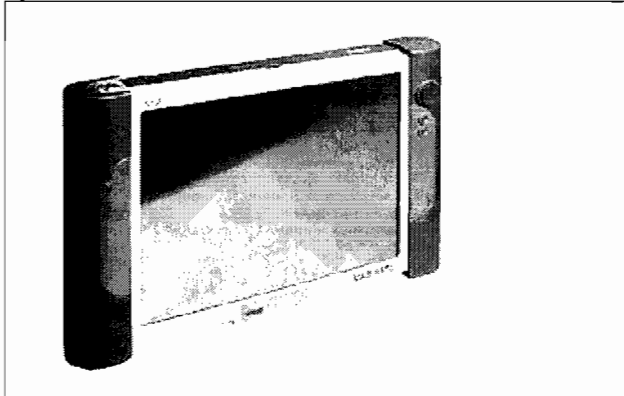
- Approved battery charger
- ← Vehicle diagnostic, measuring and information systems -VAS 5052-
- Adapter cable VAS 5052/3A
- Network connection cable VAS 5052/13
- Brand CD V. 11.55.00 or later installed

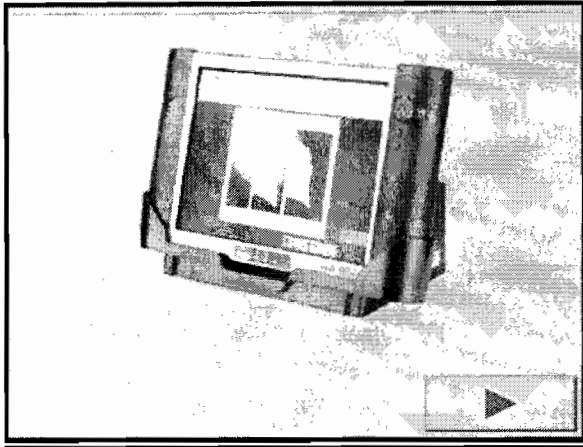
← The start screen shows the -VAS 5052-

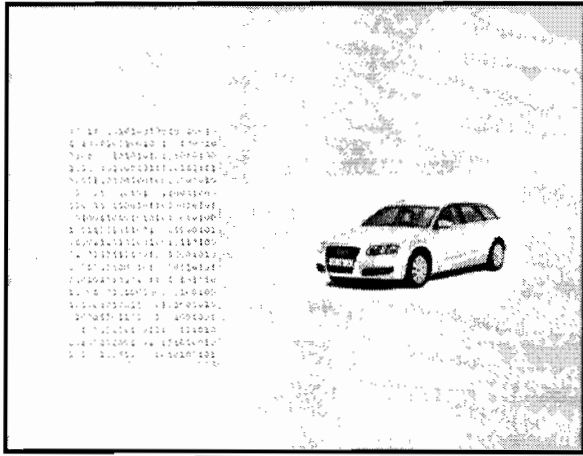
← When this screen is displayed, both tailgate drives will then be flashed. Wait until the software update is completed

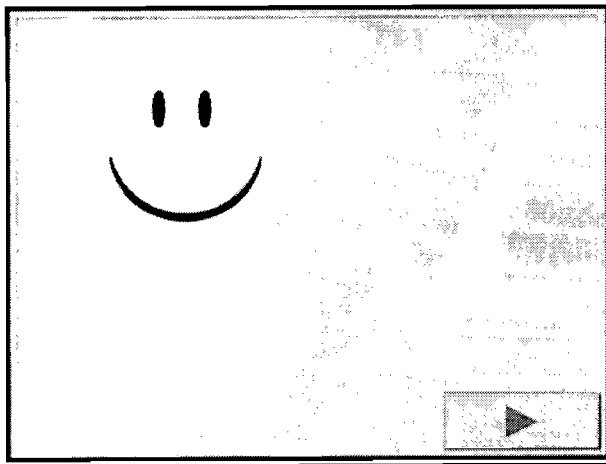
- ← If this screen display appears, the software update was successful
- Press the 'Next' button (▶)

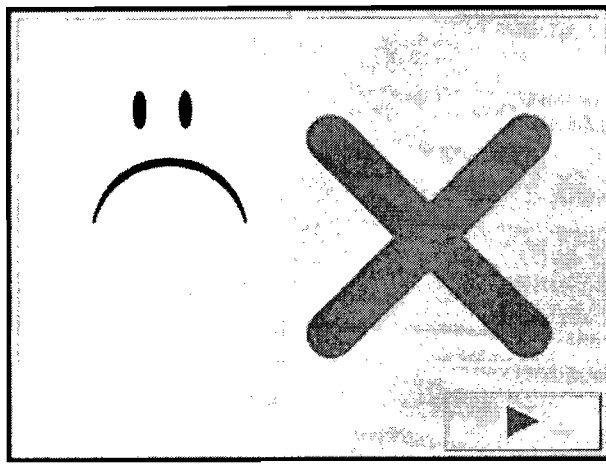
- ← If this screen display appears, the software update was not successful
- Make a note of the error number displayed on the screen
- Press the 'Next' button (▶)
- If the update was unsuccessful – **do not continue to Section C**
